Transportation Safety Board
of Canada

AVIATION INVESTIGATION REPORT A10A0032

RUNWAY EXCURSION

**CARGOJET AIRWAYS LTD.
BOEING 727-225, C-GCJZ
MONCTON, NEW BRUNSWICK
24 MARCH 2010**

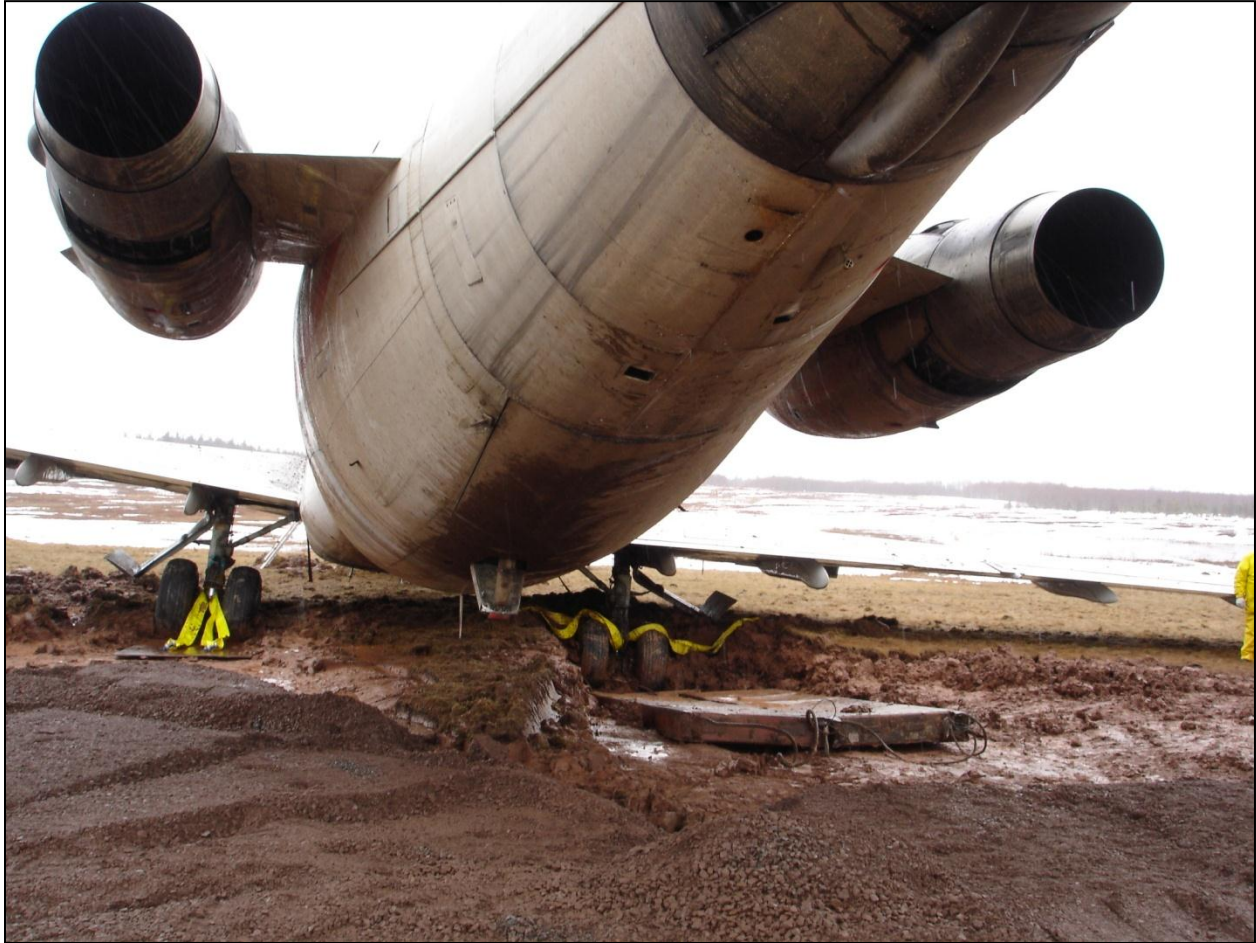
paved surface with an indicated airspeed of approximately 50 knots. The aircraft came to a stop in deep mud approximately 27 seconds after touching down on Runway 06 (see Photo 1). Maximum manual wheel braking was applied shortly after touchdown, and maintained by the flight crew throughout the entire landing roll.

Photo 1. Occurrence Aircraft Stuck in Mud (Photo taken during recovery)

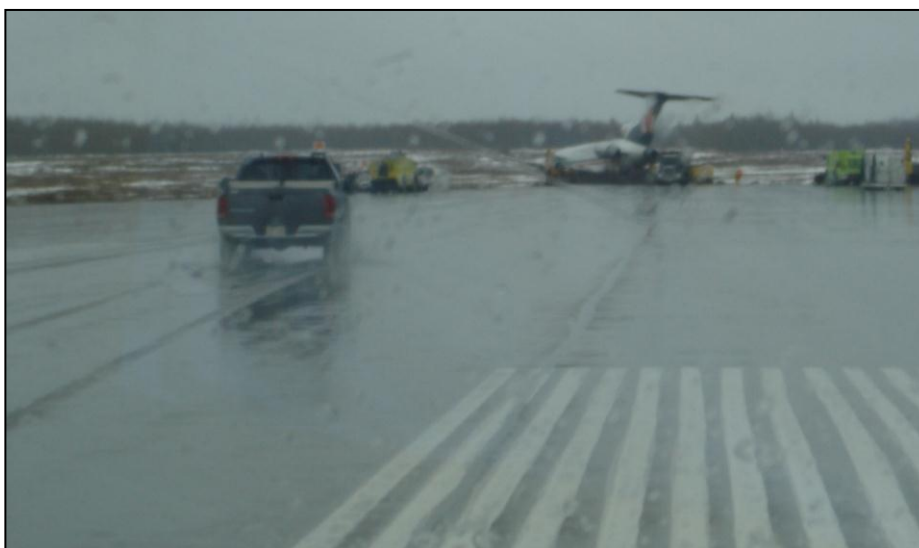
After the aircraft had been shut down, and firefighters were on-scene, standing water ² was observed on Runway 06 (see Photo 2). There was no indication of ice or slush present on the runway surface.

Photo 2. Water visible on Runway 06 (photo taken a few hours after occurrence)

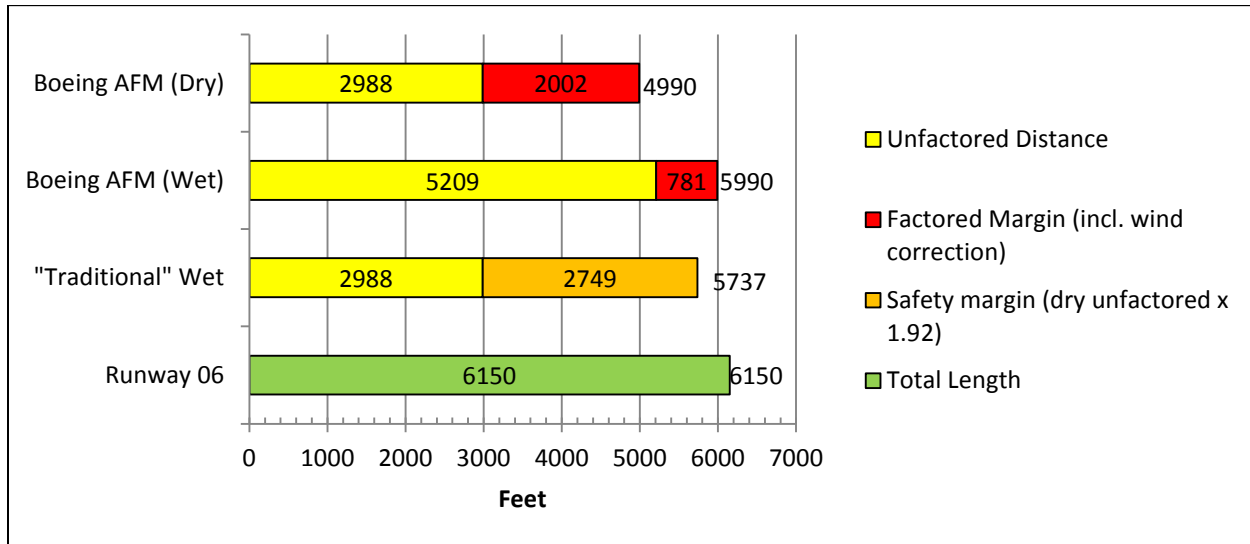
Figure 1. Comparison of AFM Dry/Wet Landing Distances versus Usable Runway (LDA)

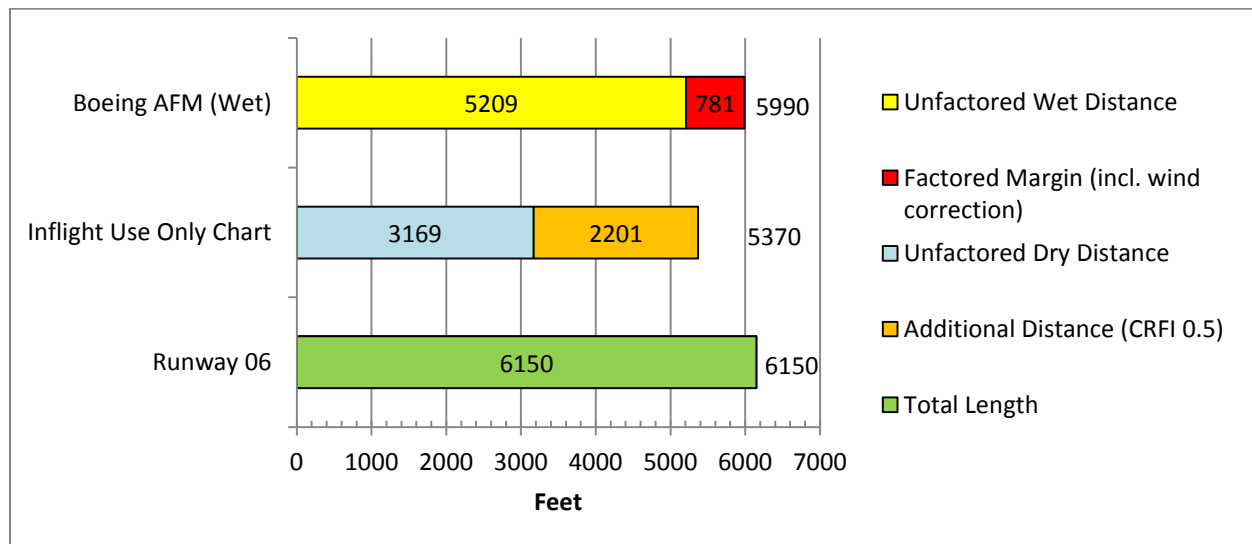
Figure 3. Comparison of AFM versus Cargojet “Landing Distance - Inflight Use Only” chart

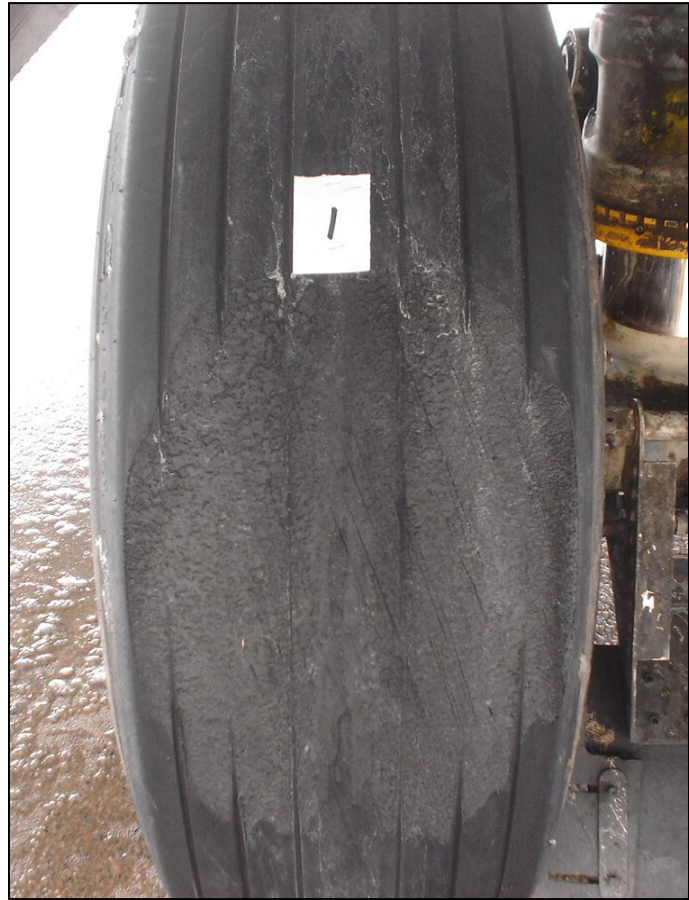
One type of hydroplaning is called reverted rubber hydroplaning, which occurs with a non-rotating or skidding tire on a surface covered with a thin water layer up to and including standing water. The heat generated by this type of hydroplaning can leave steam-cleaned marks on the runway surface and can cause rubber to revert to its original uncured state.

In this occurrence, steam cleaned marks were not detected on the runway after the incident. However, all four of the B727's main landing gear tires exhibited damage consistent with reverted rubber hydroplaning (see Photo 3).

Photo 3. Reverted Rubber Occurrence Aircraft Tire

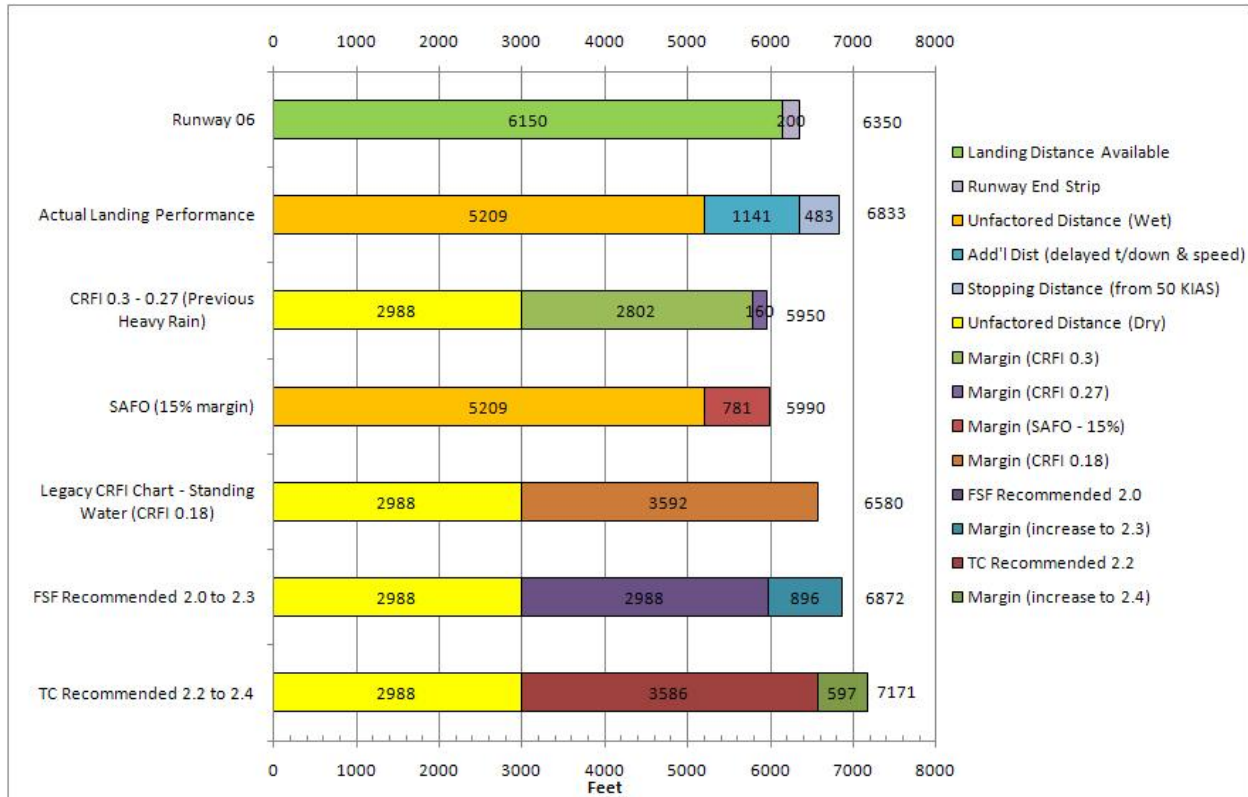
Figure 4 below provides a comparison of the actual landing performance⁶² of the aircraft in this occurrence compared to the calculated landing distances based on the various recommended safety margins suggested by SAFO 06012, the Flight Safety Foundation, Transport Canada, and previous CRFI equivalent values for heavy rain and standing water.

Figure 4. Comparison of Recommended Wet Adjustments to Landing Distance
