AIRCRAFT ACCIDENT REPORT AND EXECUTIVE SUMMARY

Reference:	CA18/2/3/8805	
Aircraft Registration	ZS-NLY	Date of Accident	16 July 2010		Time of Accident	1715Z
Type of Aircraft	De Havilland Dash 8-300		Type of Operation	Domestic Scheduled Flight		
Pilot-in-command Licence Type		Airline Transport	Age	26	Licence Valid	Yes
Pilot-in-command Flying Experience		Total Flying Hours	4 575.4		Hours on Type	1 524.9
Last point of departure		O.R. Tambo International Aerodrome (FAJS)				
Next point of intended landing		Kimberley Aerodrome (FAKM)				
Location of the accident site with reference to easily defined geographical points (GPS readings if possible)						
On runway 20 at FAKM (GPS position; South 28° 48.545' East 024° 45.868' elevation 3 910 feet AMSL)						
Meteorological Information		Surface wind; 310°/2kt, Temperature; 3°C, Visibility; +10 km				
Number of people on board	2+2+40	No. of people injured	0	No. of people killed	0	
Synopsis						
<p>On 16 July 2010 at 1715Z flight SA1107, a de Havilland Dash 8 with registration ZS-NLY, collided with a wild animal (aardvark/anteater) shortly after touchdown on runway 20 at Kimberley aerodrome. The accident occurred at night. The impact was on t

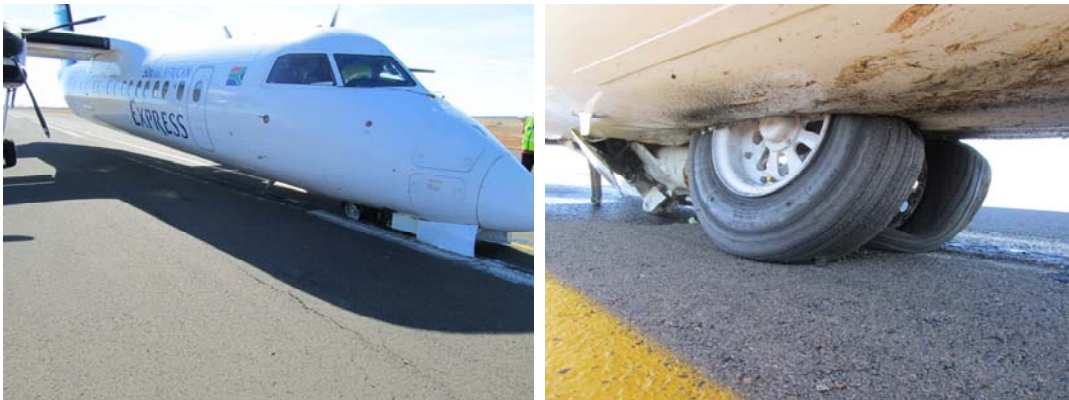
- 1.3.1 The aircraft sustained substantial damage to the nose landing gear and lower nose fuselage structure.

Figure 1. A view of the aircraft as it came to rest on the runway with the nose gear collapsed backwards.

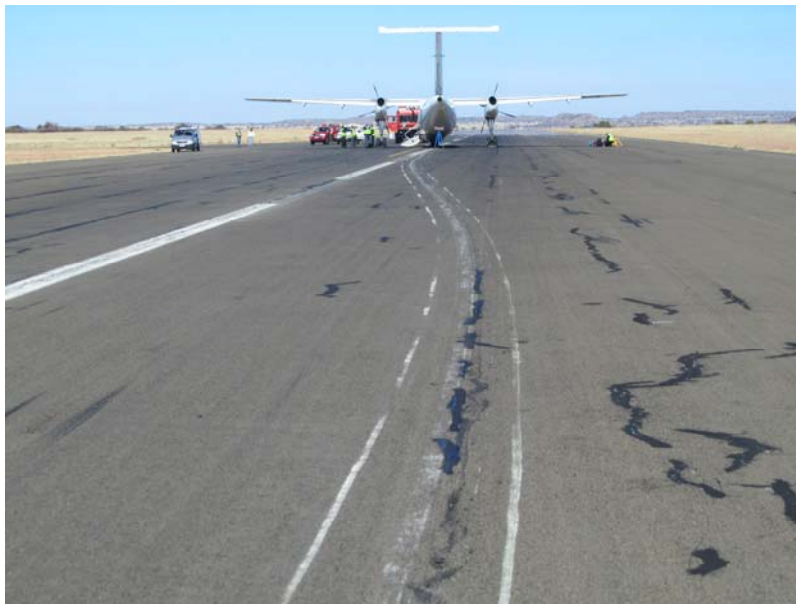
The pilot managed to keep the nose of the aircraft up for a further 479 m past the point of impact. Although both nose wheel tyres were found to be deflated, there was a clear blowout on the right nose wheel tyre some 400 m past the point where the nose gear had first made contact with the runway surface. Fourteen (14) m past the tyre blowout marking, both nose gear doors started making contact with the runway surface, followed by the nose gear strut assembly some 186 m further on. The aircraft came to a halt on the runway centre line 1 838 m past the threshold of runway 20.

Figure 4. A view of the nose gear strut assembly and the gear doors scraping on the runway.

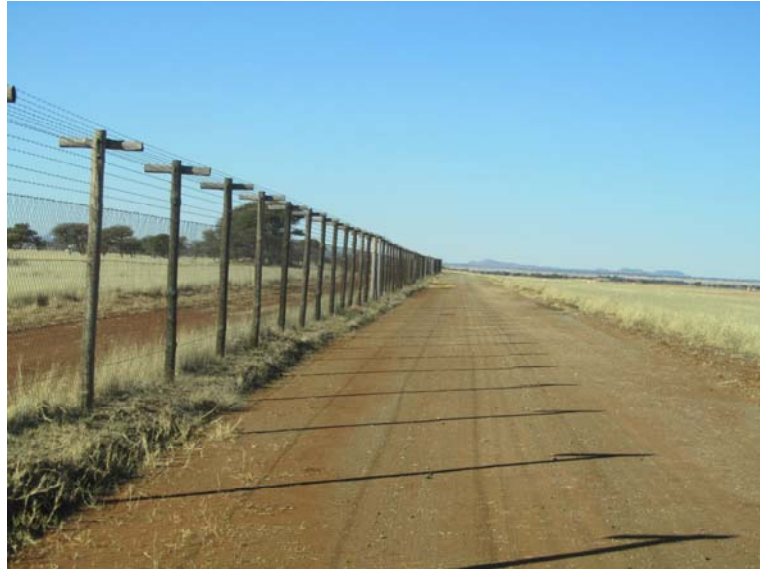
Figure 6. A general view of the aerodrome perimeter fence, consisting of wire meshing.

3.3.1 The aerodrome fence had been constructed without a proper foundation, which allowed animals to dig holes and trenches underneath the fence in order to gain access to the aerodrome property, thereby easily migrating from one side of the fence to the other.

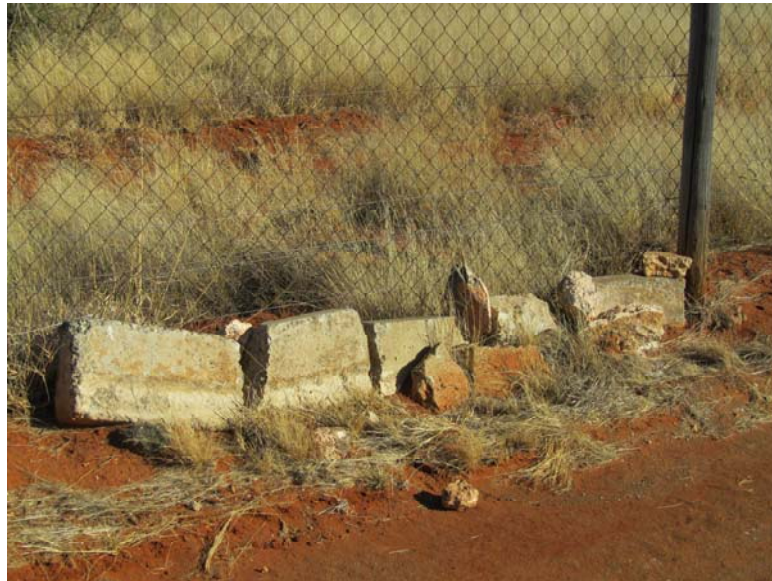
Figure 7. A section of the fence where concrete blocks were used to restrict animal access.

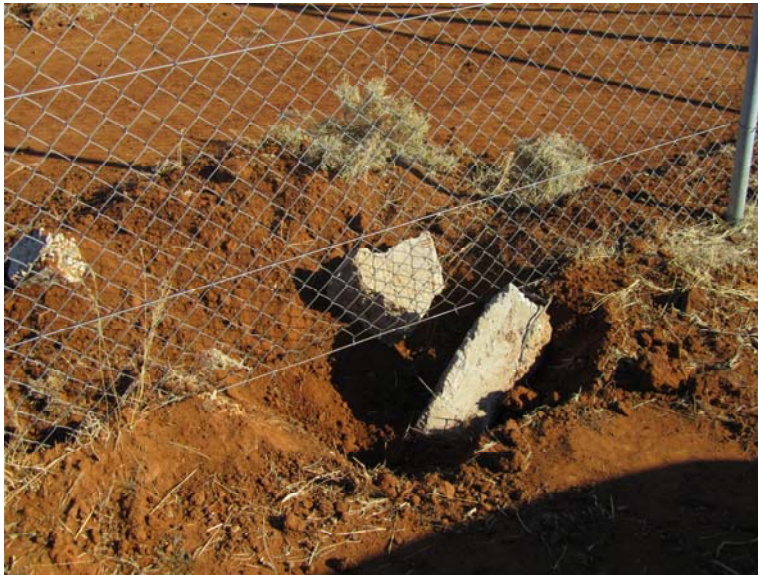
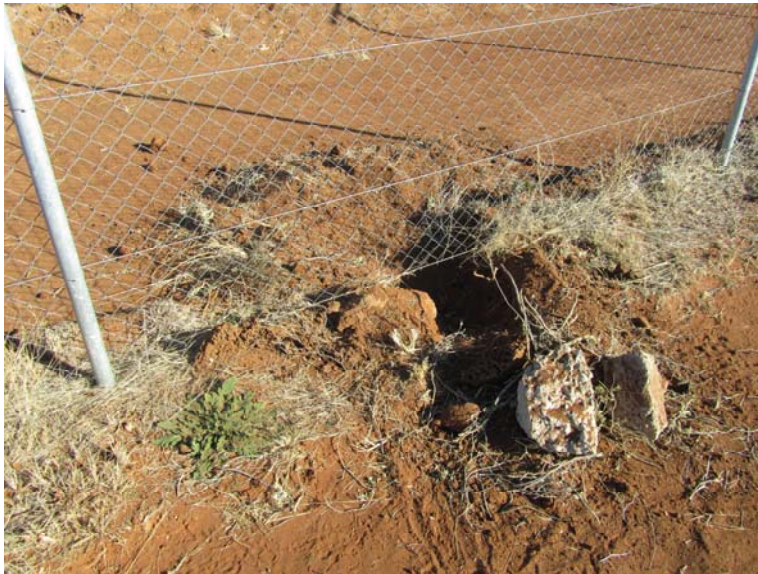
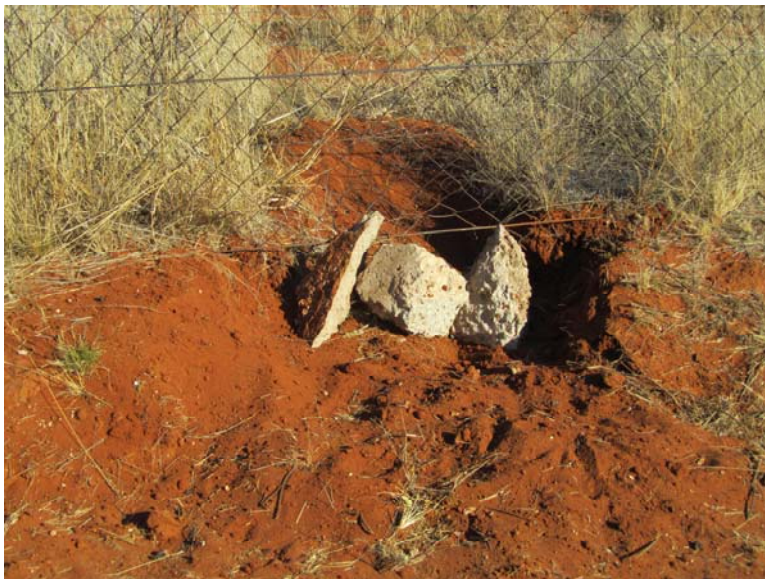
Figure 8. A substantial hole that was previously closed up and then dug open again.

Figure 9. A substantial hole that was previously closed up and then dug open again.

Figure 10. A substantial hole that was previously closed up and then dug open again.

- 3.1.20 A perimeter fence inspection the day after the accident revealed several holes, dug underneath the fence. Temporary repairs were found to have been performed on a number of these holes in order to close them, but they were found to be dug open again.

- 4.11 That the SACAA Division of Aviation Security increases its ad hoc/surveillance inspections at aerodromes known to be prone to wildlife activity. During the investigation process it was noted that some of the holes that animals dug underneath the perimeter fence were substantial in size and could easily be utilized by criminals to gain access to aerodrome property. This is seen as a serious security threat and should be treated as such.

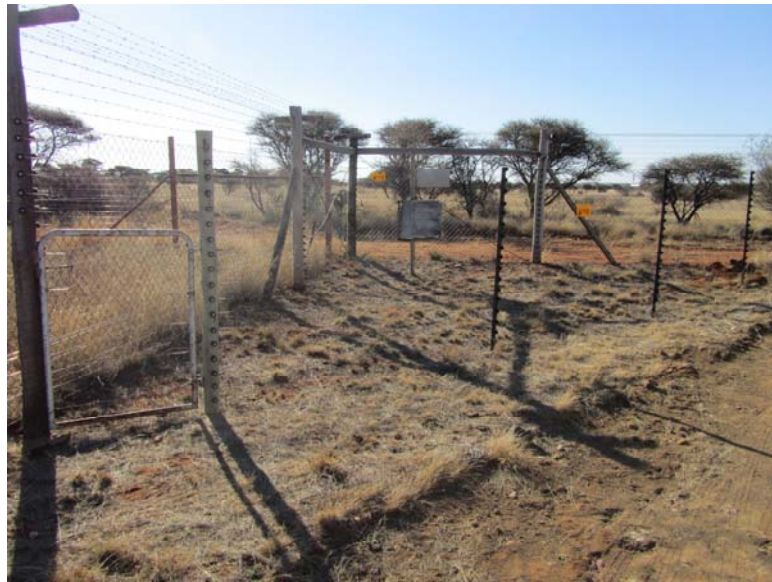
Figure 11. The solar panel was located in the designated area behind the electric fence.

- 3.1.21 A certain section of the perimeter fence used to be electrified, however it was found that the electrical supply to the fence had been disabled due to the fact that the solar panel that powered the fence was reportedly stolen on 22 June 2010.

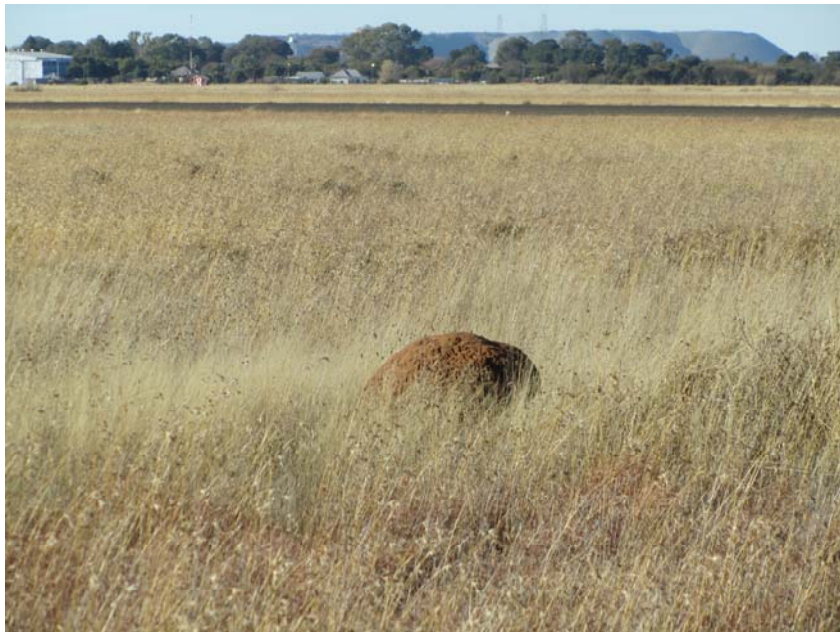
Figure 13. A general view of the aerodrome property with runway 02/20 in the background.

At the time of the accident, the grass on the aerodrome property between the runways was approximately 0.5 m in height. As a result most of the termite mounds were hardly visible, even if a person was in close proximity to them. This acted as ideal camouflage/shelter for wild animals and birds that might have roamed the aerodrome property.

- 3.1.22 The grass between the runways was found to be approximately 0.5 m in height, which allowed for good camouflage for certain species of wildlife on the aerodrome property.

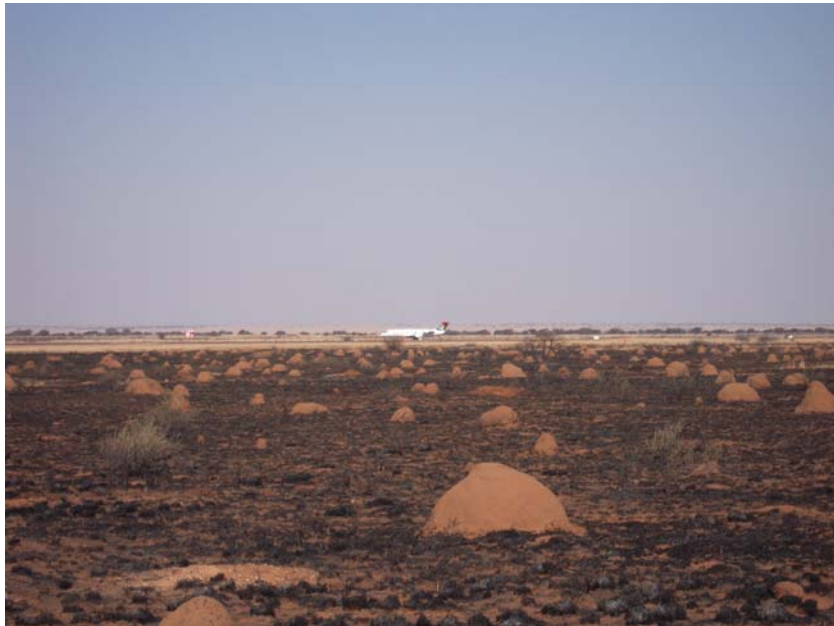
At the time the investigating team visited the aerodrome again, being 5 August 2010 several of the areas were still not subjected to any burning (still grass covered). It could however, be seen from the photo that there was indeed a serious termite mound population within the boundaries of the aerodrome property. It was noted during the visit in question that the aerodrome licence holder had indeed commence with a program whereby they had obtained the services of a contractor to start demolish these termite mounds by making use of earth moving equipment.

Figure 14. A view of the termite mounds located on the north-western side of the aerodrome.

- 4.2 That the aerodrome licence holder, in collaboration with Nature Conservation and the Endangered Wildlife Trust, engage on a proactive programme to manage the termite problem at FAKM.
- 4.3 That night operations at the aerodrome are restricted until the aerodrome licence holder has implemented a corrective action plan in accordance with the wildlife animal management programme.
- 4.4 During the investigation it was noted that the approved Aerodrome Operations Manual on record with the SACAA was last updated on 29 March 2007. It is recommended that an updated/amended copy of the Aerodrome Operations Manual be placed on record with the regulating authority.

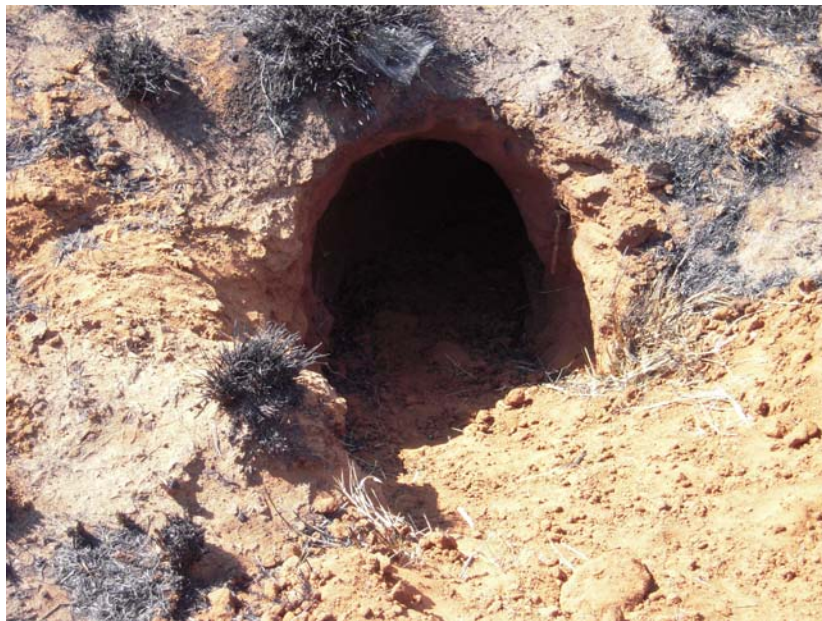
During the inspection of the aerodrome property, many animal holes/shelters of different sizes were observed. Most of the holes appeared to be new/recent and active in nature. These holes provided ideal shelter for several animal species, including the aardvark.

Figure 15. The photo displays one of many animal holes/shelters on the aerodrome property.

- 3.1.24 Several animal holes were found on the aerodrome property, which provided shelter for many different species of animals, including the aardvark.
