**MINISTRY OF TRANSPORT
DIRECTORATE GENERAL FOR TRANSPORT ACCIDENTS INVESTIGATIONS**

FINAL REPORT

“Henri Coandă” International
Airport Bucharest

AIRCRAFT	Boeing 737-300
REGISTRATION	YR-BGC
DATE AND TIME	12/30/2007 / 11:27 LT (09:27UTC)

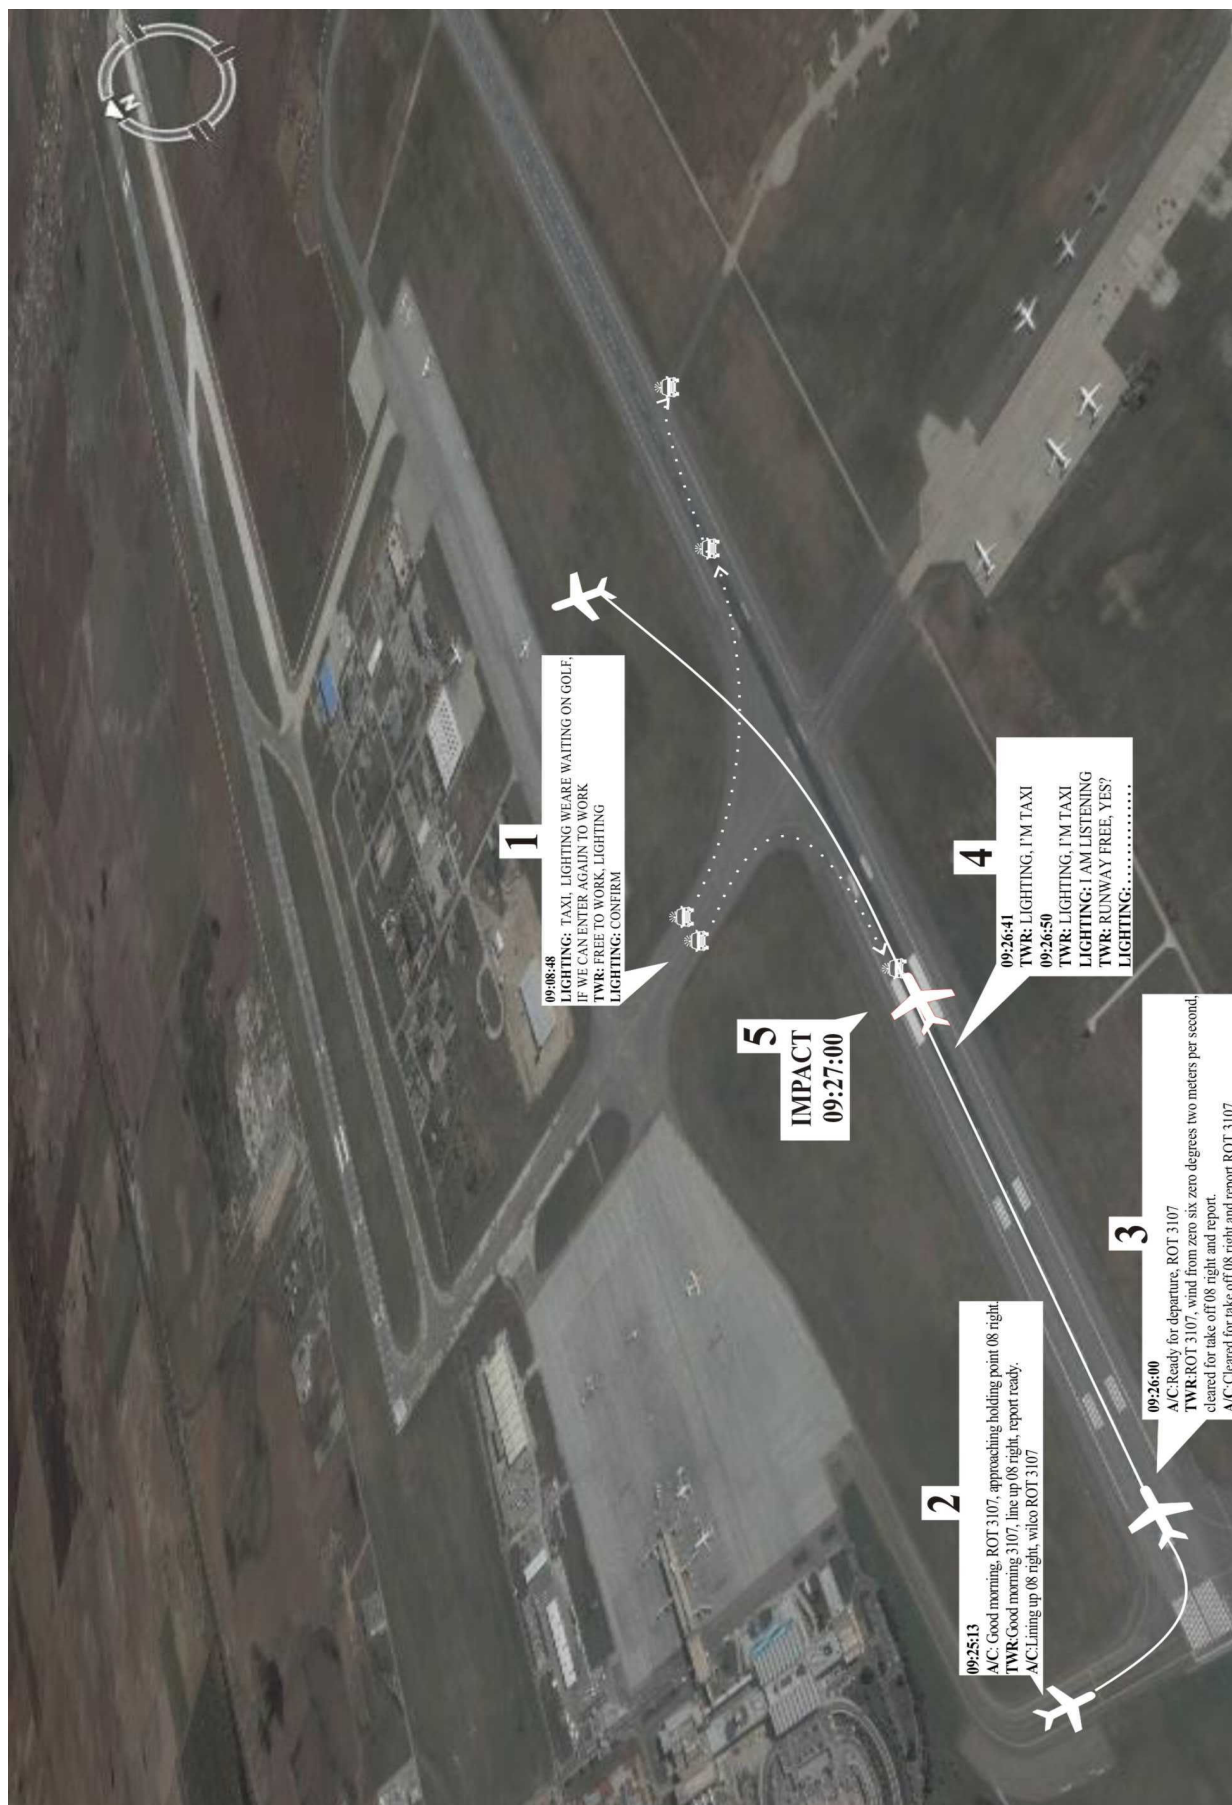
Sketch of the Accident Development

Following the impact the aircraft was damaged and exceeded the runway stopping around 137 m left of the centre line and around 950 m from the threshold 08R.

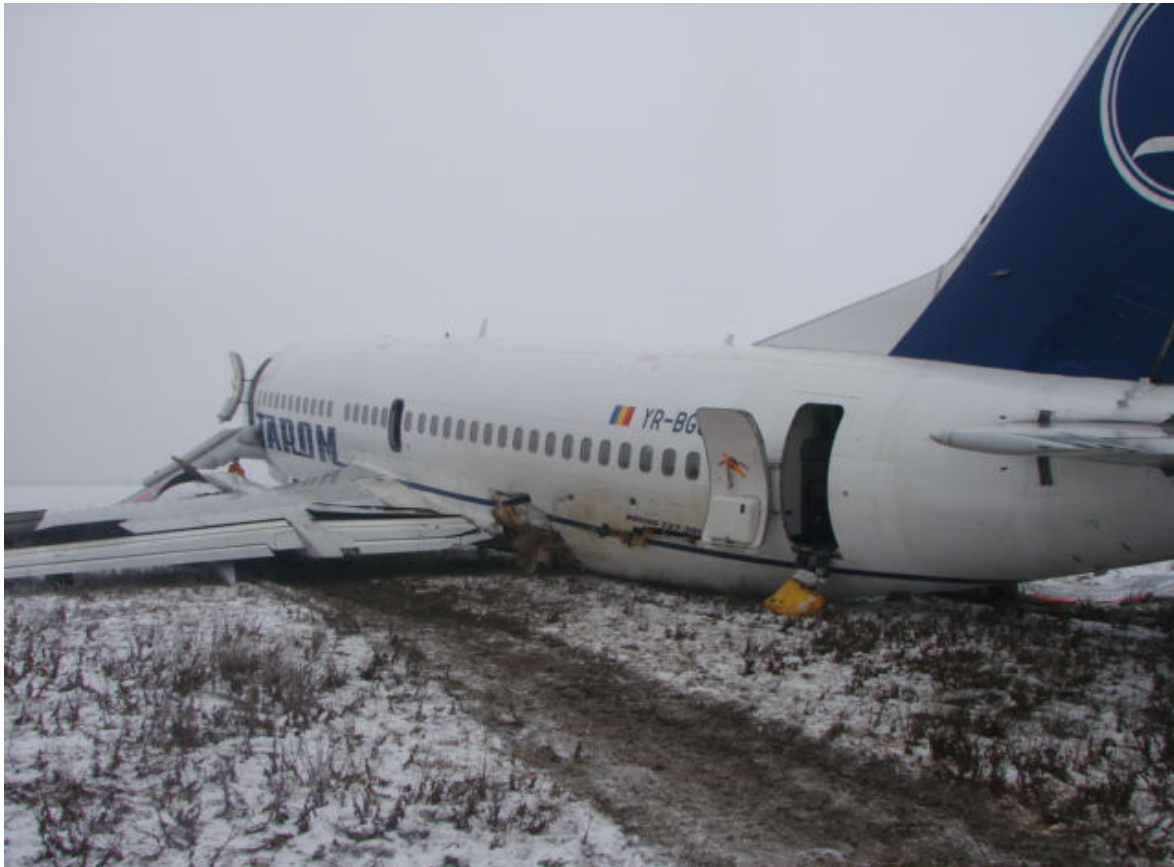
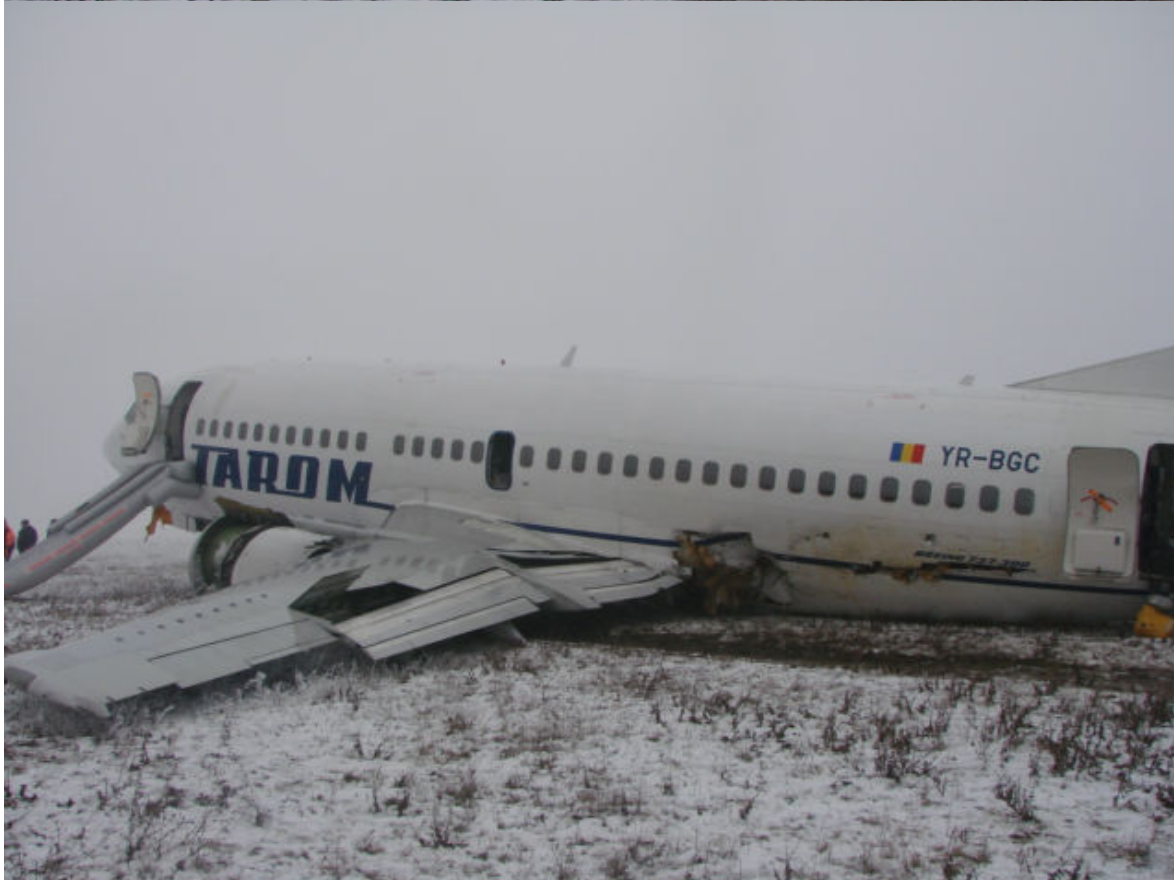
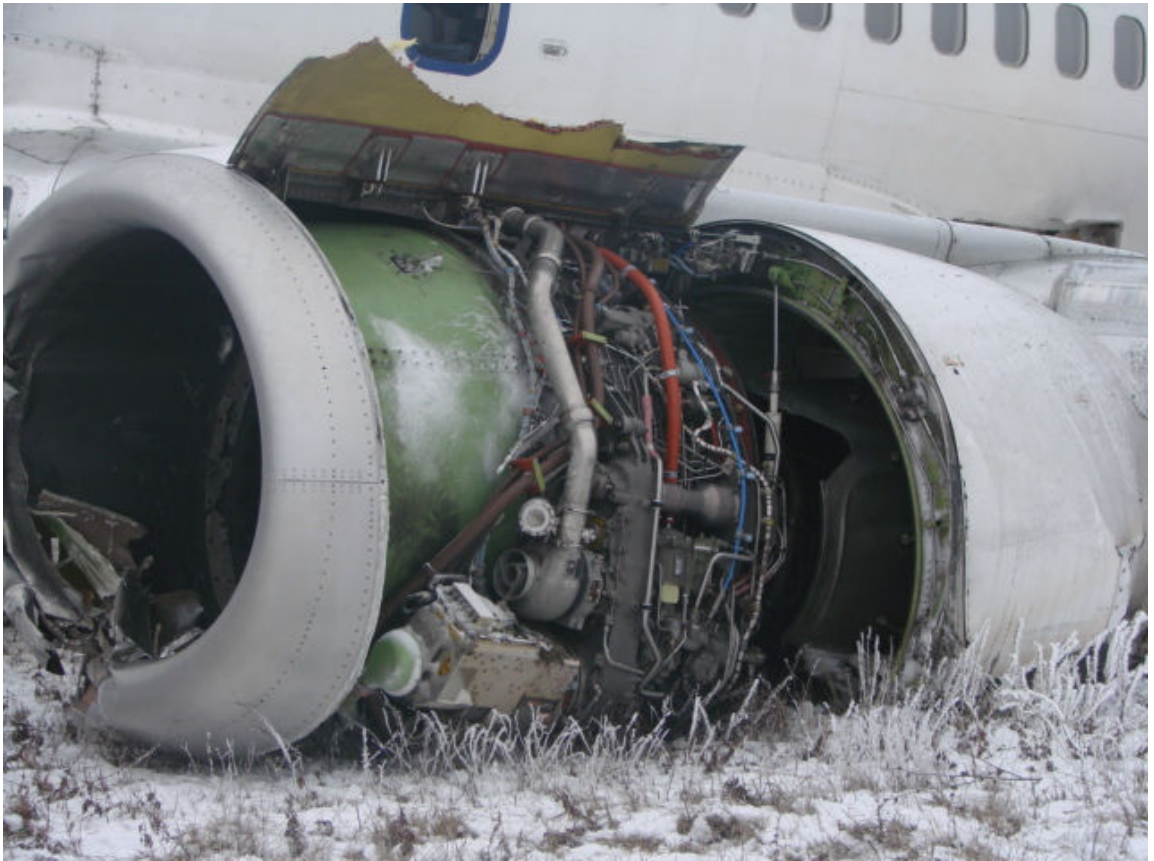
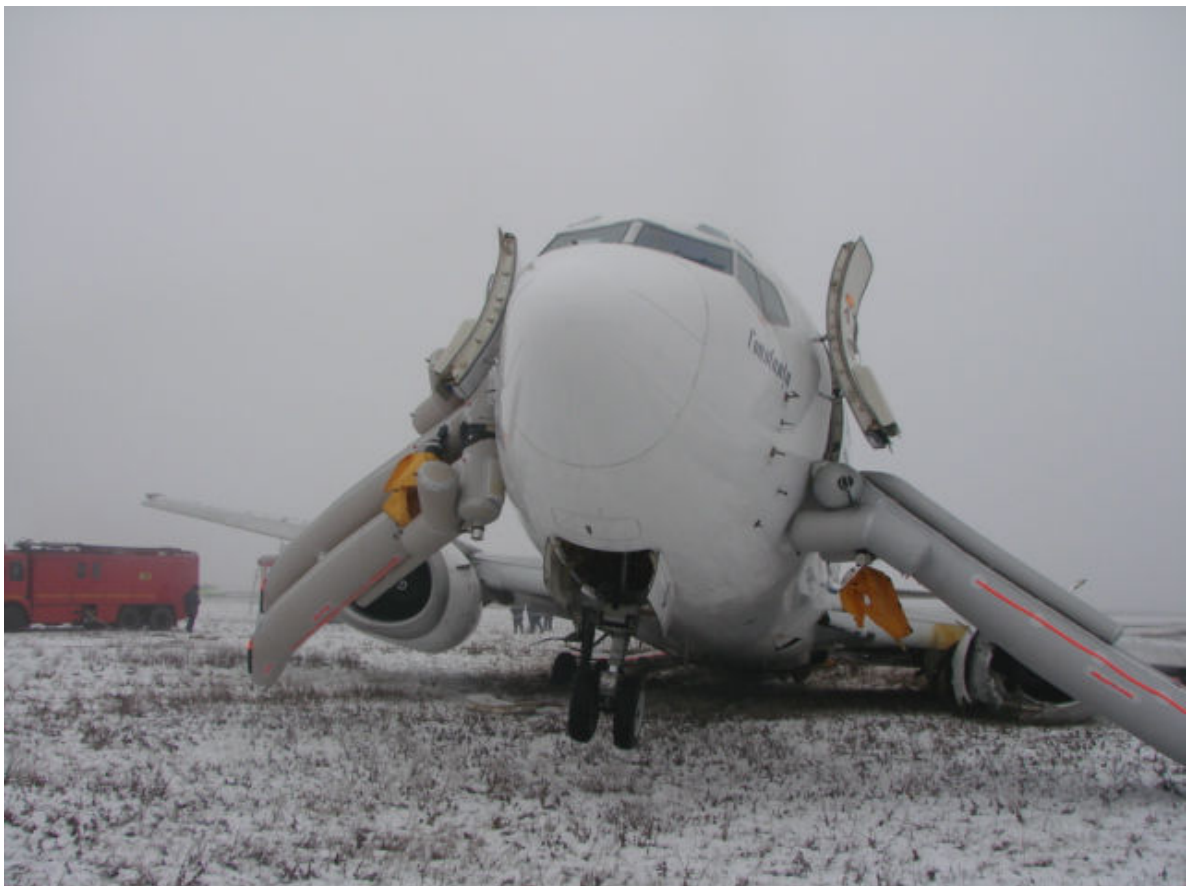
Photos of the Aircraft

The impact determined following damages of the aircraft:

- a. Landing gear: main left landing gear smashed away;

- b. Fuselage damaged by the impact between the main landing gear compartment and the left rear access door;
 - c. Engine no.1 completely damaged due to impact with the car and the ground;
 - d. Left wing affected over its entire span.
 - e. Structural deformation also in other sections of the aircraft.
- The aircraft was declared „total loss” - completely damaged.

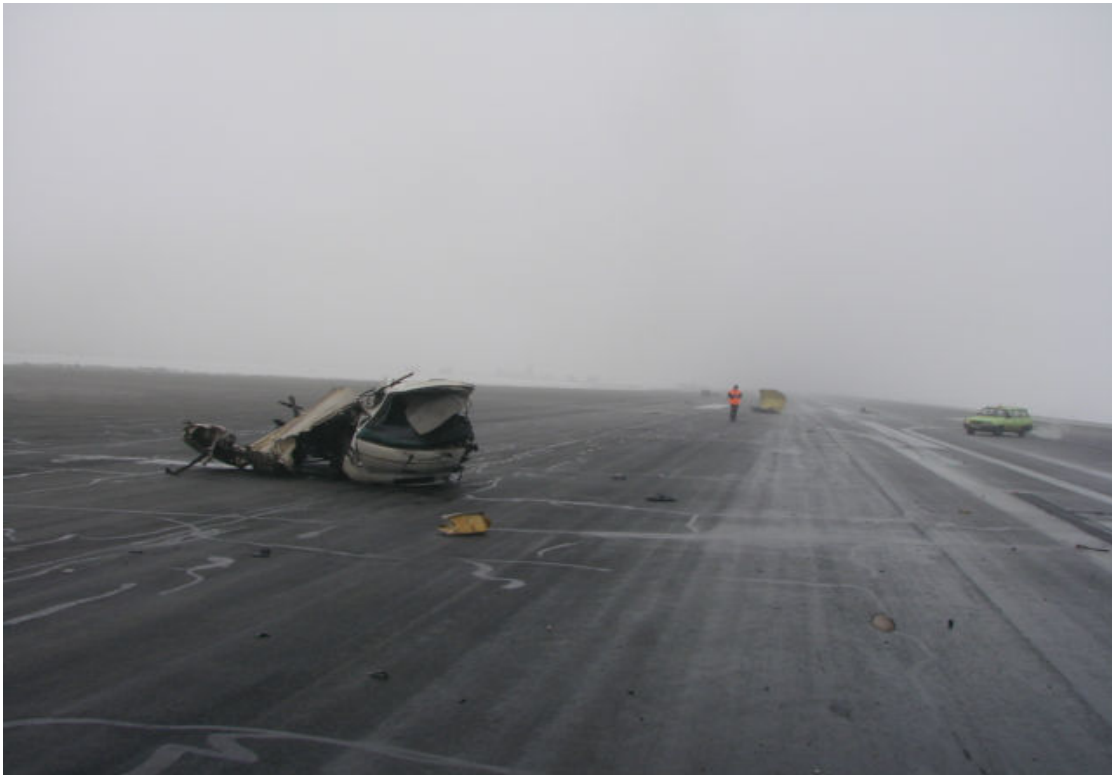
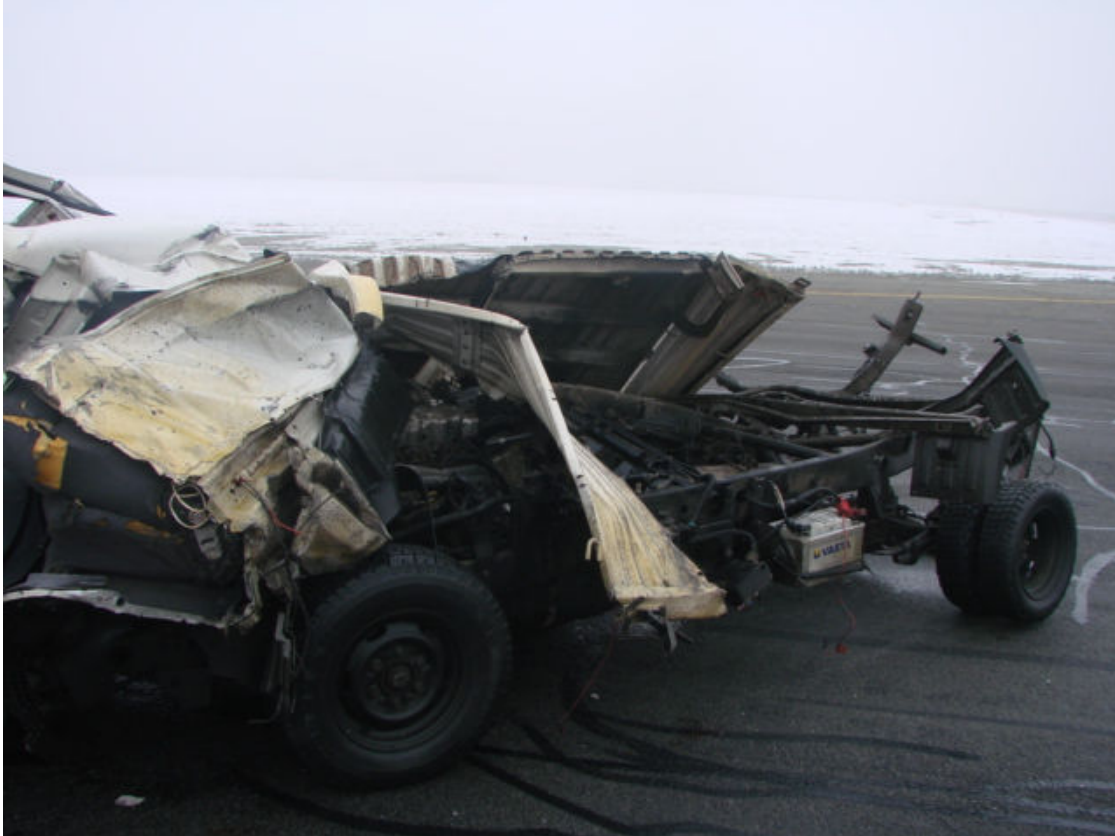
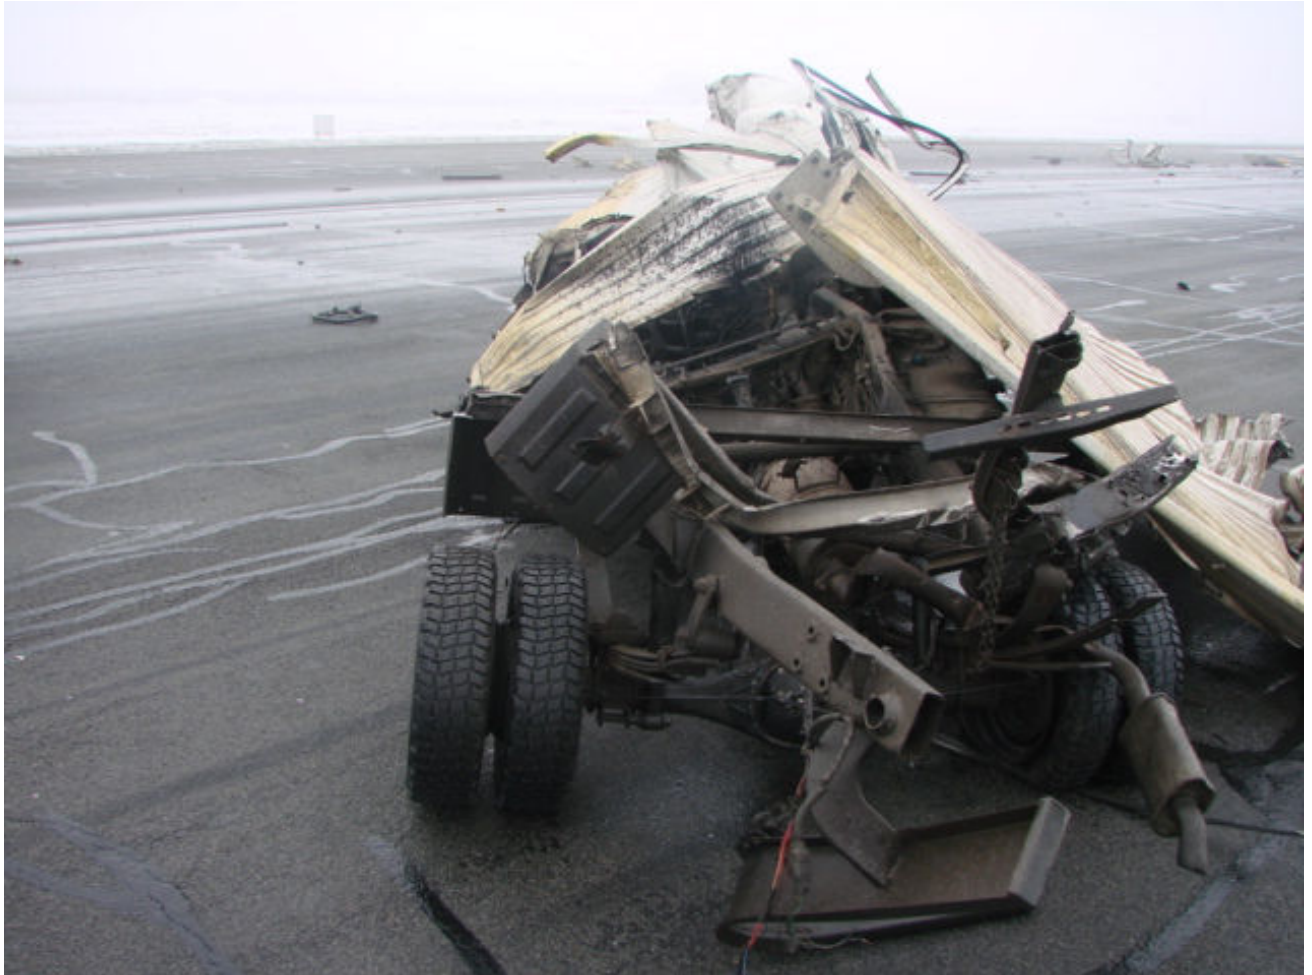
Photos of the Vehicle

The vehicle no. 1 was completely destroyed in the impact with the aircraft.
