# **McDonnell Douglas (Boeing) MD-83**

### Aircraft Accident Report No: 4/2003 (EW/C2001/5/1)

| Aircraft Type: | McDonnell Douglas (Boeing) MD-83 |
| Registration: | EC-FXI |

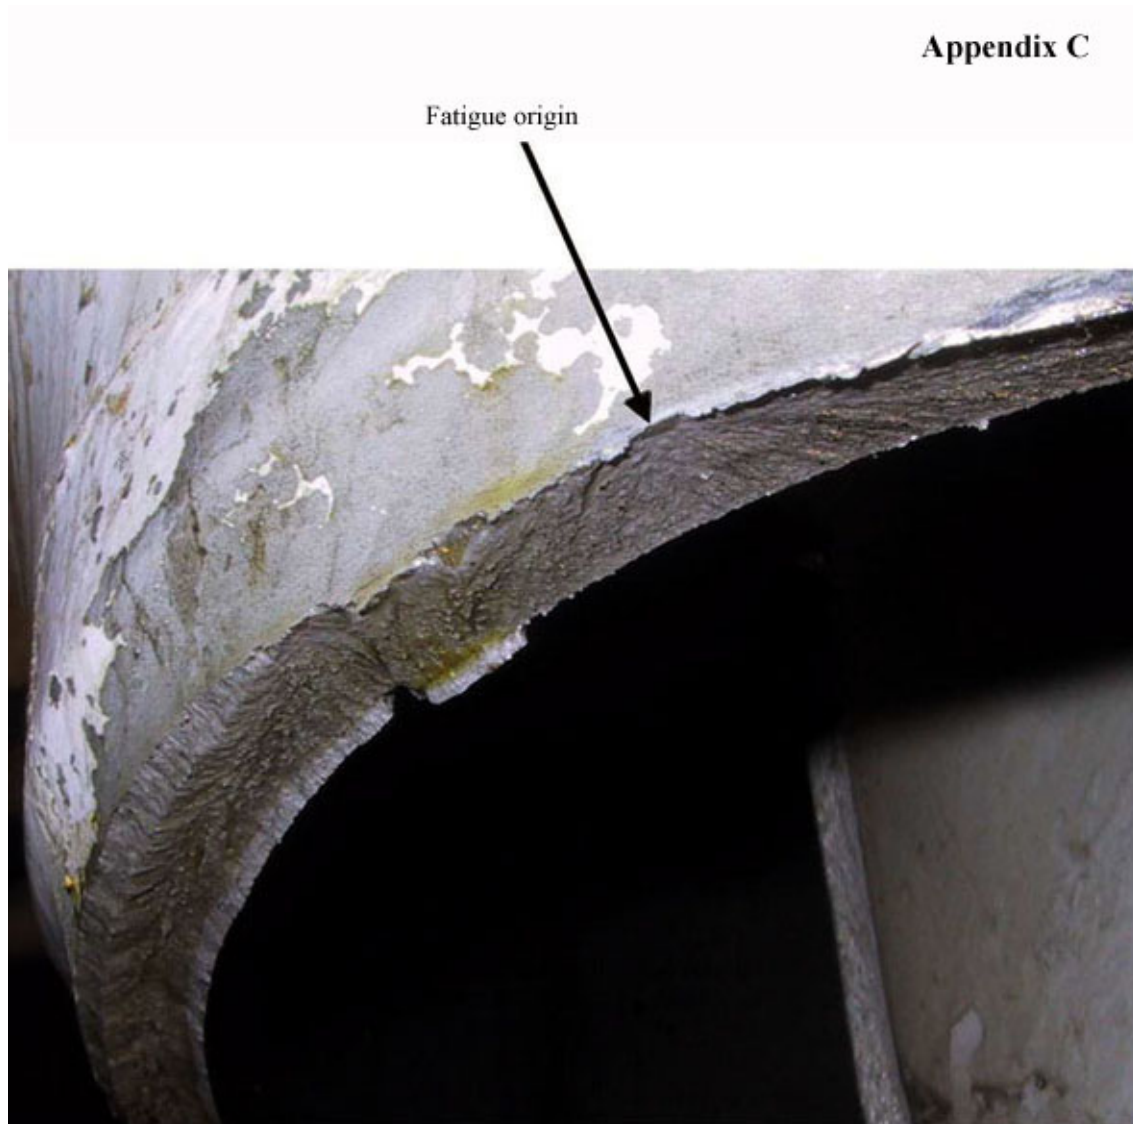
**Appendix C: 'As found' picture of upper half of fractured MLG cylinder showing the major fatigue crack**

The right wing was raised using airbags, allowing closer inspection of the cylinder fracture face. As with G-DEVR, the vast majority of the face bore signs of fast, ductile rupture, with distinctive 'chevron' features pointing towards an origin at the front face of the cylinder (Appendix C). Here, a small fatigue crack could be discerned, again similar in location and dimensions to the one observed on G-DEVR

The lower half of the fracture face was despatched for metallurgical examination in the United Kingdom under AAIB supervision. The upper half was despatched to BCA for independent examination. Both subsequent reports agreed on the presence of a fatigue crack measuring 1.0 mm deep and 3.2 mm wide at the cylinder surface in the area identified on-site. There were multiple initiation sites within this major crack and, additionally, smaller fatigue cracks were identified either side of the major crack over a chord length of about 40 mm.

'As found' picture of upper half of fractured MLG cylinder showing the major fatigue crack (arrowed)

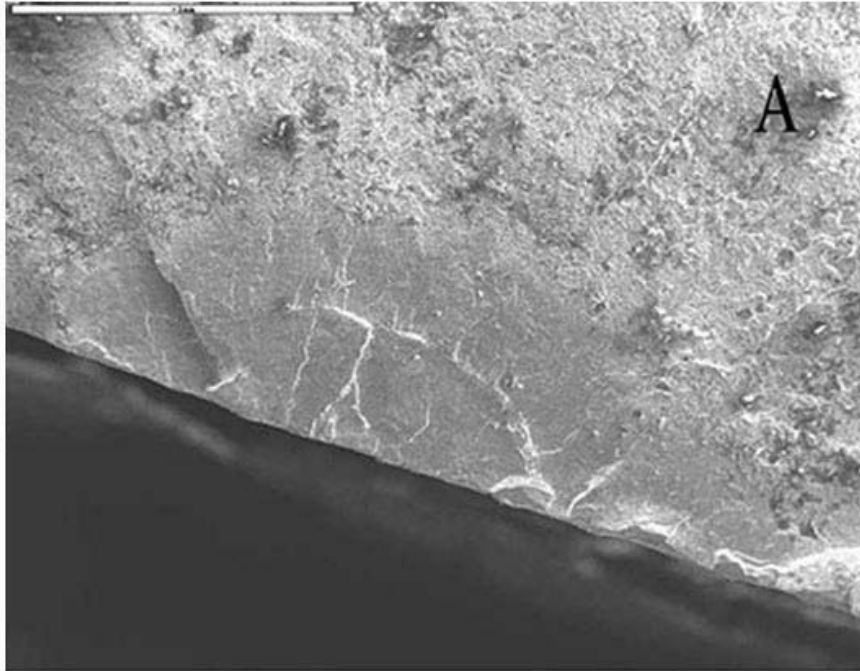
Scanning electron microscope secondary image of major crack

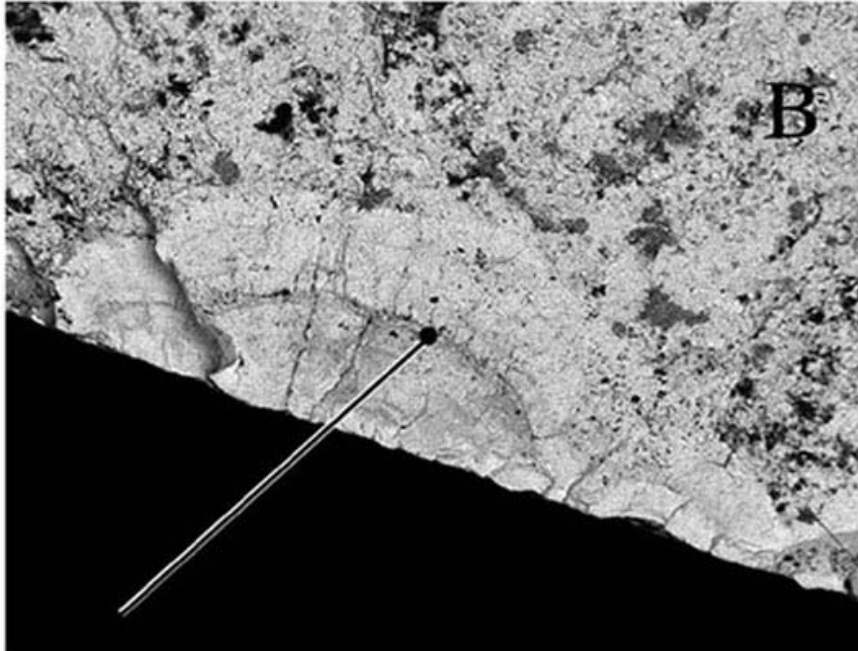
One feature which was noted was the presence of a growth band (visible as a distinct ridge) across roughly half of the crack depth (Appendix D). Analysis of this area using Energy-Dispersive X-ray showed the presence of quantities of Cadmium in the inner boundary of this area which were not present outside it.

Scanning electron microscope backscatter image of major fatigue crack

Note clearly visible growth band (arrowed)  
within which high levels of Cadmium were found

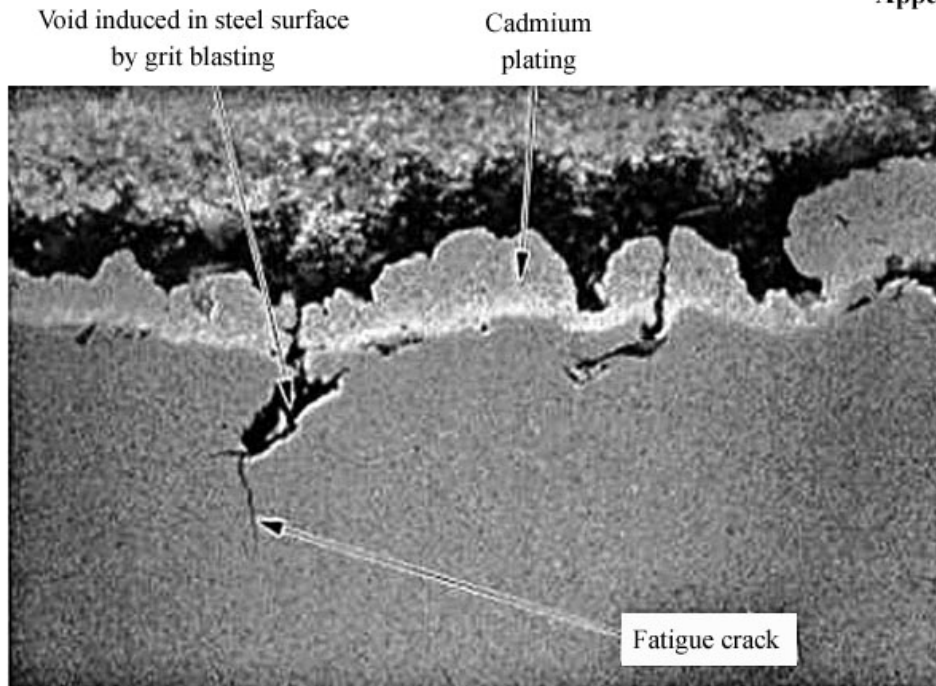
The reason for this recommendation was that the metallurgists working for the AAIB during the G-DEVR investigation felt that, based on the micro-sections of the surface, the grit-blasting operation performed prior to Cadmium plating was causing a high degree of smearing of the peened finish, leading to sharp-edged voids and even embedded alumina grit, which were potential initiation sites for fatigue. Indeed, in the opinion of the AAIB's metallurgists, it could be seen that embryonic fatigue cracks were growing from some of the deeper and sharper stress-raising voids.

SEM photograph of the surface finish of the failed cylinder from G-DEV R  
Note embryonic fatigue crack growing from imperfection

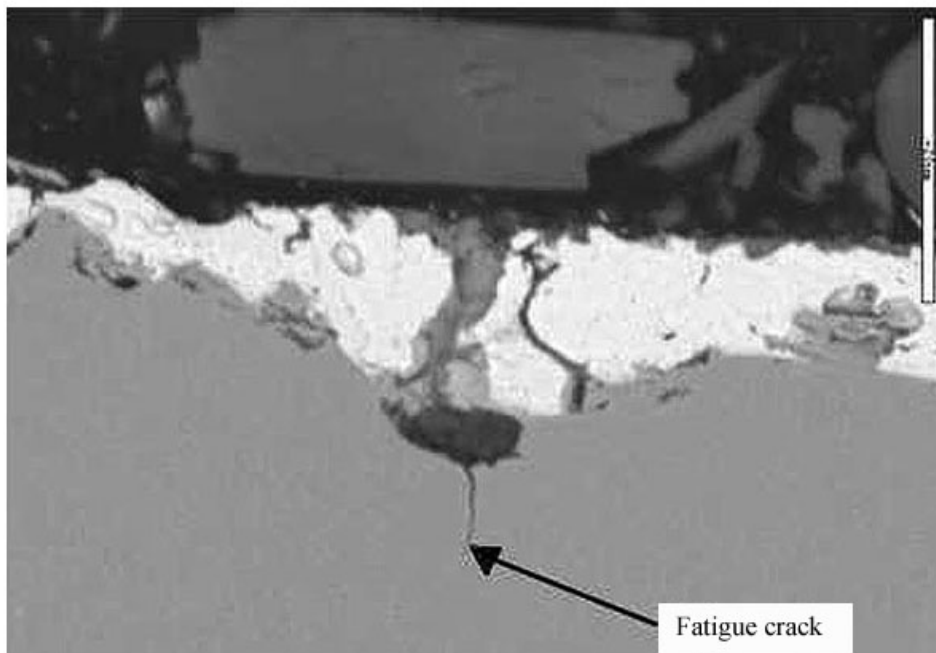
Microsections of the material revealed a similar surface finish to that observed on the cylinder from G-DEVR, with the same smearing of the shot-peened finish caused by grit-blasting resulting in microscopic fissures, some containing embedded particles of alumina grit (Appendix E). These fissures were a maximum of about 20 microns in depth. The Cadmium plating was present but it was clear that the original paint finish had been removed (for previous crack checking) and that the re-applied finish was flaking-off in places.

SEM photograph of the surface finish of the failed cylinder from EC-FXI  
Note embryonic fatigue crack growing from imperfection  
which is an embedded particle of Alumina grit
