# Air Accident Investigation Unit Ireland

**ACCIDENT**  
**Fairchild Aircraft Corporation**  
**SA 227-BC Metro III, EC-ITP**  
**Cork Airport, Ireland**  
**10 February 2011**

**AAIU Report No: 2014-001**  
**State File No: IRL00911013**  
**Report Format: Formal Report**  
**Published: 28 January 2014**

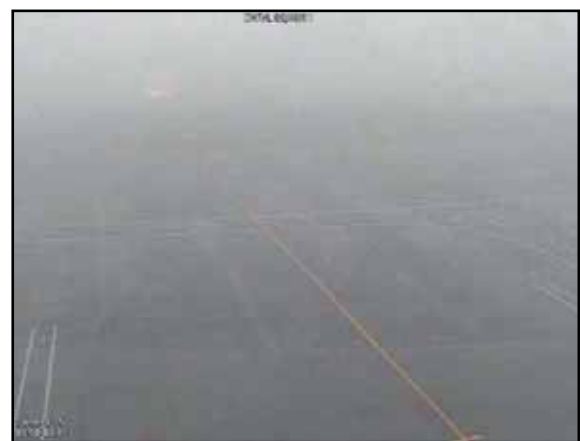
**Photo No. 3:** Second flash fire

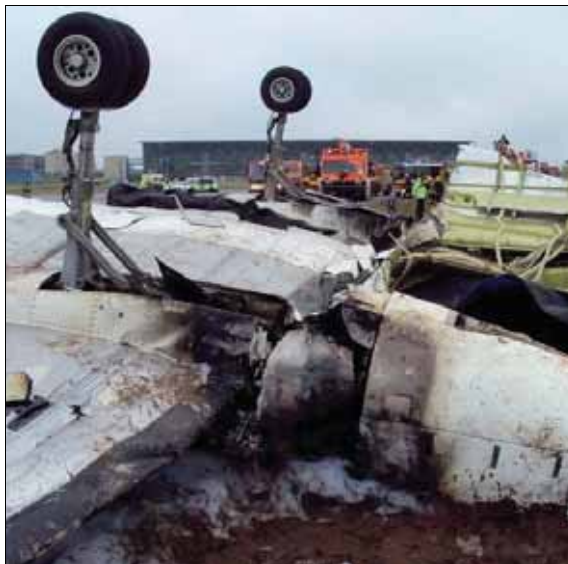
**Photo No. 9:** Left Engine Fire damage

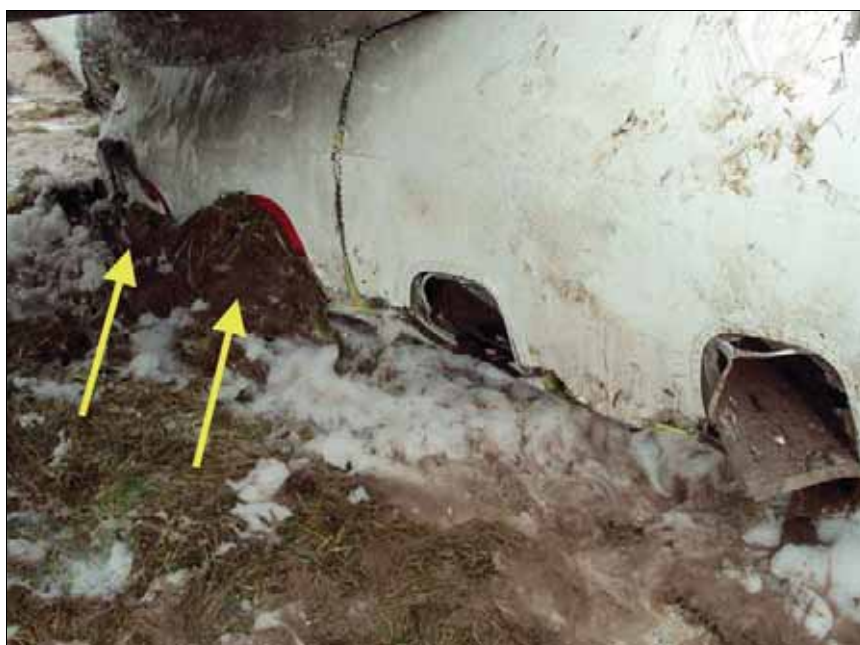
The AFS could not gain entry into the aircraft by normal means as the passenger door at the front left of the fuselage was severely crushed and could not be opened. The three emergency exits in the cabin were unusable due to crushing and were also blocked with soil from inside the cabin (**Photo No. 12**).

**Photo No. 12:** Starboard Emergency Exits

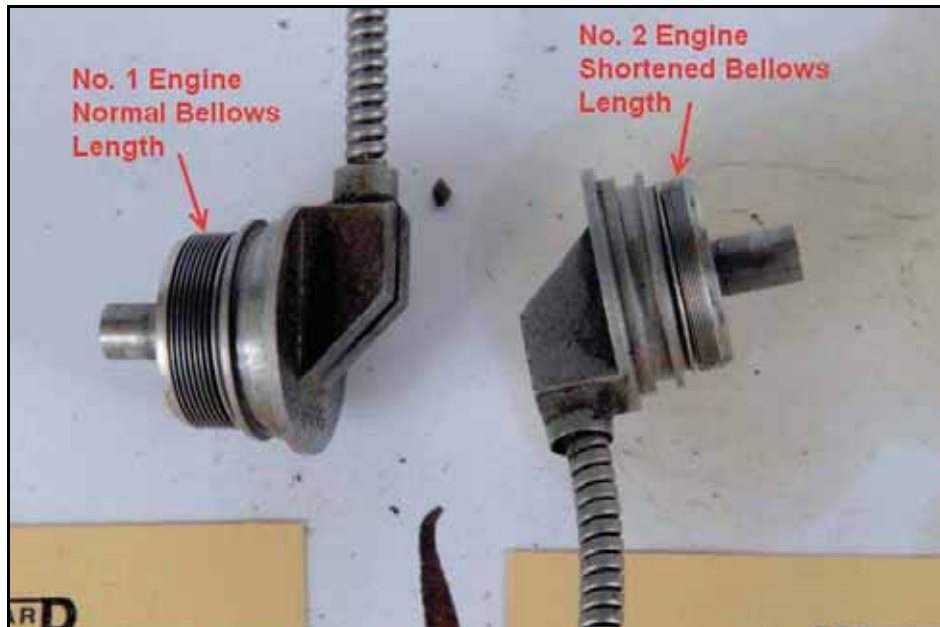
The length of the No. 2 engine bellows being considerably shorter than specified is consistent with a breach or leak within the system.

**Photo No. 1:**  $P_{T2}/T_{T2}$  sensor bellows from No. 1 and No. 2 Engines
