Lateral runway excursion during landing roll, nose landing gear collapse

Aircraft	Airbus A300-B4 registered EI-EAC
Date and time	16 November 2012 at 4 h 25 UTC ⁽¹⁾
Operator	Air Contractors
Place	Bratislava Airport (Slovakia)
Type of flight	International public cargo transport
Persons on board	Captain (PF) ; Copilot (PNF) ; Flight Engineer
Consequences and damage	Aeroplane severely damaged

This is a courtesy translation by the BEA of the Final Report on the Safety Investigation. As accurate as the translation may be, the original text in French is the work or reference.

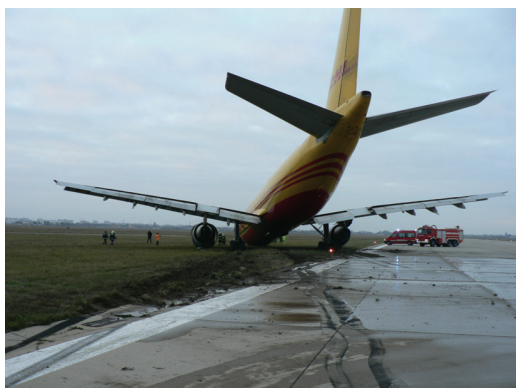
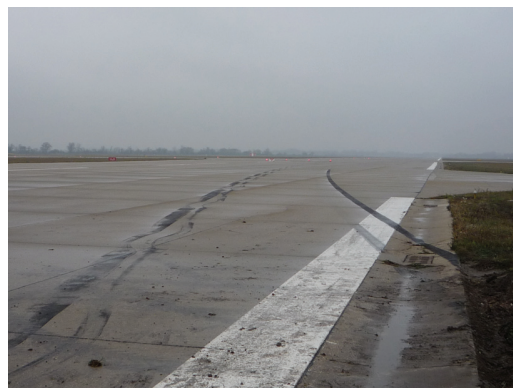
On the runway, a continuous line of rubber from the nose gear tyres was observed. It began on the runway centreline (point 04 on the illustration below) then veered towards the left as far as the edge of the runway. On the last part of the path, another tyre mark from the left rear tyre (tyre n°5) on the left main landing gear was also observed.

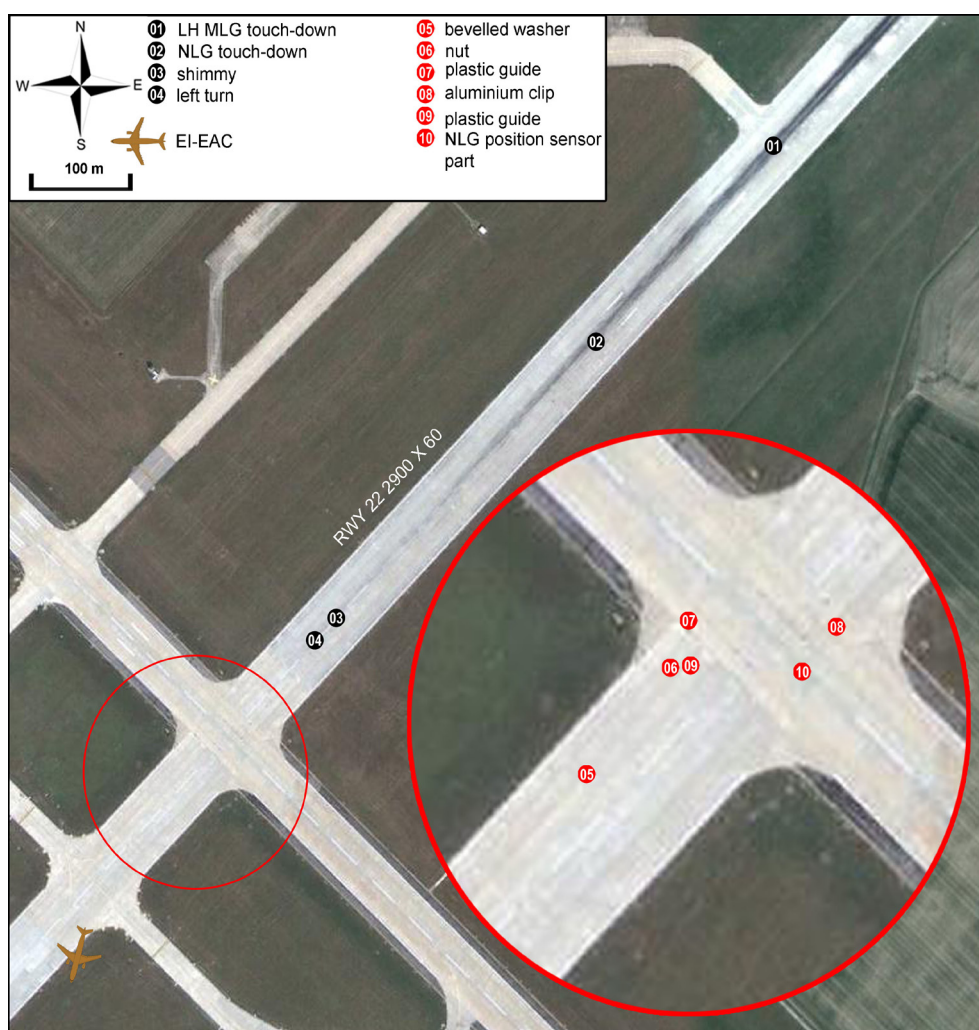
On the runway, parts of the nose gear were found at the beginning of the marks made by the nose gear tyres. Among them was the shock strut apex pin (see list of parts referenced in red on the illustration below).

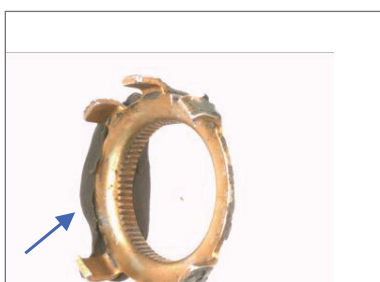
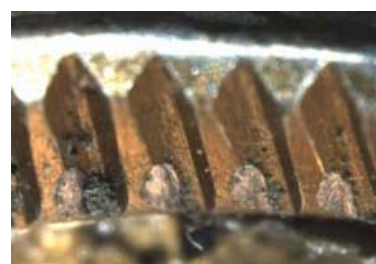
At the accident site, the grooved washer (in blue on the above diagram and part n°5 on the diagram of the central shaft in paragraph 2.2) was not found. The other parts making up the nose gear shock strut assembly were examined at the BEA. The observations and examinations of the shaft showed:

- ☐ Contamination (grease and dust) on the inner side of the shaft head. This seemed to indicate that it was not in contact with the grooved side of the washer (red);
- ☐ Circular marks around the fillet. This seemed to indicate the presence of a washer blocked against the fillet;

- ☐ The shaft thread in good condition. This seemed to indicate that the nut was not torn off but unscrewed in service. At the end of the last grooves on the shaft, damage was observed;
- ☐ The damage to the inner extremities of all of the grooves on the washer lock (n°7).

The examinations showed that the washer lock was not completely engaged on the last series of grooves on the shaft.

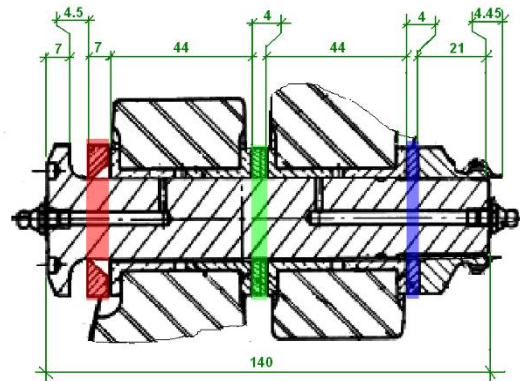
Dimensional diagram 1

The bevelled washer in red in the diagram is installed the wrong way round. In this position, the washer is no longer in direct contact with the shaft head because of the presence of the fillet between the shaft and the shaft head.

In both cases, play of 4.5 mm appears between the shaft head and the first washer installed. This gap makes complete engagement of the key washer on the grooves impossible at the other end of the shaft. The grooves on the washer lock are engaged over less than 1 mm on the shaft grooves, instead of the nominal 4.45 mm.

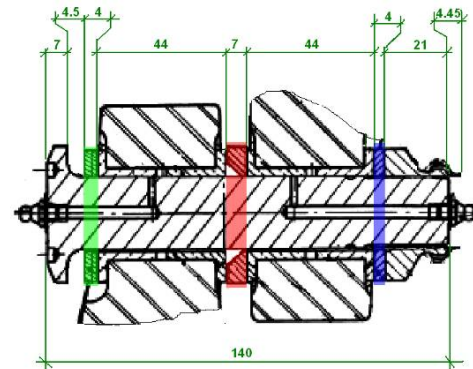
Dimensional diagram 2

In case of inversion of the red and green washers, play is also visible between the shaft head and the badly positioned washer, also because of the fillet.

In the case of the second assembly, the greater thickness of the n°1 washer (7 mm instead of 4.2 or 4.4 mm) introduces an additional difficulty during insertion of the centre hinge. Abnormally high effort is necessary to align the bearings of the two arms of the torque links and insert the hinge completely. The second assembly scenario is consequently more difficult to perform than the first.

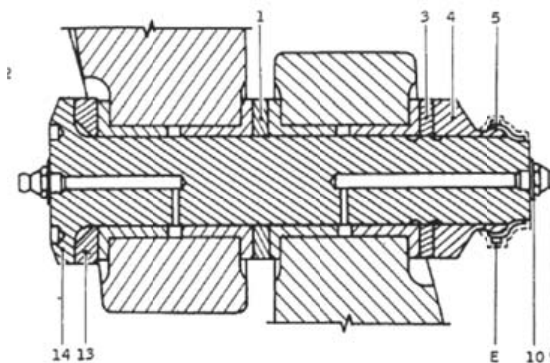
Extract from AMM 32-21-15 p. Block 401

The assembly diagram used in the AMM 32-21-15 p. Block 401 « Nose gear torque Links– Removal/Installation » gives exact details of the position and the shape of each washer. However the text associated with the diagram does not specify the order for installation and does not inform the operator of the need to install the first washer with its bevelled side in contact with the shaft head. It states:

- ☐ During disassembly, keep the washers (3), (1) and (13) (diagram below).
- ☐ During re-assembly, re-install the washers and refer to the AMM 32-21-15 p. Block 801 « Nose gear torque Links – Approved repairs» in order to measure the play between the two torque link arms :

Despite the presence of a detailed diagram, the absence of clear and detailed instructions in the text of the manufacturer's AMM, allowing the operator to ensure that the assembly was correct, contributed to the incorrect assembly.

Following the accident, Airbus provided all Airbus A300/A300-600/A310/AST customers with recommendations on the maintenance of nose gear steering torque link assembly (Operators Information Transmission - OIT ref 999.0014/13 dated 3 April 2013). This publication draws operators' attention to the importance of correct assembly of the washers on the nose gear torque link centre hinge. It was stated that a warning would be added to the AMM 32-21-15 p. Block 401 « Nose gear torque Links – Removal/Installation » during its next revision.
