**AIRCRAFT ACCIDENT REPORT**

**Saudi Arabian Airlines**

**Lockheed L-1011, HZ-AHK**

**August 19th 1980**

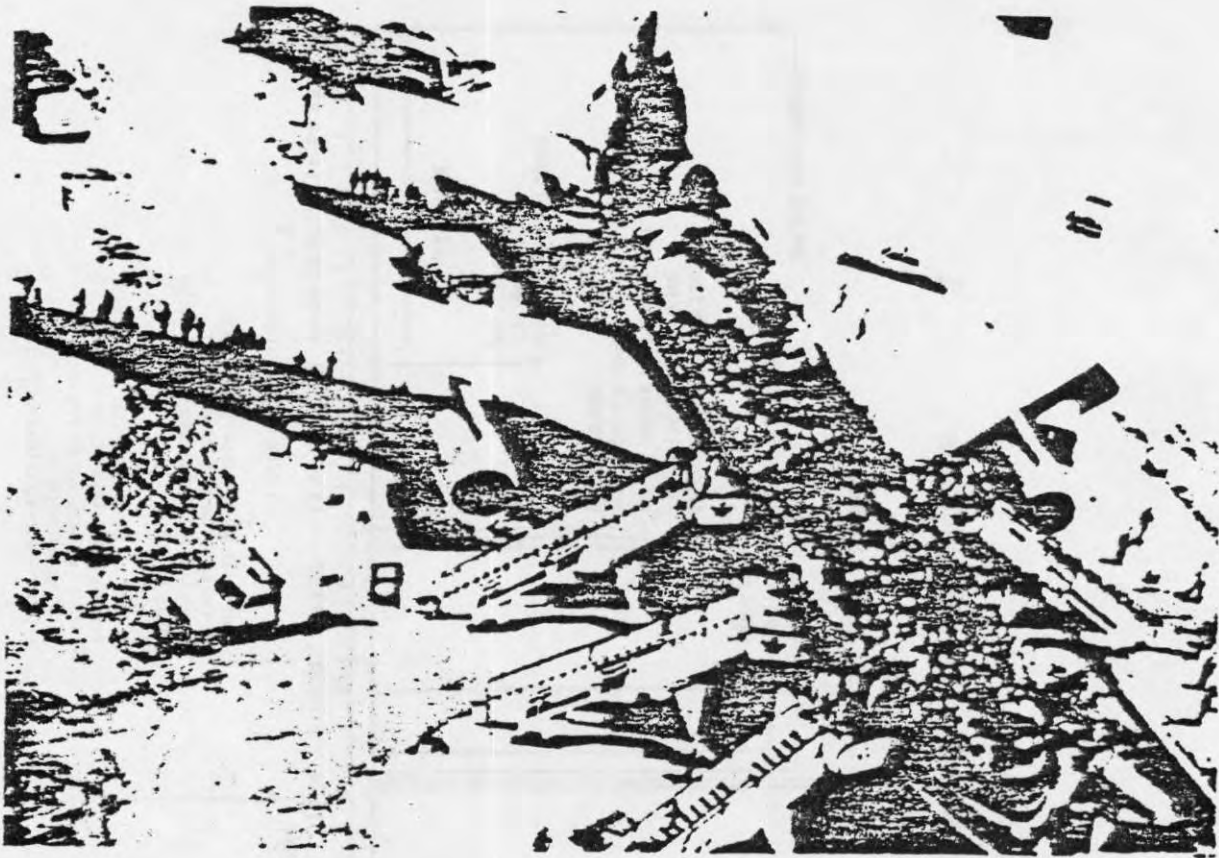
PHOTO NO. 1 - OVERALL VIEWS OF AIRCRAFT.

Attempts by the crash, fire, rescue personnel (CFR) to enter the aircraft and open the doors were unsuccessful until the No. 2 door on the right side of the aircraft was opened at about 1905, about 23 minutes after all engines had been shut down. At 1908, the fuselage interior was observed to be engulfed in flame. (see Figures 1, 2, and 3)

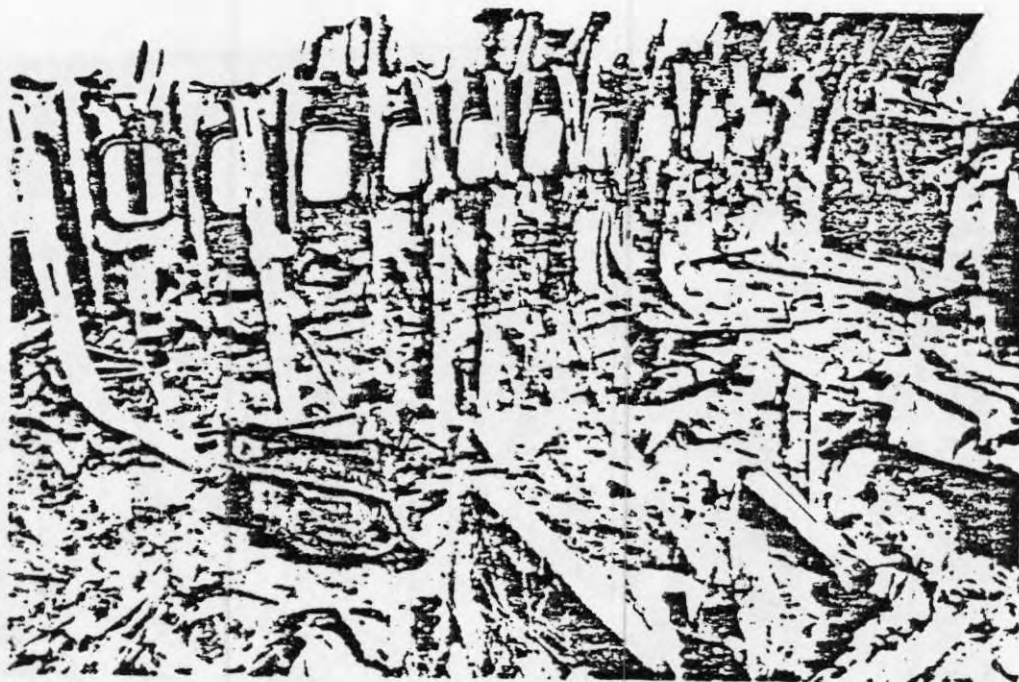
PHOTO NO. 2 - FLOOR COLLAPSE INTO  
C-1 AREA

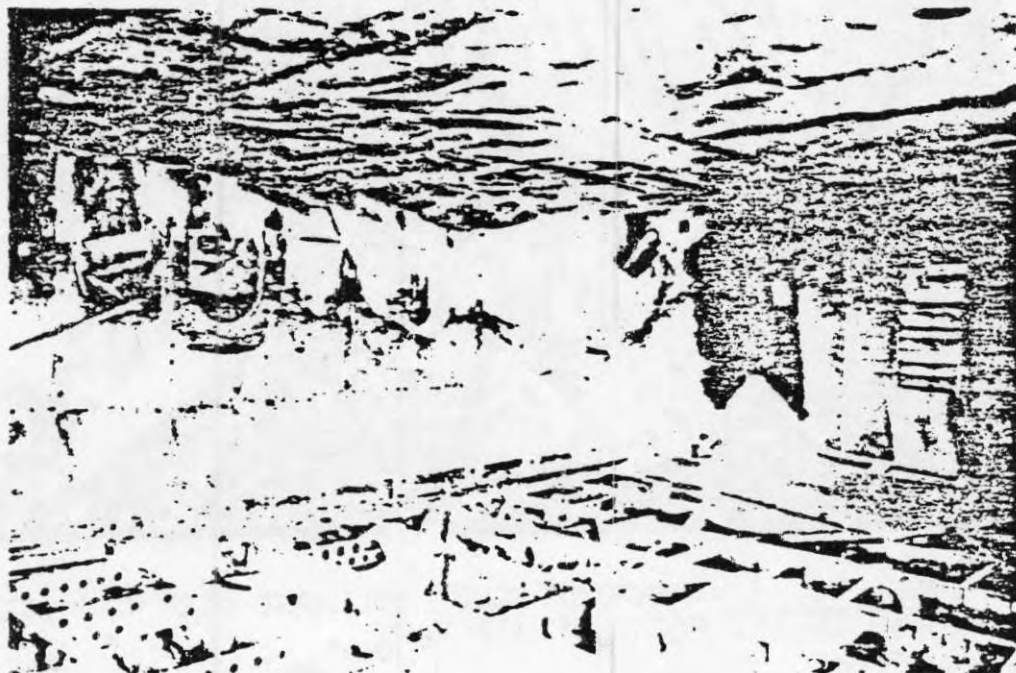
PHOTO NO. 3 - C-1 AREA FROM  
INSIDE C-1 COMPARTMENT

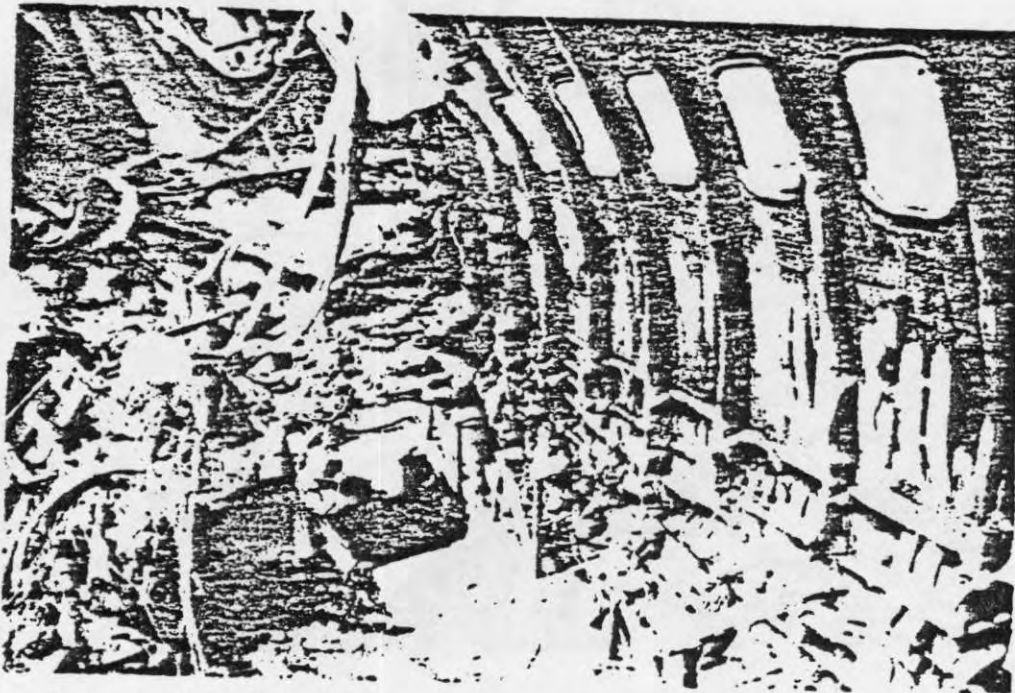
PHOTO NO. 4 - VIEW OF FLOOR COLLAPSE OVER C-3  
AREA. TAKEN TOWARD AFT OF AIRCRAFT.

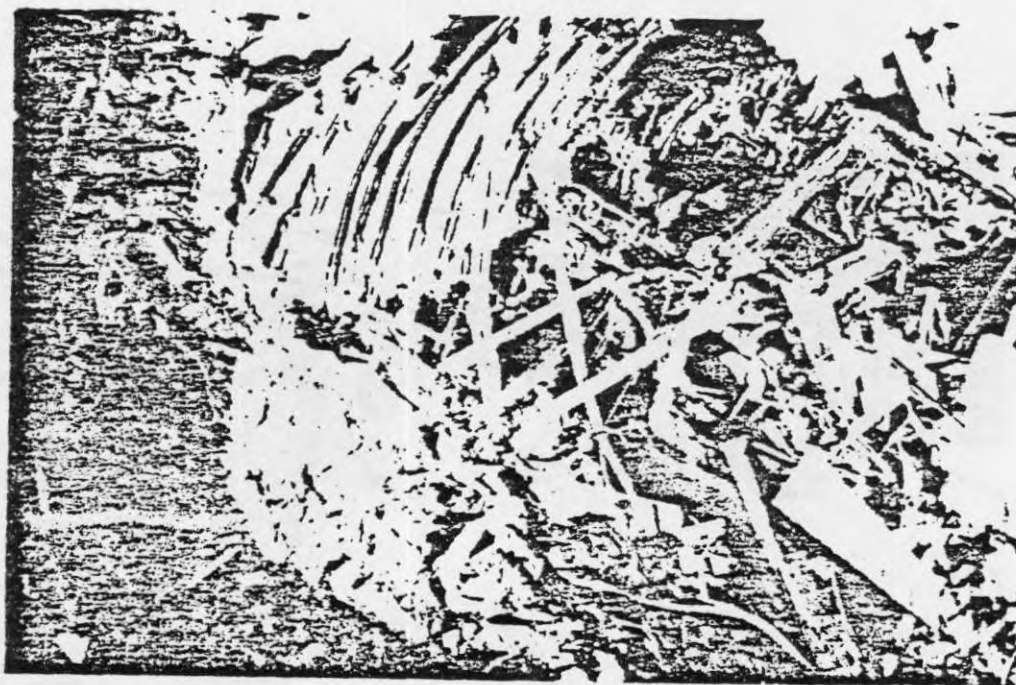
PHOTO NO. 5 - VIEW OF FLOOR COLLAPSE OVER C-3 AREA.  
TAKEN TOWARD FRONT OF AIRCRAFT.

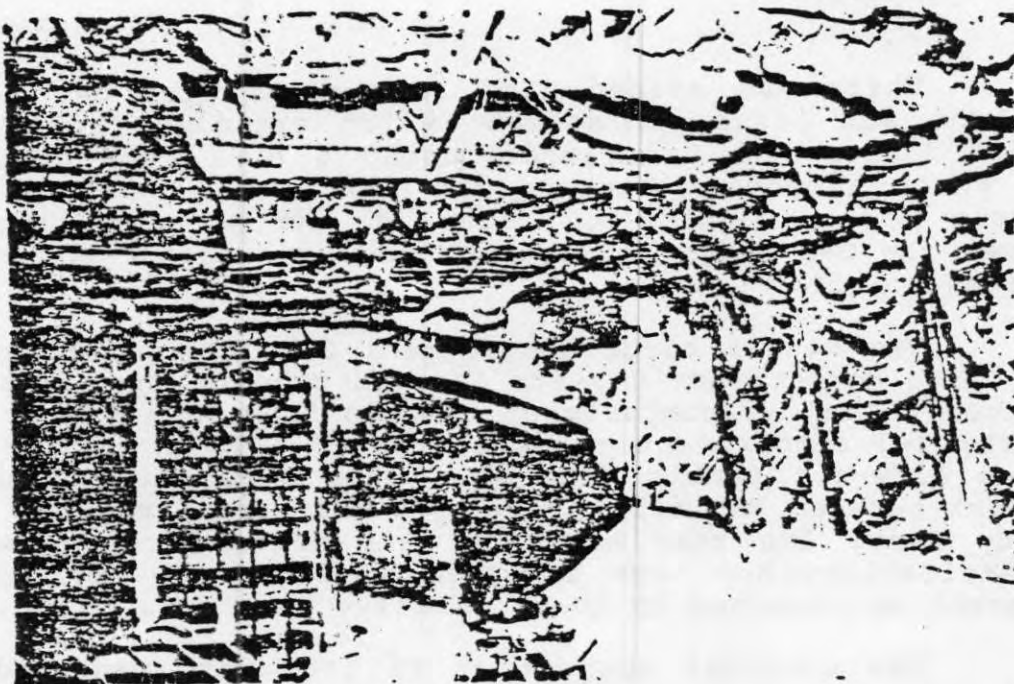
PHOTO 6 - C-3 COMPARTMENT. VIEW TOWARD AFT OF AIRCRAFT. NOTE COLLAPSED FLOOR AT REAR RIGHT.

The hole in the ceiling of the forward left side of the C-3 compartment extended from about FS 1675 aft to about FS 1725 and from BL 80 inboard about 40 inches. The cabin floor material above the hole was also burned away. The initial observation of the material surrounding the hole from the C-3 into the cabin revealed a "shingle" type pattern of the debris. That is, the material was burned away more at the bottom and less at the top generally in a tapered manner. Such a burn pattern indicates fire from the inside of C-3 burning upward and outward into the cabin area. (See Photos 6 & 7).

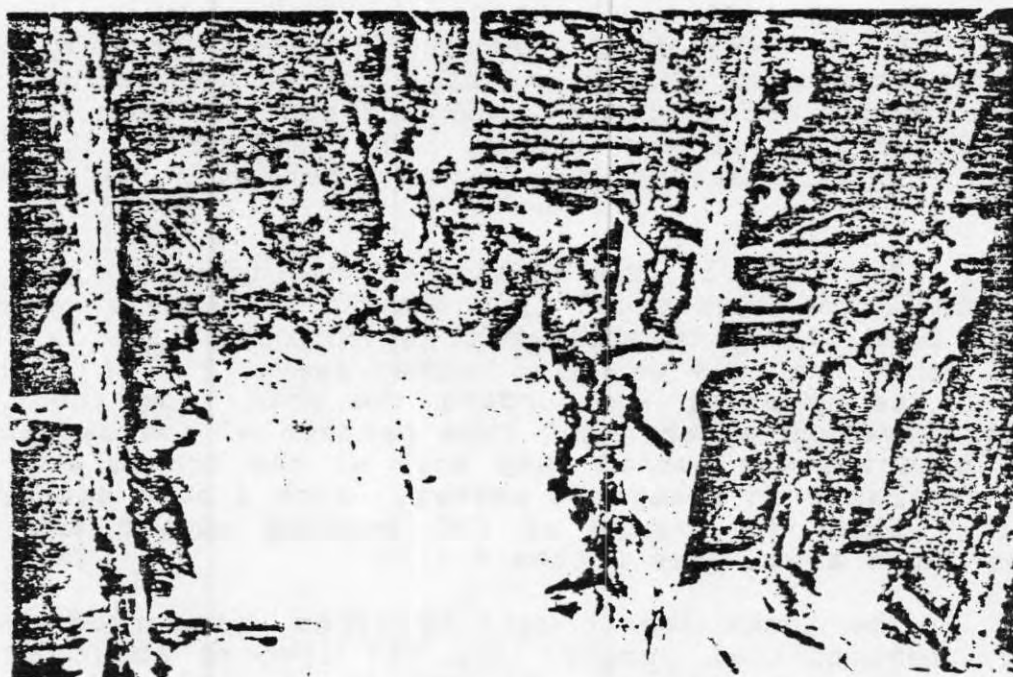
PHOTO 7 - C-3 COMPARTMENT. VIEW THRU HOLE IN FLOOR FROM C-3 AREA UP INTO LEFT REAR CABIN AREA.

A large hole was burned through the floor on the left side near the pressure bulkhead in the area of the aft lavatory installations.

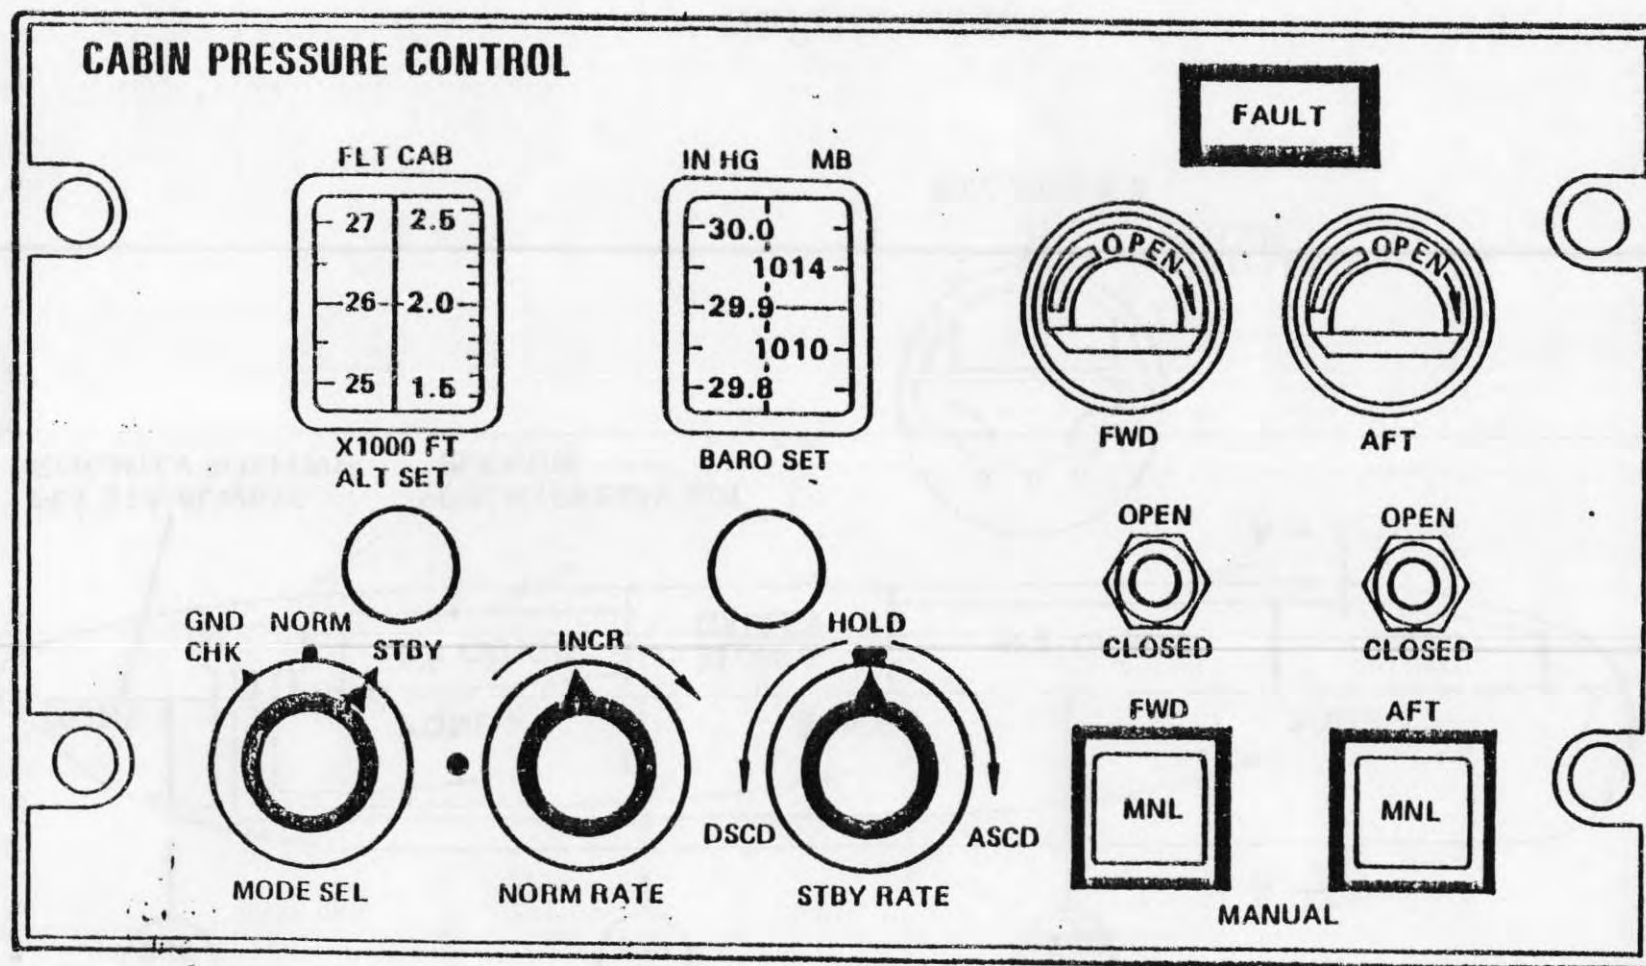
The cabin pressure control panel was recovered from the wreckage but was severely fire damaged. Some of the Indicator positions were found as follows (Figure No. 4):

1. Dials were burned off. Position determined by set screw location.
2. Switch was loose - may not be actual position at time of fire.
3. Switches, if depressed, will release if the Teflon detent latching system is destroyed.

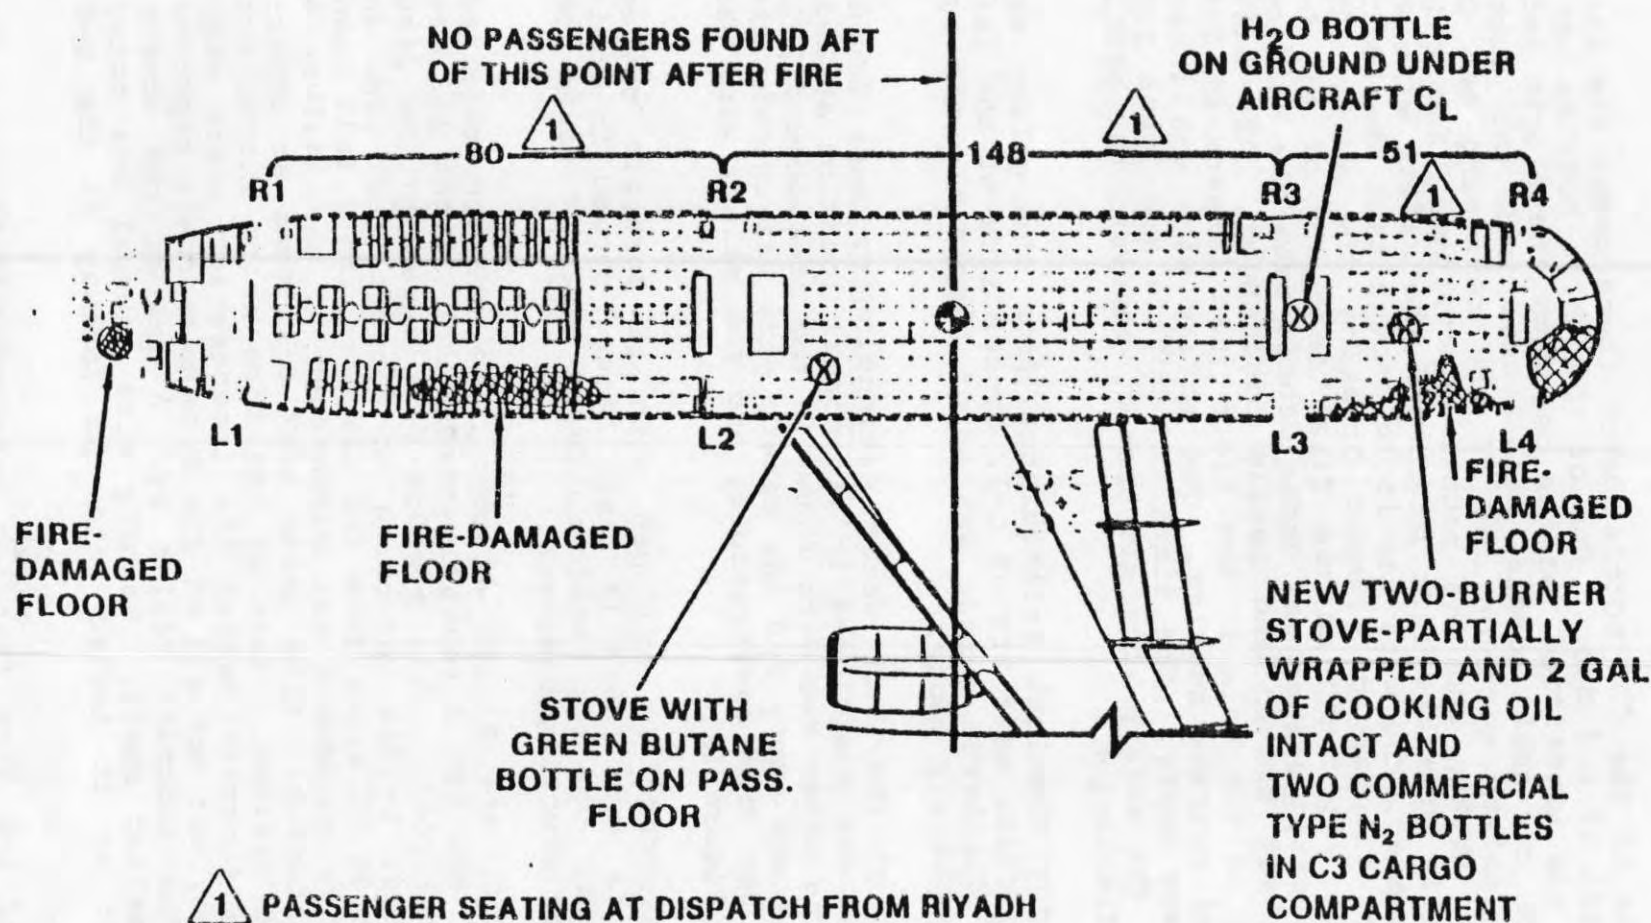
FIGURE 10

Passenger placement, fuselage fire damage (floor) and significant articles.

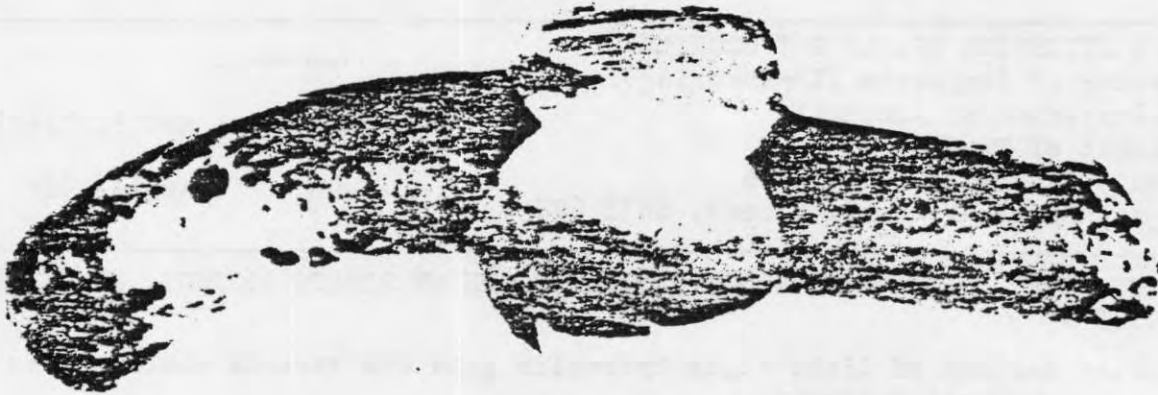
Fig 1

Hydraulic Pipe

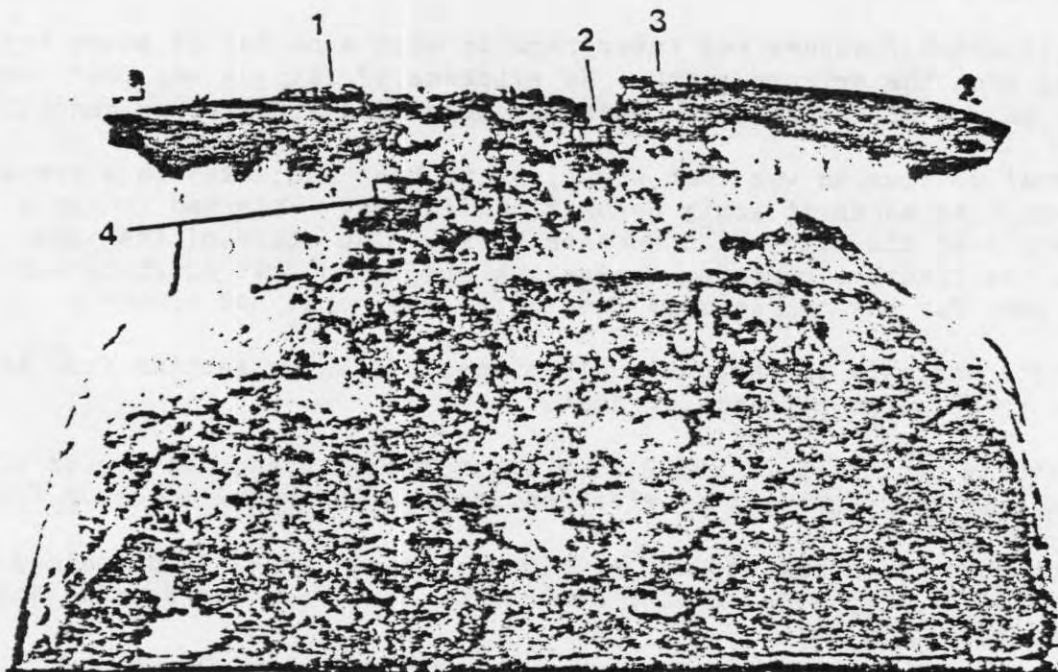
Fig 2

Flange Section from Heat Exchanger
