INTERSTATE AVIATION COMMITTEE
AIR ACCIDENT INVESTIGATION COMMISSION
FINAL REPORT

Type of occurrence	Accident
Aircraft type	Airplane, Boeing 737-200
Registration	EX-009
Registered owner	"Itek Air" Airline
Operator	"Itek Air" Airline
Regional Aviation Authority	Department for Civil Aviation, Kyrgyz Republic
Place of Occurrence	Manas Aerodrome (distance 9.7 km, bearing 273° M from the ARP)
Date and Time	24.08.08, 14 hours 45 min UTC, (local time 20 hours 45 min)

On August 24, 2008 at 1445 hrs UTC (2045 local time, hereinafter local time will be given) at Manas Aerodrome a Boeing 737-200 aircraft registered EX- 009 operated by Itek Air crashed while conducting a scheduled passenger flight IRC 6895 from Bishkek to Teheran at night in visual meteorological conditions.

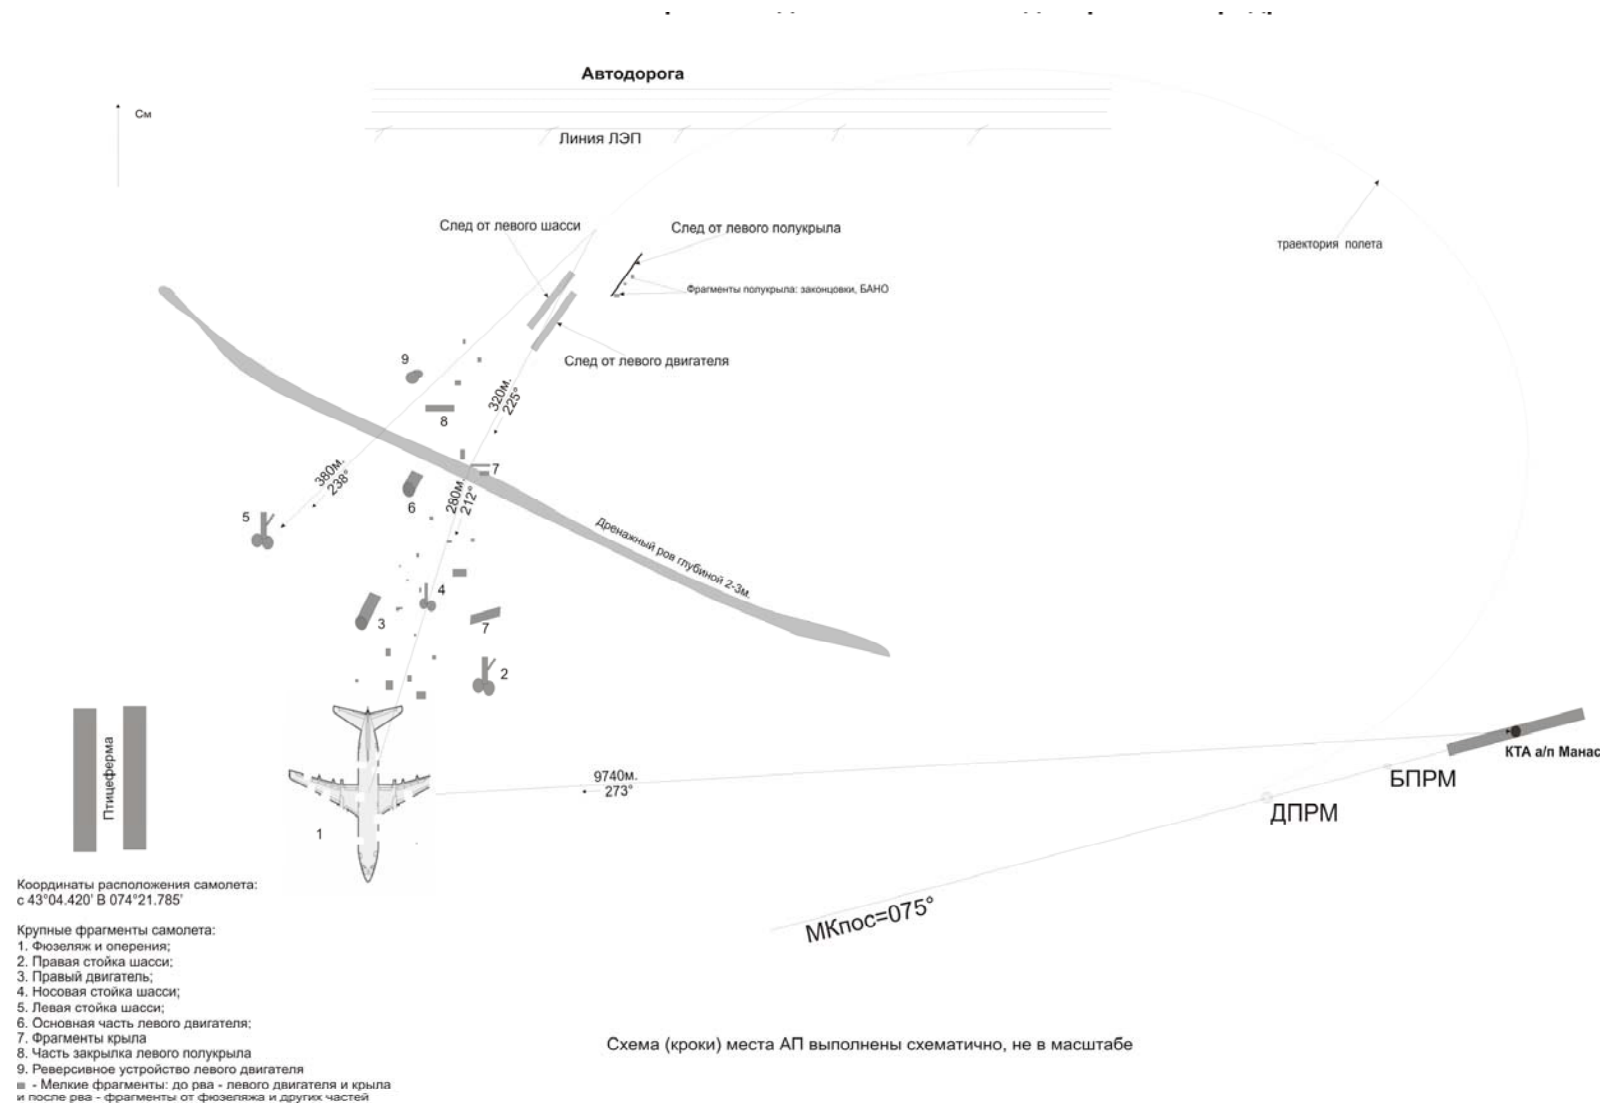
Fig. 6. Wreckage plot (no scale).

The aircraft touched the ground left wing first at a distance of 620 m and bearing of 039° M from the place of its final stop. The left wingtip was partly crushed on the impact. Small fragments of the wing were found at the following distances from the place of the first impact: first fragment – 27 m, second fragment – 42 m, third fragment (a piece of the navigation light glass) – 46 m.

The plot on Fig. 6 shows the positions of the largest fragments.

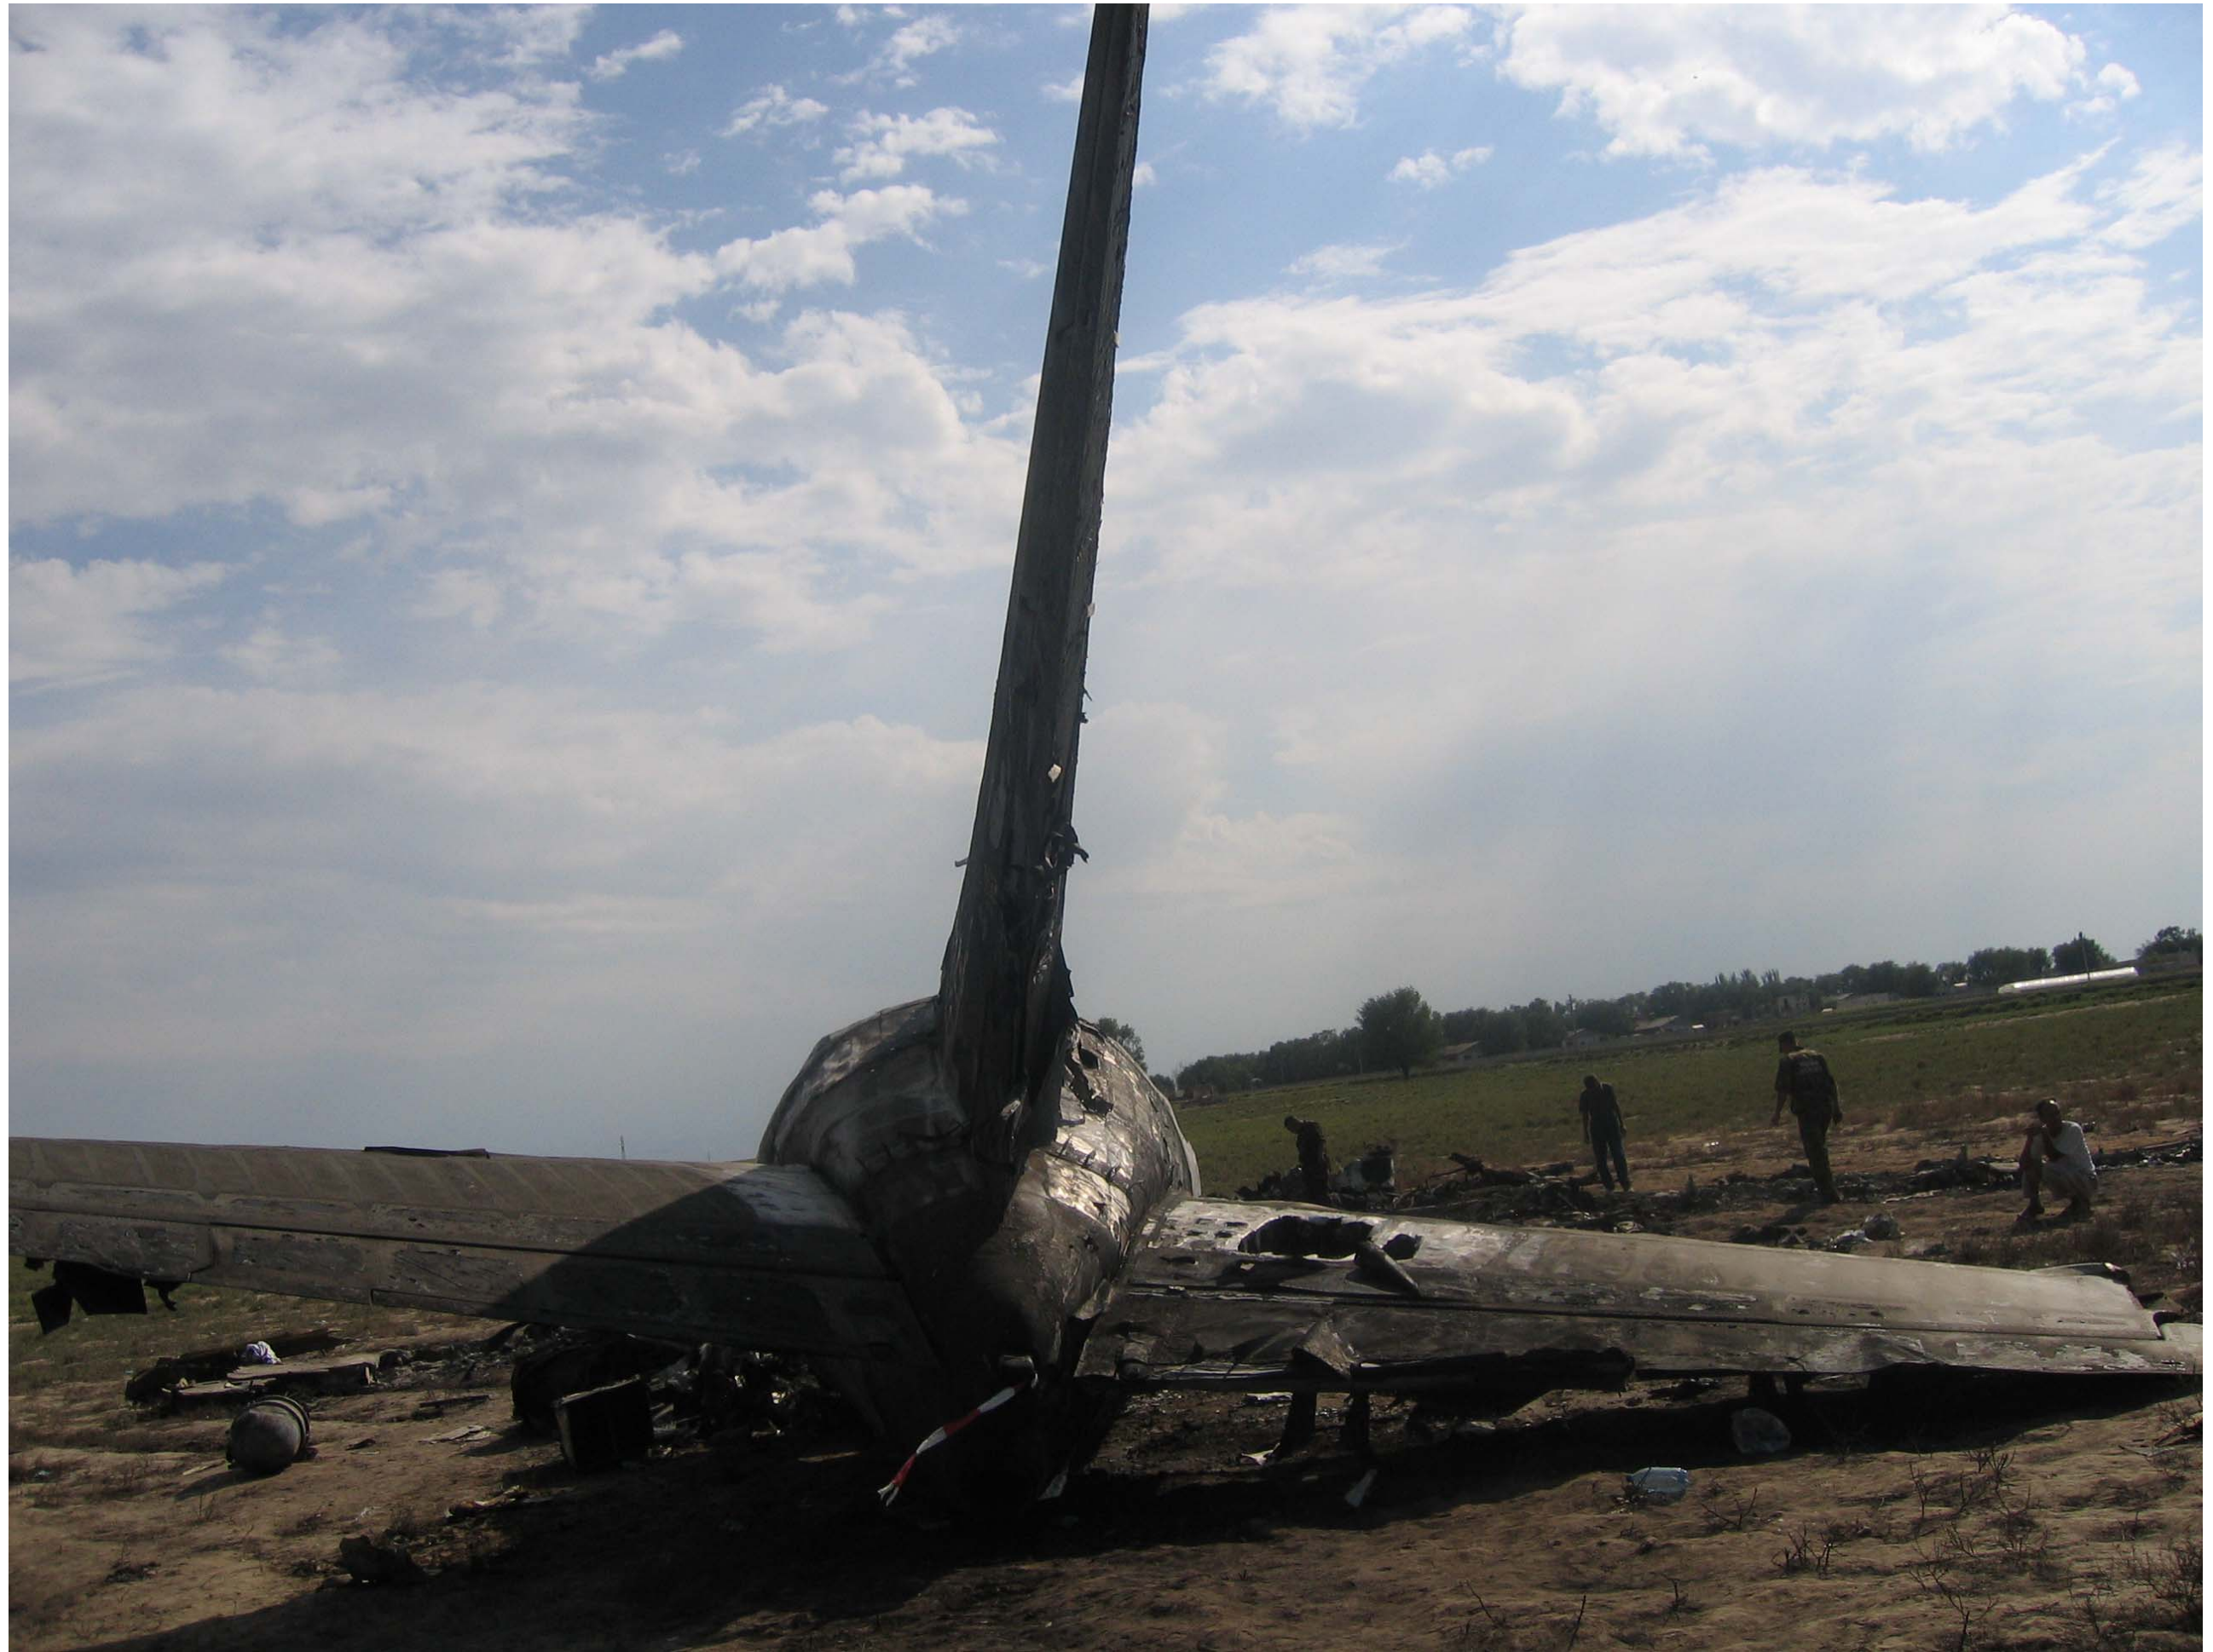
Fig.7 Wreckage of the aircraft structures. Backward view.

The aircraft was almost totally burned out in the ground fire, excepting the tail part.
