Report

Accident on **16 October 2012**
at **Lorient Lann Bihoué (56) Aerodrome**
to the **the Bombardier CRJ-700**
registered **F-GRZE**
operated by **Brit Air**

Bureau d'Enquêtes et d'Analyses
pour la sécurité de l'aviation civile

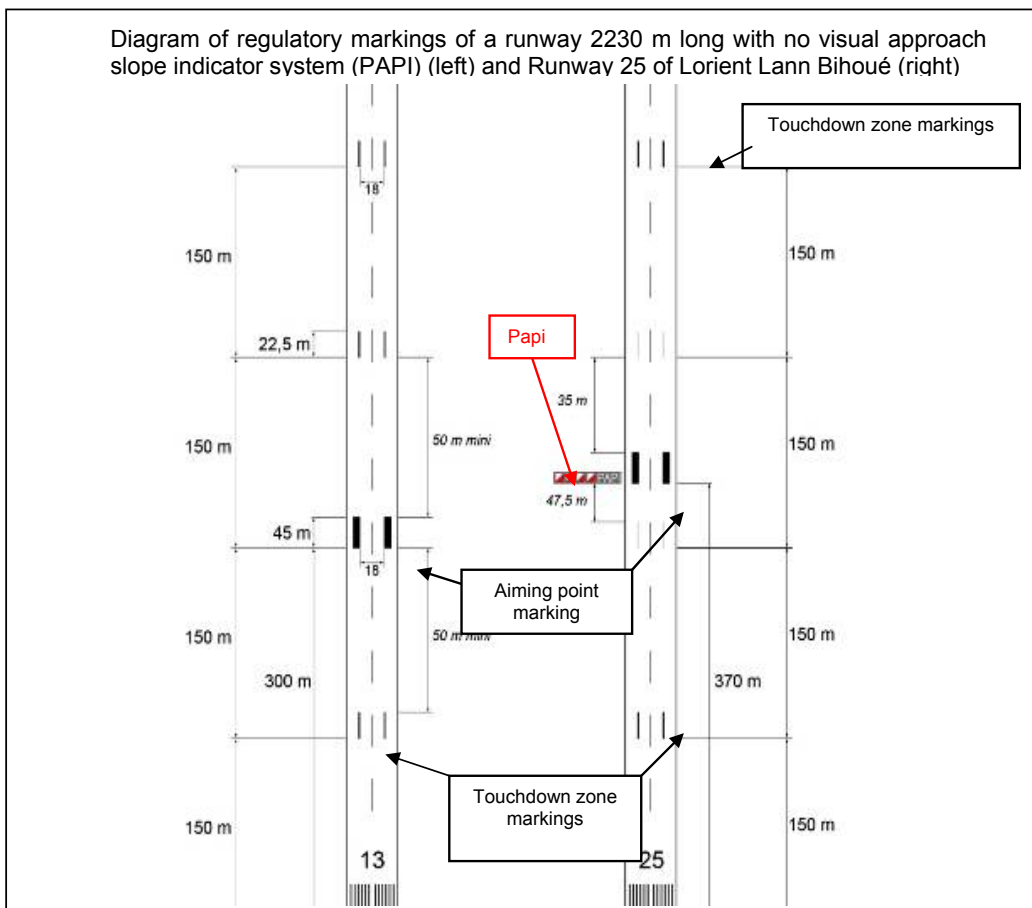
At Lorient Lann Bihoué, the PAPI is located 370 m from the threshold of runway 25. The aiming point markings are therefore also located in the same place. Touchdown zone markings are placed 150 and 600 m from the runway threshold. The other touchdown zone markings (theoretically 300 and 450 m from the runway threshold) are not apparent due to their proximity to the aiming point markings.

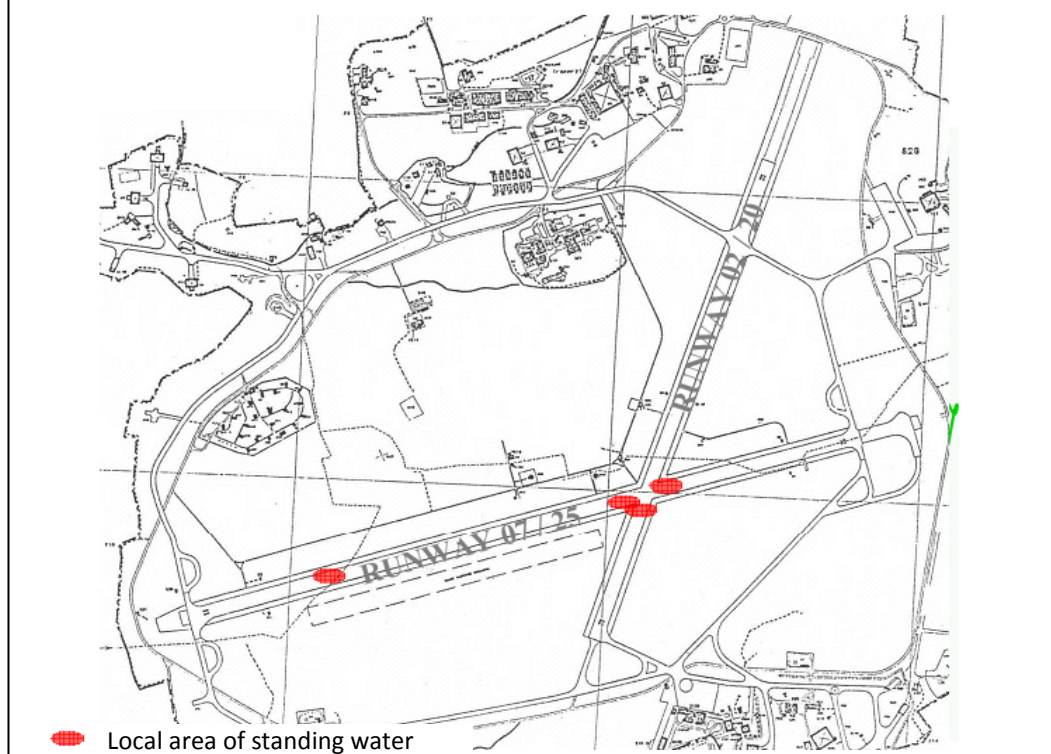
RUNWAY PROFILE CORRECTION ZONES TO ELIMINATE RAINWATER RETENTION AND PHOTOGRAPHS OF THE RUNWAY IN RAINY WEATHER

After the accident, two fire trucks poured water on the south side of the runway over the last 1,200 m. Water retention zones were found on certain sections⁽¹⁶⁾.

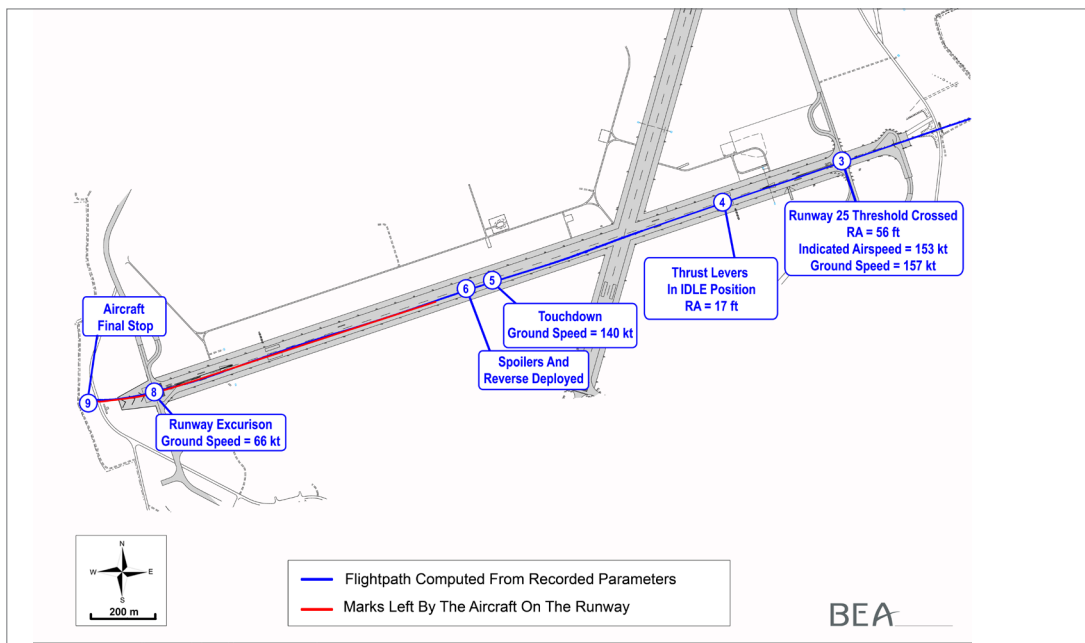
The flight path of the aeroplane was calculated from its ground speed, magnetic heading⁽¹⁸⁾ and drift recorded on the FDR. It was consistent with the marks left by the aeroplane on the runway.

The positioning of the thrust levers to IDLE and touchdown of the main landing gear occurred respectively at 330 and 1.130 m from the threshold of runway 25.

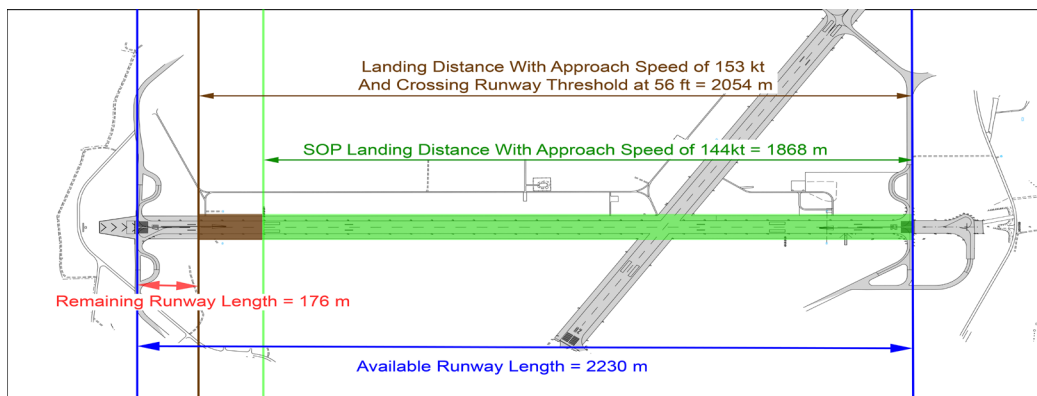
Under the event flight conditions, aeroplane performance would theoretically permit it to land on a contaminated runway, even if the remaining length of runway after the aeroplane came to a complete stop had only been 176 m.

Condition of runway	Gain in runway length with SOP compared with that of the event
Dry	124
Wet	171
Contaminated	186

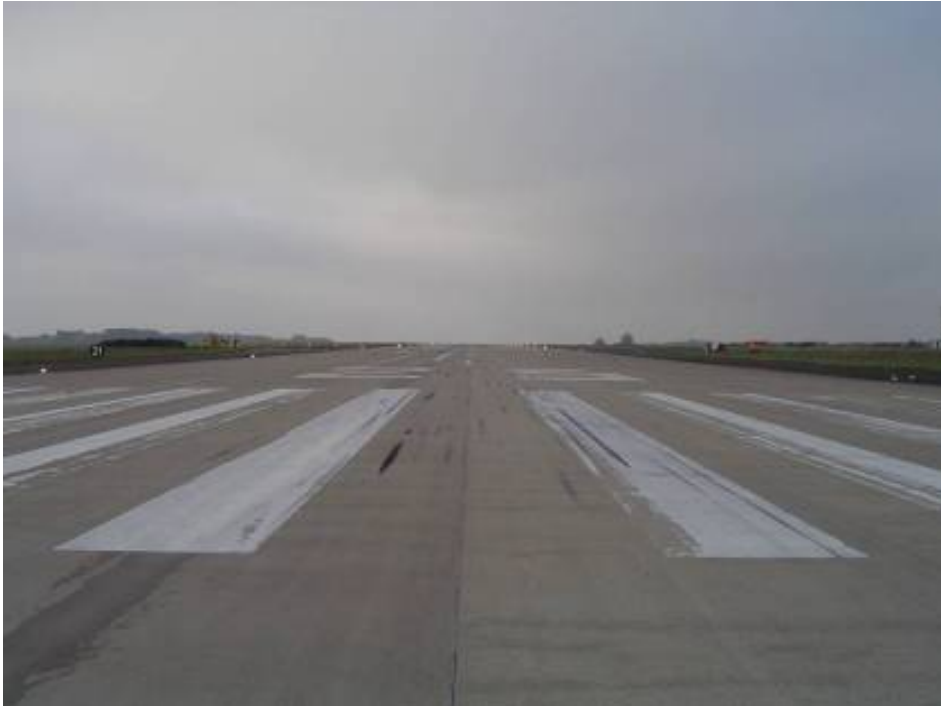
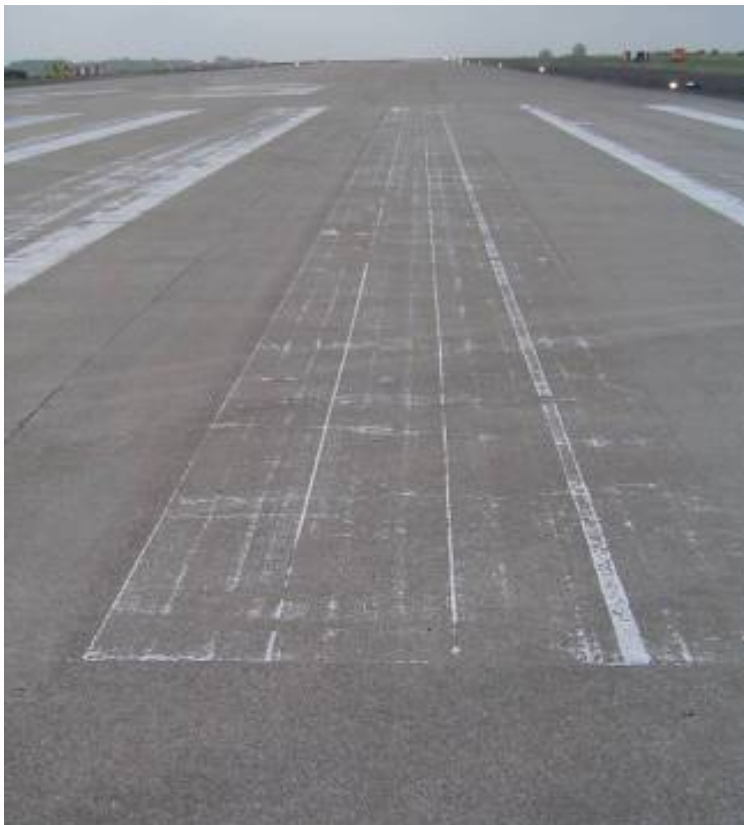
-Markings on the threshold of runway 25

On 14 November 2012, an inspection of runway 25 showed that the ground markings lacked a significant amount of paint (see appendix 5).
