COMMAND OF AERONAUTICS
AERONAUTICAL ACCIDENT
INVESTIGATION AND PREVENTION CENTER

FINAL REPORT
A – N° 67/CENIPA/2009

AIRCRAFT **PR - MBK**

MODEL **AIRBUS A-320**

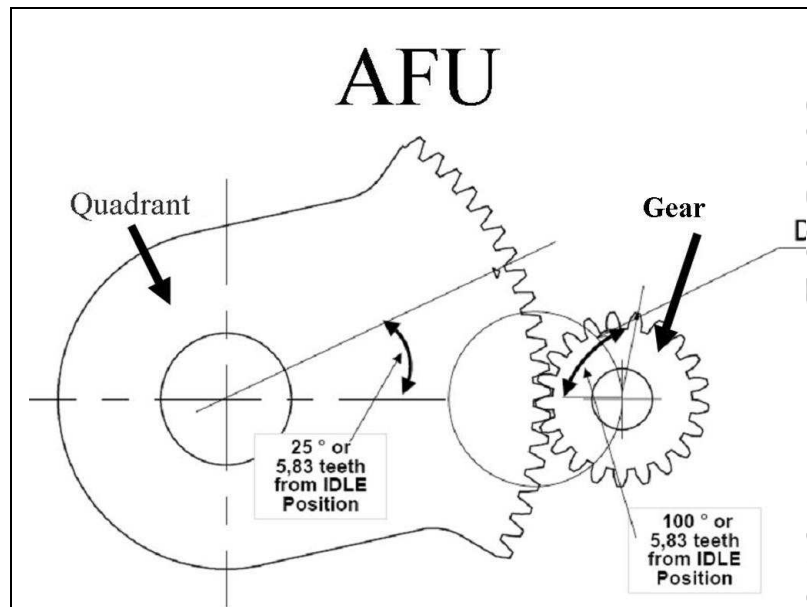
Figure 6 - Quadrant and gear of the AFU.

The aluminum structure of the units was found melted due to the heat of the post-accident fire. In the midst of the melted aluminum mass were the gears and the quadrants made of steel.
