*REPORT C 1993:57*

**Air Traffic Accident  
on 27 December 1991  
at Gottröra, AB county**

*Case L-124/91*

The Board of Accident Investigation (SHK) has investigated an aircraft accident which occurred on 27 December 1991 at Gottröra, AB county, involving an aircraft with registration OY-KHO.

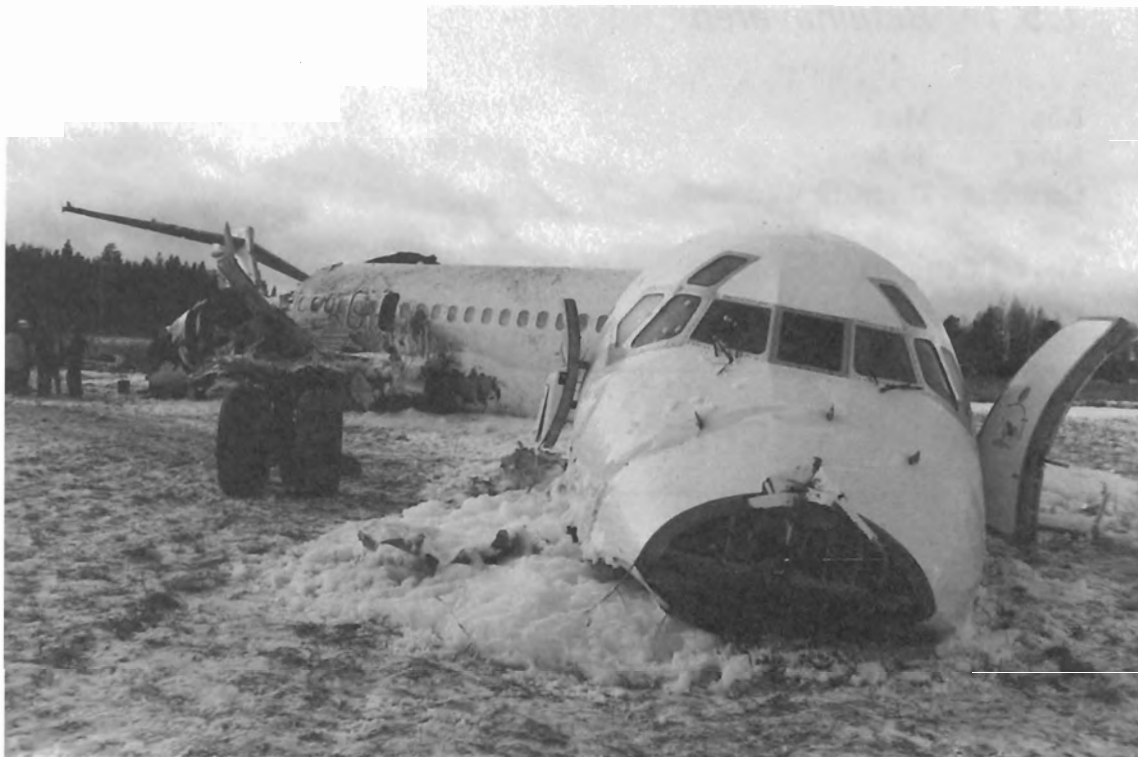
## 1.3 Damage to the aircraft

The aircraft was totally destroyed on impact.

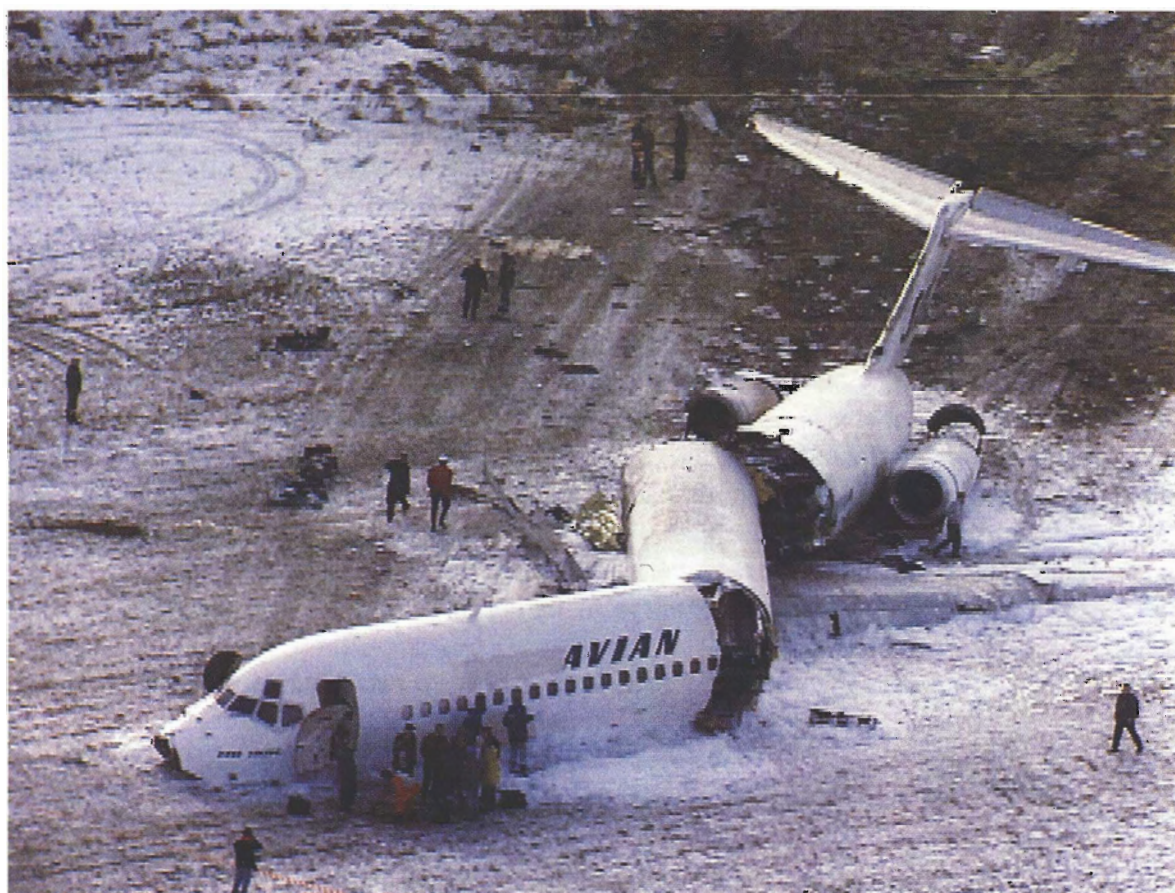
*The aircraft wreckage*

The underside structures were much damaged in the forward part of the wreck. The indentations were largest in the left of the front part – approx 80 cm – and smallest in the right rear part – approx 18 cm. Damage to the underside structure in the middle and rear parts was limited. The cabin floor had limited damage. Apart from damage in the areas of the breaks, the floor structure was ruptured only at row 5 on the right side.

The major part of the right wing had separated from the fuselage. Wing parts lay spread out along the path of the crash. The underside of the left wing was severely damaged.

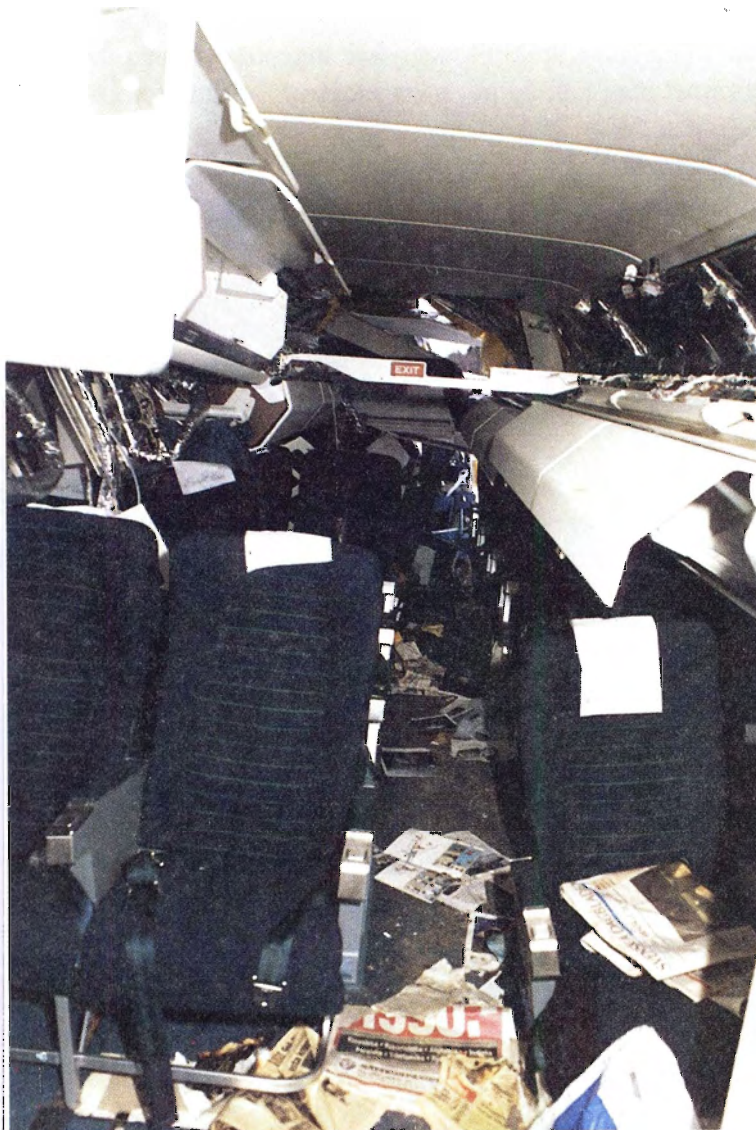
***Cabine damage***

In the forward portion of the passenger cabin the overhead bins and their mountings had been damaged. The two modules on the left had parted completely from their mountings and fallen down onto the backs of passenger seats. On the right side the modules had parted from their ceiling mountings but not from the wall mountings. The modules from row 3 and rearwards were resting on seat backs. A number of bin lid locks had broken and the lids had come open. The cabin divider – which was between rows 3 and 4 – had fallen down together with the bins. In the middle portion of the wreck the damage was limited to the break areas. At the forward break the forward part of the left bin had fallen. At the rear break the bins on both sides had fallen. A number of bin lid locks had broken. According to available information, the bins were not excessively loaded with baggage.

In all three parts of the wreck most of the PSUs had loosened from the bin structures and were hanging either by their outer hinges or by wiring. Many of the oxygen masks had been released from the PSUs and some had also been activated. Some of the cabin crew oxygen masks had also been released.

In the forward galley area the walls of galley 3 had been deformed in two places and one floor mounting had ruptured. The ceiling at galley 1 had been pressed downwards. The ceiling panel between galleys 2 and 3 had fallen in. The exit sign at galley 3 was missing. The door to the flight deck had broken off.

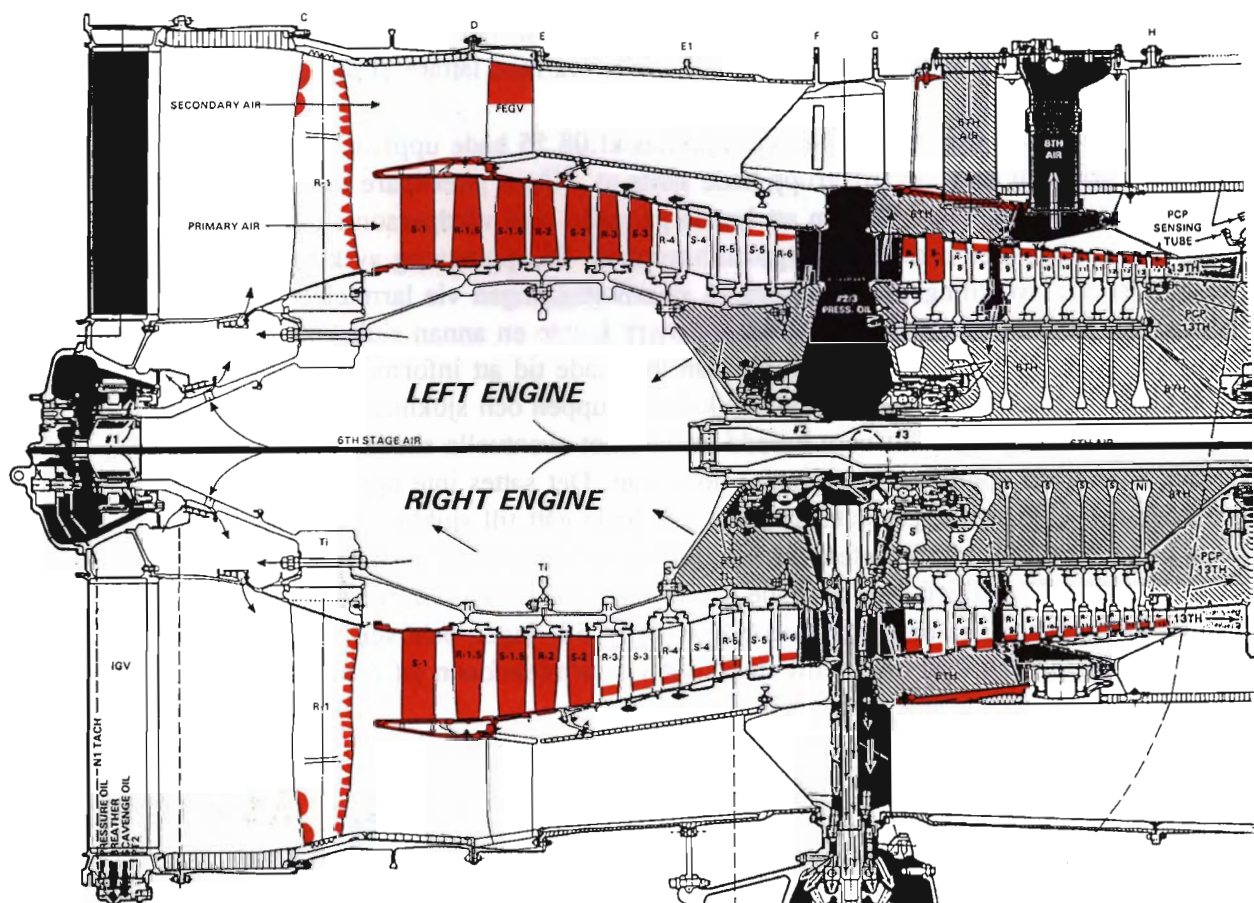
#### *Fan- and compressor-damages*

Both engines exhibited extensive external and internal damage. The external damage consisted chiefly of impact damage to the air intakes, engine cowlings and exhaust sections.

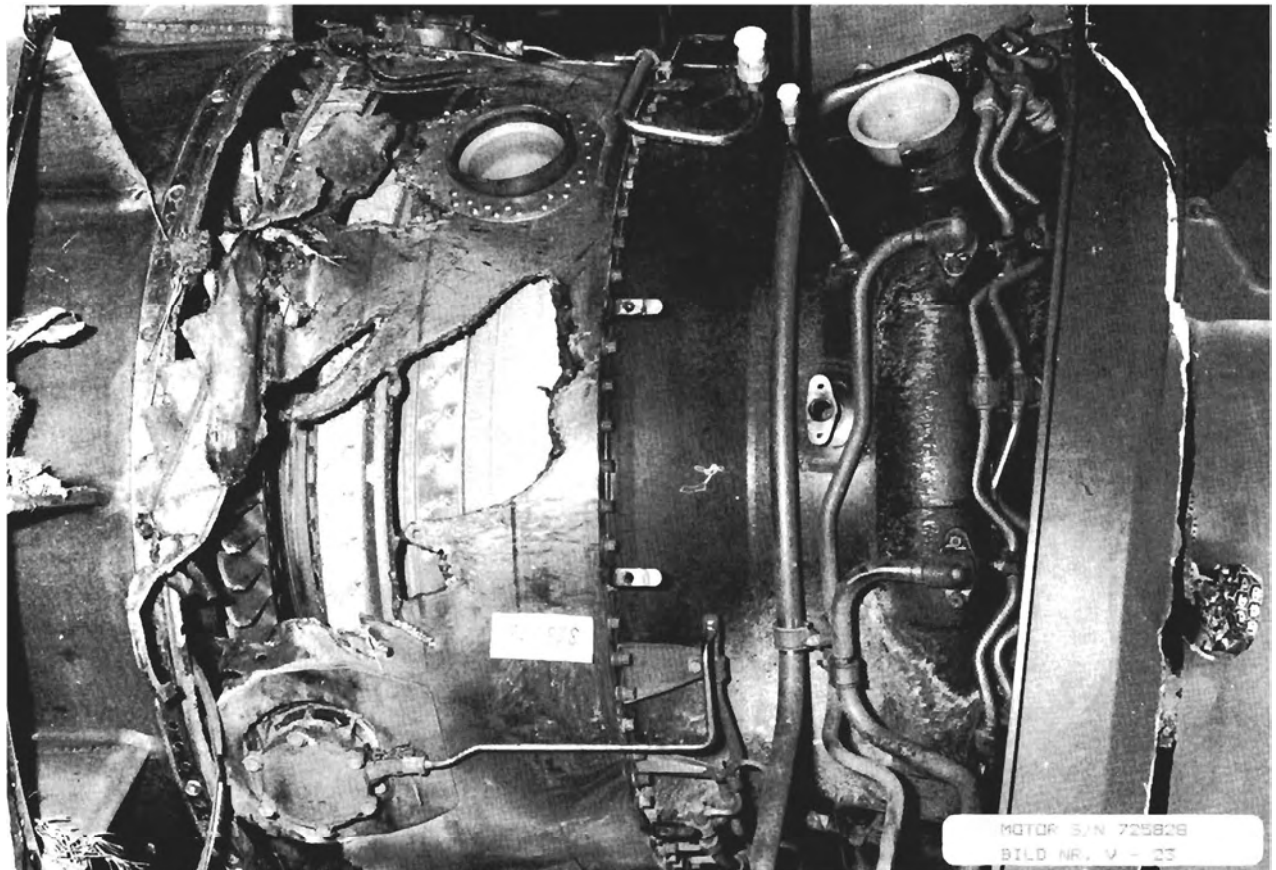
***Compressor cage damage***

The stg 7 stator had ruptured and left its original position between rotor stgs 7 and 8. Parts of its outer shroud with suspended vanes stuck out through the rear compressor case between the 9-o'clock and 1-o'clock positions. The inner shroud

with its seal had ruptured and projected from a hole in the rear compressor fan duct between the 4-o'clock and 7-o'clock positions. Of a total of 52 guide vanes in stg 7, 12 had left the engine.

The front part of the stg 8 stator outer shroud, which supports the stg 7 stator, had ruptured around its whole circumference.

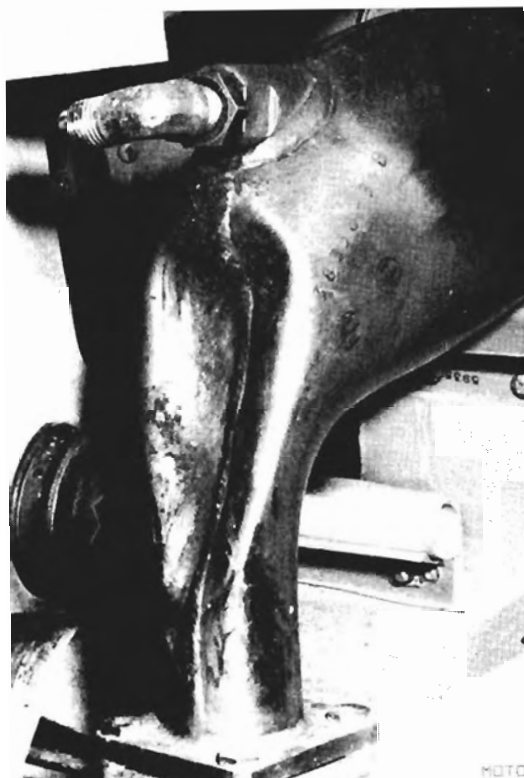
#### *Damaged fuel duct*

Fuel duct P/N 9938338-6 between the fire bulkhead towards the fuselage and the engine fuel regulator at compressor stg 7 had impact damage on the side facing the engine. On the opposite side of the fuel pipe approx 42 mm from its upper flange there was an approx. 22-mm-long fissure in a welded seam, with a maximum gap width of approx. 1.2 mm. In tests, the measured flow through the fissure was approx. 5 litres per min at a fuel pressure of 1 psig and approx 13 litres per minute at 15 psig.

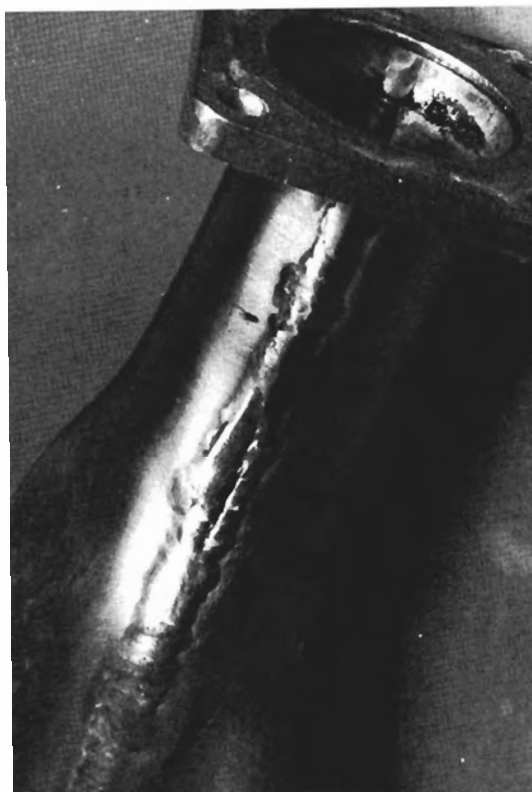
#### *Fissure in welded seam*

Metallurgical examination of the pipe revealed that there were manufacturing defects in the weld seam in the area where the fissure had occurred. The weld fissure is judged to have arisen in connection with the opposite side of the fuel pipe being subjected to the impact that caused the damage on that side. The impact created tensions in the defective weld joint which caused it to crack.

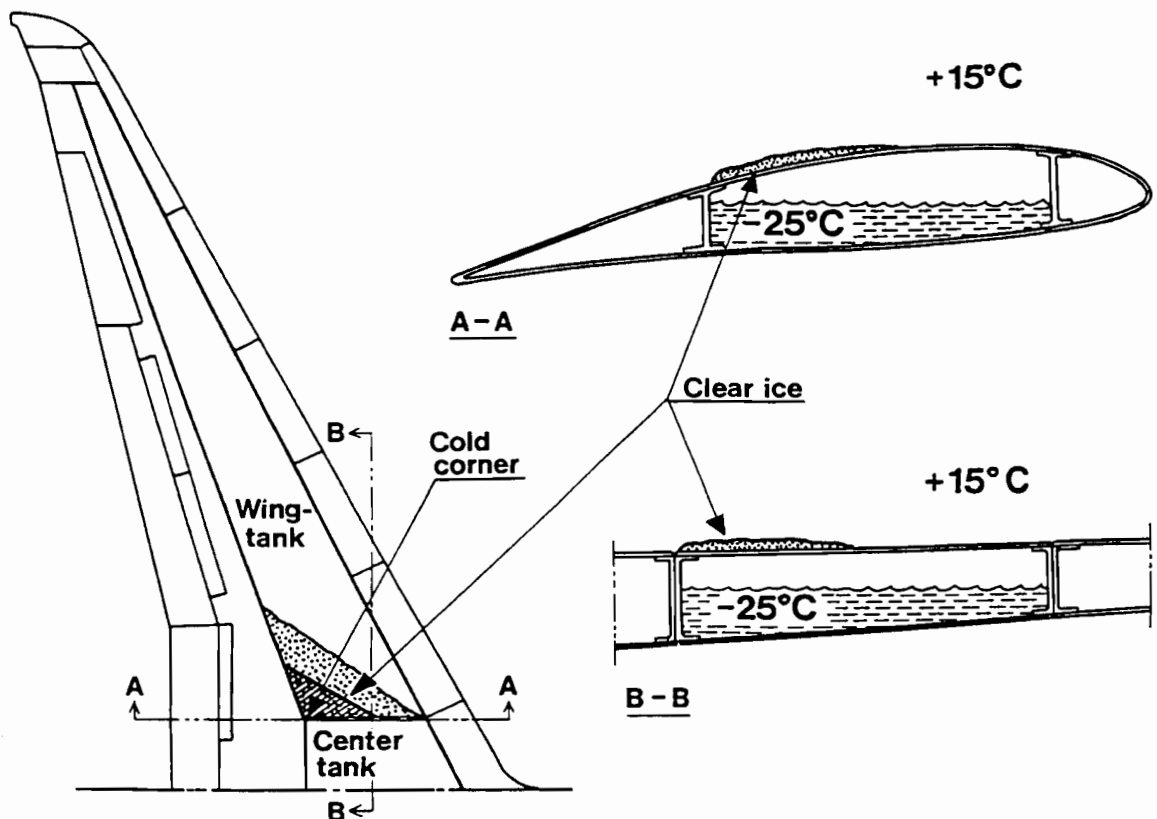
#### *Clear ice*

series the volume of the centre tank was increased by partly extending it into the enlarged wings. The innermost part of the neighbouring wing tanks, which contain the unused, often greatly chilled, remaining fuel, then came almost exactly in front of the engine air intakes.

Up until 1981 several cases of "soft" FOD damage had been reported on all DC-9 versions. In the same year both engines, one seriously, of a Finnair DC-9-51 were damaged by clear ice which came off the wings at takeoff and was ingested by the engines. This event was reported to the authorities, manufacturer and operators.
