Auxiliary Power Unit Battery Fire
Japan Airlines Boeing 787-8, JA829J
Boston, Massachusetts
January 7, 2013

Incident Report

NTSB/AIR-14/01
PB2014-108867

Aircraft Incident Report

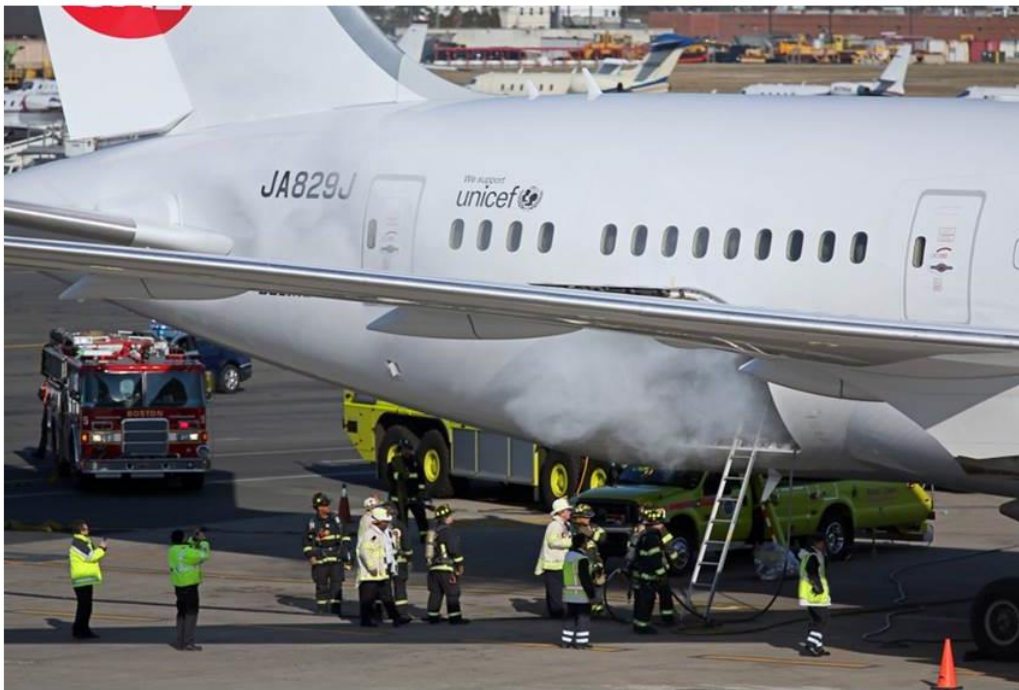
still present but was less intense than before. The airport security camera video showed smoke coming out of the airplane, as shown in figure 1, at 1040:26.

Figure 1. Photograph of smoke emanating from the incident airplane's aft E/E bay.

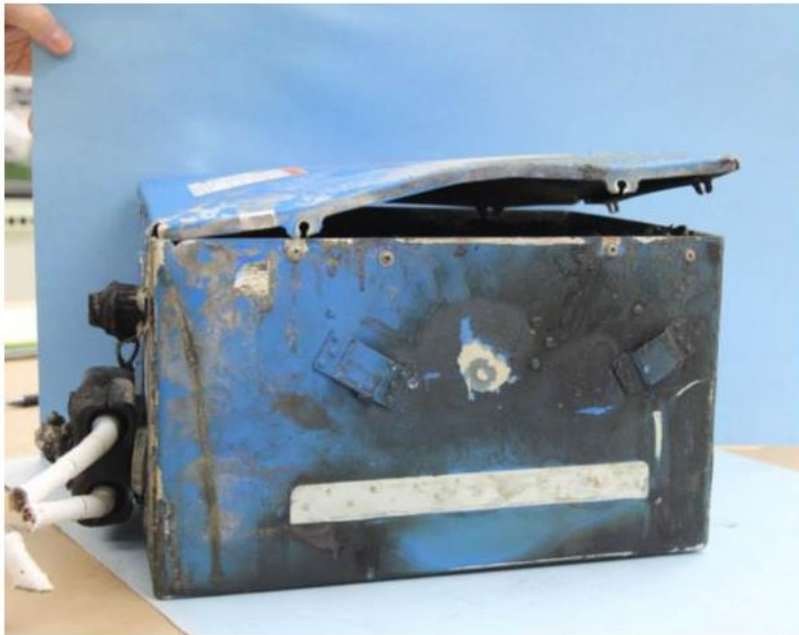
circular areas of thermal damage to the paint were located at the same elevation as the battery cell vent discs (as viewed from the exterior).³² An area of thermal damage to the paint was adjacent to and opposite from the cell 6 vent disc. A distortion and an area of missing paint and soot were adjacent to and opposite from the cell 7 vent disc. Paint discolorations were visible at the cell 5 and 8 vent locations.

The lid on the battery case was bulged and creased. The right aft lid corner (as viewed from the front of the battery case) exhibited more soot, charring, and residue than the rest of the lid and the most damage to the lid fastening points.³³ Figure 6 shows the bulged battery case lid and side 4 of the battery case.

Figure 6. Right aft corner of the battery lid and side 4 of the battery case.

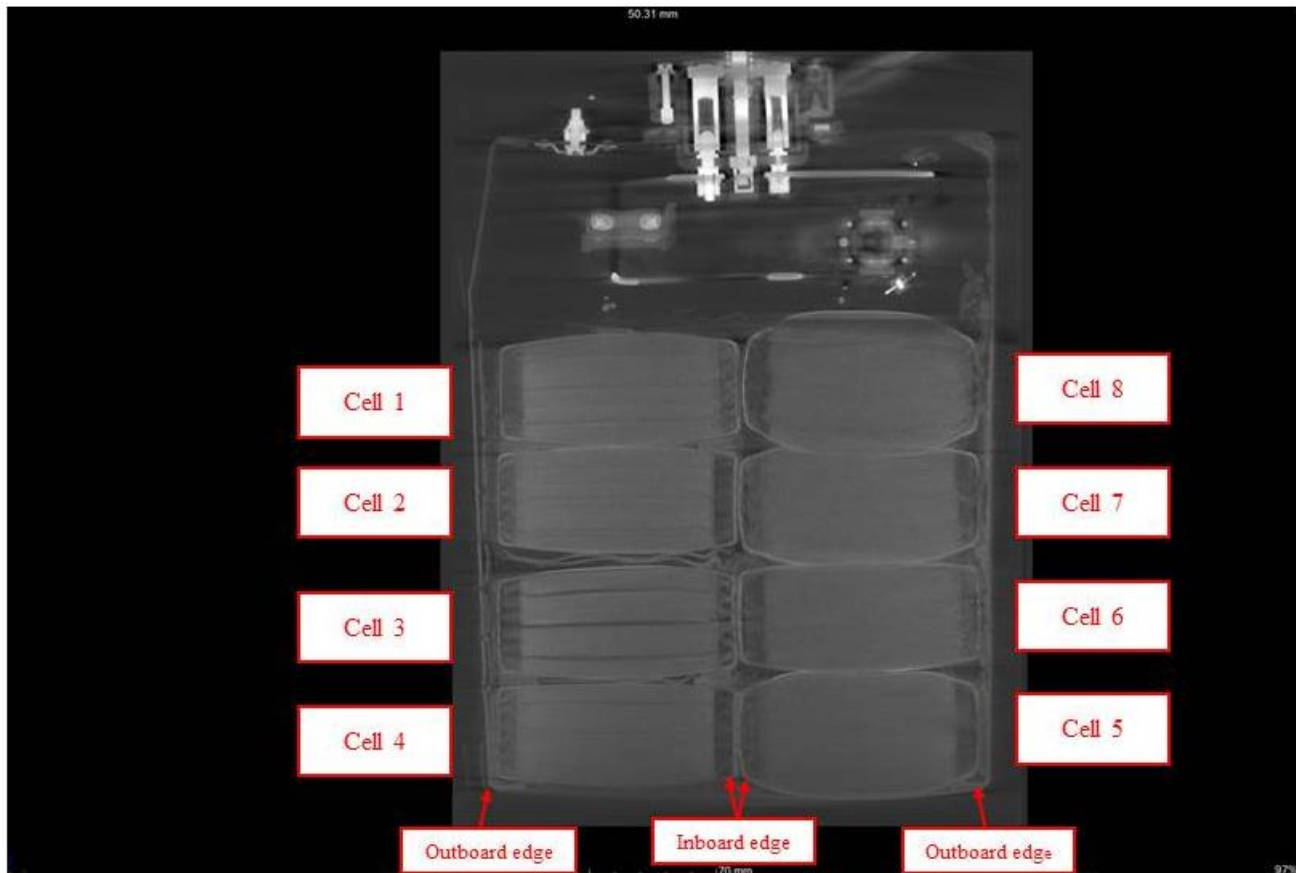
Figure 7. Cross-sectional view of the APU battery.

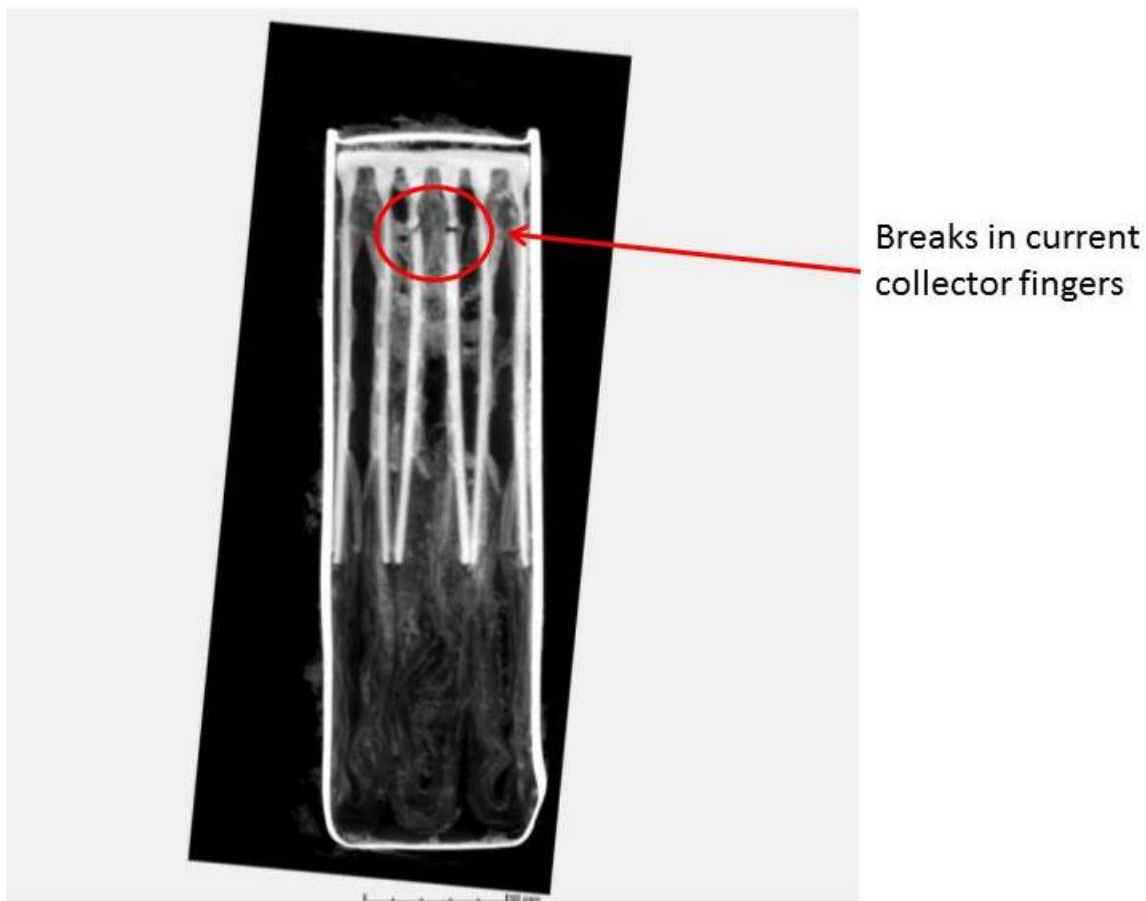
- Cell 5: Two cell wall breaches in separate locations were identified. The larger of the two breaches appeared to consist of separate smaller holes. The smaller breach appeared to consist of a single hole with some material missing from the outer cell wall around the hole. The areas inside the cell near the breaches differed from the general appearance of the cell. Also, two of the six aluminum (cathode) current collector fingers had breaks with rounded material on the ends. These breaks, as shown in figure 8, appeared as complete separations through the fingers. The current collector finger breaks occurred in the center winding. The other four aluminum current collectors and all of the copper (anode) current collectors were intact.

Figure 8. Cross-sectional view of cell 5 aluminum current collectors.

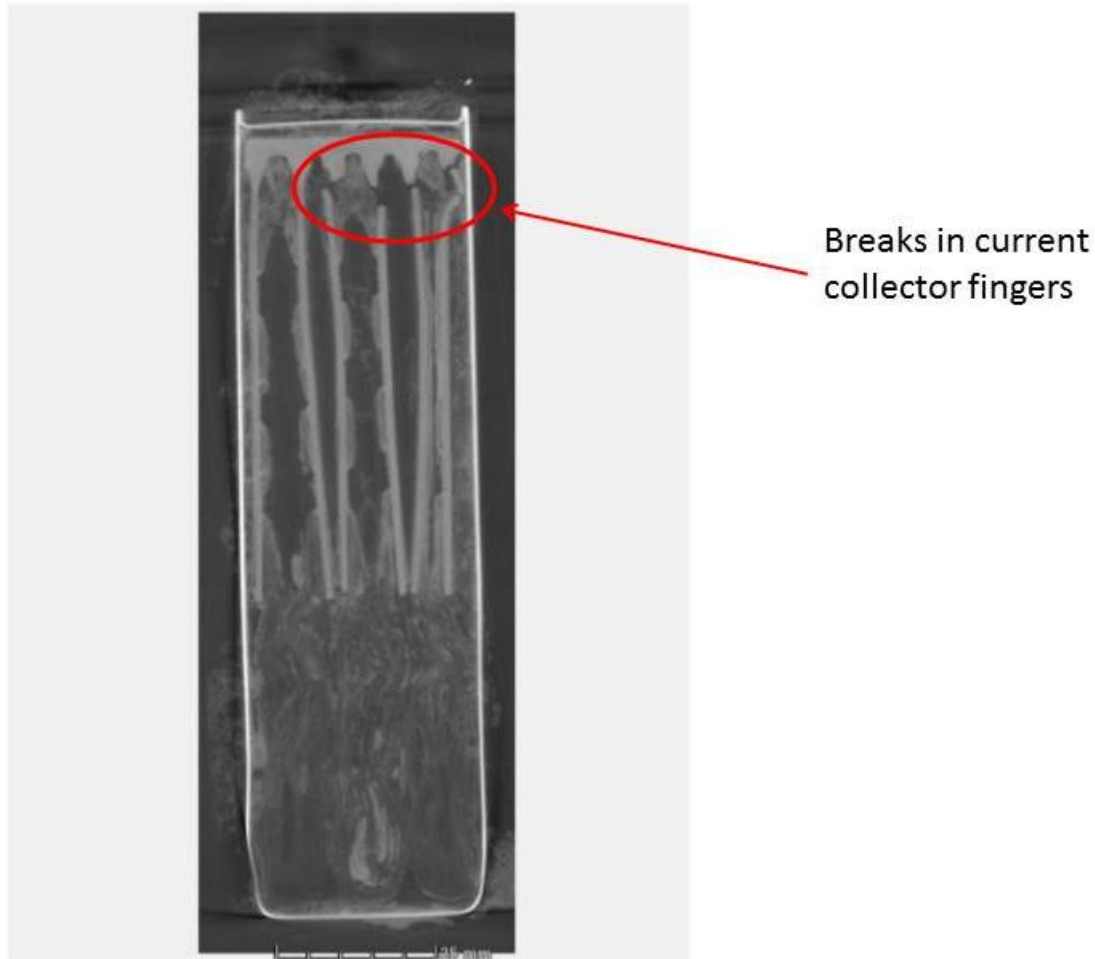
- Cell 6: Four of the six aluminum current collector fingers had breaks, as shown in figure 9, including one with breaks at multiple locations and another that was missing more material at the breakage location than the other current collector fingers with breaks. The current collector finger breaks occurred in the winding closest to cell 5 and the center winding. The other two aluminum current collectors and all of the copper current collectors were intact.
- Cell 7: Four of the six aluminum current collector fingers had breaks, including one with multiple breaks. All six current collector fingers appeared to be displaced from their original positions. The current collector finger breaks occurred in the winding closest to cell 6 and the center winding. The other two aluminum current collectors and all of the copper current collectors were intact.

Figure 9. Cross-sectional view of cell 6 aluminum current collectors.

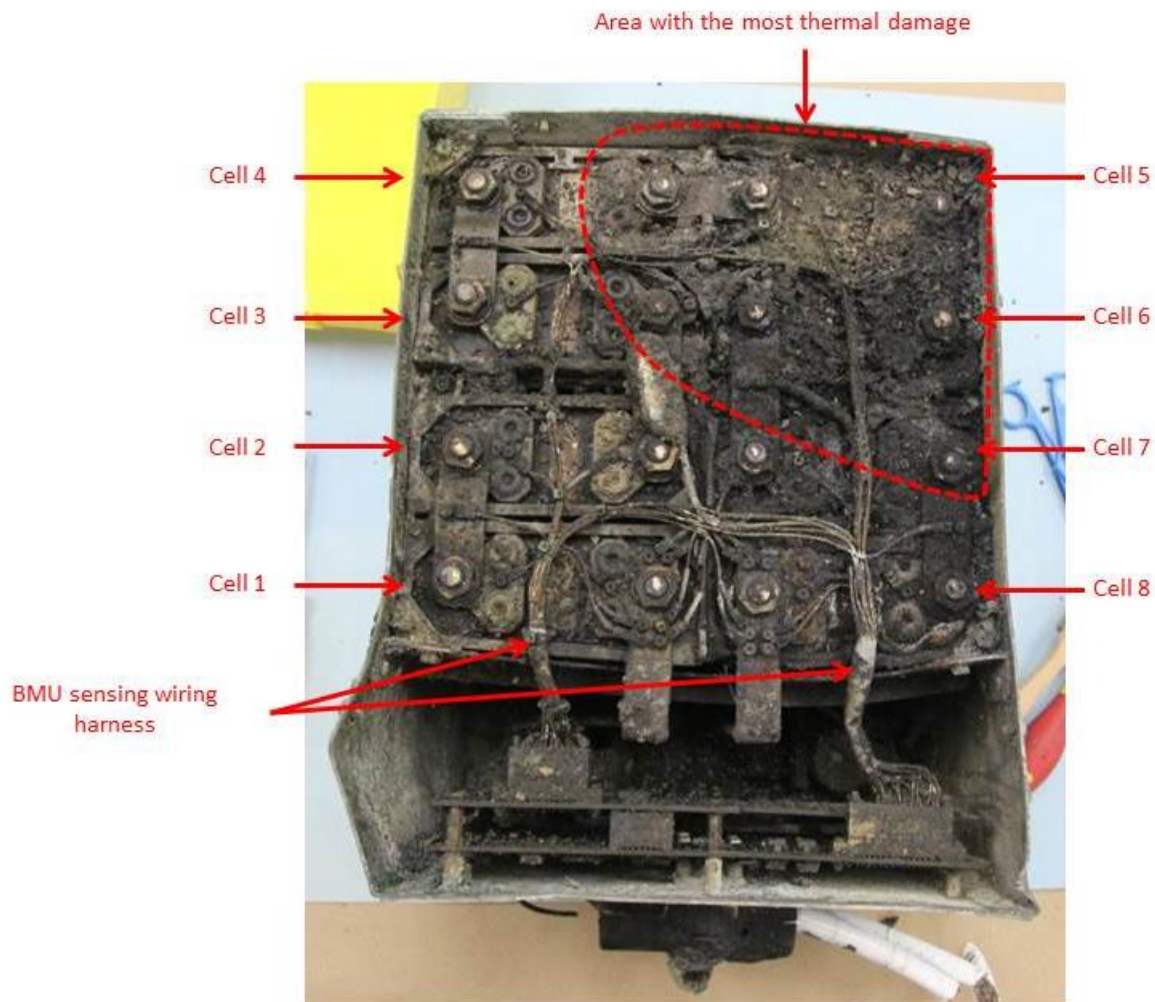
³⁶ For the vent discs on cells 5 through 8, the four petals were generally splayed out and positioned out of plane with each disc’s original position, which was indicative of a more forceful opening than that for the vent discs for cells 1 through 4. For cell 5, the petal closest to side 1 of the cell was completely missing.

Figure 10. Thermal damage to battery.

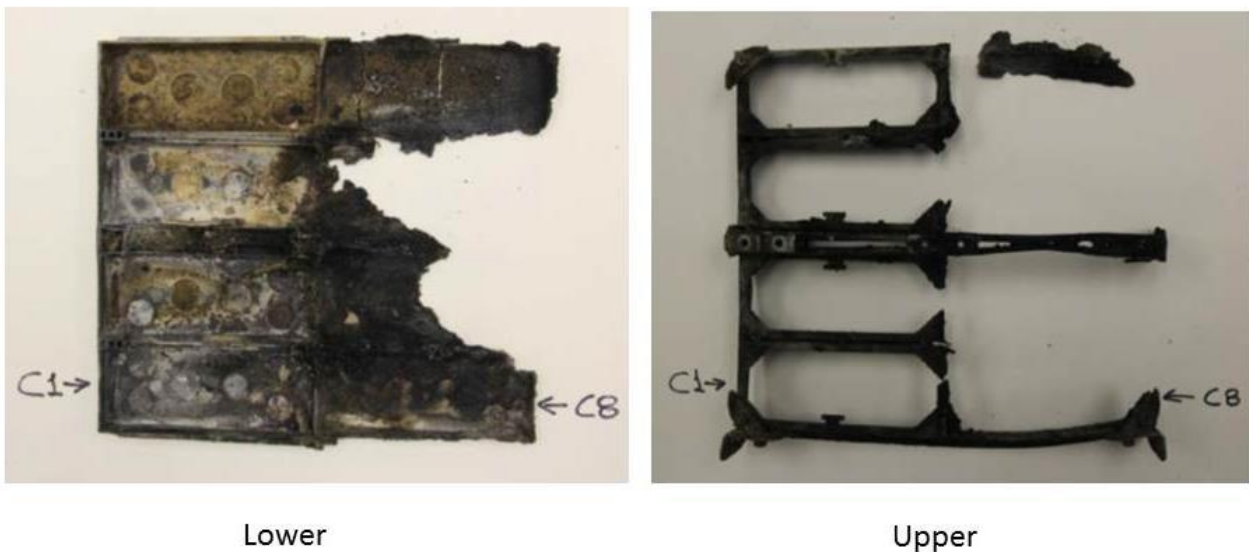
Debris and discoloration consistent with thermal damage were present on the cell 1 through 4 footprints on the lower fixation tray. The footprints of cells 5 through 8 were thermally decomposed, as shown in figure 11. Portions of the lower fixation tray under cells 5 and 6 could not be readily distinguished from other thermally damaged materials in the battery case. The portions of the upper fixation tray that contacted cells 1 through 4 sustained less damage than the portions that contacted cells 5 through 8. The cell 4 upper fixation tray imprint remained mostly intact, but the imprints for cells 1 through 3 showed progressively more damage. Minimal material remained from the portions of the upper fixation tray that contacted cells 5 through 8, which is also shown in figure 11.

Figure 11. Lower and upper fixation trays.

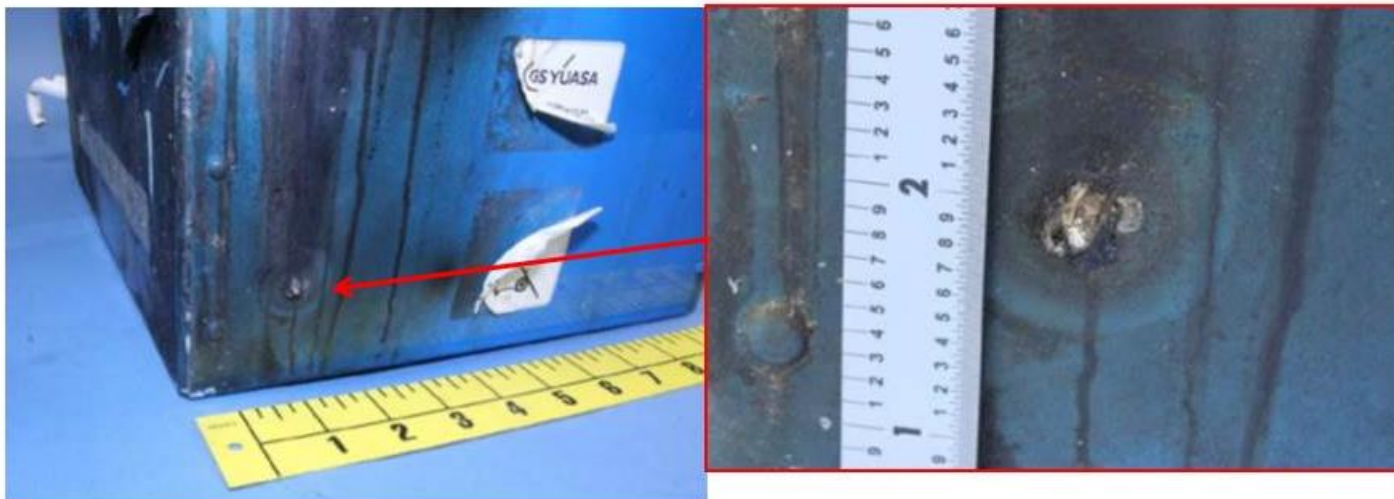
As stated in section 1.4.1, the battery case exhibited a 0.25-in-wide nodular protrusion on the lower left of side 3, as shown in figure 12. The protrusion extended about 0.12 in from the case. The protrusion appeared metallic and had no paint. Two concentric rings surrounding the protrusion corresponded with the discoloration of exterior paint. Deposits consistent with thermally degraded materials were observed on and near the protrusion. Three holes on the periphery of the protrusion were identified. The largest of these holes was elliptical in shape, with its longest dimension measuring 0.080 in. The two other holes, which were similar in size, measured about 0.004 in. Most of the interior side of the protrusion contained dull gray flaky material consistent with spatter, as well as shiny black material consistent with charred plastics and tars.

Figure 12. Protrusion on the lower left of battery case side 3.

The side of the cell 5 case that faced side 3 of the battery case had been heavily damaged, especially toward its edges and corners. Four holes were identified on the lower portions of this side of the cell case, all of which exhibited large amounts of dark, rough-appearing features consistent with decomposition products. The largest hole (in terms of size and amount of decomposition products) was about 0.2 in; this hole corresponded with the location of the protrusion on the battery case.

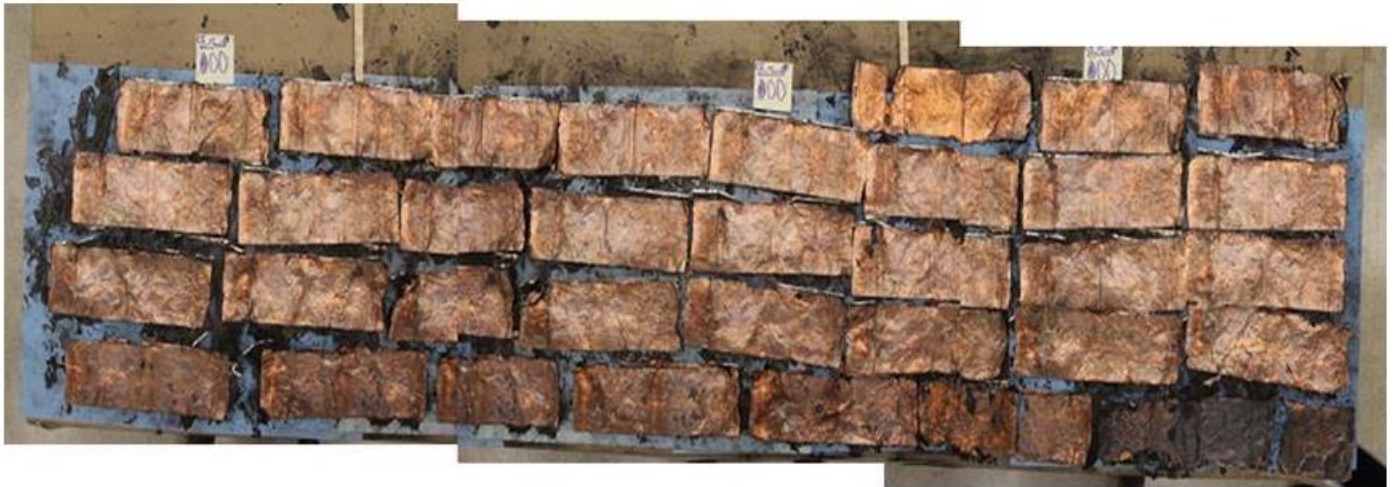
For the winding that was closest to battery case side 3, the copper foil was discolored at the header fold with small ripples. The copper foil also exhibited a band of darker color adjacent to the nodular protrusion, which was consistent with high heat exposure. This band of color propagated from the exterior to interior wraps of the winding. The center winding copper foil had ripples along the header fold. This winding appeared to have more overall damage than the other two windings. The winding closest to cell 6 showed the most fragmentation of the aluminum foil and the coated material. The first and second wraps of the winding had thermally adhered to the interior of the cell case, and portions of the first wrap had also thermally adhered to subsequent wraps of the winding. One of the innermost wraps showed folds in the copper foil on the side facing cell 6, which were present through several layers of the winding, as shown in figure 13. Other notable features found during the winding examination were the lack of any sizeable repeating rifts in the windings and the greater amount of damage to the exterior wraps of the windings compared with the interior wraps.

Figure 13. Cell 5 winding closest to cell 6.

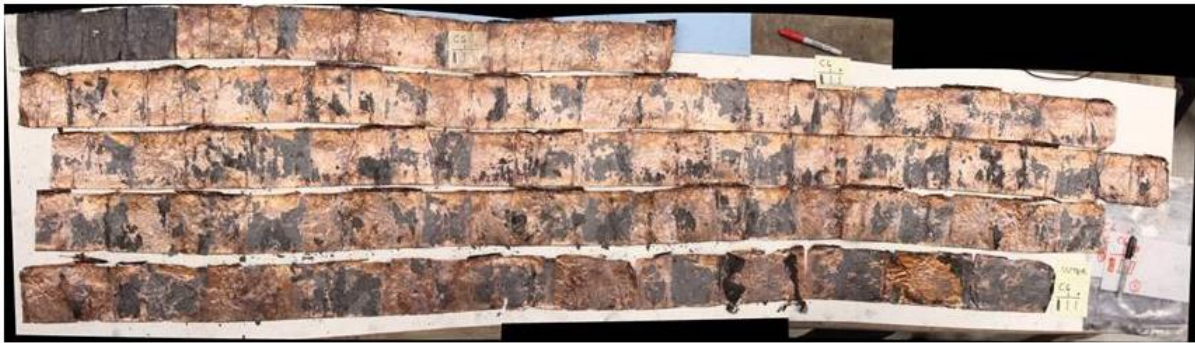
For all three windings, large portions of the active material coating for the copper foil had delaminated, exposing large areas of the foil. Pinholes and localized areas of thermal discoloration, which were consistent with localized hot spots, were observed near the edges of the copper foil. The winding closest to cell 5 showed areas of concentrated thermal discoloration that appeared in a repeating pattern on the copper foil, as shown in figure 14. One area of thermal discoloration began on multiple exterior wraps and became lighter toward the interior wraps. Another area of thermal discoloration began about midway through the wraps and continued all of the way to the interior wraps. This pattern of thermal discoloration, which was concentrated on the side of the foil closest to the copper current collectors, exhibited a radiating pattern of wrinkles. The center winding showed an area of thermal discoloration that began at one of the outermost wraps and continued into the winding. The winding closest to cell 7 showed a repeating area of thermal discoloration at one of the outermost wraps.

Figure 14. Cell 6 winding closest to cell 5.

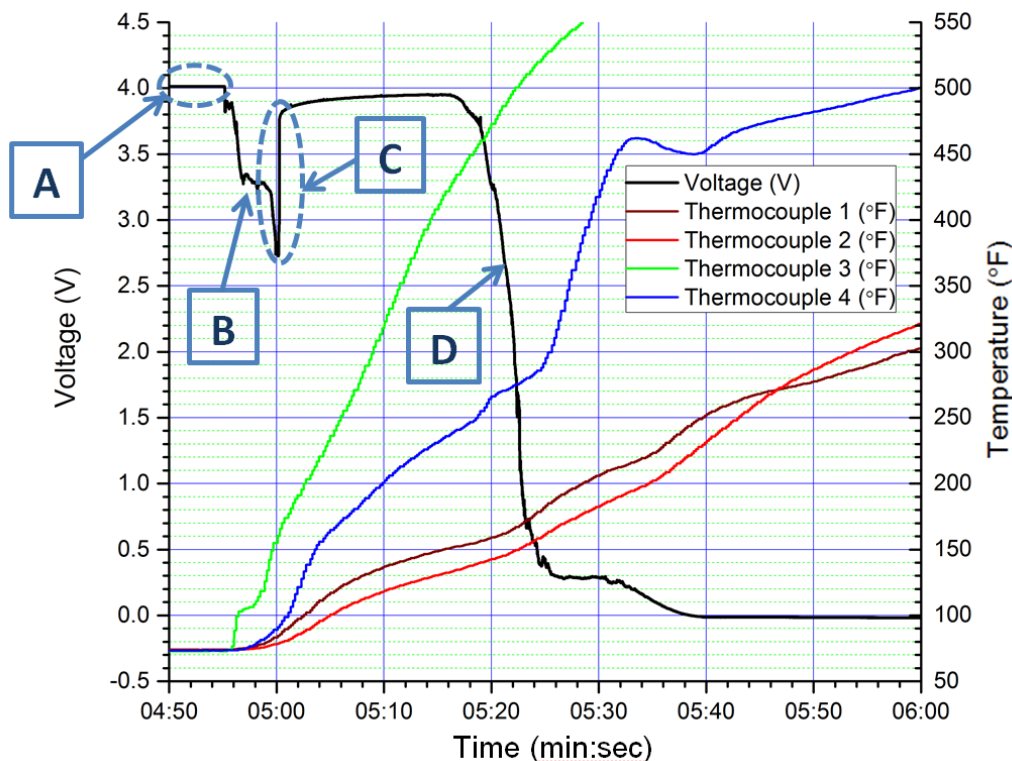
Figure 15. Results of cell-level internal short circuit abuse test.
