# **AIRCRAFT ACCIDENT REPORT 2/2015**

## **Report on the serious incident to Boeing B787-8, ET-AOP London Heathrow Airport on 12 July 2013**

**Air Accidents Investigation Branch**

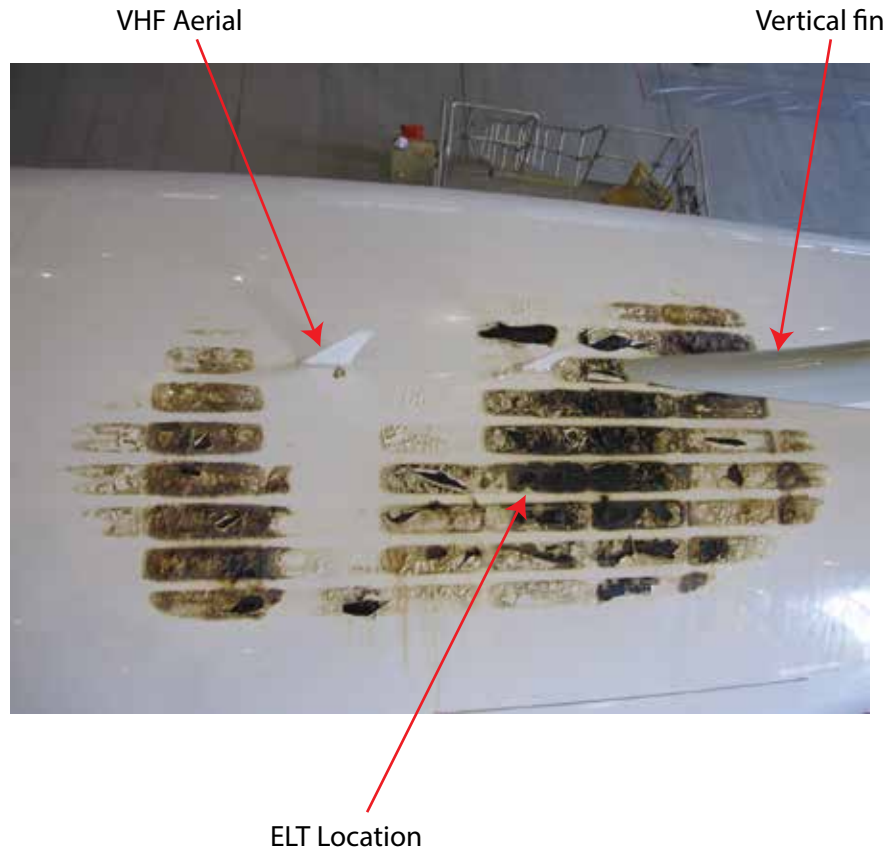
**Figure 1**

The aircraft structure sustained fire damage to a section of the rear fuselage crown skin and fuselage frames. The damage extended over an area of approximately 9.5 square metres, bounded by frame nos. 1644 to 1794 and stringers 7L to 3R (Figure 1). In this area the fuselage insulation blankets had been destroyed or severely damaged. The structural damage was most severe

in the area adjacent to the location of the ELT, with significant resin loss and ply disbonding in the fuselage skin and frames. The cabin interior tie-rods in this area had sustained damage to their upper portions and the Environmental Control System (ECS) ducts in the region of the fire had been damaged.

External view of fuselage damage

In addition to the fire damage, soot deposits were found over large areas of the crown skin. Large quantities of soot contamination were also found behind all of the rear cabin sidewall structure and in the lower fuselage, extending from the central equipment bay to the rear pressure bulkhead.

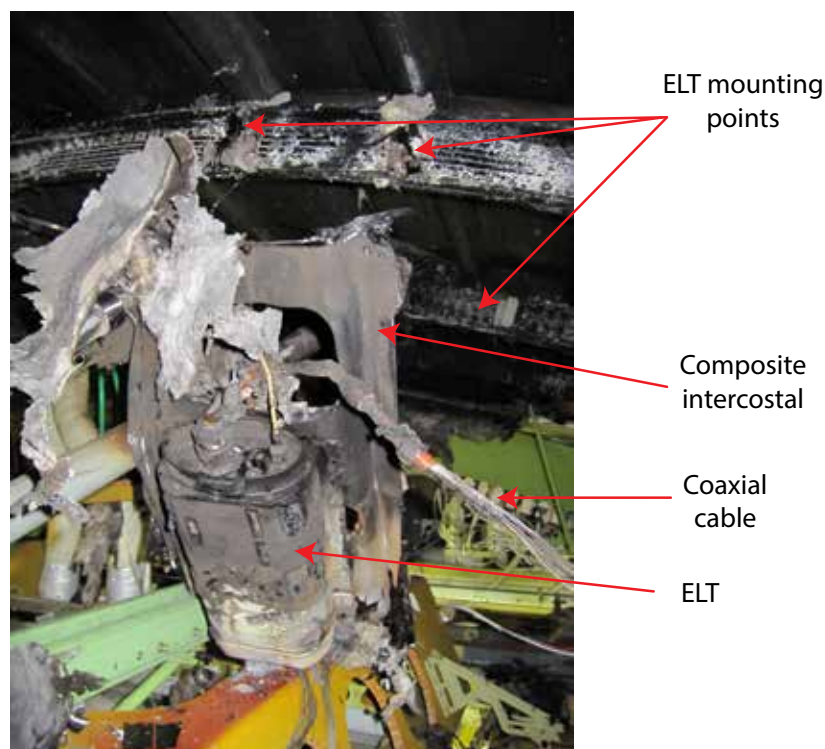
**Figure 9**

The ELT, its mounting plate and sections of the frames to which it was attached, had suffered severe thermal damage. The ELT forward frame attachment point had failed and the ELT was supported only by its rear attachment point and the coaxial cable (Figure 9).

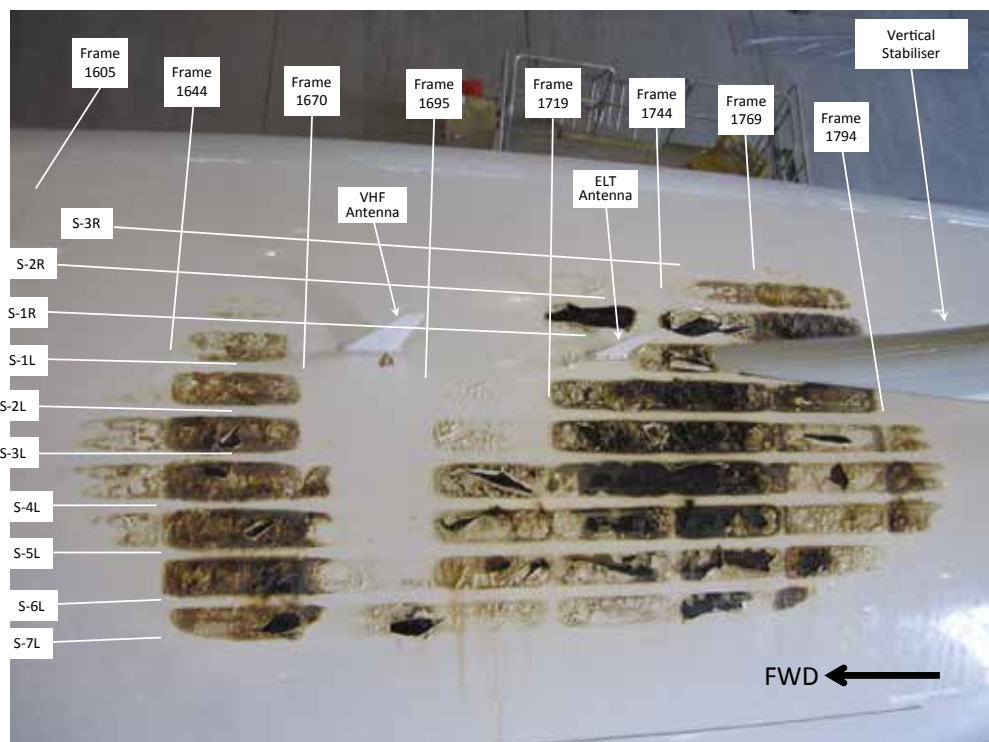
**Figure 10**

Fire damage was found on the interior of the fuselage skin between stringers 4R and 7L, which extended forward to frame 1618 and rearwards to frame 1815. This damage appeared more severe in the region of the ELT mounting structure. The external fuselage skin showed clear evidence of heat damage in the location of the ELT and its surrounding area (Figure 10). Despite the degree of damage observed, the fuselage skin had not been breached by the fire.

The cabin interior tie-rods had been damaged in this region. The damage was generally restricted to the portions of the rods within 12 cm of the damaged fuselage crown skin. The cabin environmental control system (ECS) ducts in the rear crown skin area had also been damaged. There was no evidence that the fire had progressed to any other area of the fuselage.

Photograph of external skin damage with frame and stringer numbers super-imposed

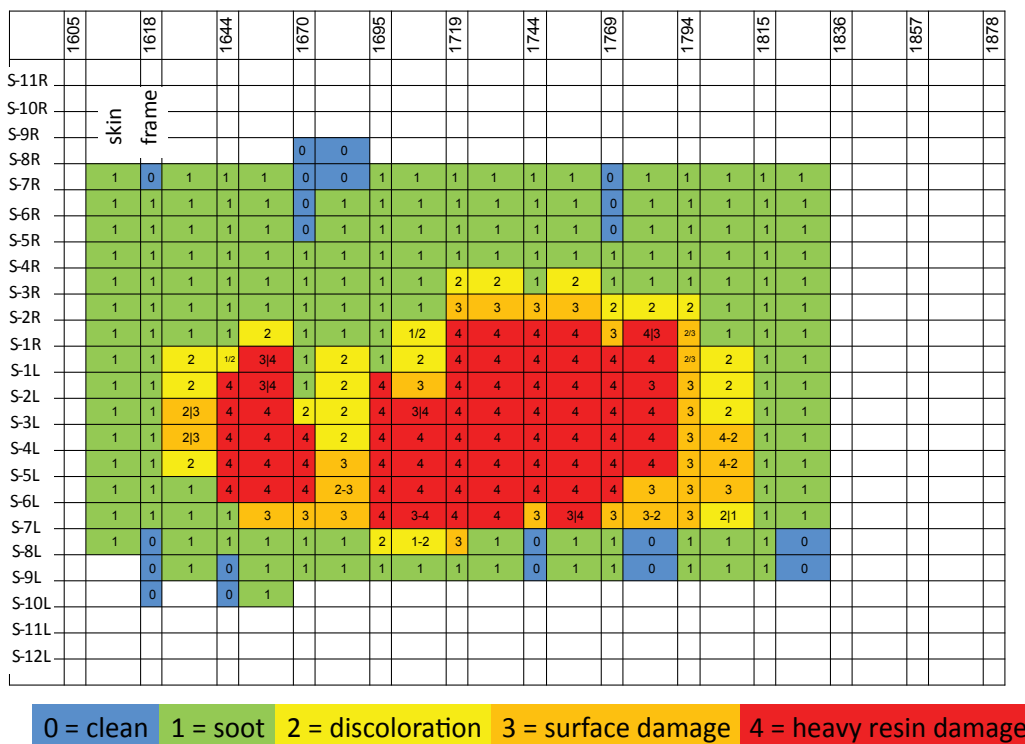
**Figure 12**

During the course of the aircraft repair, a large section of the rear crown skin was replaced, together with all the damaged frame sections. This included all the areas identified as being damaged or discoloured in Figure 12. To facilitate removal the damaged section was cut into six pieces which, together with the damaged frame sections and the remains of the insulation blankets, were transported to the AAIB headquarters for further investigation.

Plot of interior skin damage (viewed from above)

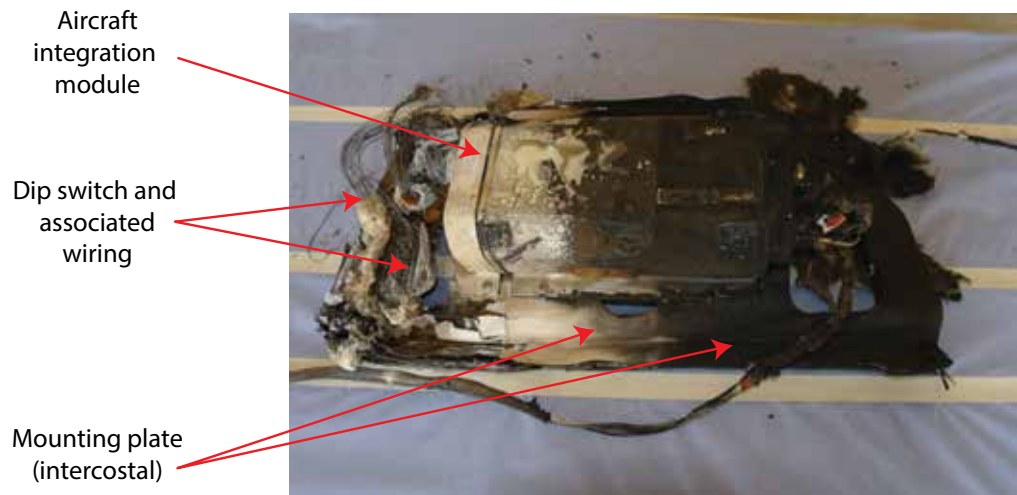
**Figure 14**

Initial examination of the ELT, after removal from the aircraft, showed that the ELT case was badly heat damaged and all of the orange paint had burnt off. Heavy sooting and carbon deposits were evident on the forward two-thirds of the ELT TU. There was no sooting on the rear third of the TU or the AIM, indicating that temperatures on this portion of the ELT had been sufficiently high to burn off the soot deposits (Figure 14). A small gap was evident between the AIM and TU.

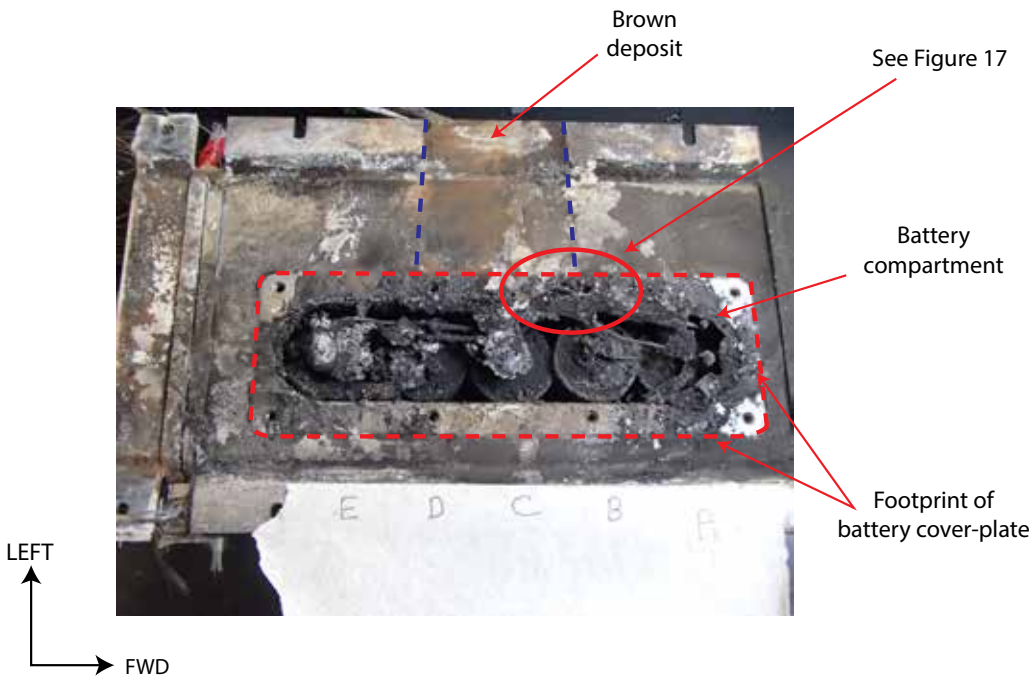
**Figure 16**  
Upper surface of ELT with battery cover-plate removed;  
tops of battery cells visible

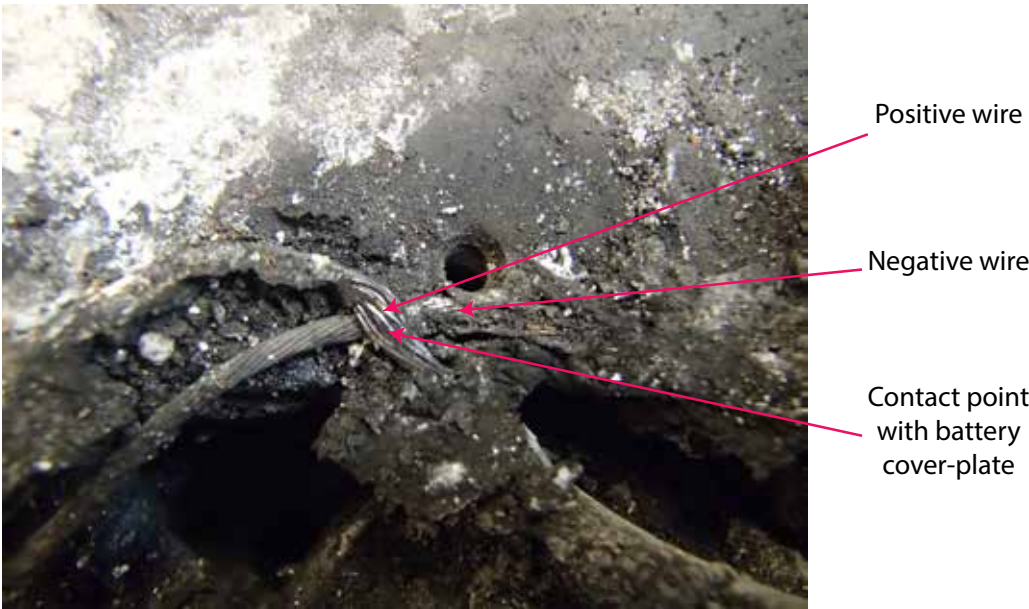
The ground fire on ET-AOP was initiated by the uncontrolled release of stored energy from the lithium-metal battery in the ELT. It was identified early in the investigation that ELT battery wires, crossed and trapped under the battery compartment cover-plate, probably created a short-circuit current path which could allow a rapid, uncontrolled discharge of the battery. Root Cause testing performed by the aircraft and ELT manufacturers confirmed this latent fault as the most likely cause of the ELT battery fire, most probably in combination with the early depletion of a single cell.

- a) The trapped ELT battery wires created a short-circuit condition, providing a current path for an unplanned discharge of the ELT battery.
- b) The ELT battery may have exhibited an unbalanced discharge response, resulting in the early depletion of a single cell which experienced a voltage reversal, leading to a thermal runaway failure.
- c) The Positive Temperature Coefficient (PTC) protective device in the battery did not provide the level of external short-circuit protection intended in the design.
- d) There was no evidence that the reset behaviour, and the implications of the variable switching point of the PTC, had been fully taken into account during the design of the ELT battery.
- e) The absence of cell segregation features in the battery or ELT design meant the single-cell thermal runaway failure was able to propagate rapidly to the remaining cells.

**Figure 17**  
Zoomed-in view of crossed ELT battery wires, identified in Figure 16

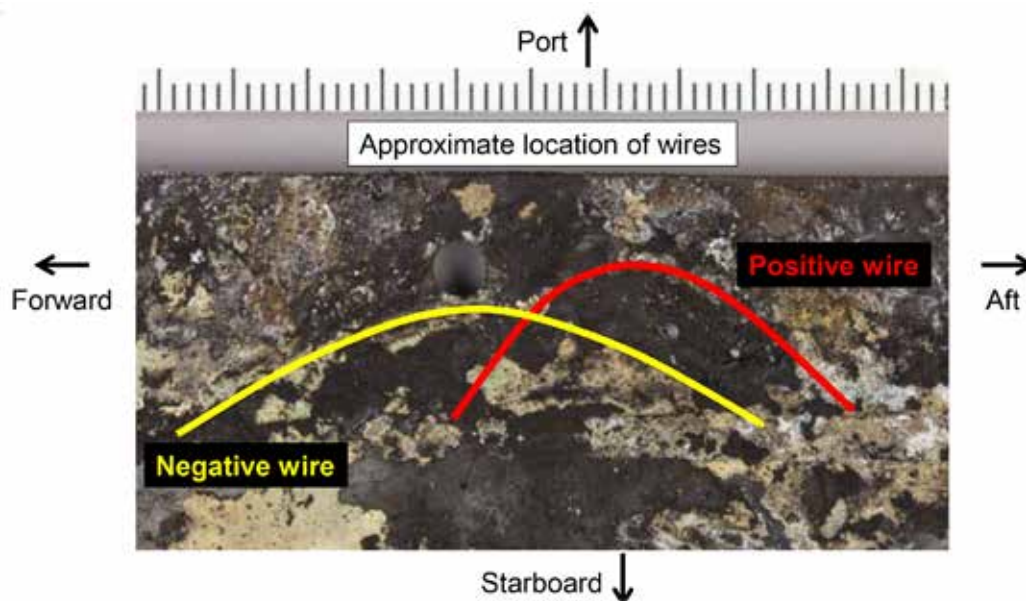
**Figure 19**

Two adjacent contact locations were identified along the path of the trapped wires (Figure 19). These were consistent with having been made by two separate wire strands from the positive (upper) conductor. A very thin layer of material rich in copper and silver, consistent with the battery wire material, had been transferred to the cover-plate at these locations. There was no evidence of arcing, melting or fretting.

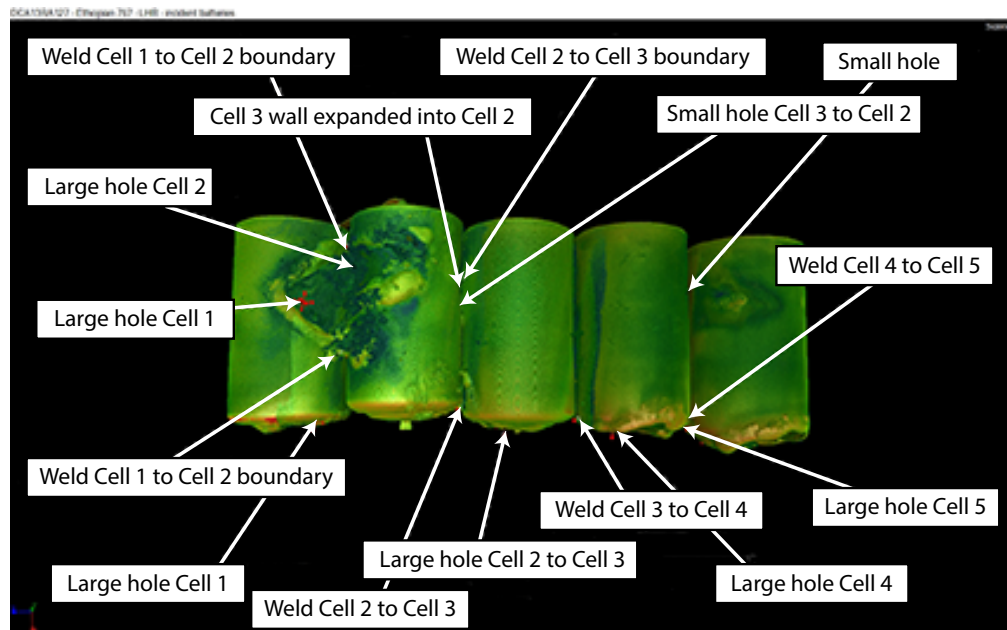
**Figure 20**

Corrosion pits were evident on the surface of a number of the cells.

Rendered image from CT scan of battery,  
showing Cell 1 to Cell 5 (left to right)

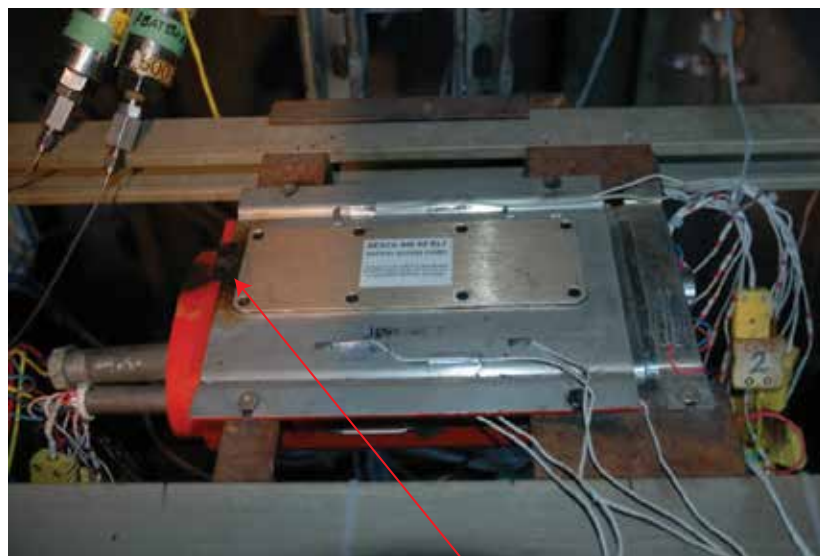
The cells were found burnt and blackened but most of the decomposition products were retained within the ELT (Figure 31).

Evidence of minor escape of development products

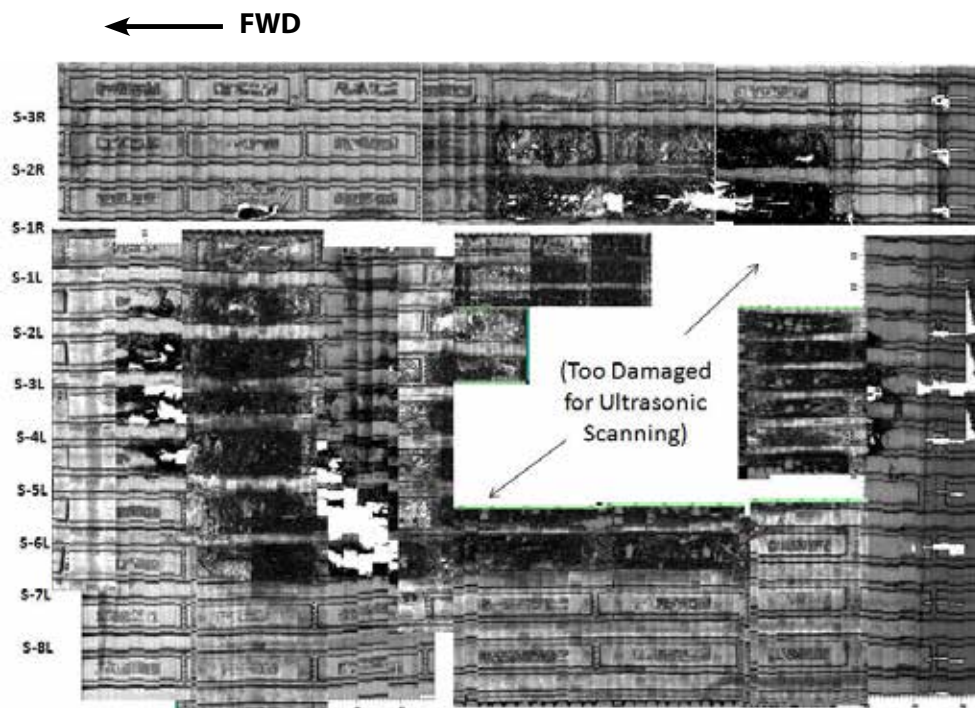
**Figure 38**

Ultrasonic pulse-echo mosaic of crown skin damage

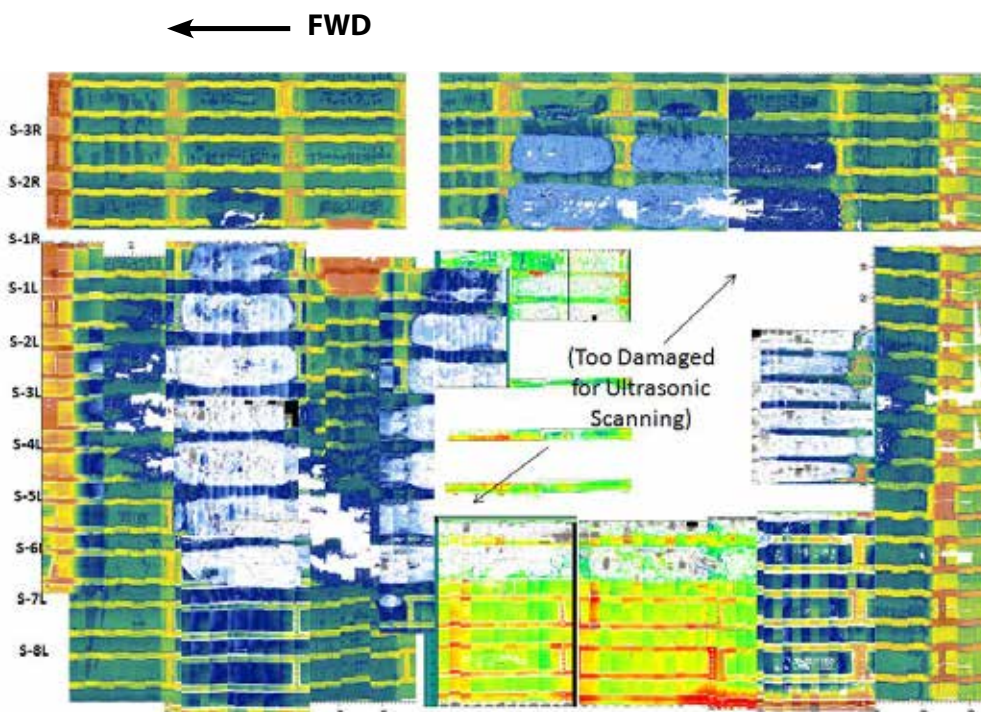
**Figure 39**

Figure 39 provides an indication of the depth of undamaged material, measured from the outer face of the skin section. The darker blue areas indicate areas where damage extends through the majority of the skin thickness. The white areas represent areas which have full-thickness delamination. This illustrates that in the region of the ELT, where the fuselage skin has its smallest cross section, all the resin within the CFRP had been consumed. In areas of greater cross section, despite significant visual damage, some resin was still present.

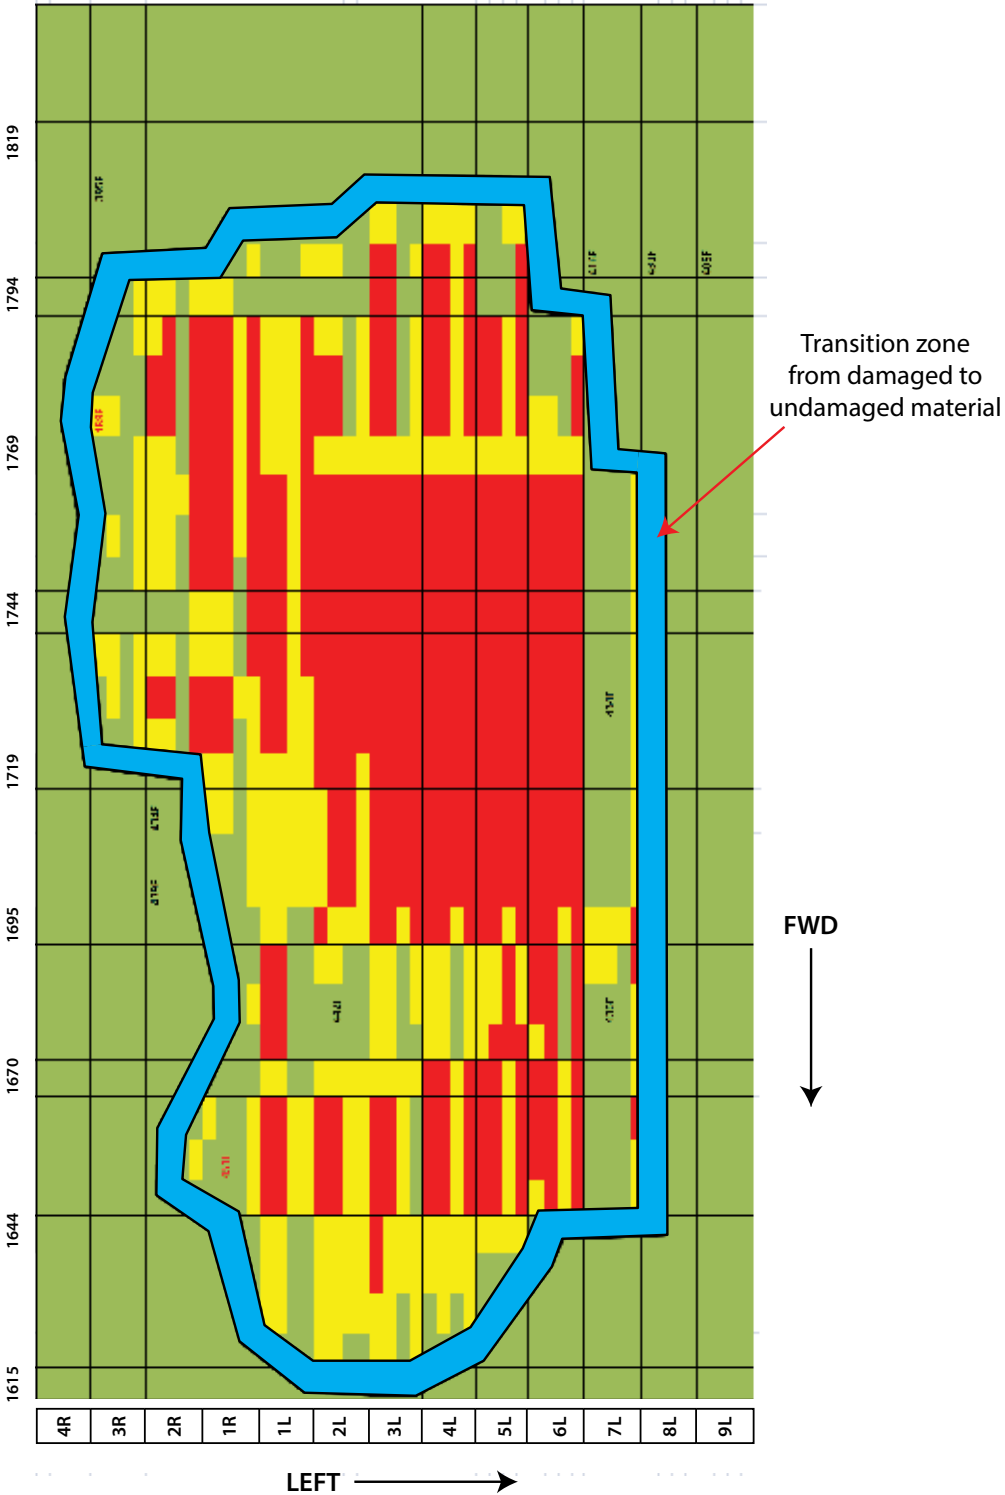
The FTIR technique was used to assess the condition of thermally degraded resin beyond the boundary of delamination. The results indicated that within the crown skin, the typical transition zone extended approximately six inches beyond the boundary of any delamination. The FTIR results were superimposed on the composite skin-stringer damage mosaic (Figure 42) to provide an overall image of the damage to the skin panels and the stringer webs (Figure 43).

**Figure 42**  
Boundary of damaged skin panel resin

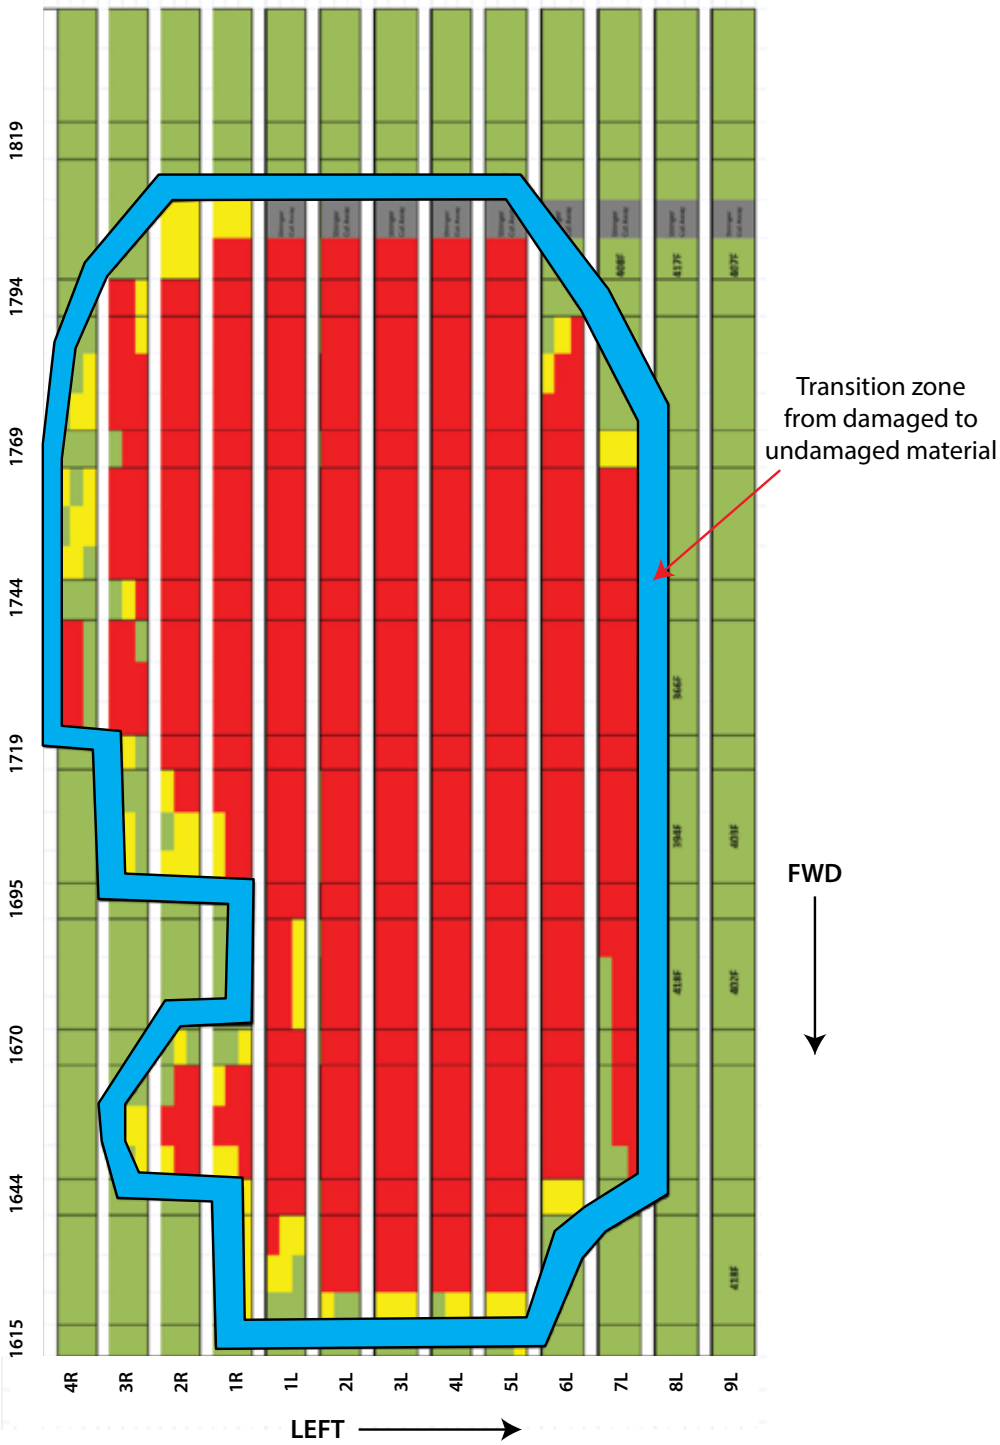
**Figure 43**  
Boundary of thermal damage on stringer webs
