AIRCRAFT SERIOUS INCIDENT INVESTIGATION REPORT

AIR NIPPON CO., LTD.
BOEING 737-500, JA8419
OVER THE SEA APPROXIMATELY 60 NM SOUTHEAST OF
KUSHIMOTO VORTAC
JULY 5, 2006

June 27, 2008

Aircraft and Railway Accidents Investigation Commission
Ministry of Land, Infrastructure, Transport and Tourism

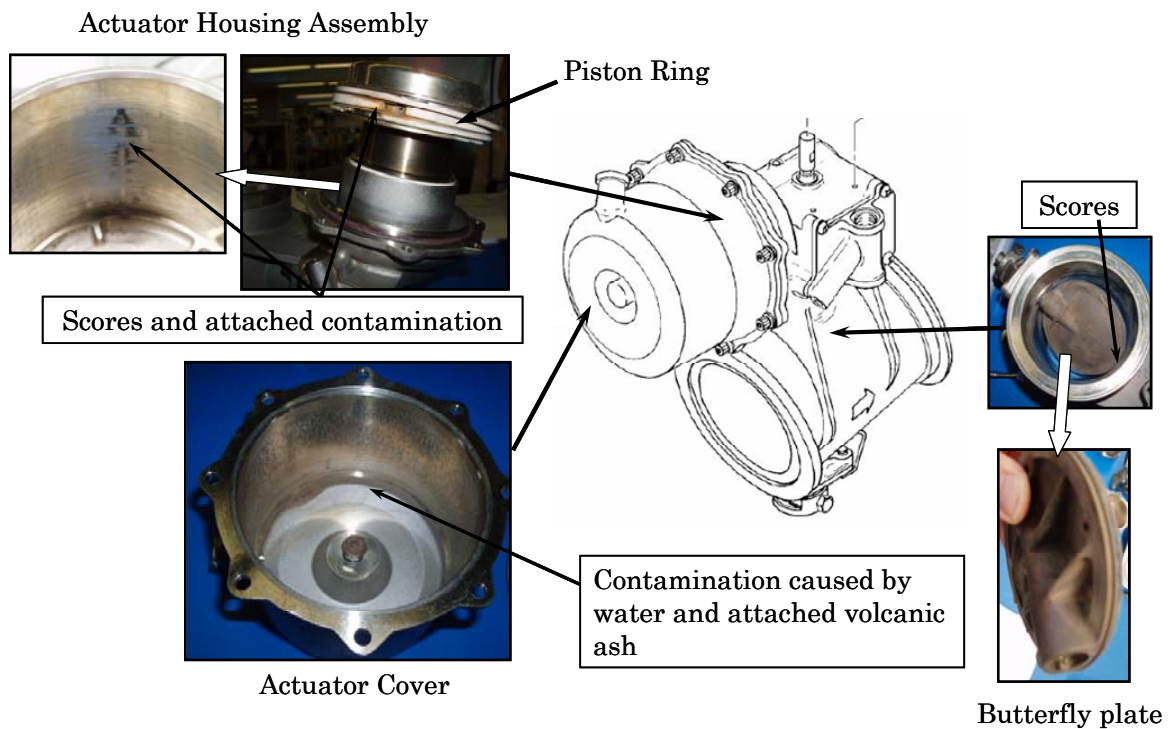
Photo 1 Dismantled No.1 PRSOV

Shallow scores were found on the valve body and the lower section of the butterfly plate. The damage was attributable to contamination that filled the groove in the butterfly plate seal ring and prevented the seal ring from being compressed.

The inner surface of the actuator housing had scores that were caused by a piston ring set stuck due to contamination.

The valve linkage hinge was corroded with granular contamination on it.
(See Figure 2 and Photographs 1 and 2.)

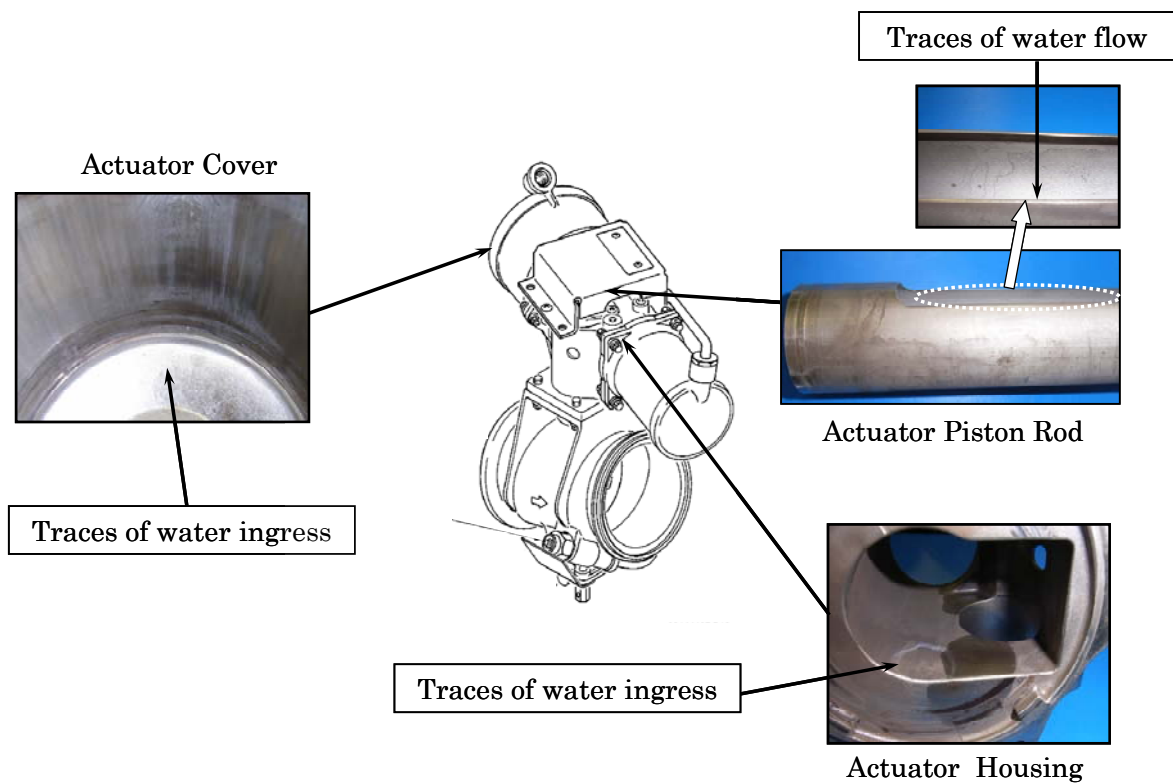
Photo 3 Dismantled No.1 HSV

Traces of water ingress were found on the actuator cover.

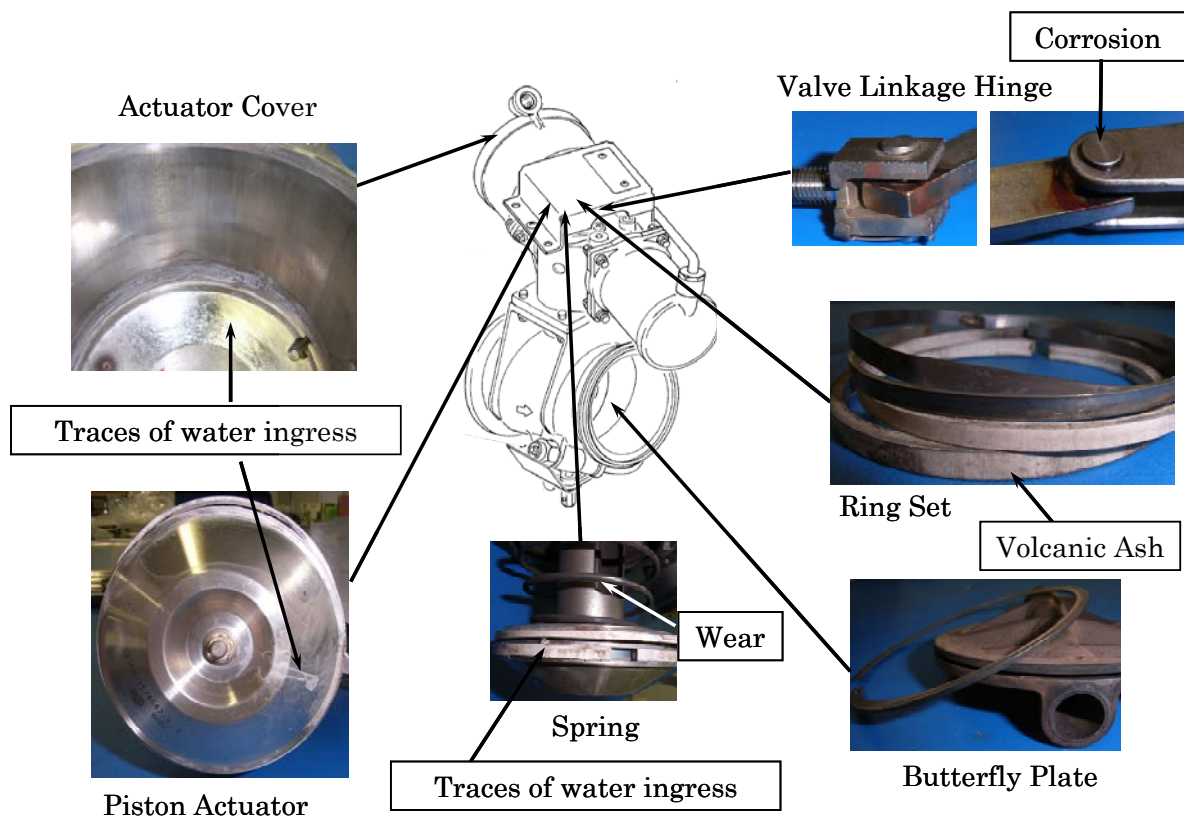
Photo 4 Dismantled No.2 HSV

Traces of water ingress were found on the inside and outside surfaces of the hollow piston actuator rod.

The valve linkage hinge was corroded.

The outer periphery of part of the spring was worn due to interference with other parts.

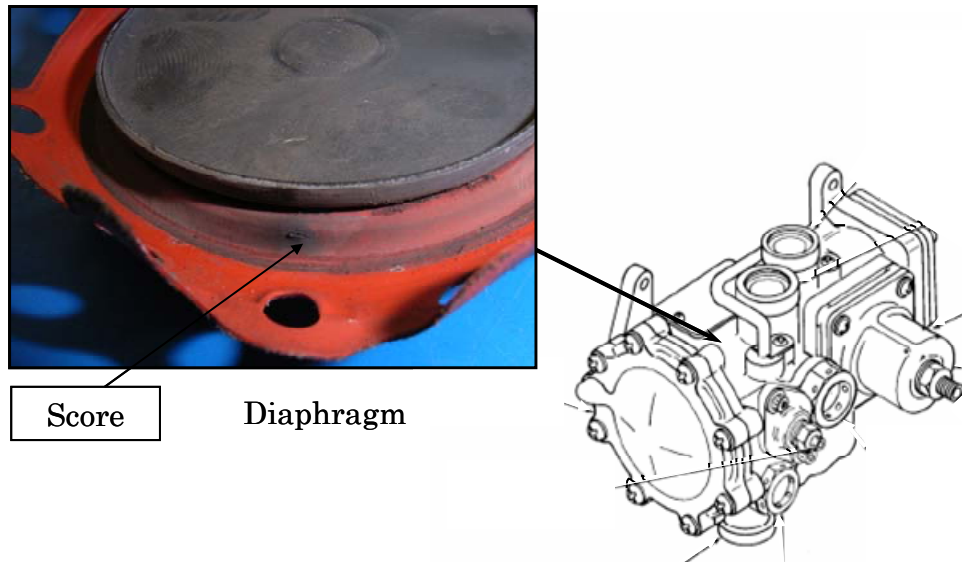
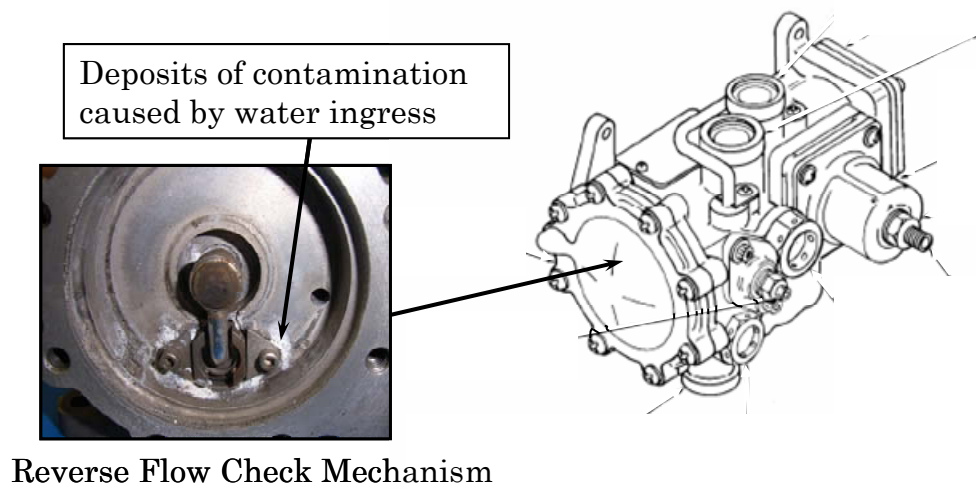
- (1) The No. 1 regulator had a small score on the diaphragm mounting area.
- (2) The No. 2 regulator had deposits of contamination in the area around the reverse flow check mechanism on the diaphragm end side, where traces of water ingress were also found.

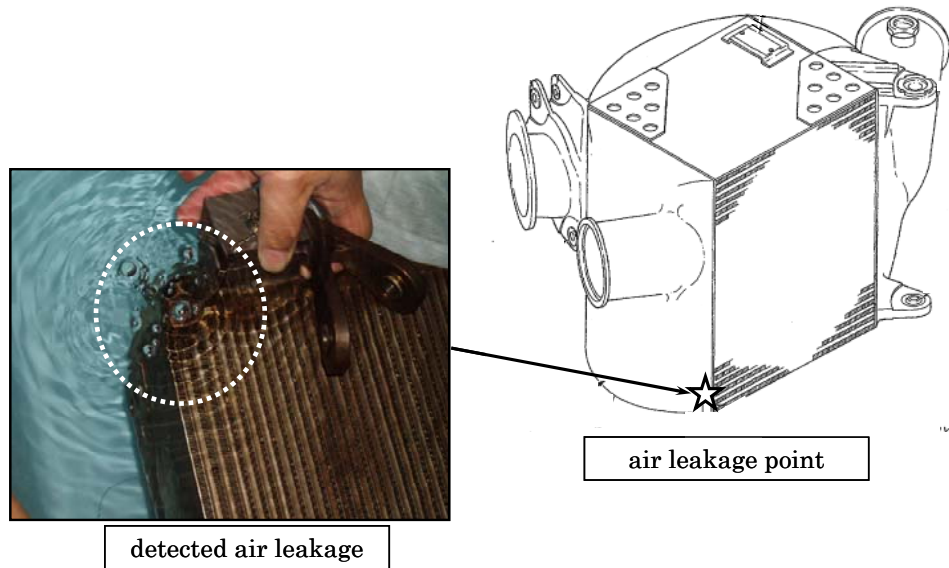
Photo 7 Test of No.1 Pre-cooler

Air leakage was found from a welded corner.

- (3) As a result of the functional tests conducted on the No. 1 and No. 2 pre-coolers at the manufacturer, the pressure drop of the No. 1 unit (0 psi pressure drop within 10 seconds) and that of the No. 2 unit (27 psi pressure drop within 10 seconds) were both found to conform to the design standard (33 psi or smaller pressure drop within 10 seconds after applying 50 psi initial pressure).

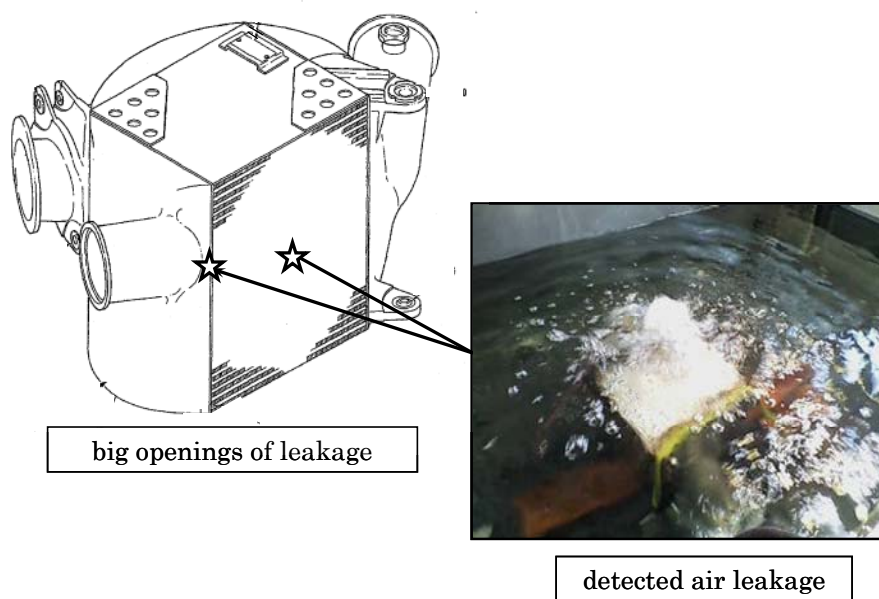
Photo 8 Test of No.2 Pre-cooler

There were openings both near the center of the ram air outlet core and in a straight-line weld, from where heavy air leakage was detected.

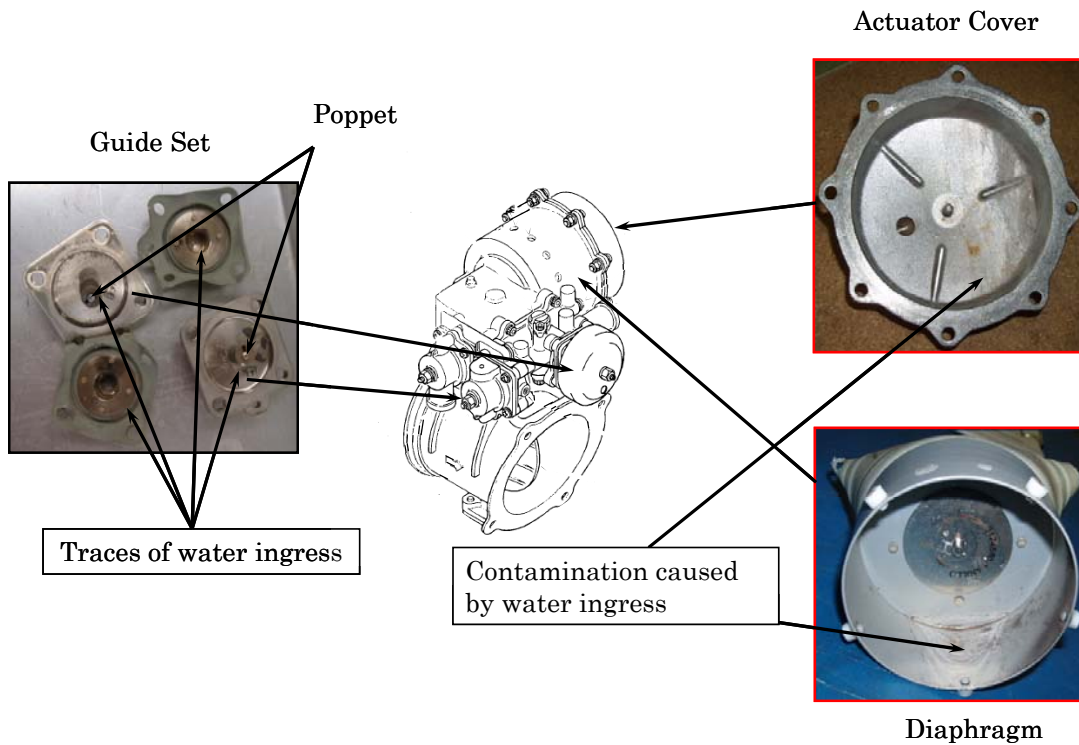
Photo 9 Dismantled No.1 PCV

In addition, the butterfly plate was found to have shifted toward the “open” side from the normal position.

- ① Traces of water ingress and contamination deposits were found inside the actuator housing.
- ② The vent hole in the servo body assembly was found to be narrowed due to contamination.

- ③ The retainer of the actuator reference pressure regulator diaphragm was found broken into three pieces.
- ④ The servo reference pressure regulator had traces of water ingress on the guide set side of the guide-set-to-poppet-valve connection.

The poppet valve was found to be partially darkened due to wear.

It is estimated that, when higher-temperature 9th-stage bleed air flowed into the pre-coolers, both the No. 1 and No. 2 PCVs, the role of which is to control the fan air, operated sluggishly due to contamination deposits and thus failed to allow sufficient fan air to flow to the pre-coolers, causing insufficient cooling and the No. 1 and No. 2 overheat switches to trip, which then caused both bleed valves to close (as indicated by illumination of both BLEED TRIP OFF lights), resulting in an abnormal drop in cabin pressure.

As to contamination deposits inside the PCVs, it is estimated that the cause was a significant amount of detergent having entered the bleed related valves and other components during water washing of the engines for gas path cleaning, which was conducted at the time of C-check of the aircraft as described in 2.8.5.

In addition, since the aircraft was parked for about three days after the engine test run, it is estimated that detergent in the remaining water dried out to form a solid residue, which subsequently constituted contamination that would have caused sluggish movement of the PCVs.

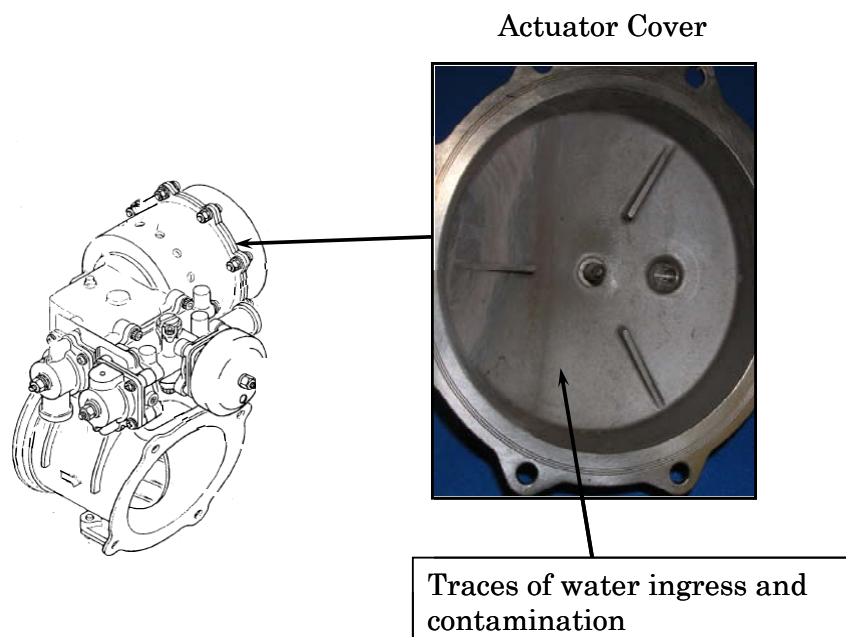
Photo 10 Dismantled No.2 PCV

The butterfly plate was found to have shifted toward the “closed” side from the normal position.

Traces of water ingress and contamination deposits were found inside the actuator housing.

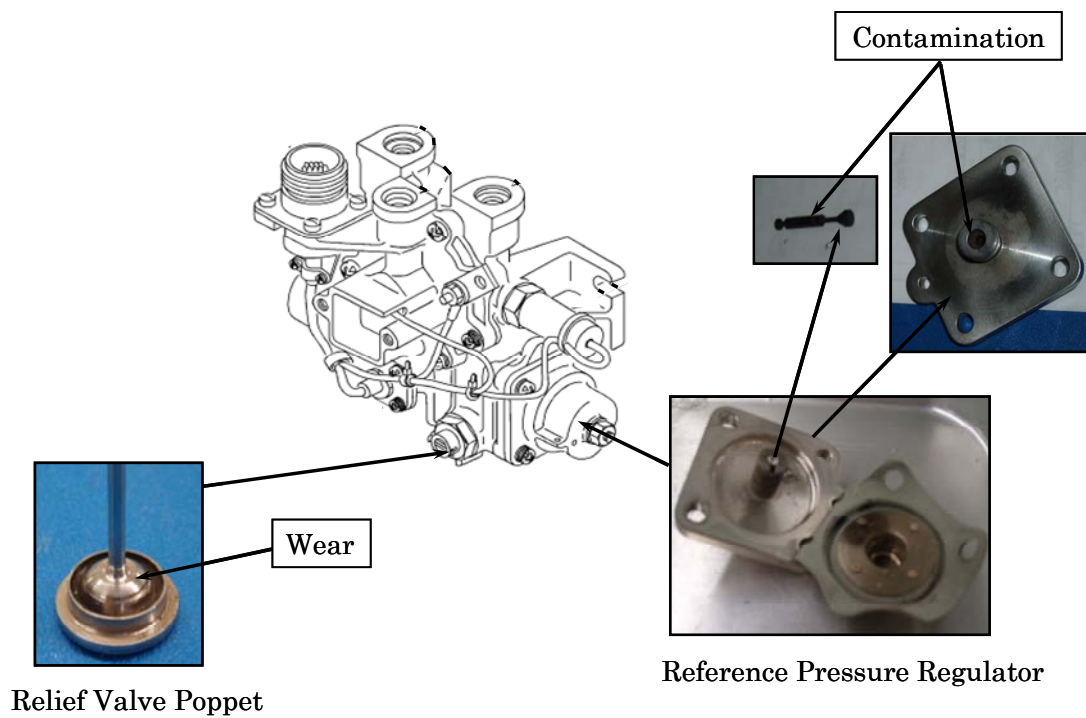
Photo 11 Dismantled No.1 BAR

Contamination deposits on and around the reference pressure regulator valve were wet with moisture, which impaired movement of the valve.

The relief valve poppet was worn.

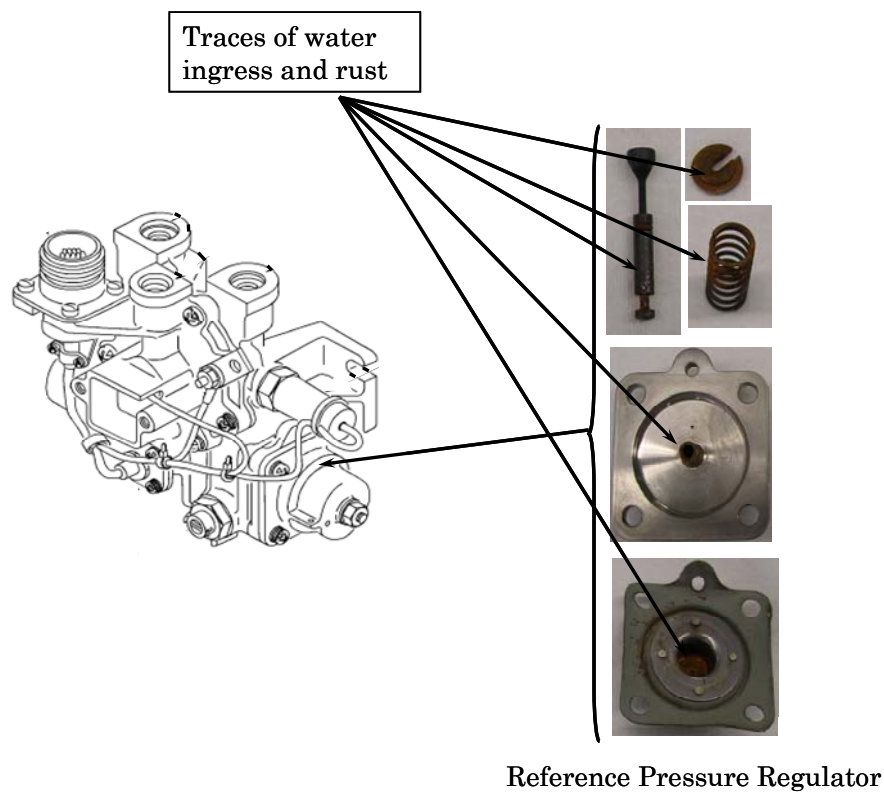
Photo 12 Dismantled No.2 BAR

The valve, spring and retainer of the reference pressure regulator were rusted red

The relief valve poppet was worn.

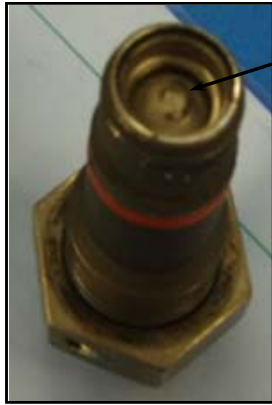
Photo 13 Dismantled No.1 Pre-cooler Sensor

- (1) The results of the functional test on the No. 1 sensor showed that the signal pressure level exceeded the limit when the bleed duct air temperature was lowered to 387°F. Due to the insufficient drop in signal pressure level, the PCV was in a condition difficult to close.

The ball was not free to move
and the sensor was fouled
with contamination deposits.
