**Turkish Airlines DC-10 TC-JAV**  
**Report on the accident in the**  
**Ermenonville Forest, France**  
**on 3 March 1974**

**ACCIDENT TO  
TURKISH AIRLINES DC-10 TC-JAV  
IN THE ERMENONVILLE FOREST  
ON 3 MARCH 1974**

**FINAL REPORT**

February 1976

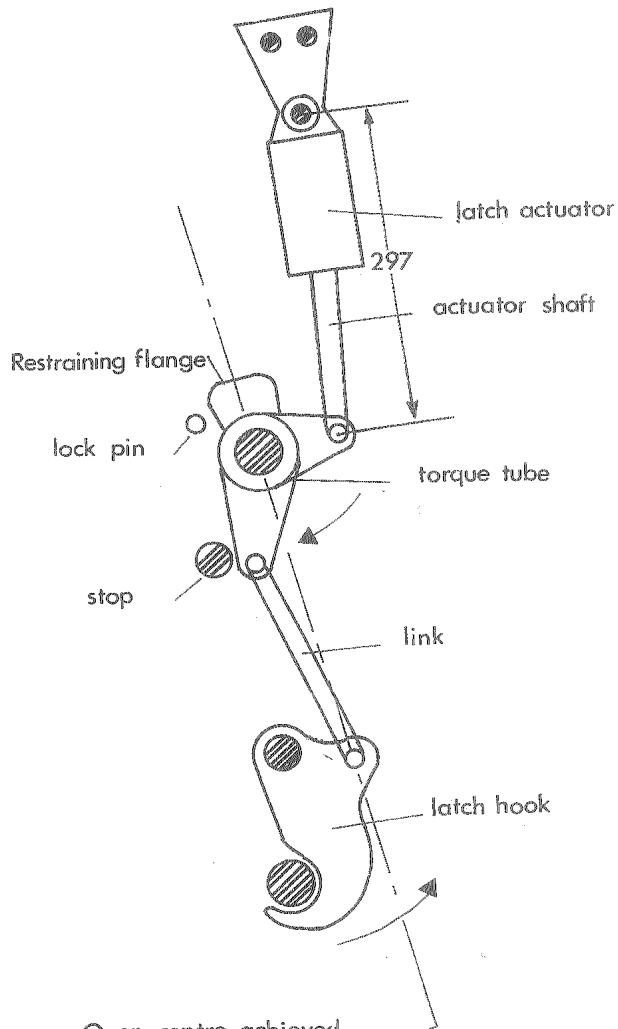
Fig. 1

Over-centre achieved  
System irreversible  
Correct closure

Under these conditions, the chain of operation between actuator and latches is not irreversible: any force exerted on the latches is re-transmitted to the actuator instead of being absorbed by the 4 stops provided for that purpose (fig 1).

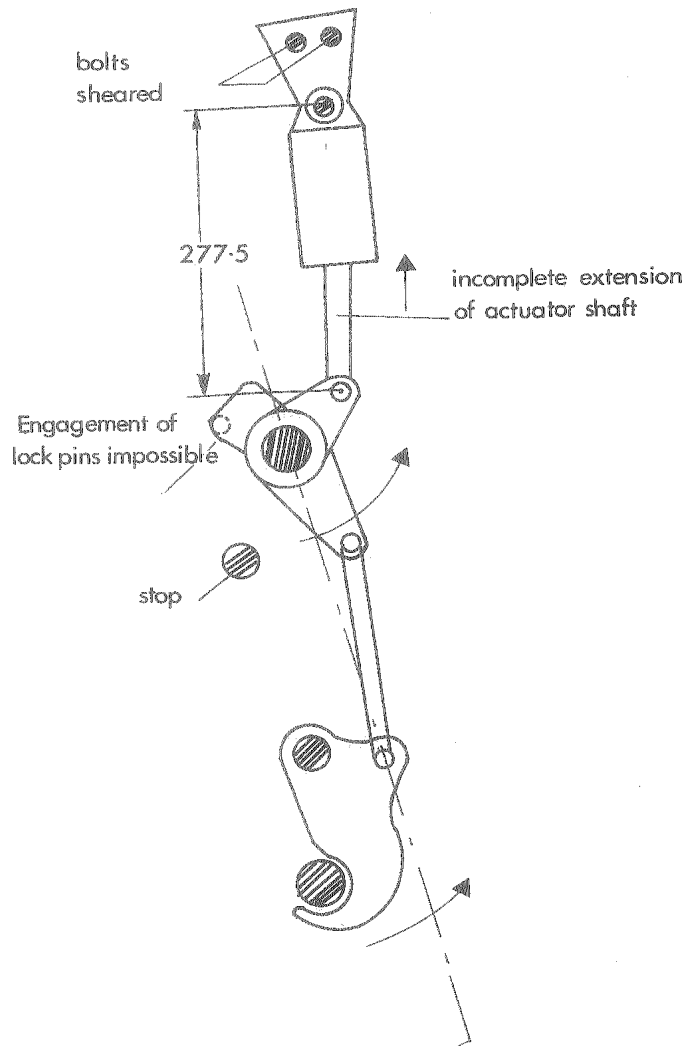
Fig 2

Over-centre not achieved  
System reversible  
Incorrect closure

Expert examination of the wreckage of the door, of which the closing system (latches, latch actuator and operating mechanism) was found in good condition, has revealed various deficiencies. The latter were such that the aircraft's take-off was undertaken with the latches very near to their correct position when closed, but at the same time the links which control the latches had not achieved over-centre (fig 2) and as a natural consequence the lock pins could not have been engaged.

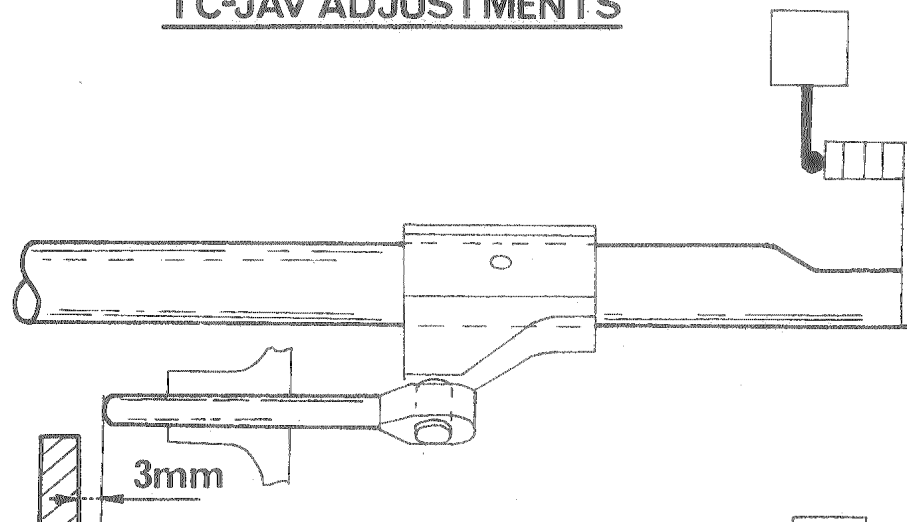
FIG.3

- When the lock tube was pushed towards the locked position, the switch switched off the flight deck warning light, although the ends of the lock pins were still 3 millimetres away from the restraining flanges (fig 3). It should be noted, moreover, that according to the Maintenance Manual, the ends of the lock pins in the unlocked position must not be more than 2 mm away from the flanges.

In conclusion, the adjustment of the lock limit warning switch was defective and caused the flight deck warning light to go out when the latches were not necessarily closed.

Position at which  
flight deck visual  
warning light is  
switched off

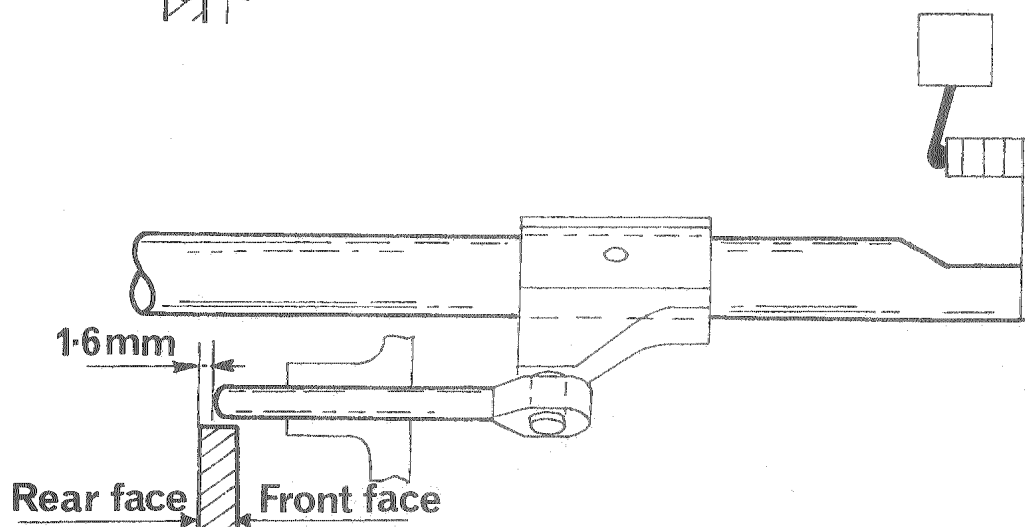
FIG.4

Because of the defective adjustment of the extreme positions of the lock tube, the handle could be closed without excessive force, although the latches were not completely closed.

Extreme position  
of lock tube  
Handle closed

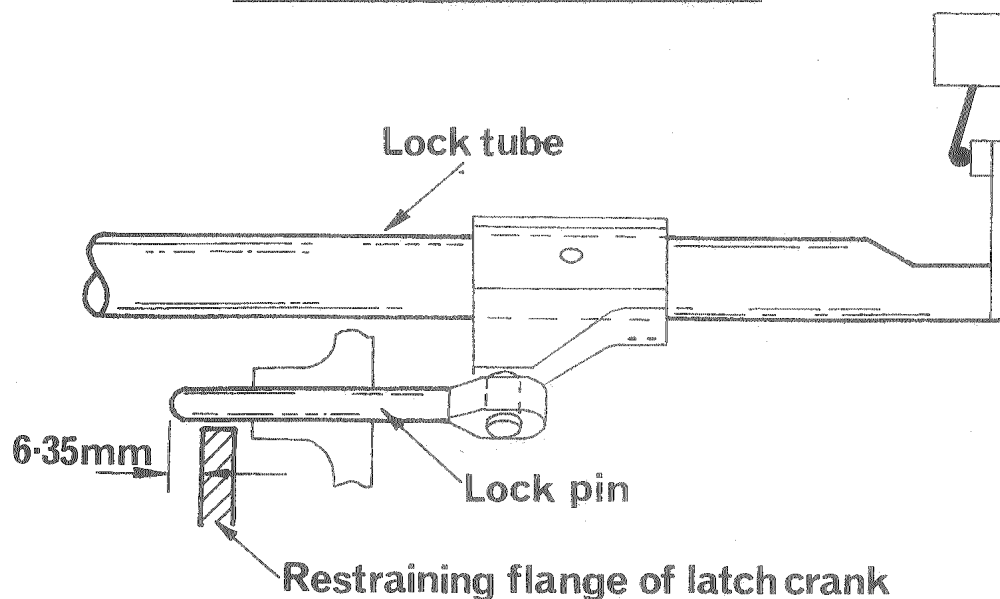
FIG.5

Lock limit  
warning  
switch

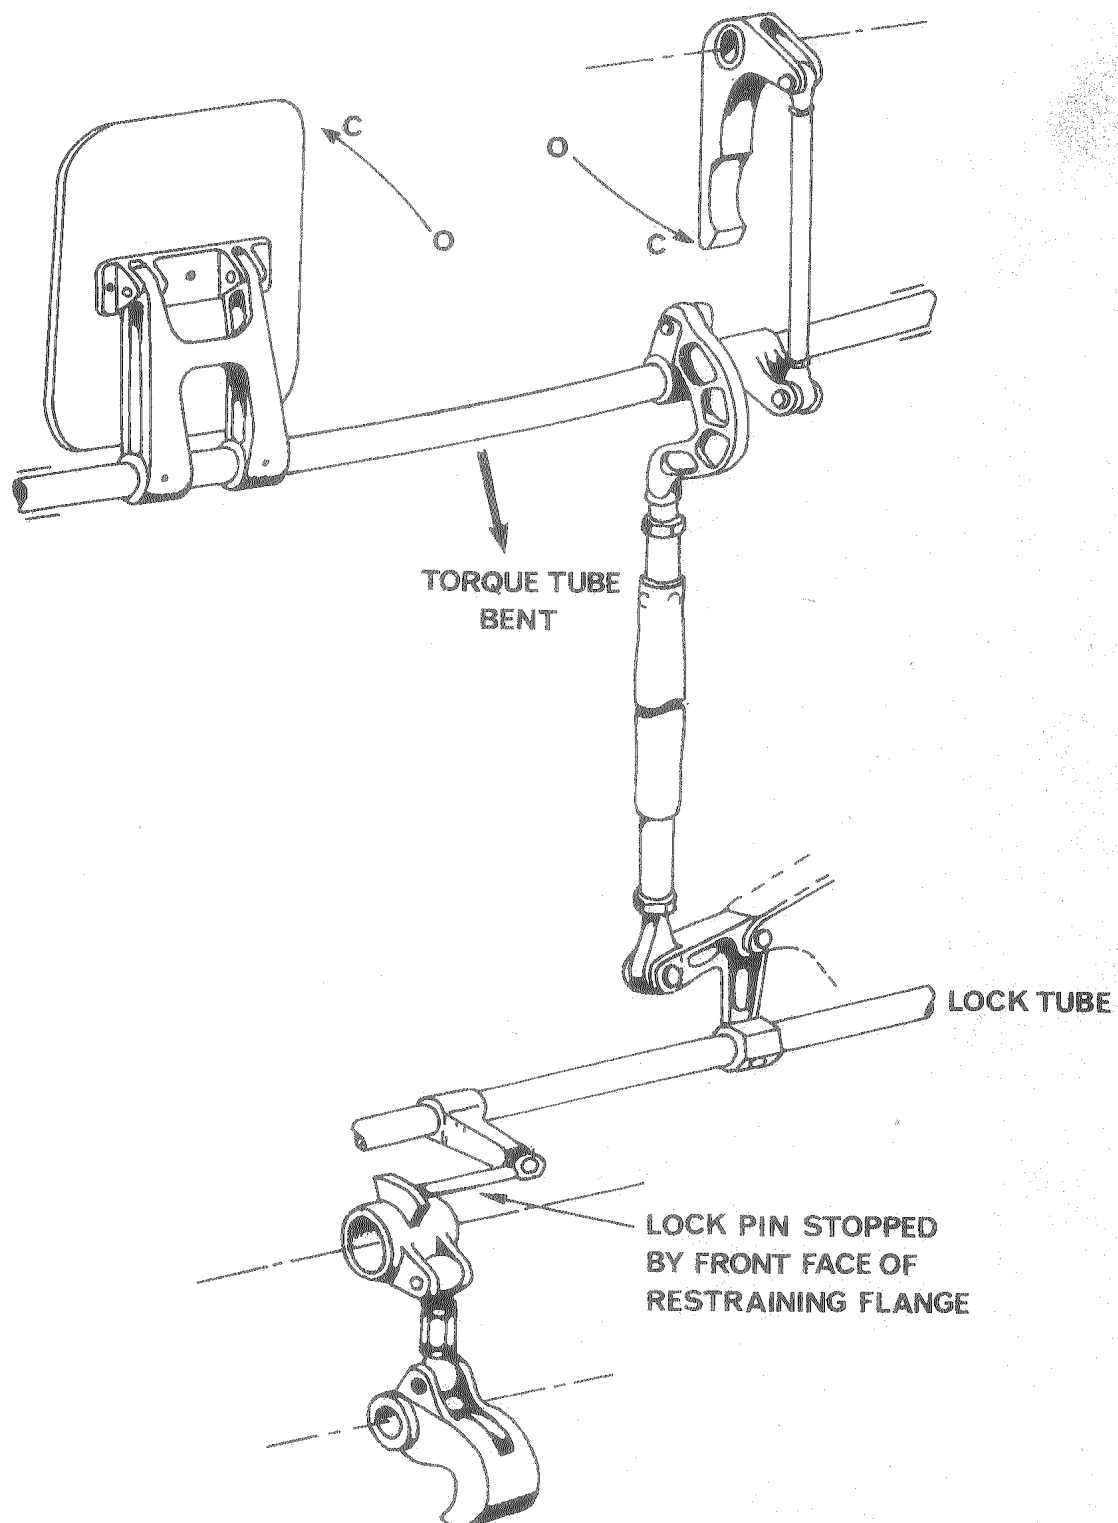
FIG.7

## FORCED CLOSURE

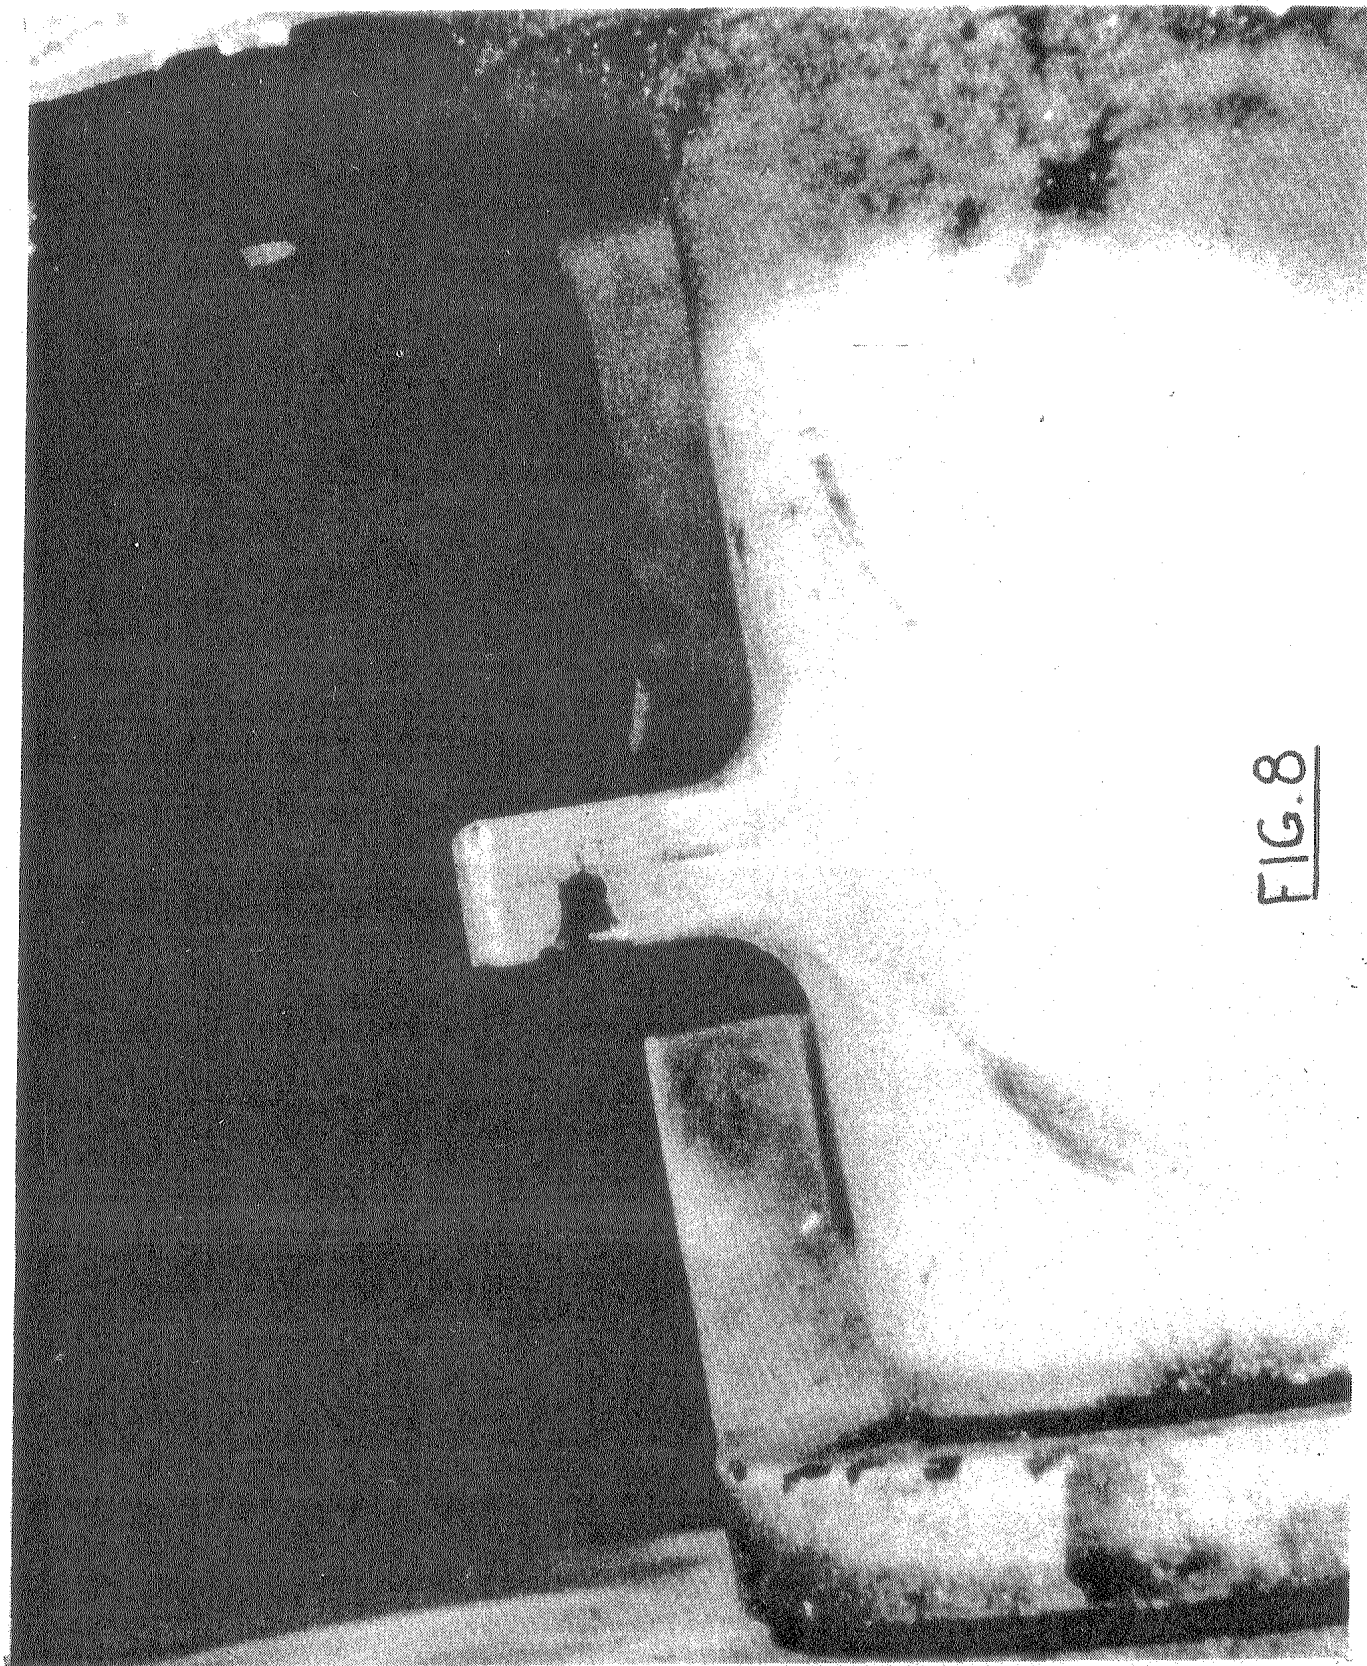
FIG. 8

It should be noted that the edges of the restraining flanges of the 4 latch cranks showed heavy marks (detachment of paint and metal) made by the lock pins (fig 8). These marks were not produced during the last flight, for in that case the latches would have been engaged. They show that in earlier circumstances the operation whereby over-centre is achieved was incomplete, for the pins must pass freely without any friction (figs 1 and 5).

It should be noted that the partial engagement of the lock pins as reproduced on the new door corresponds to the friction marks which they made on the edges of the flanges of the door of TC-JAV, which occurred only on the leading half of the edges (fig 8).
