**Statens haverikommission**  
Swedish Accident Investigation Board

## ***Report RL 2009:14e***

**Incident involving aircraft OE-LRW  
at Åre/Östersund airport, Z län  
(Jämtland county),  
Sweden on 9 September 2007**

Case L-27/07

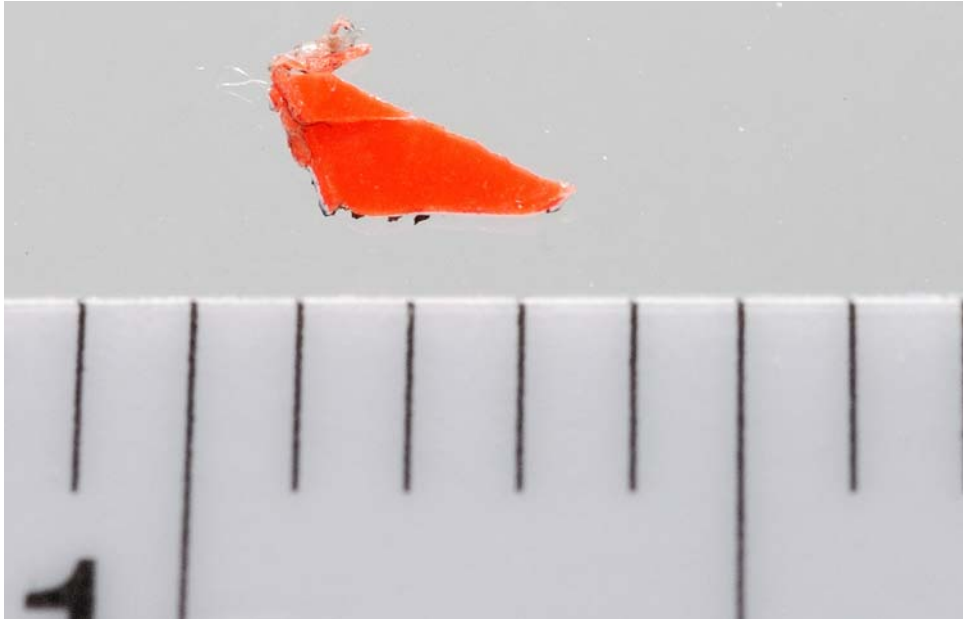
Fig.1. Particle found at the landing gear.

This foreign object consisted of an unknown piece of plastic material coloured orange, measuring about 2.8 x 1.5 mm. The particle was retrieved and sent, together with one of the damaged reflective poles from the airport to SKL<sup>5</sup> for examination and analysis (see Section 1.16.1)

No damage was found to the aircraft. The only evidence that could be found was the paint particle discovered in the landing gear and that could be identified as part of the reflective tape from the snow poles next to the approach lights.

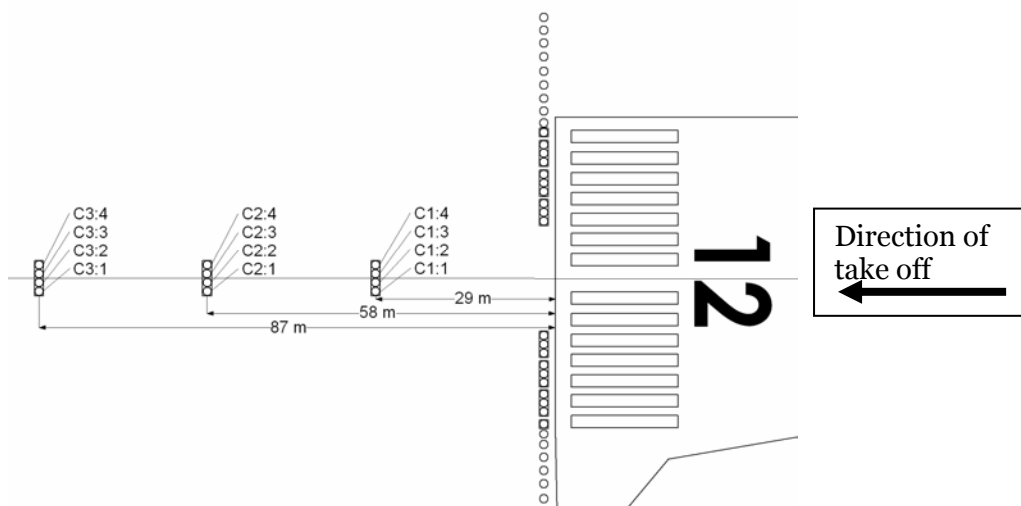
During inspection of the runway on 10 September damage was discovered to the approach lights for runway 12. This lighting was of the Barrette CL Cat I international standard type, and consisted of a 720 m long centreline with the approach lights located at right angles to the runway. There was also a long horizontal transverse light bar located further from the runway end. Damage had occurred to the three approach light bars nearest to the runway, C1, C2 and C3.

Fig.2. Part of the approach lighting to runway 12 at Åre/Östersund airport

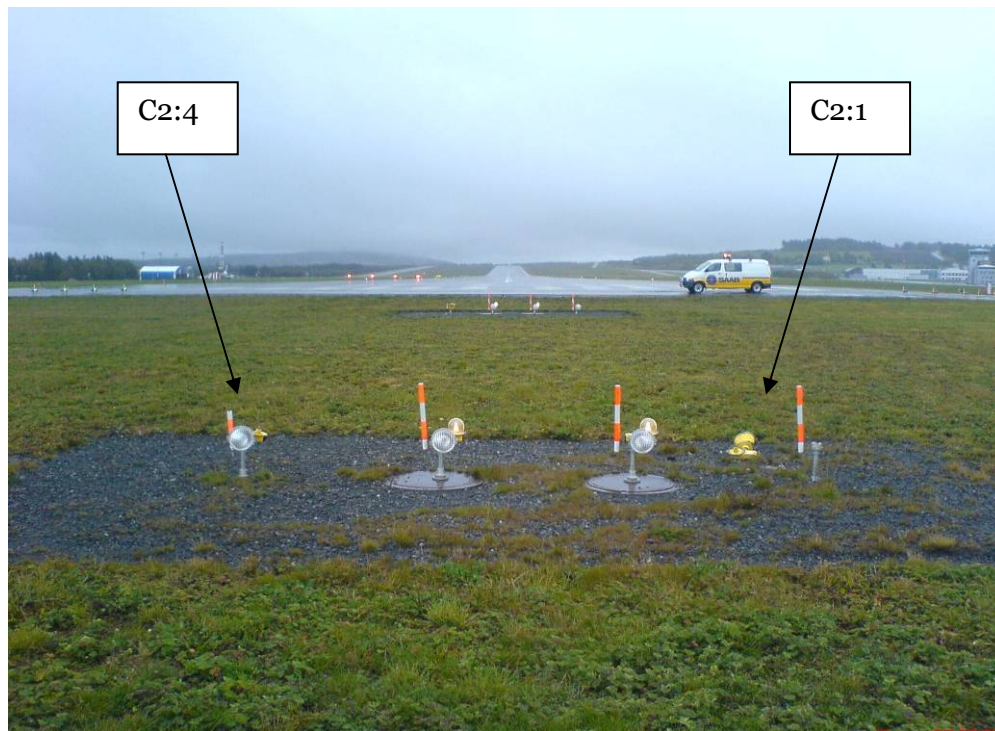
- C1:1: glass housing for low intensity lighting broken, and high intensity light fitting twisted,
- C1:4: lamp housing for high intensity lighting deformed, with two longitudinal scores, broken lens in the high intensity light fitting, reflective snow pole broken off, glass housing for low intensity lighting broken and light fitting direction twisted,
- C2:1: High and low intensity light fittings detached from the upright, lamp housing for high intensity lighting deformed with longitudinal scoring and broken lens, glass housing for low intensity lighting broken,
- C2:4: glass housing for low intensity lighting broken, light fitting twisted, reflective snow pole broken off and connection box cracked,
- C3:1: reflective snow pole bent, low intensity lighting broken, reflective snow pole detached from upright.

Fig.3. Second row of approach lights.

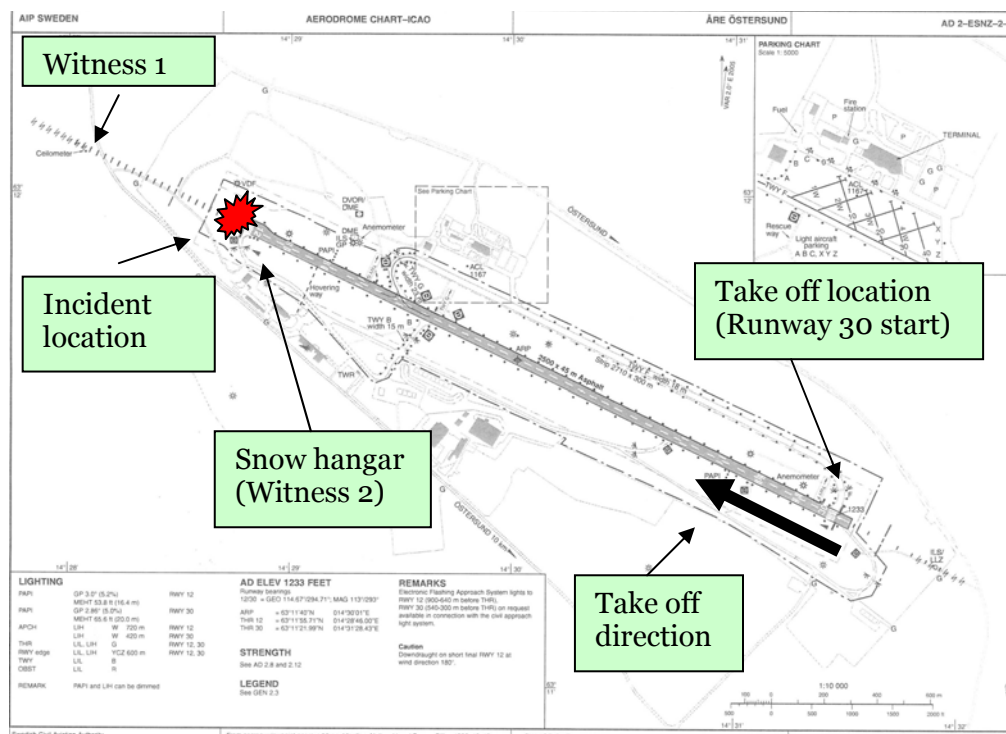
The incident occurred at Åre/Östersund airport, ESNZ, in connection with a take off to the north-west on runway 30. The incident, during which the air-

craft landing gear struck the opposite runway's approach lighting, took place at the gravel surface beyond the end of the asphalted runway.

Fig. 6. Map extracted from AIP-Sweden showing Åre/Östersund airport with annotations for the incident sequence.

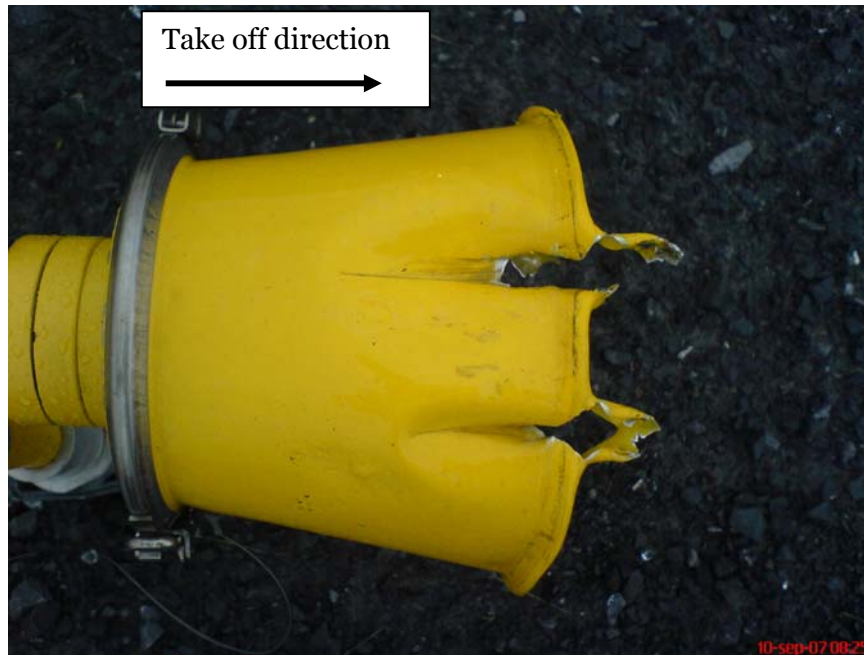
Figure 7 shows the damage to lighting fixture C 1:4. The lamp housing has two longitudinal parallel dents and tears. The sheet metal material at the front

edge of the lamp housing has been torn out in the direction of the runway where the aircraft took off.

Fig.7. Lamp housing C1:4.

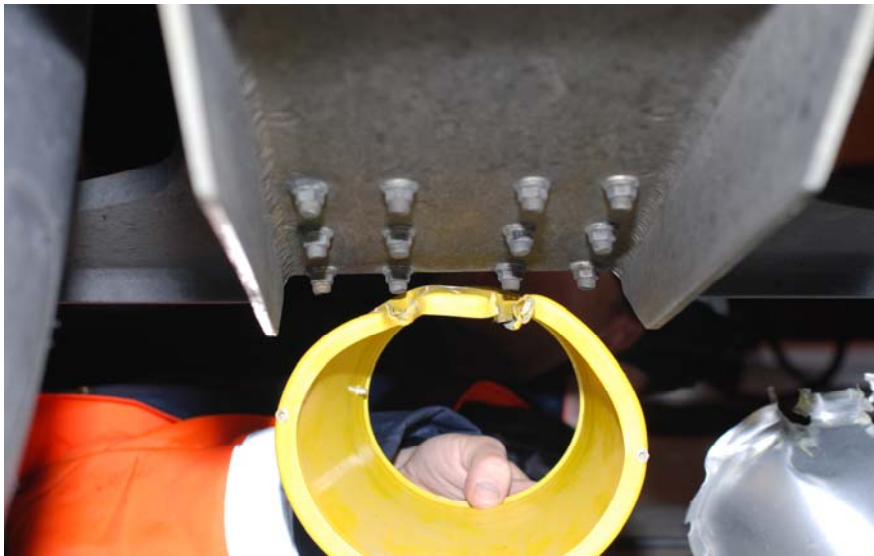
Figure 8 shows a detail view of part of the MD-83 landing gear. The distance between the inner pair of rows of the projecting bolts matches the damage to the lamp housing very well.

Fig.7. Detail view of part of the MD-83 landing gear and lamp housing C1:4.

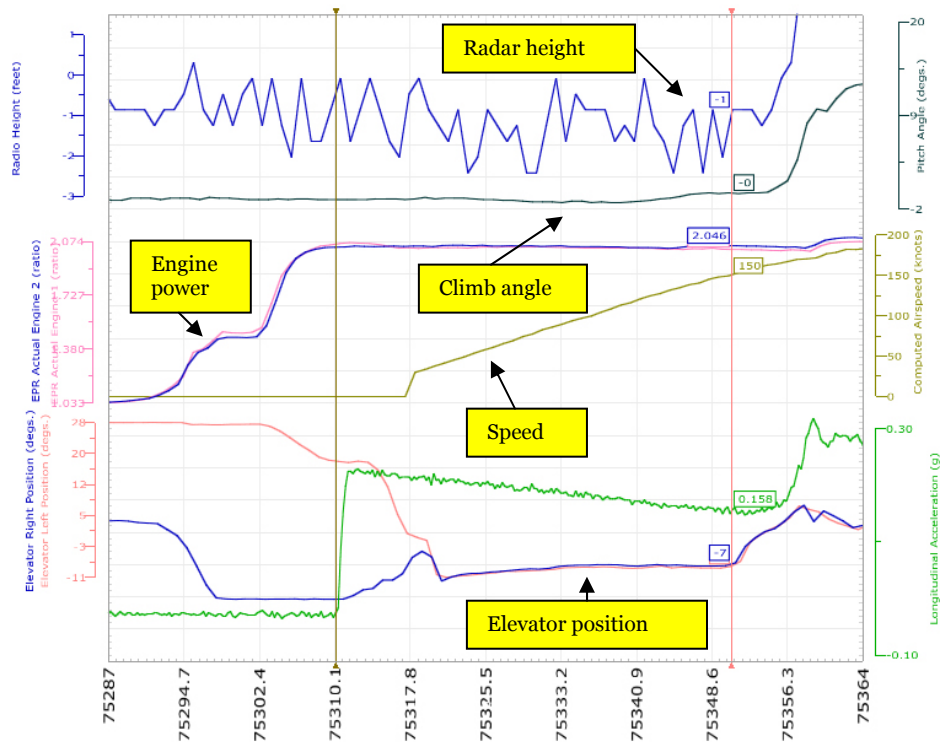
Fig.8. Extract from the flight data recorder during the take off sequence. The horizontal axis shows the time in seconds.

Figure 8 shows certain parameters taken from the flight data recorder during the take off sequence. The horizontal axis shows the time in seconds. The beginning of the take off sequence is indicated by a vertical line at 75 310.1, and the moment when rotation began is at 75350.6, i.e. when the elevators were moved to lift off the runway, with the speed at that time being 151 knots Computed Airspeed, CA. The difference between CA and the speed that the pilots could see on the instruments, the indicated air speed (IAS) is negligible. According to the flight data recorder rotation took place at about  $2^{\circ}$  per second, up to about  $+14^{\circ}$  pitch angle.

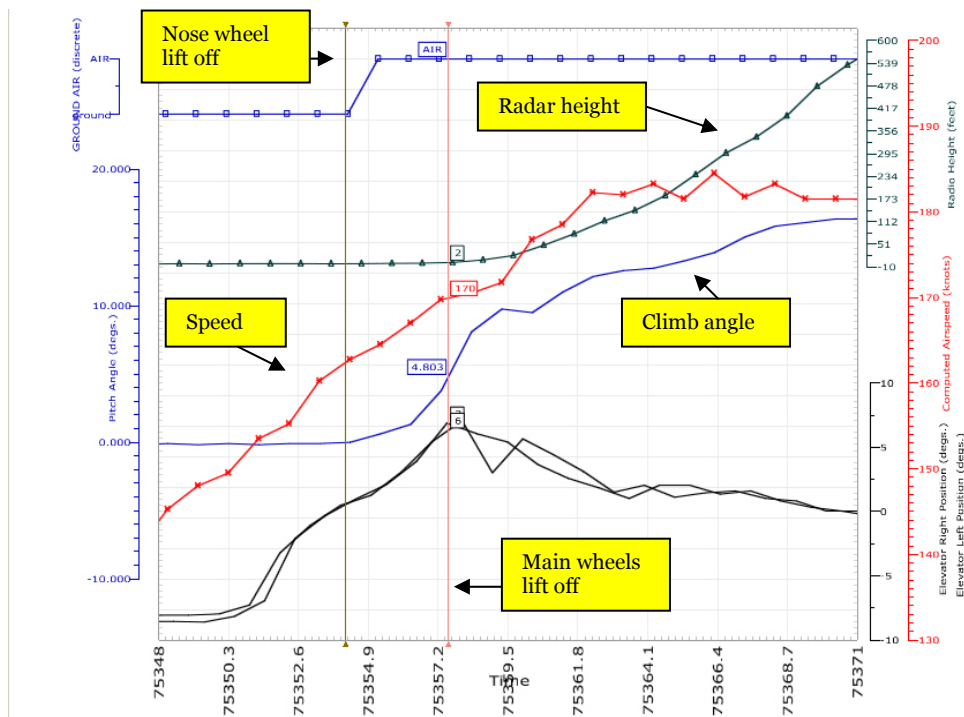
Fig. 9. Extract from the flight data recorder during the later part of the take off sequence. The horizontal axis shows the time in seconds.

The aircraft rolled for about 47 seconds along the runway before the nose wheel lifted off. This took place at about 164 kt (CA), and after a further 3.5 seconds, approximately, the main wheels left the runway. During the subsequent second the aircraft collided with the two transverse light bars closest to the runway 12 threshold, at a height of about 45 cm above ground.
