# NATIONAL TRANSPORTATION SAFETY BOARD

## AIRCRAFT ACCIDENT REPORT E. R. A. O. LIBRARY

ALLEGHENY AIRLINES, INC.  
WORD 262, MOHAWK/FRAKES 298, N29824  
BEWEDUM AIRPORT  
CLARKSBURG, WEST VIRGINIA  
FEBRUARY 12, 1979

NTSB-AAR-79-12

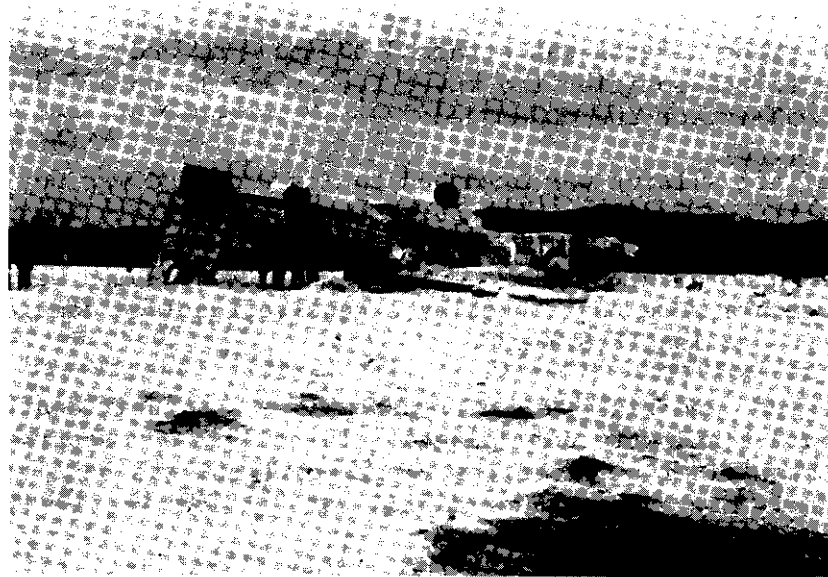
The aircraft crashed within the airport boundary. Shortly after liftoff, the right wingtip contacted the left side of the runway, 4,398 ft from the takeoff end of the runway, and the outboard portion of the right wing broke off; the wing came to rest 192 ft from the point of first contact. The aircraft fuselage hit the runway in an inverted position, slid down the runway, and came to rest off the right side of the departure end of runway 21, 60 ft from the end of the runway and 137 ft to the right of the runway centerline. There was no fire. (See figure 1 and Appendix E.)

Examination of the aircraft structure disclosed no evidence of preimpact structural damage. Both engines remained with the center section of the wings. The left engine and nacelle remained in place, and the right engine mount separated from the wing. The right engine came to rest adjacent to the center section.

Figure 1. The Nord 262 as it came to rest at the end of runway 21.
