PB89-910406  
NTSB/AAR-89/04

## **AIRCRAFT ACCIDENT REPORT**

DELTA AIR LINES, INC.  
BOEING 727-232, N473DA  
DALLAS-FORT WORTH INTERNATIONAL  
AIRPORT, TEXAS  
AUGUST 31, 1988

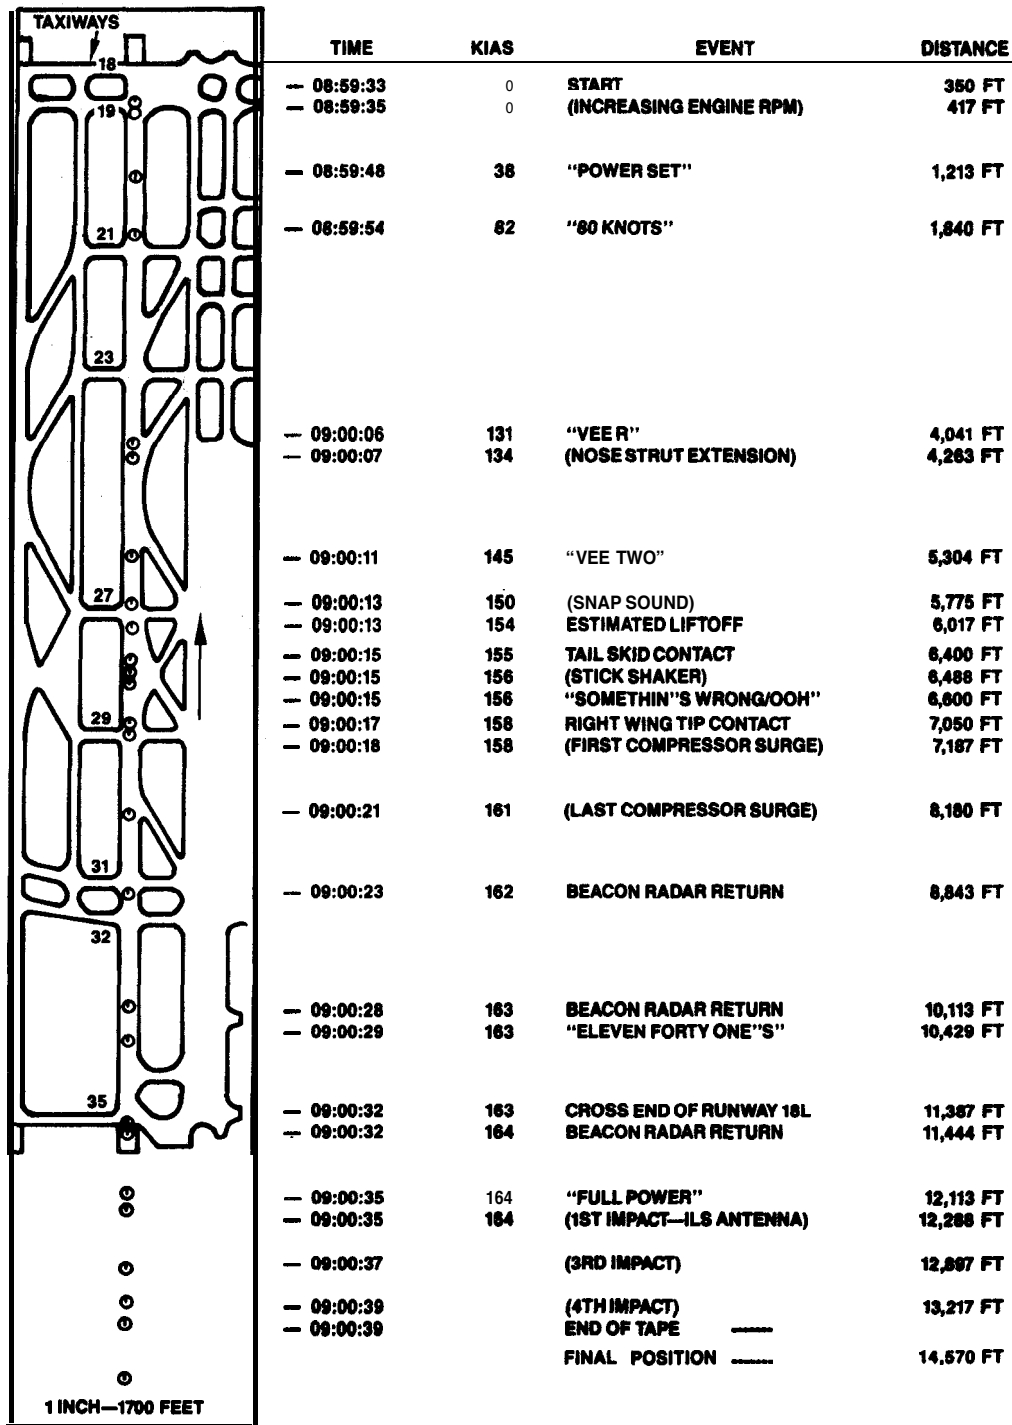
The first impact mark was made by the tail skid contacting the runway centerline and a runway centerline light between taxiways 27 and 29, at a distance of approximately 4,990 feet prior to the departure end of runway 18L (see figure 5). About 650 feet from this point, the right wing tip struck the right side of the runway near taxiway 29, approximately 4,340 feet prior to the departure end of runway 18L. The taxiway markers for taxiways 31 and 32 were found knocked over, but they did not exhibit any impact damage. Additionally, the grass was found to be scorched between the end of the runway and the ILS antenna. Approximately 5,300 feet from the point of the right wing tip runway contact, and approximately 900 feet beyond the departure end of runway 18L, the airplane impacted and destroyed the ILS localizer antenna. From this point and beyond, airplane components such as the right wing tip and portions of the right inboard and outboard ailerons began separating from the airplane.

Figure 5.-- Flight 1141 takeoff events.

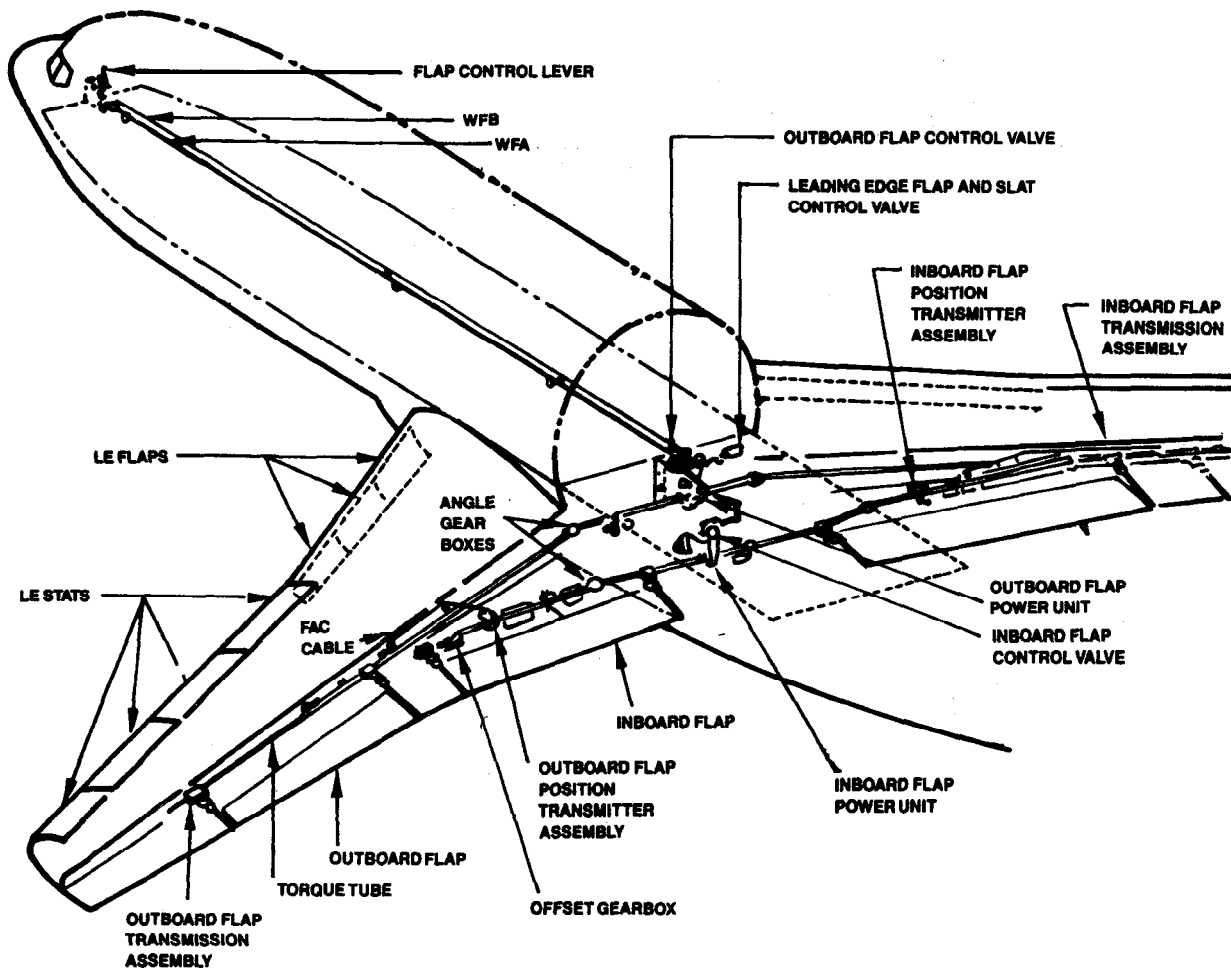
**Trailing Edge Flap System.**--The flap control mechanism in the cockpit area was found in the flap up position. (See figure 7.) The mechanism was intact and functional. The flap handle spring tension was normal. The flap control cables were attached, and continuity was established to the forward fuselage break. From the fuselage break, further continuity of the cables was established to the outboard flap control valve

Figure 7.--Trailing edge flap system.

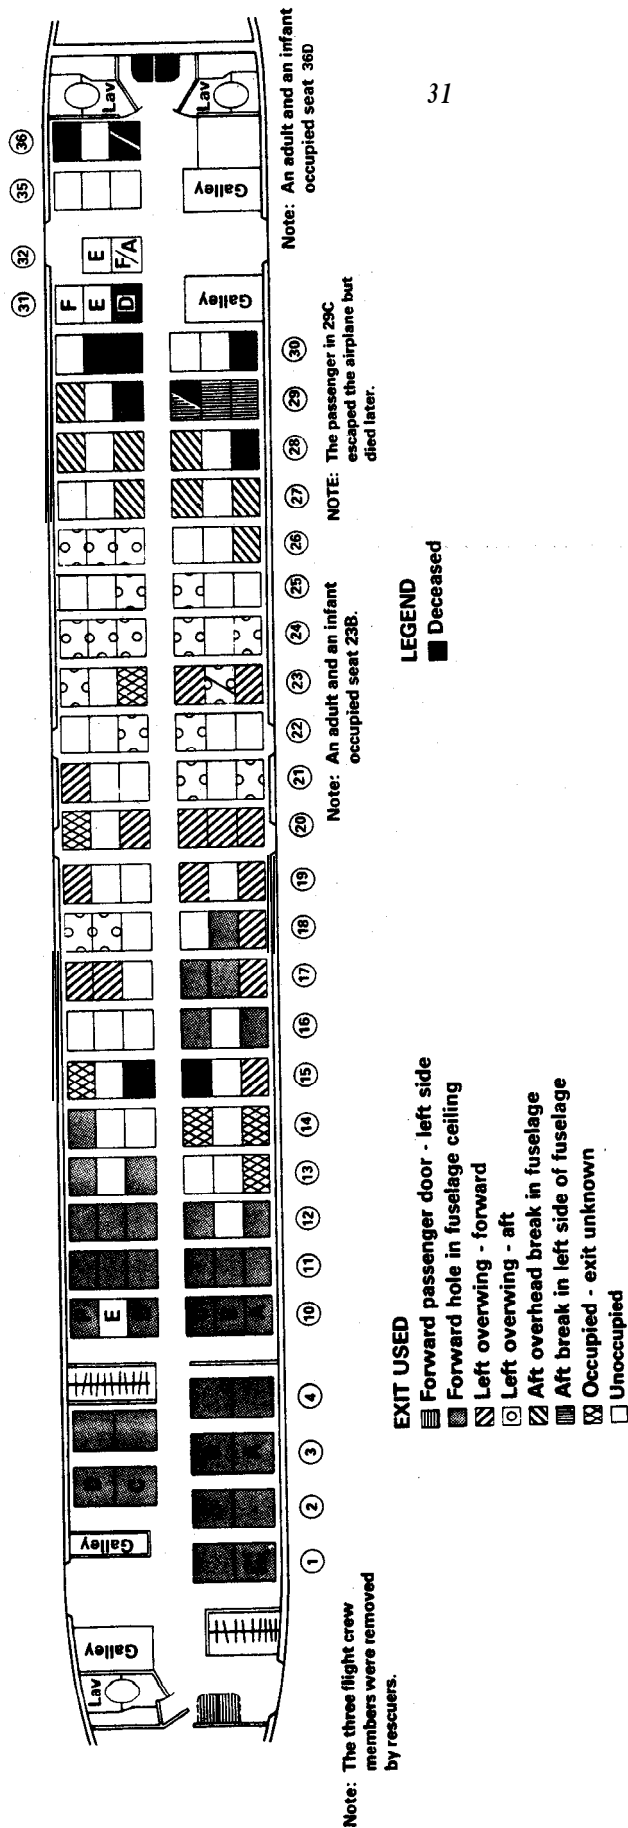
*The investigation found that although the fuselage had separated in several places, the occupiable volume of the cabin was not substantially compromised. Passengers generally stated that impact forces were not severe. Further, the cause of deaths of the passengers in the aft section of the cabin were attributed to smoke inhalation and fire rather than impact injuries. Exit from the aft cabin was hampered by the fire that impinged on the right side of the airplane. Exit from the mid and forward cabin was through breaks in the fuselage and through the left side exits, except for the left aft service door which was not opened.*

Figure 8.--Configuration of B727-232 and escape routes used.

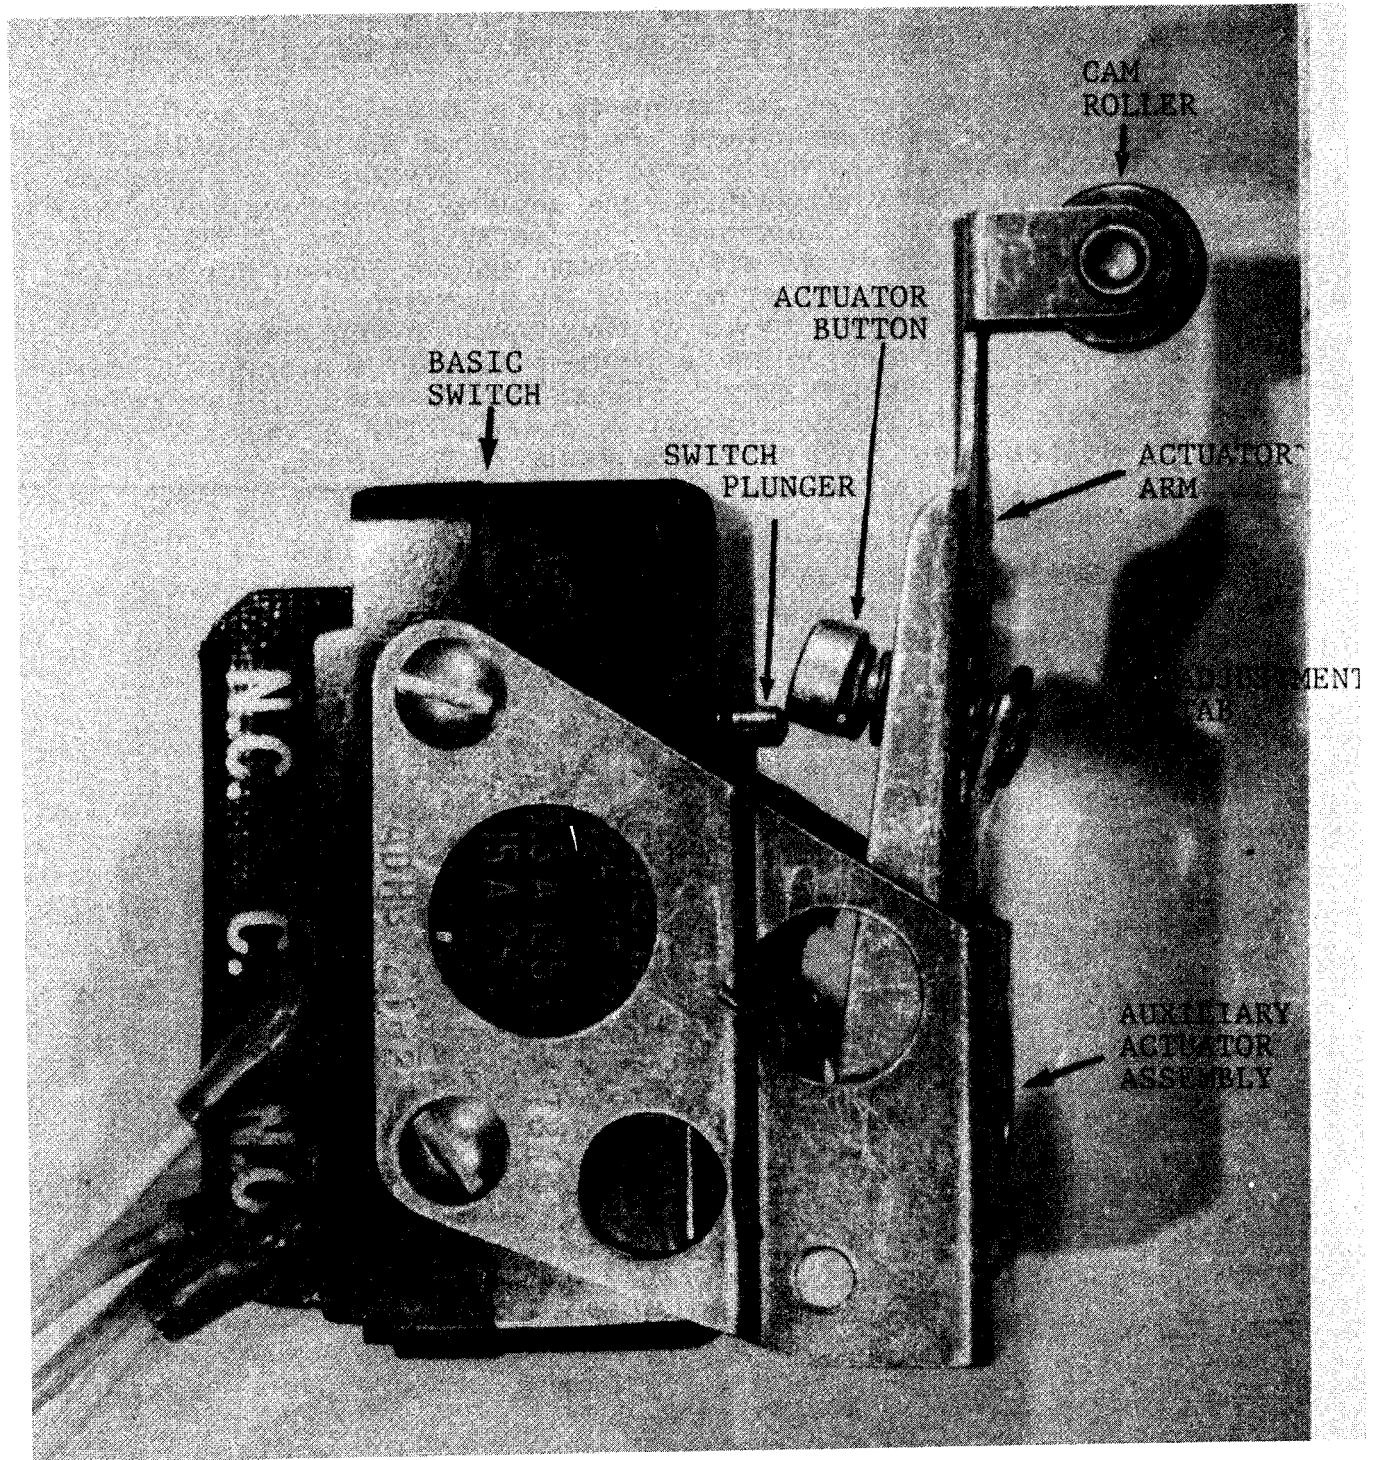
*Switch activation movement, with the switch assembly still installed in the clutch pack assembly, was observed through a microscopic TV camera and recorded. The outer bottom edge of the actuator button would initially contact the top center of the switch plunger and would remain in this position as the plunger was being depressed and the switch tripped. As the switch tripped, the exposed portion of the switch plunger would slide slightly inward toward the bottom of the actuator button and become perpendicular to the switch casing. Approximately 10 switch activations were observed, and each time the switch properly tripped.*

*The cables that were still attached to the clutch pack assembly containing the switch assembly were then removed to free the jammed cam which moves the switch actuator mounted on the clutch pack assembly structure. Proper orientation of the cam to the switch, as it would relate to thrust lever position, was then established. During this procedure, numerous switch activation sounds were heard. Other switches are installed in the clutch*

*Figure 9.-- Photo of throttle switch.*

pack assembly. It is not known if the takeoff warning switch activated each time the outermost surface of the cam made contact with the switch actuator.

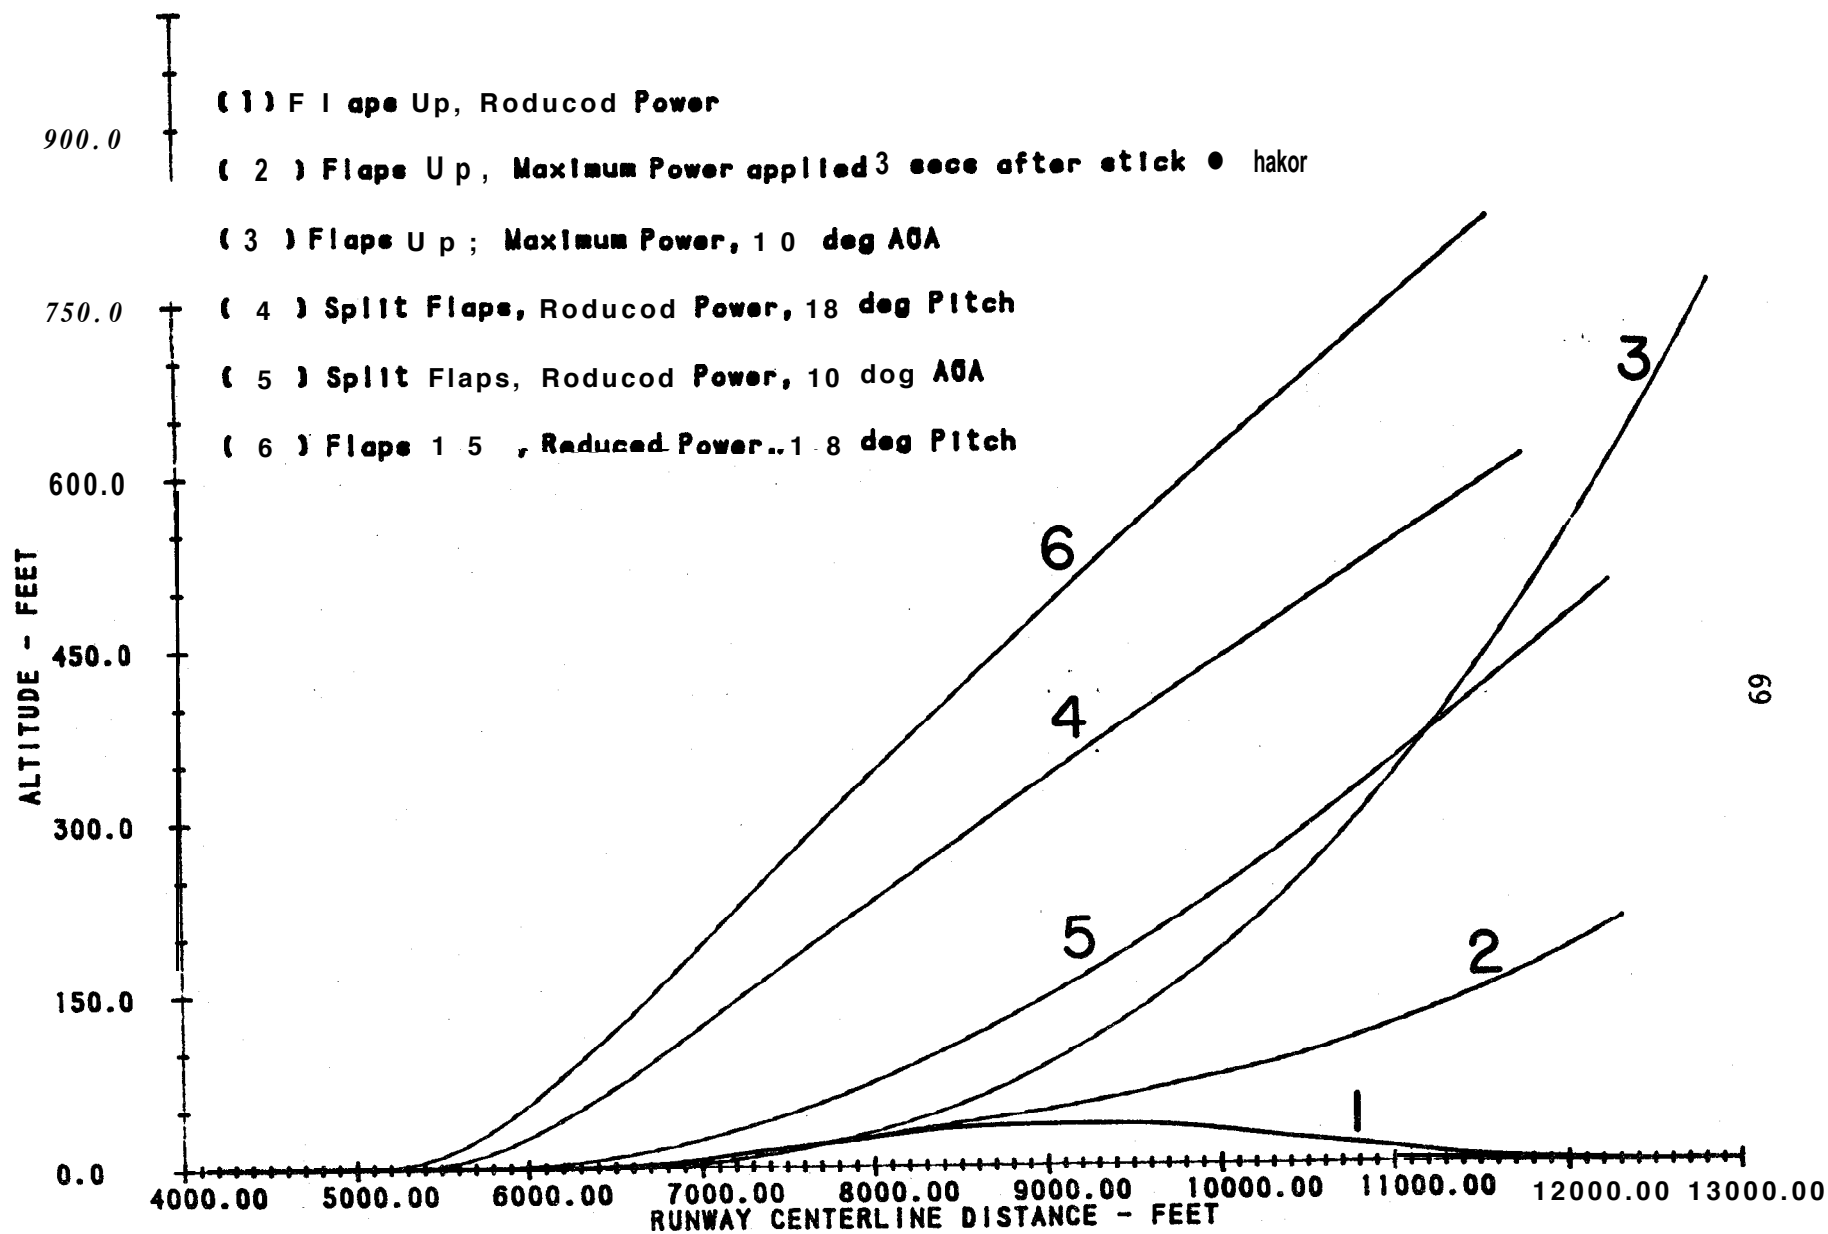
The performance analysis, based upon the lift versus AOA data for the split flap configuration, indicates that had flight 1141 been so configured during the takeoff roll, the airplane's tail may have contacted the runway surface as the captain rotated to the takeoff attitude. However, the airplane, with its geometry-limited  $10^\circ$  pitch attitude would have lifted off at about 150 KCAS instead of the actual liftoff speed of 158 KCAS. A continued rotation at a rate greater than  $1.5^\circ$  per second would have resulted in stickshaker activation; but there would have been considerable margin to stall when the warning occurred and the airplane would have transitioned to a climbing flightpath with a vertical acceleration in excess of 1.26. If the captain had ignored the stickshaker warning and continued to exert sufficient back force on the control column to raise the airplane's nose at a rate of  $3^\circ$  per second, the airplane would have achieved a  $3^\circ$  climbing flightpath at an AOA of about  $15^\circ$  within 2 seconds after liftoff. There would have been no airflow separation to explain the sudden roll of the airplane, and there would have been no engine inlet air turbulence to explain the compressor surges which were evident on the CVR. A more likely and proper flight crew reaction to the stickshaker activation would have been to relax the back force on the control column to silence the stickshaker, provided that that response would not result in a loss of critical altitude. Under such circumstances, the airplane would have continued to accelerate while developing sufficient lift force to transition to a climbing flightpath. These performance data indicate that about 10 seconds after liftoff, the airplane would have been about 100 feet above the ground and climbing at about 1,200 feet per minute. The stickshaker would have activated only momentarily.

Figure 13. -- Takeoff profiles.

*The Safety Board concludes that the actual performance of flight 1141 is not explainable by the "split flap" theory. A possibility that one flightcrew member reacted to the delayed liftoff and stickshaker onset by intentionally or inadvertently retracting the flaps to 0° is also implausible, since the 20 seconds required for the trailing edge flaps and leading edge devices to retract with consequent effect on flight performance would place the airplane far beyond the point at which the roll instability and engine compressor surges actually occurred. If the flaps retraction sequence had started at rotation, the airplane would have had sufficient lift to climb several hundred feet prior to the flaps reaching 0°. Furthermore, each of the flightcrew members positively stated that they did not reset the flap control lever after the takeoff was initiated, and that they knew of no situation in which they would have done so.*
