FINAL
KNKT.12.05.09.04

NATIONAL TRANSPORTATION SAFETY COMMITTEE

Aircraft Accident Investigation Report

**Sukhoi Civil Aircraft Company
Sukhoi RRJ-95B; 97004
Mount Salak, West Java
Republic of Indonesia
9 May 2012**

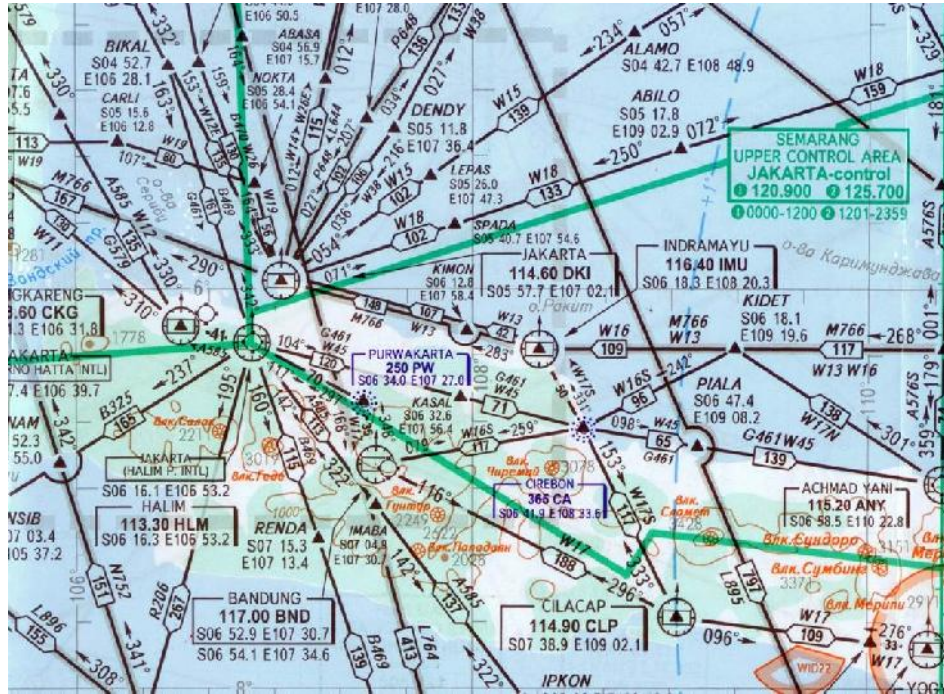
Figure 8: Navigation chart available in the aircraft

The navigation chart for the purpose of this flight did not contain information related to the Atang Sanjaya Training Area / WI(R)-4 and the terrain contour.

Figure 8 shows the chart that was available in the aircraft. This chart was typical of an instrument navigation chart that was suitable for en-route flight.

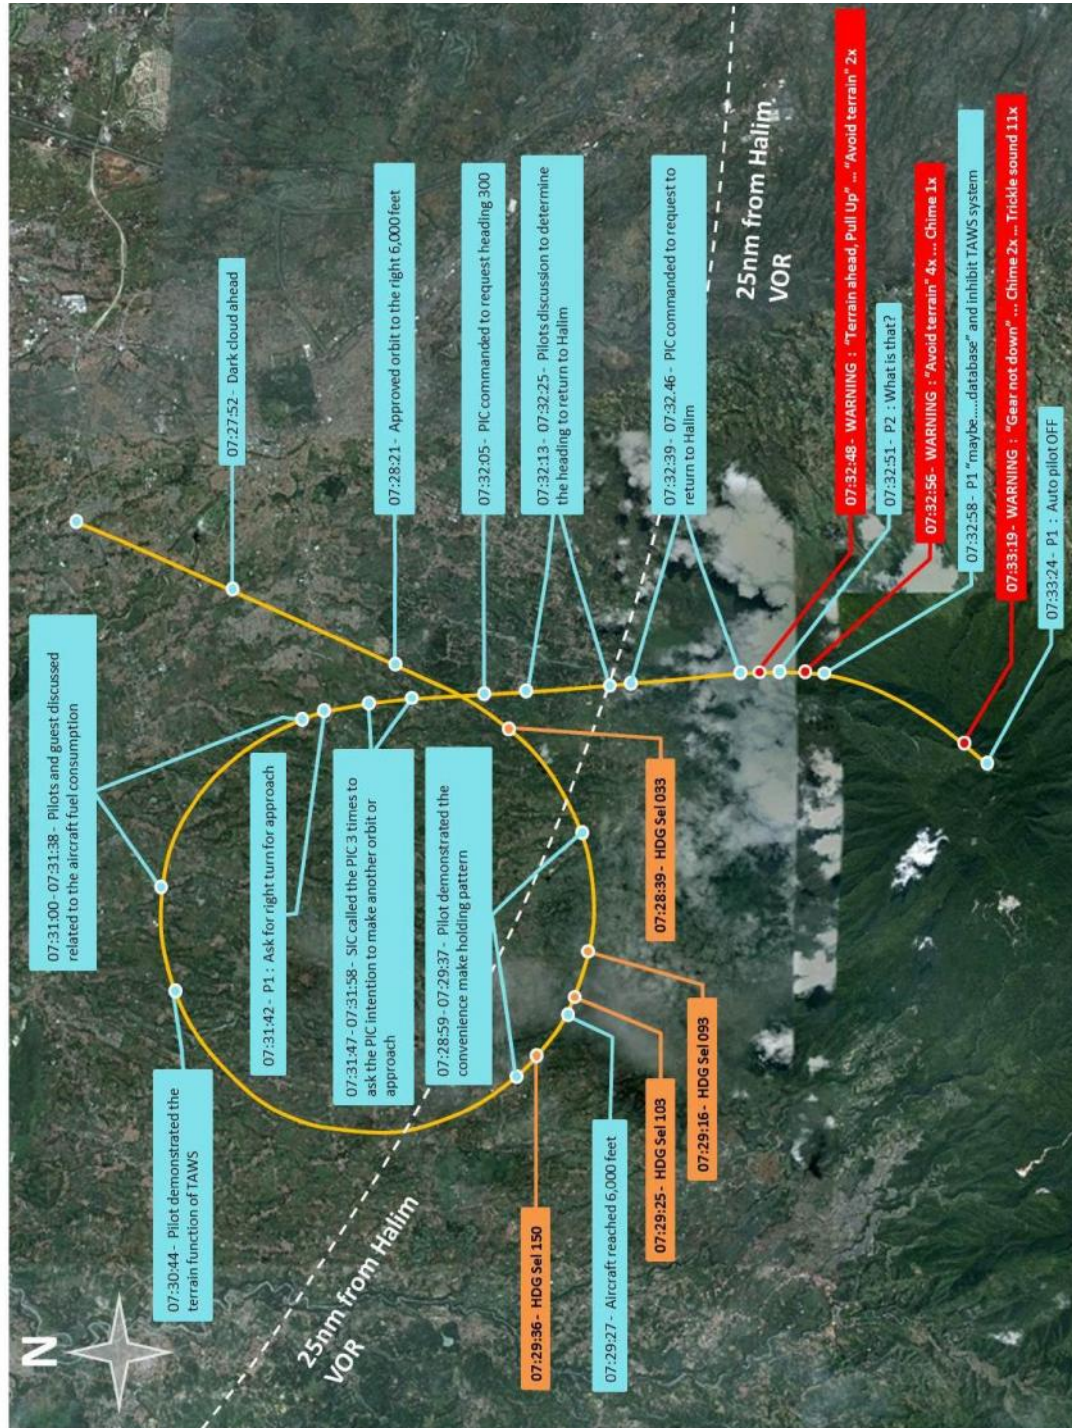
Figure 17: Event link of the final segment of the flight

Several pertinent excerpts from the CVR were superimposed with the flight path derived from the FDR as shown in figure 16.

At the final segment of the recording approximately 38 seconds before the end of recording, there were several alerts and warnings from the TAWS and from the aircraft warning system.

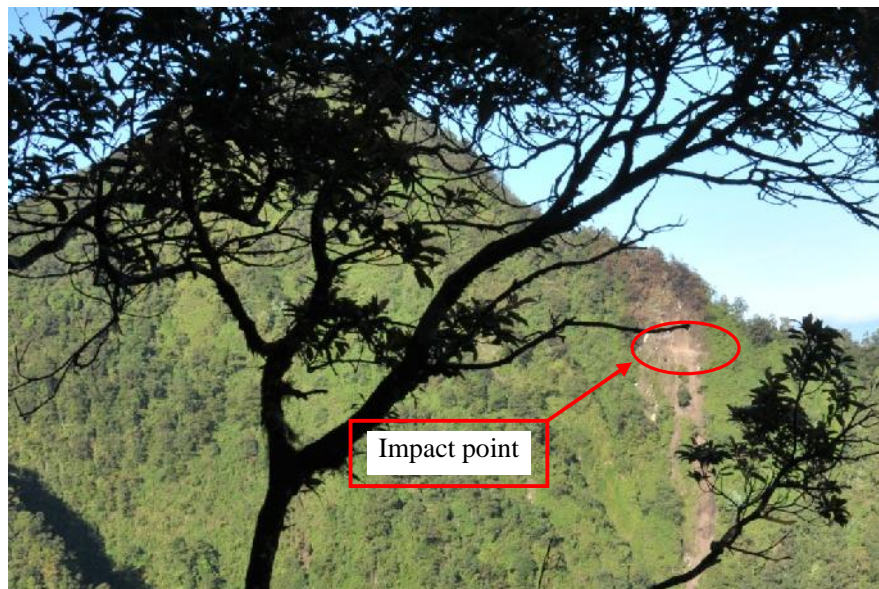
Figure 18: The ridge facing to the east

The aircraft impacted terrain at 6,000 feet ASL on an approximately 85 degree slope ridge. The wreckage was spread over a wide area. Most of the wreckage such as landing gear, engines and vertical stabilizer were found at the bottom of the valley at approximately 500 meters below the impact point.

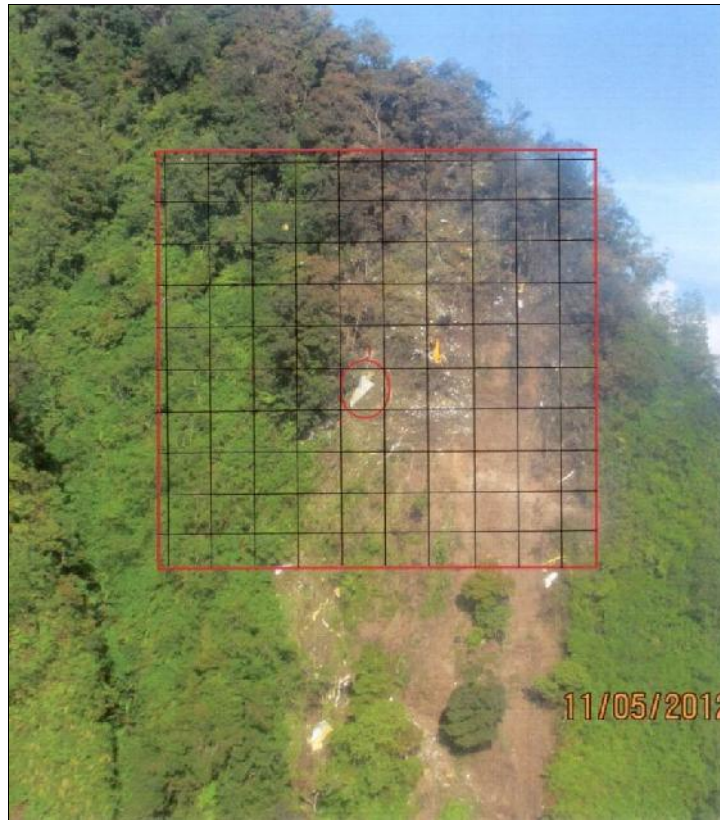
Figure 19: The accident site

The area surrounding the impact point was burnt. Some wreckage in that area was found partially burnt.

The aircraft was destroyed by impact forces and post-impact fire.

Evidence of fire was found surrounding the impact point, especially above the impact point. Some wreckage and vegetation in that area were burnt. Wreckage in the valley below was found without any indication of fire. This situation indicated a post-impact fire.

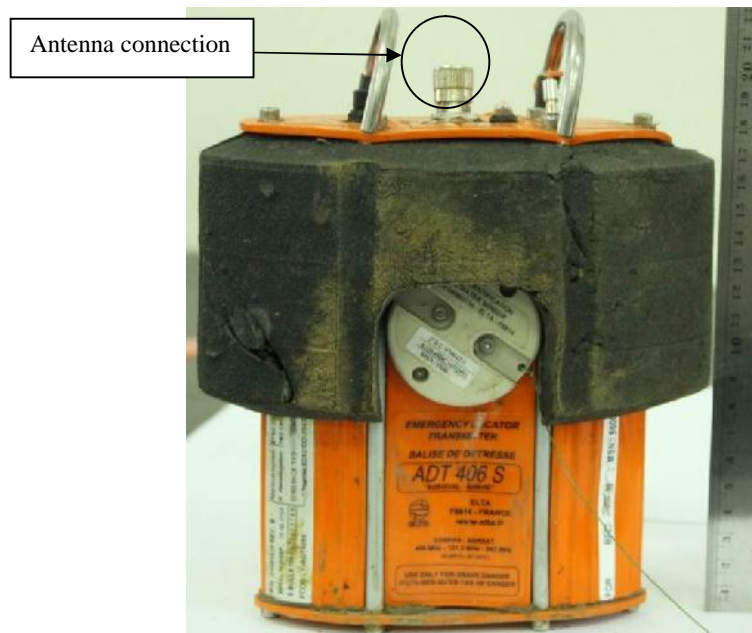
Figure 21: Emergency Locator Transmitter with antenna detached

The ELT was found with the antenna detached due to the high magnitude of impact force. The separation of the antenna from the ELT unit explained the reason why no distress signal was transmitted.

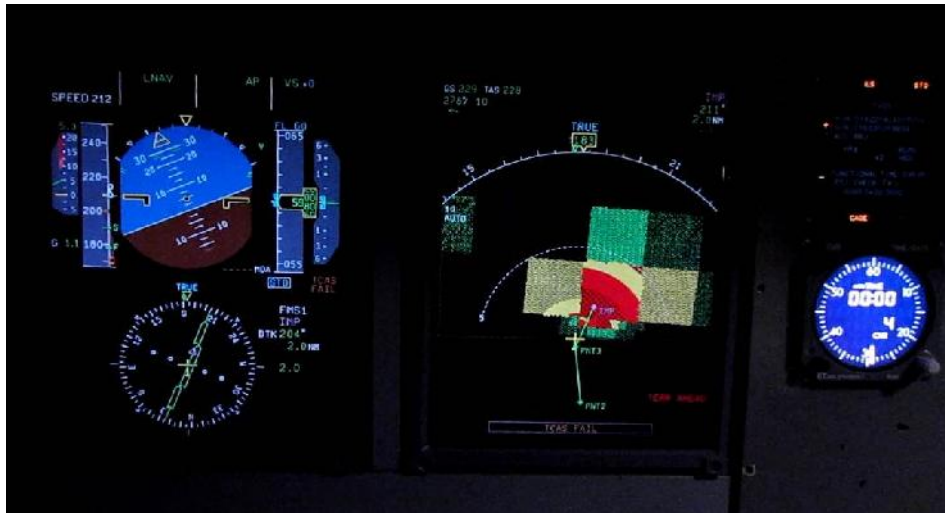
Figure 22: The cockpit instrument displayed in the simulation of the last segment of the flight

The collision with the terrain could be avoided if the crew performed the appropriate actions in responding the TAWS warning within 24 seconds after the first TAWS warning activated.
