# National Transportation Safety Board

| <b>Accident Number:</b> | DCA11MA039 |
| <b>Operator/Flight Number:</b> | Southwest Airlines, Flight 812 |
| <b>Aircraft and Registration:</b> | Boeing 737-3H4, N632SW |

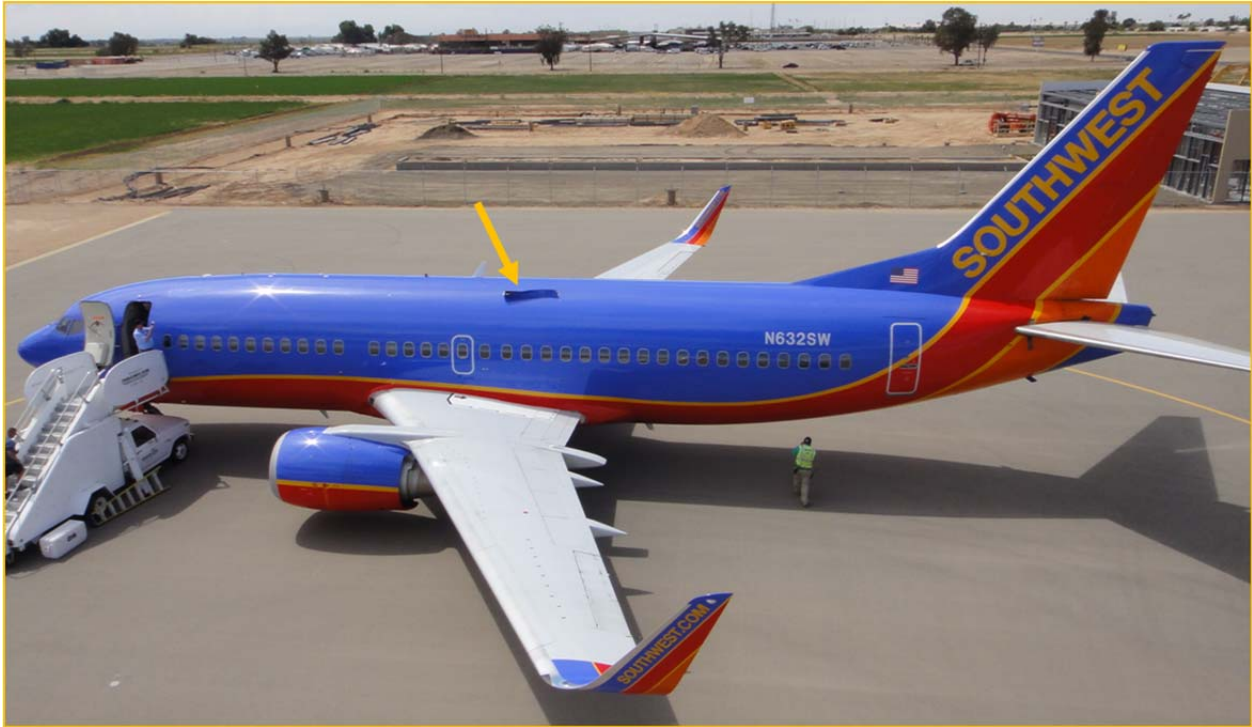
Postaccident inspection of the airplane revealed that a section of fuselage skin about 60 inches long by 8 inches wide had fractured and flapped open on the upper left side above the wing (see figure 1). The damaged section of fuselage side skin was bounded by body station<sup>2</sup> (BS) 663 and BS 727 in the fore-aft direction and stringer<sup>3</sup> (S)-4L and S-5L in the circumferential direction (see figure 2). S-4L is the location of a lap joint with three rivet rows. The entire section of skin remained attached along the lower edge and was deformed outward. There were some abrasion marks on the fuselage skin below the forward edge of the hole that matched the shape of the forward edge of the attached section. The fracture along the upper edge was through the lower rivet row of the lap joint. The forward edge was fractured about 1/2 inch aft of the edge of the bonded doubler at BS 663. The aft edge was fractured along the forward rivet row of the BS 727 butt joint. There was some deformation to the intercostal installed between the BS 663 and BS 685 frames. There was no visible damage to the surrounding frames, stringers, and stringer clips. Some insulation was missing from the location around the hole. During the postaccident skin repair, two cracked stringer clips were found along S-4L (at BS 685 and at BS 706).

**Figure 1.** Photograph of N632SW with the hole in upper left fuselage.

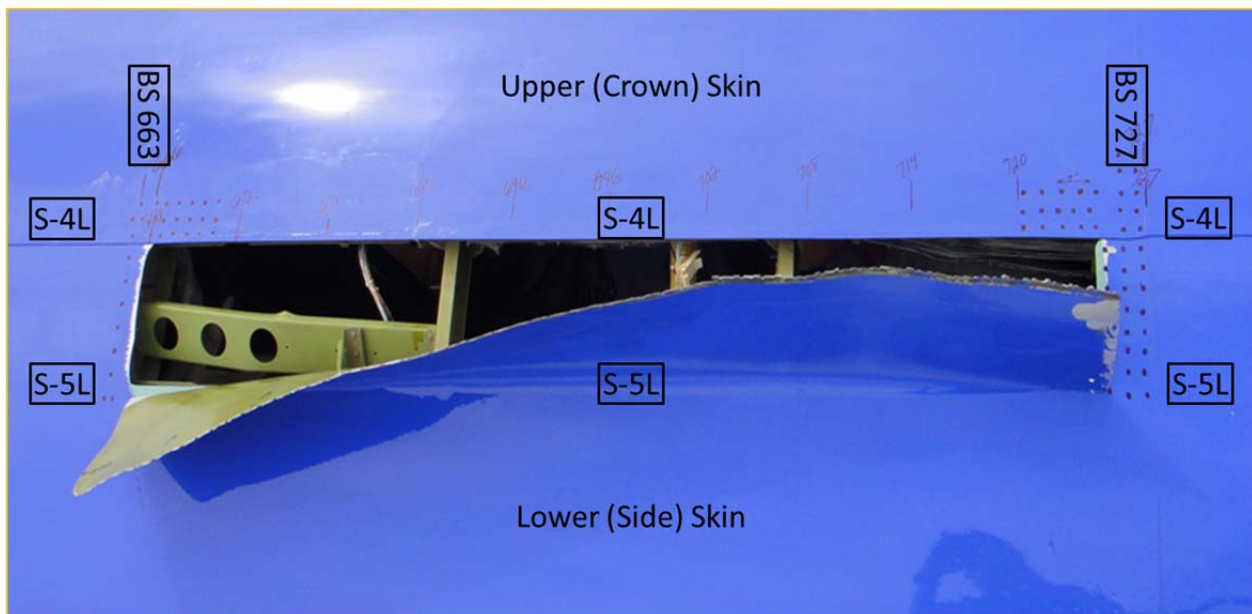
**Figure 2.** Close-up photograph of hole in fuselage side skin on N632SW.

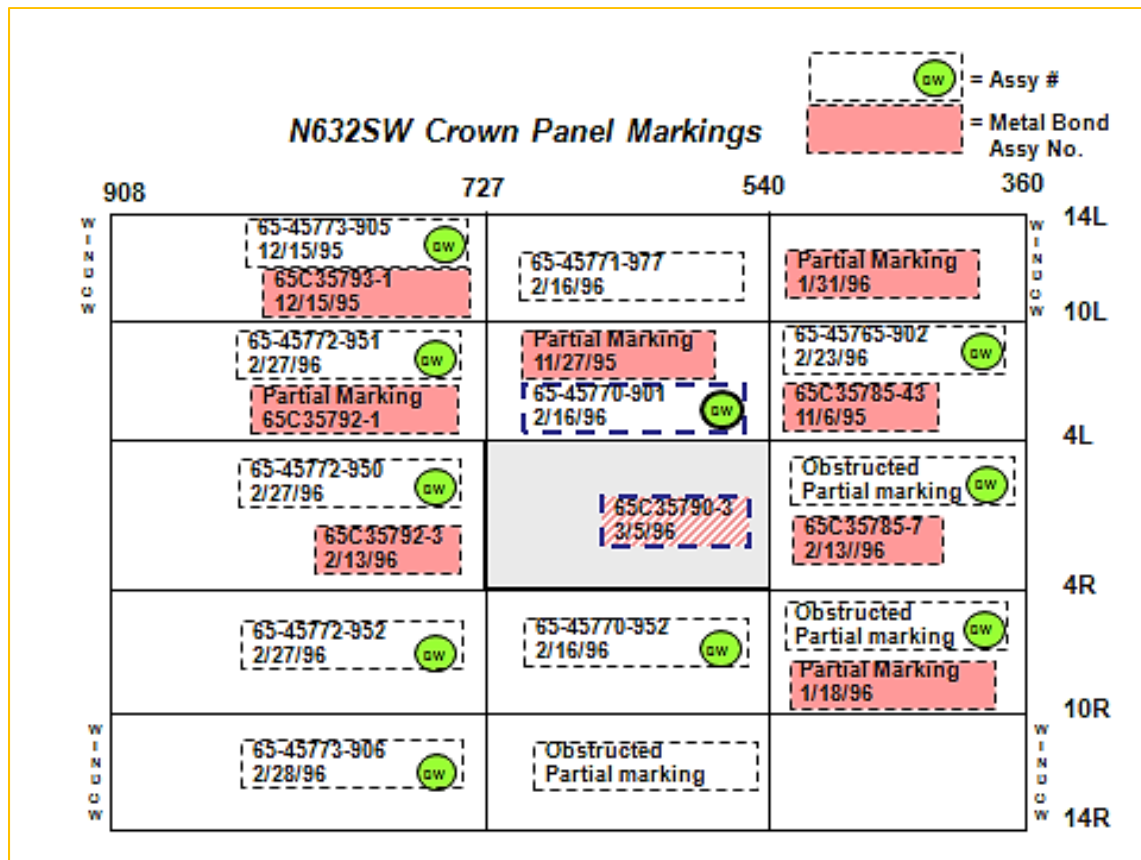
After the accident, all of the airplane’s interior components and insulation were removed, allowing examination of the interior surface of the fuselage skins. The visible markings on the skin panels<sup>5</sup> surrounding the crown skin panel (BS 540 to BS 727, S-4L to S-4R) immediately above the fractured skin panel were documented. Typically, a skin panel should have two markings: one for the manufacture of the skin panel itself and one for the manufacture of the built-up panel assembly. Additionally, the built-up panel assembly should have a marking to indicate that the assembly had been approved by the QA process. Figure 3 shows the markings on the accident airplane. The three-panel crown assembly from S-10L and S-10R that included the fracture had QA stamps dated February 16, 1996, with the exception of the grey panel in figure 2. The panel assemblies aft of the accident crown panel had QA stamps dated February 27, 1996. One of the three panel assemblies forward of the accident crown panel had a QA stamp dated February 23, 1996, while the other two markings were obstructed. The accident crown skin panel above the fracture and coincident with the lap joint where the fracture occurred only had a stamp for the skin panel manufacture and was dated March 5, 1996.

**Figure 3.** Documented markings on the accident airplane skin panels.

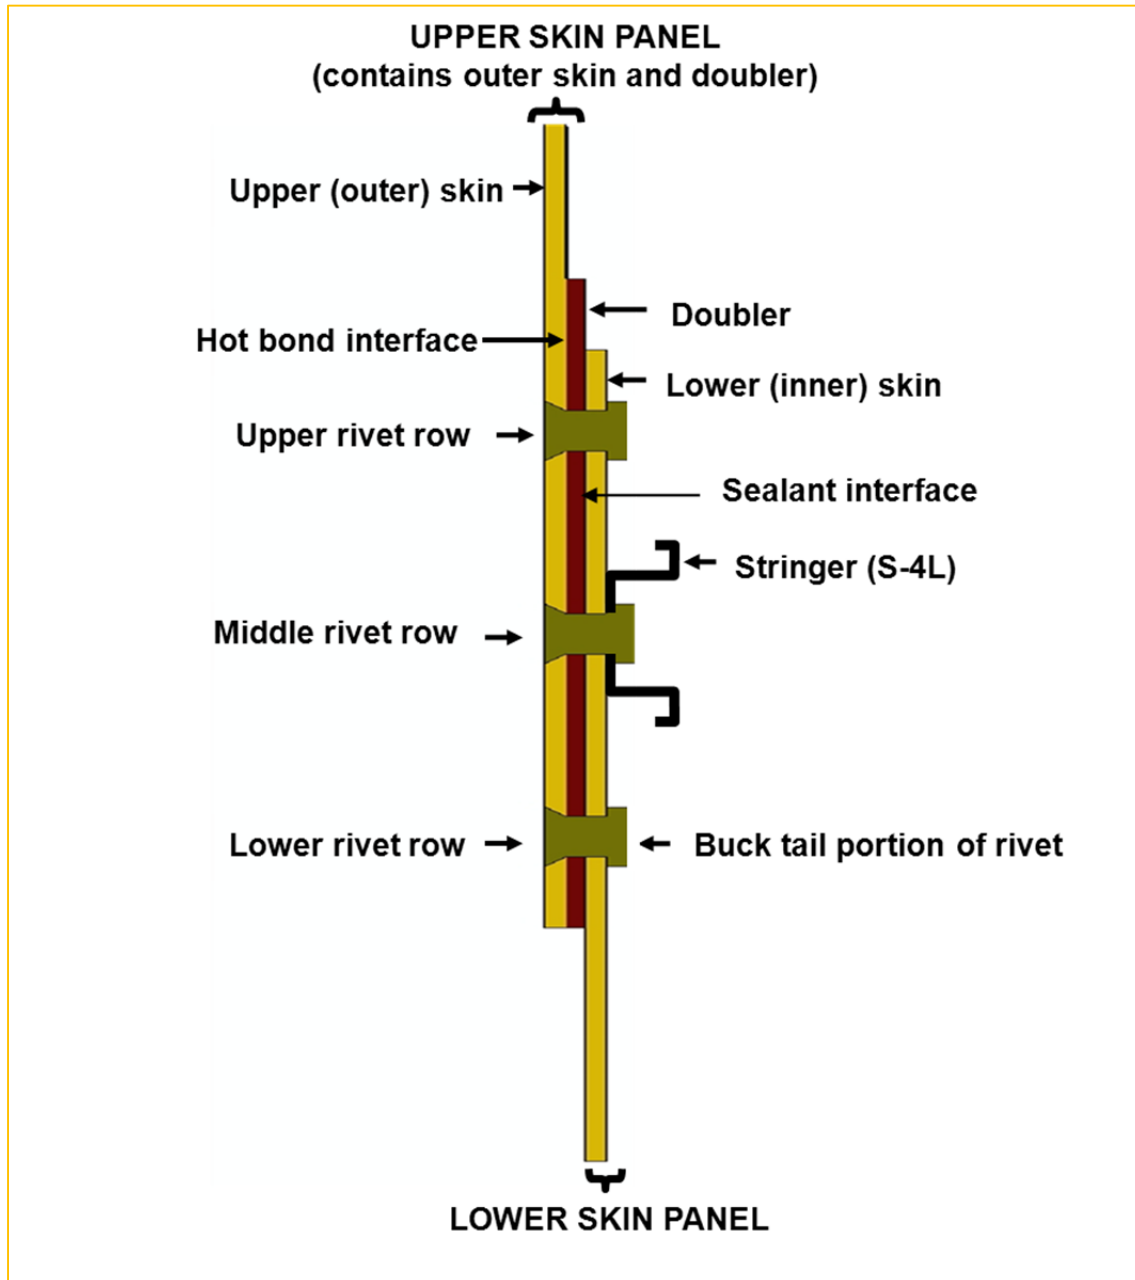
The area of the accident airplane skin panels containing the hole was excised from the airplane and sent to the NTSB materials laboratory for detailed examination, which revealed that the longitudinal fracture extended through the lower skin portion of the lap joint at S-4L. The fracture extended between BS 666 and BS 725 and through the lower row of rivets of the lap joint, intersecting 58 consecutive rivet holes at approximately 1-inch intervals. (A cross section of the lap joint on the accident airplane is shown in figure 4.)

**Figure 4.** Diagram of a Boeing 737 lap joint in the fracture area (not to scale).

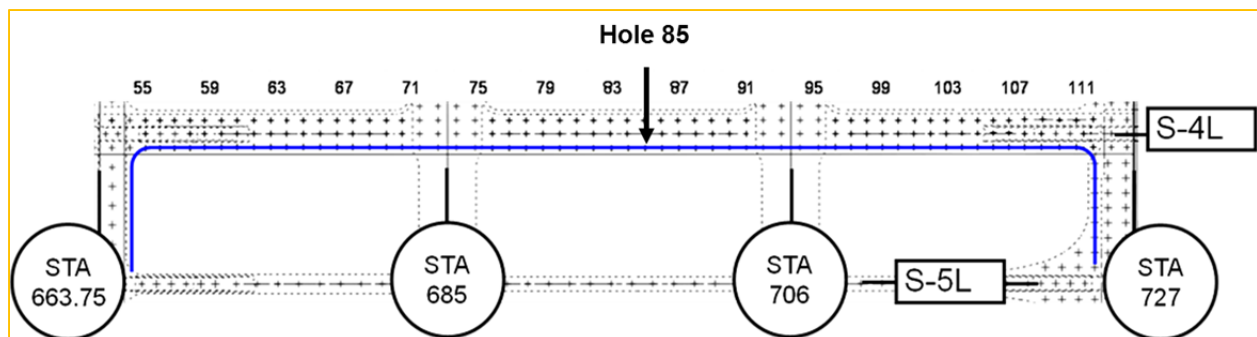
Microscopic examination of the longitudinal portion of the fracture surfaces revealed thumbnail fracture features consistent with fatigue cracking that originated from 54 out of 58 rivet holes. The fatigue cracks emanated from the outer surface of the lower skin. This surface is not visible from the interior or exterior of the airplane. In nine adjoining rivet holes (81 through 89), fatigue cracking occurred through 100% of the skin thickness. The depth of each fatigue crack varied along its length. The two longest fatigue cracks were found on the forward and aft side of rivet hole 85. The crack on the forward side of the rivet hole measured 0.55 inch, and the crack on the aft side measured 0.60 inch. The fatigue cracks propagated forward and aft with respect to each rivet hole. Figure 5 shows a drawing of the fuselage skin in the area of the fracture. As the distance from rivet hole 85 was increased, the length of a fatigue crack on each side of a rivet hole for each successive rivet hole decreased. The fracture face in the areas located outside of the fatigue crack regions showed rough texture features consistent with overstress separation. The remaining 4 of the 58 rivet holes (69, 71, 97, and 98) contained no evidence of fatigue cracking. The fracture intersected two tear straps<sup>6</sup> at BS 685 and BS 706. The face of the fracture for the tear straps contained no evidence of fatigue cracking.

**Figure 5.** Drawing of the lap joint in the area of fracture (blue line represents the fracture).

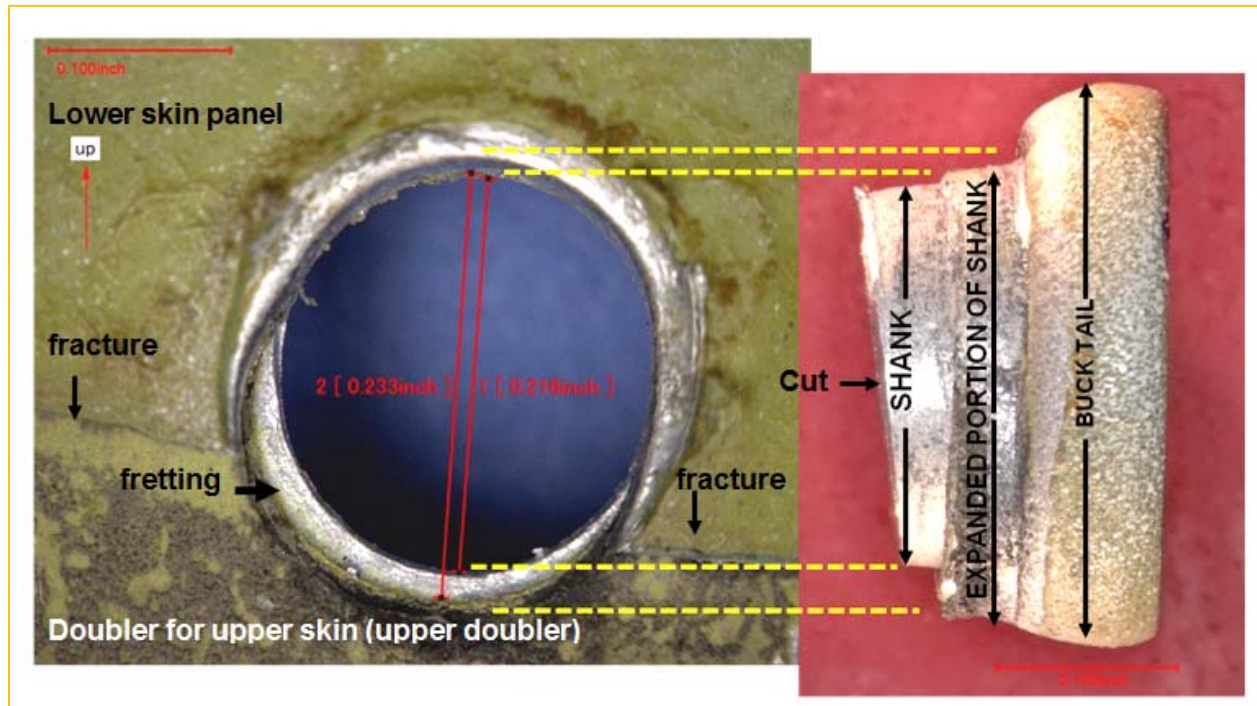
circular but slightly oval. Many of the rivet holes appeared similar to a figure 8 or a double-drilled hole. The fracture (fatigue cracks) intersected the lower portion of a majority of the lower-row rivet holes. The corresponding area located at the underside of the expanded portion of the rivets also showed fretting damage consistent with the underside of the expanded portion of the shank rubbing against the doubler. The bore of many rivet holes contained deposits of dark gray material consistent with BMS5-95 sealant.

**Figure 6.** Rivet hole 85L when viewed from inner face of the skin panel (left side) and side view of corresponding rivet that was removed from the rivet hole (right side).
