AIRCRAFT ACCIDENT REPORT

Uncontrolled Descent and Collision With Terrain

United Airlines Flight 585

Boeing 737-200, N999UA

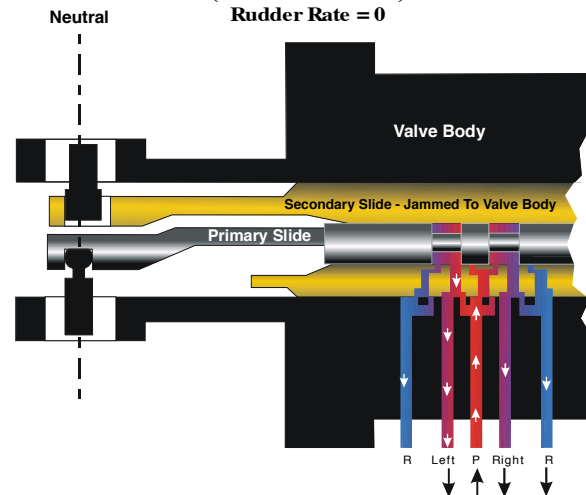
Intended Operation:
Secondary Slide Jammed Full Open, Primary Slide Opposing
 (Full Cross Flow)
 Rudder Rate = 0

Figure 14. PCU servo valve intended operation with the secondary slide jammed to the servo valve housing and primary slide opposing.

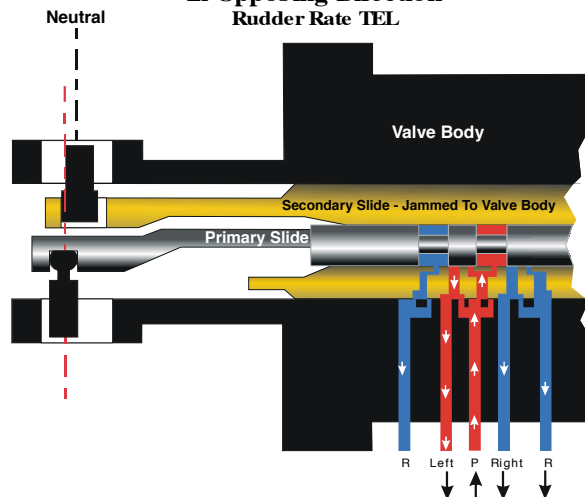
Newly Discovered Failure Effect:
Secondary Slide Jammed Full Open, Primary Slide Over-Stroke
In Opposing Direction
 Rudder Rate TEL

Figure 15. PCU servo valve with the secondary slide jammed to the servo valve housing and the primary slide in the overtravel condition.

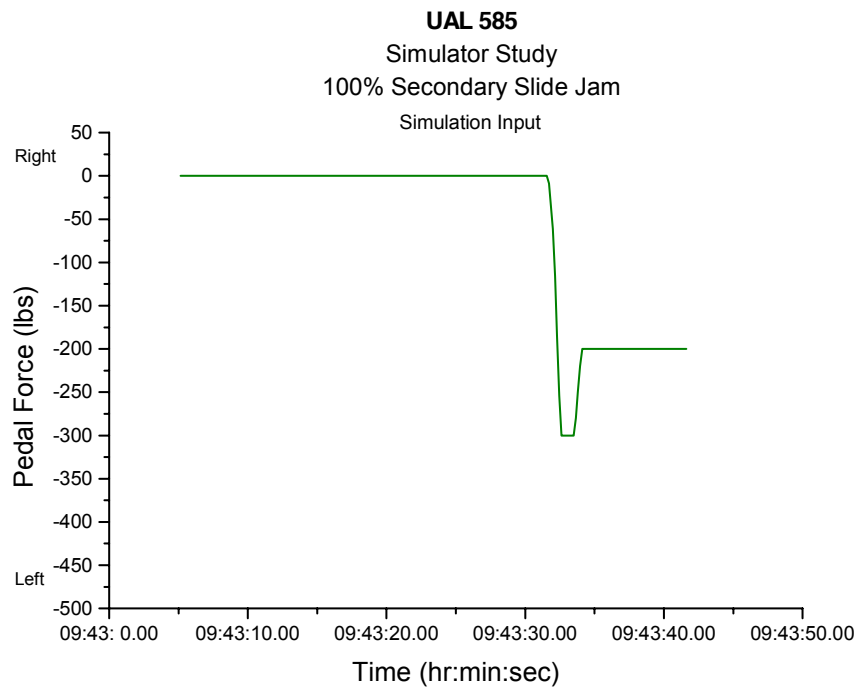
⁷² The Safety Board's best-match simulation used 300 pounds of force reducing to 200 pounds, based on ergonomic and other research data (see section 1.18.3). The Safety Board was also able to match the United flight 585 FDR data using only the minimum pedal force necessary to sustain full rudder authority (about 70 pounds).

Figure 16. Pilot rudder pedal force positions for United flight 585.

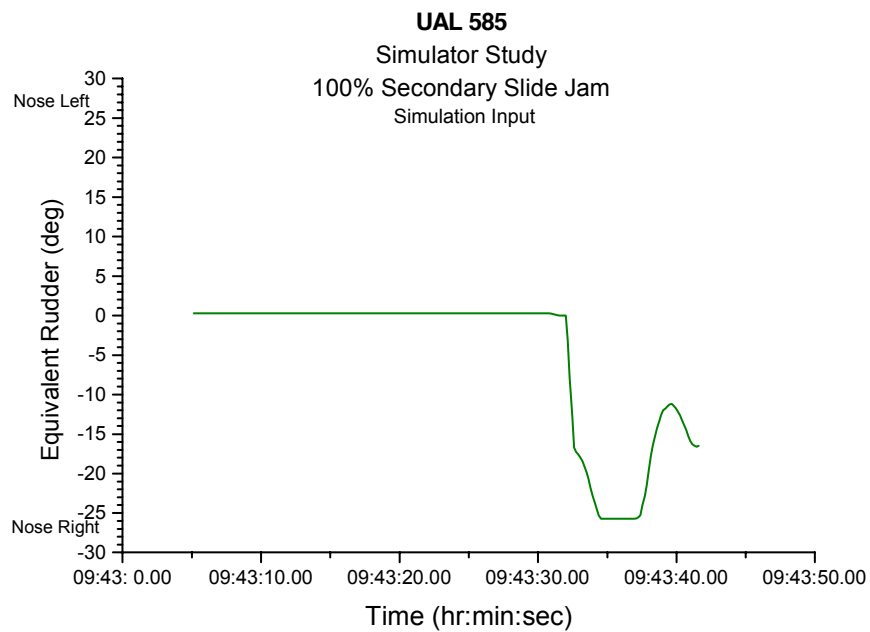
Figure 16a. Rudder surface positions for United flight 585.

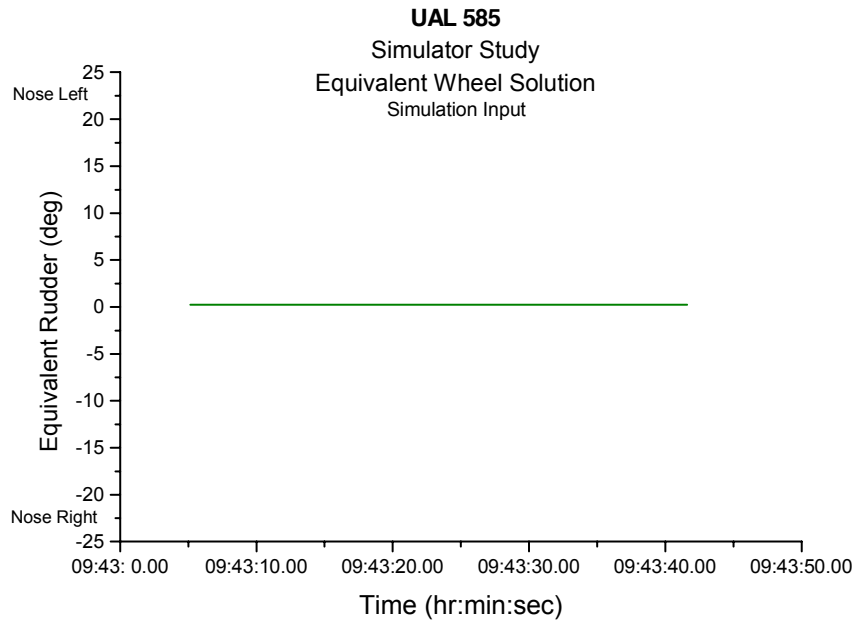
One of the Safety Board simulation scenarios that produced a good match with the FDR data and other physical evidence assumed a sustained equivalent control wheel input

Figure 17. Rudder surface positions for United flight 585 assuming a sustained equivalent control wheel input.

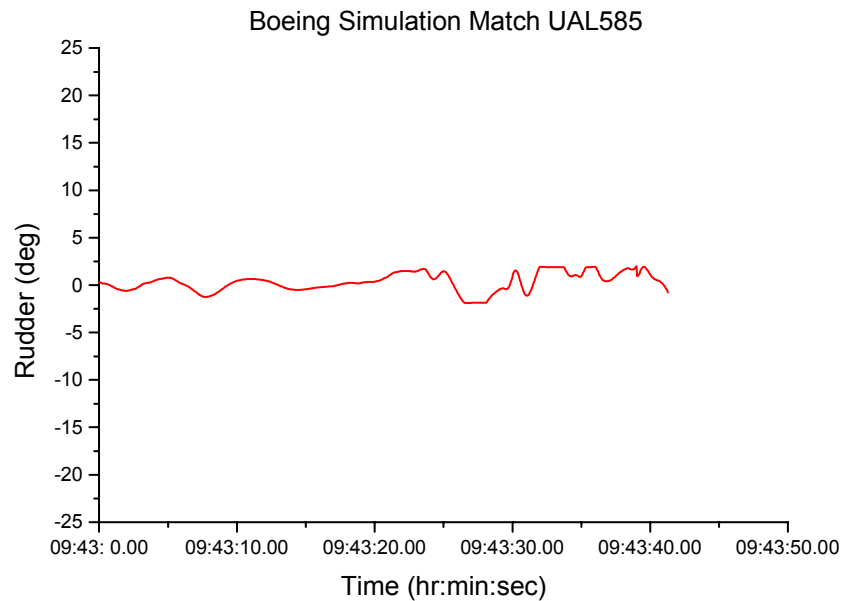
In a June 23, 1997, letter to the Safety Board, Boeing provided its analysis of the United flight 585 accident.⁷³ Boeing's analysis concluded that a rudder hardover scenario did not fit the FDR data and that a "new rotor model" did match the data.⁷⁴ Further, Boeing derived this new rotor model to match the available data and introduced a rotational effect of near zero just before 0943:28, which increased linearly to about 0.4 radians per second just before 0943:29 and then increased linearly to about 1.8 radians per second about the time the airplane impacted the ground (just before 0943:42).

Figure 18. United flight 585 rudder surface positions according to Boeing's new rotor model.
