**THE DANISH  
ACCIDENT INVESTIGATION BOARD**  
The Aviation Unit

**Report**  
**HCLJ510-000721**

Incident involving ATR72-212A  
Registration OY-CIN  
Bornholm Airport (EKRN)  
27 January 2010

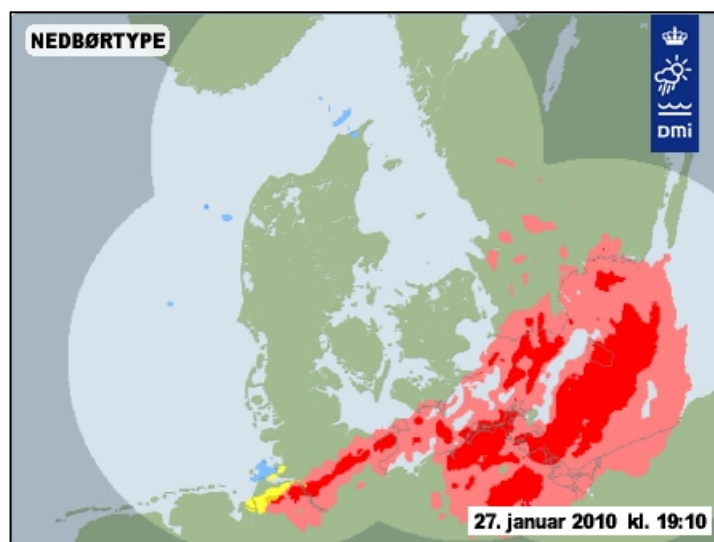
Radar (local time)

The picture indicates moderate snow fall at EKRN, but no CB activity. No lightning was registered.

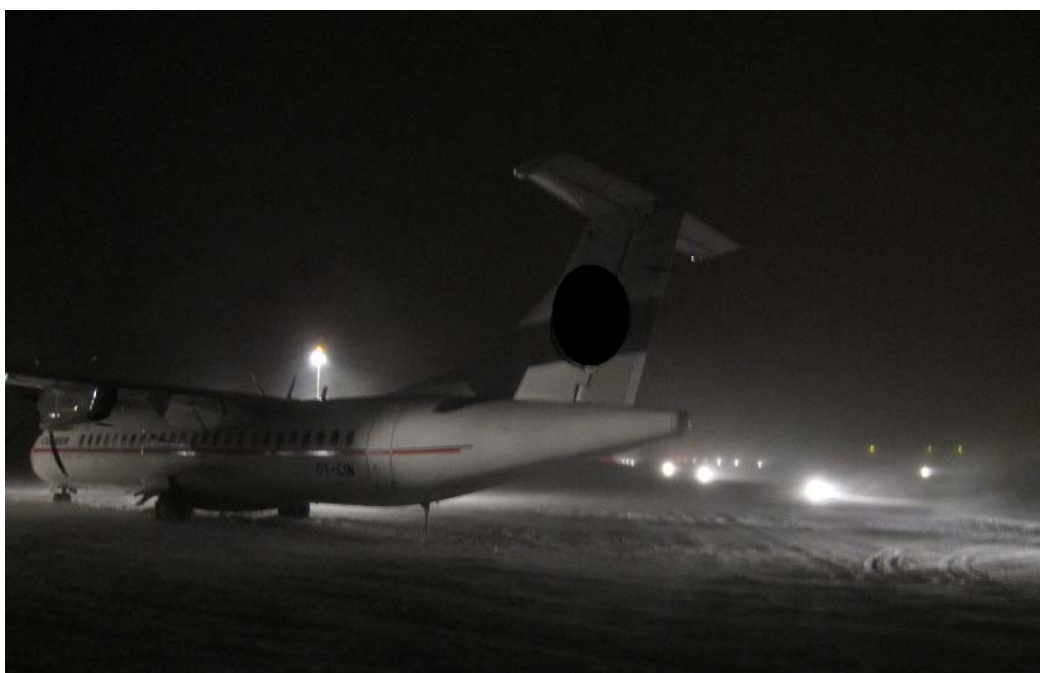
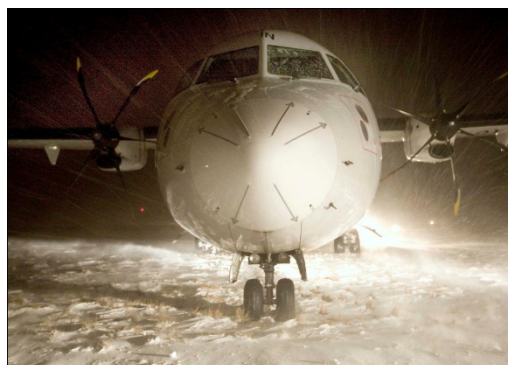
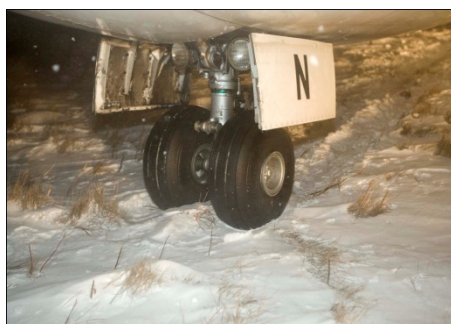
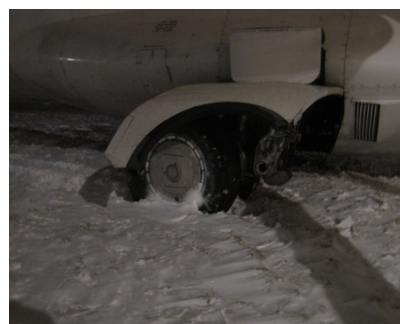
### **1.12 Place of incident**

The aircraft came to a complete stop 830 metres after the displaced threshold to runway 29 and approximately 25 metres into the safety zone. See enclosure 8.

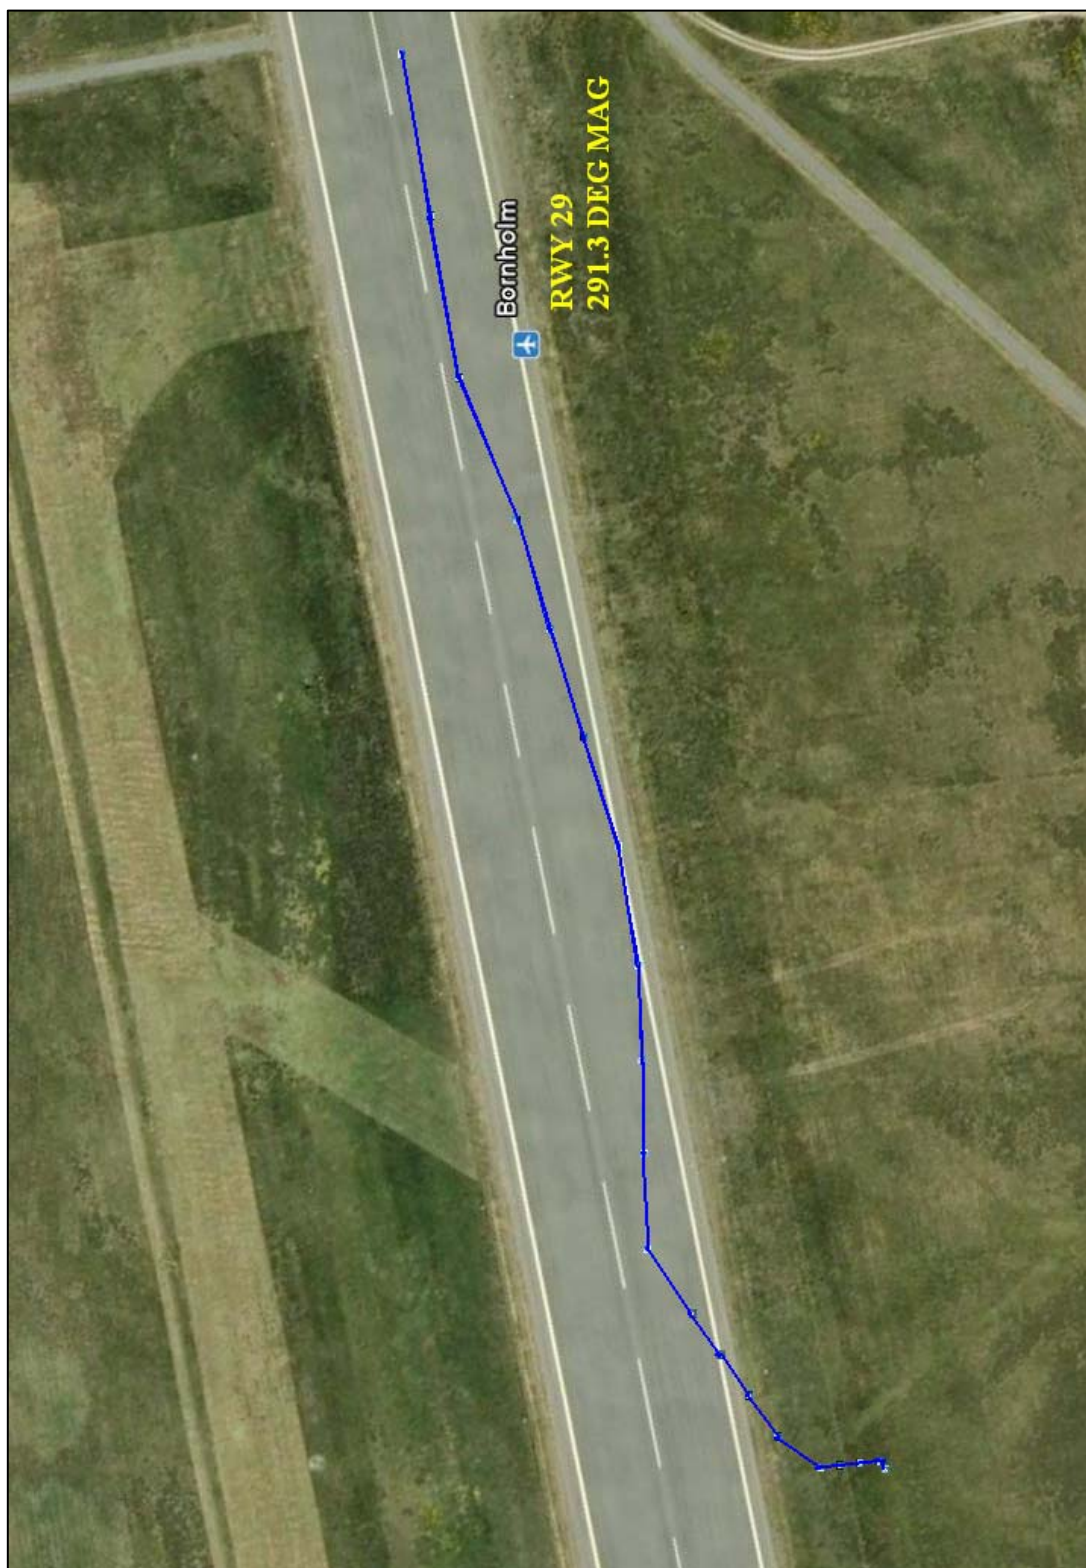
Enclosure 1 - Landing roll (overview picture)

- a) During the landing roll, the external visual references were limited because it was dark and snow drifting. The snow drift from the south to the north may have led to an optical illusion that the aircraft drifted to the north at first touch-down. In addition to the marginal crosswind conditions leading to a significant increase in the magnetic heading , intensified by a 3° bank to the right, an optical illusion may have led to the first full rudder deflection to the left during the first touch-down.

- b) The subsequent full rudder deflections during the landing roll might, in AIB's opinion, be seen as pilot reactions to the combination of lateral accelerations and heading augmentation during marginal crosswind conditions.

- c) The speed during the landing roll was decreasing gradually leading to a decrease of rudder effectiveness which, in marginal crosswind conditions, made it all the more difficult for the pilots to re-establish directional control.

- d) As a result of the marginal crosswind conditions, during the last part of the landing roll, it is likely that the aircraft was exposed to the weathercock effect, which intensified the aircraft's trajectory over the side of the landing runway.

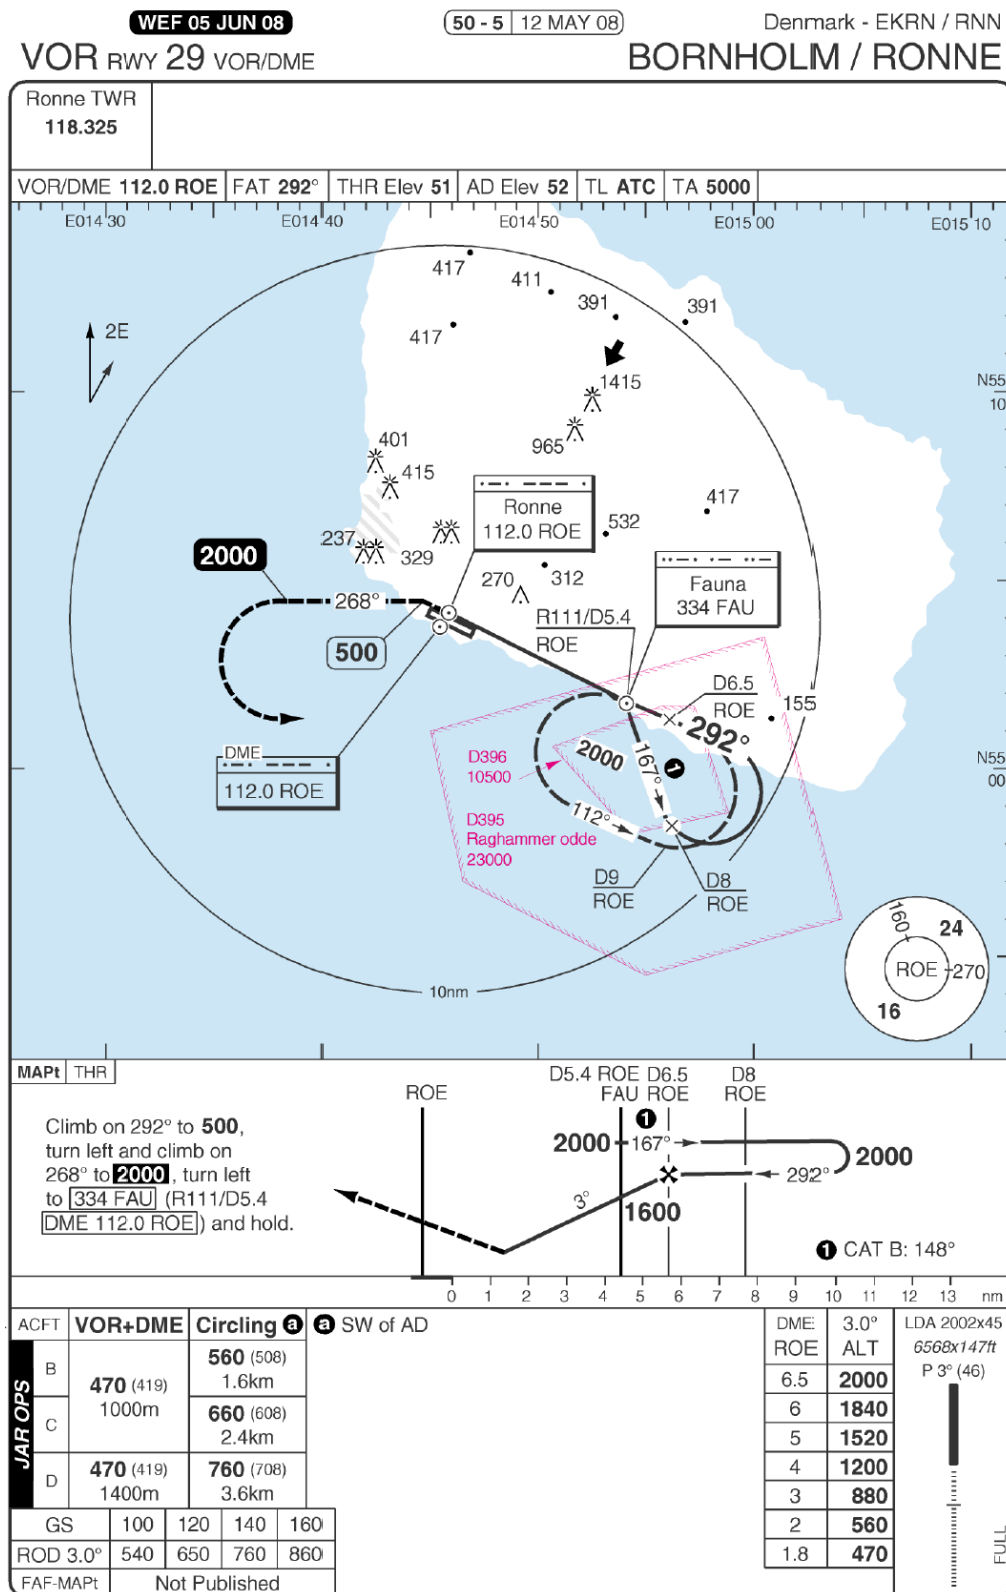
# Enclosure 9 - The operator's approach chart (VOR/DME RWY 29)

The operator's approach chart for a VOR/DME approach to runway 29 indicated a minimum RVR value of 1000 metres. The approach chart did not give any information to the pilots regarding increased minima in the event of changed approach lighting conditions. This could have had a bearing on the pilots' decision-making process when planning the flight.
