**REPORT ON THE MISHAP OF THE AIRCRAFT
BOEING B747-271C REGISTERED 4X-ICM AT
LIEGE (BELGIUM) ON OCT 01, 2003.**

Cellule d'Enquêtes d'Accidents
et d'Incidents d'Aviation

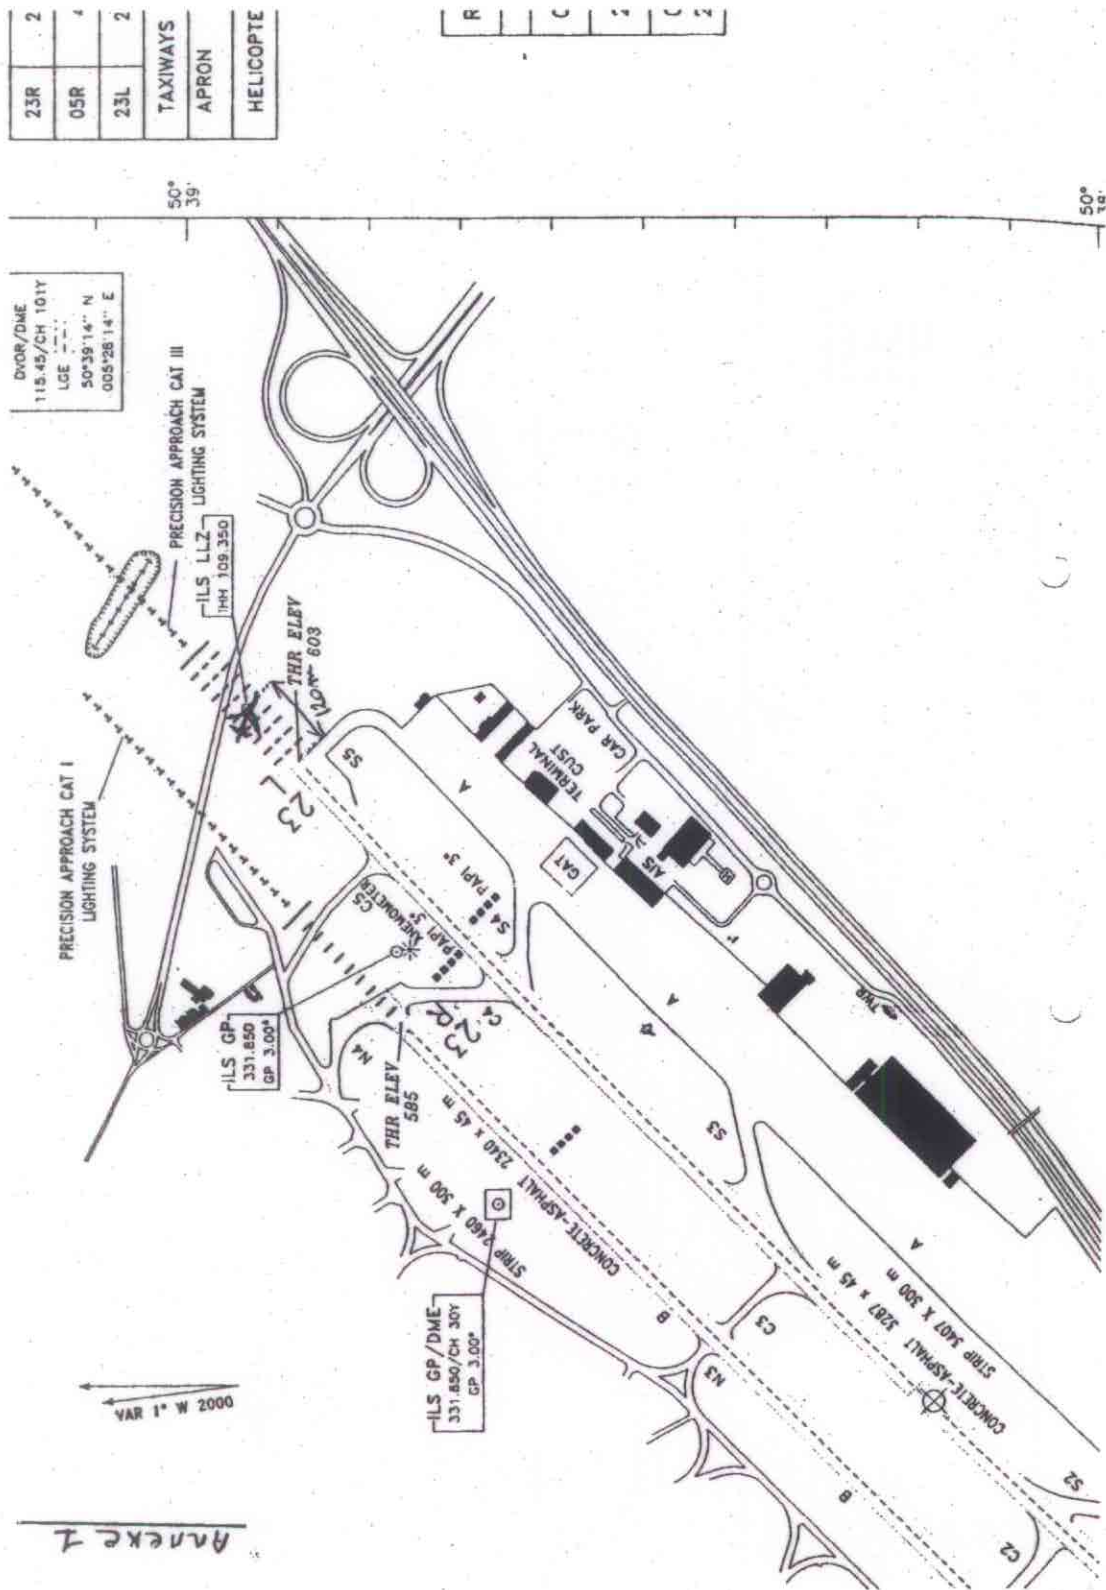
SITE DIAGRAM.

The aircraft overran the runway by approximately 120m. A diagram of the site is at annex 1, page 1. A visual inspection of the runway was carried out on October 2, 2003. Special emphasis was put on the roll out zone.
