Final Report

EgyptAir Boeing 777-200 aircraft cockpit fire

On 29th July 2011

Registration SU-GBP

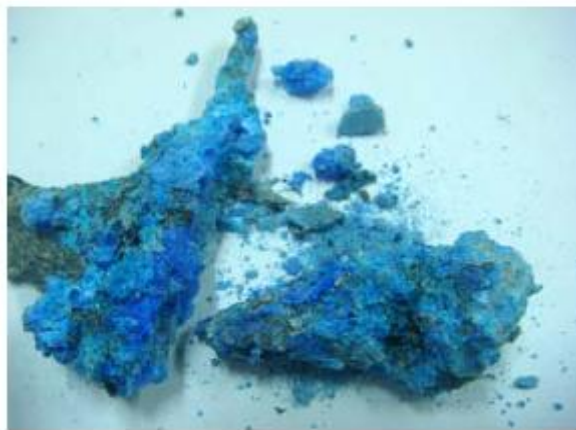
Sample No.4: Bright Blue Material (Flight Deck R.H.S. AFT of Main hole Adjacent to Wiring).

The test results showed that the bright blue material mainly consists of Mascagnite ($(\text{NH}_4)_2\text{SO}_4$).

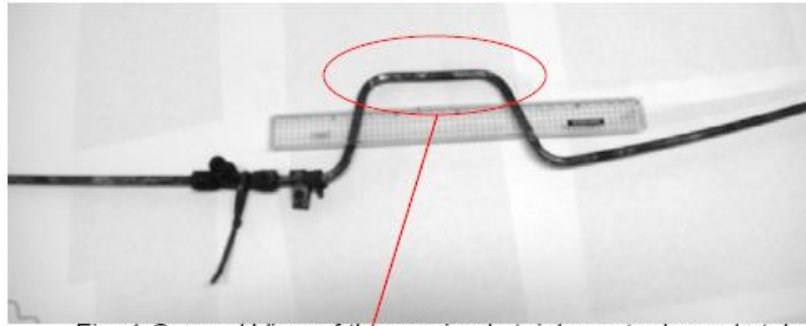
Fig. 1 General View of the received stainless steel supply tube

The tube surface was covered by fire products, and some areas have rough surface. The molten metal is basically aluminum alloy, resulted from the fire.

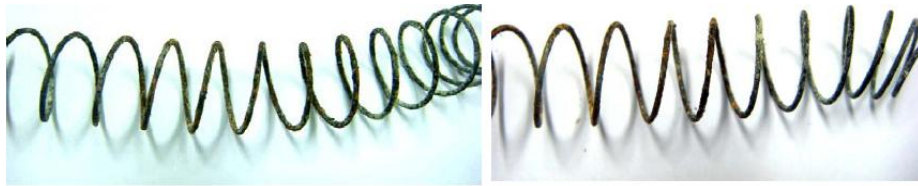
The stainless steel spring surface was covered by fire products with some spot rusted area (red color). No direct evidence of a short circuit was found, but most of the wiring near the supply tubing and portions of the tubing were missing, with evidence of melting on the remaining portions.

According to CMRDI view, most plausible cause for the observed melting of the stainless steel spring assembly is an oxygen fuel flame caused by high attained temperatures

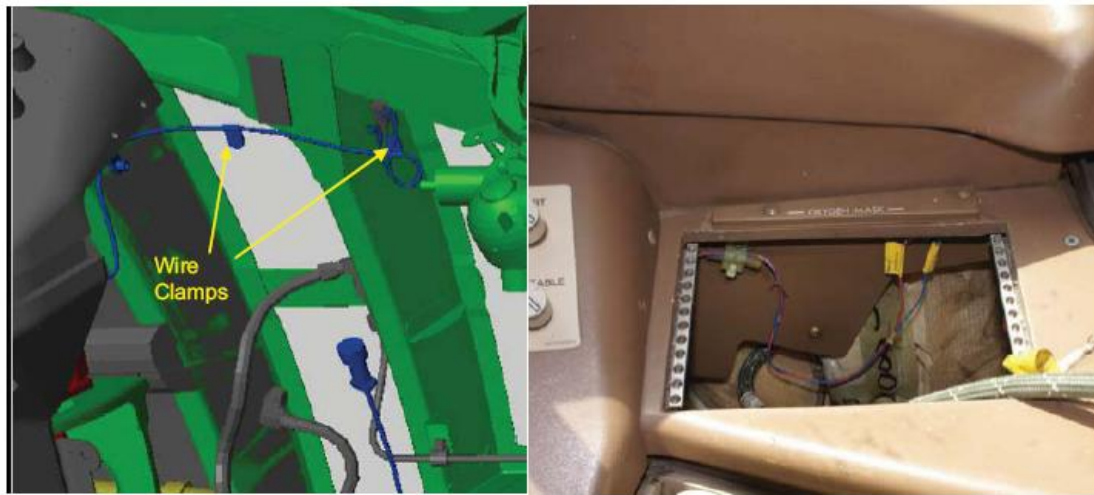
Current Design As found on a different 777-200

The 777-200 aircraft were found to differ from Boeing's current design. In particular, the wiring to the first officer's oxygen mask light plate differed in the follow aspects: a wire clamp was missing, the wiring was not sleeved, and a large loop of unsupported wire was found. All of EgyptAir's 777-200 had a similar wiring configuration at the first officer's oxygen mask location. The captain's side wiring was similar, except that sleeving was present on all airplanes inspected.

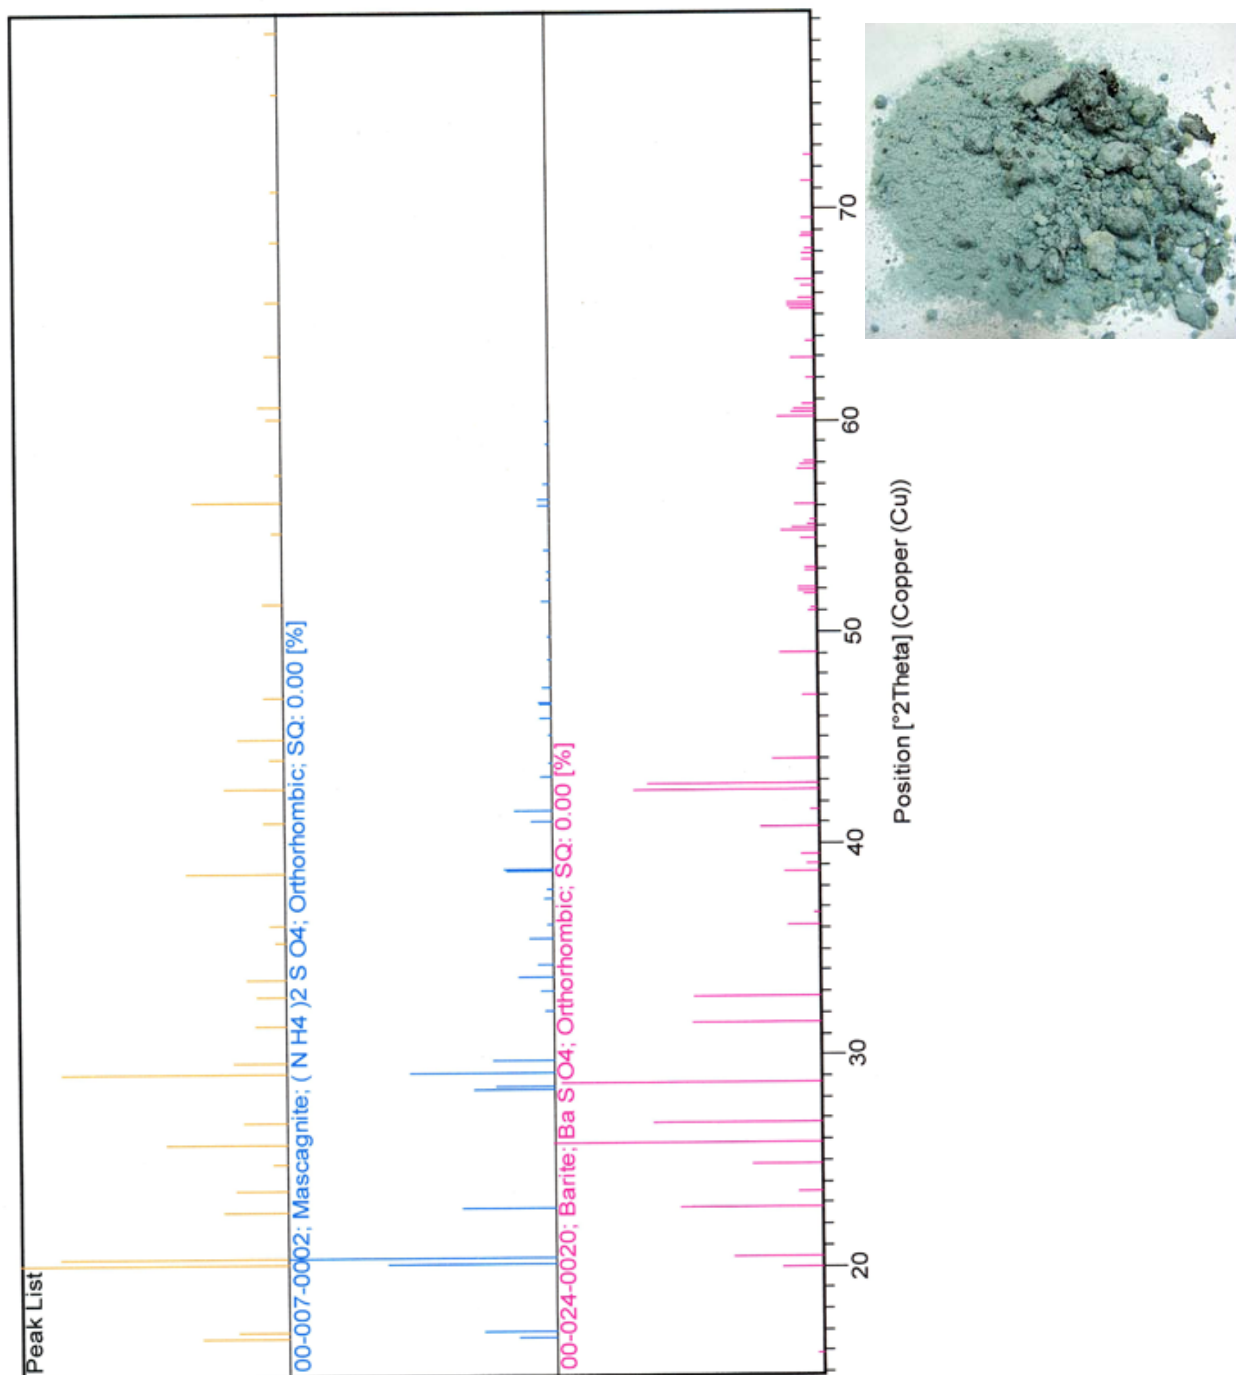
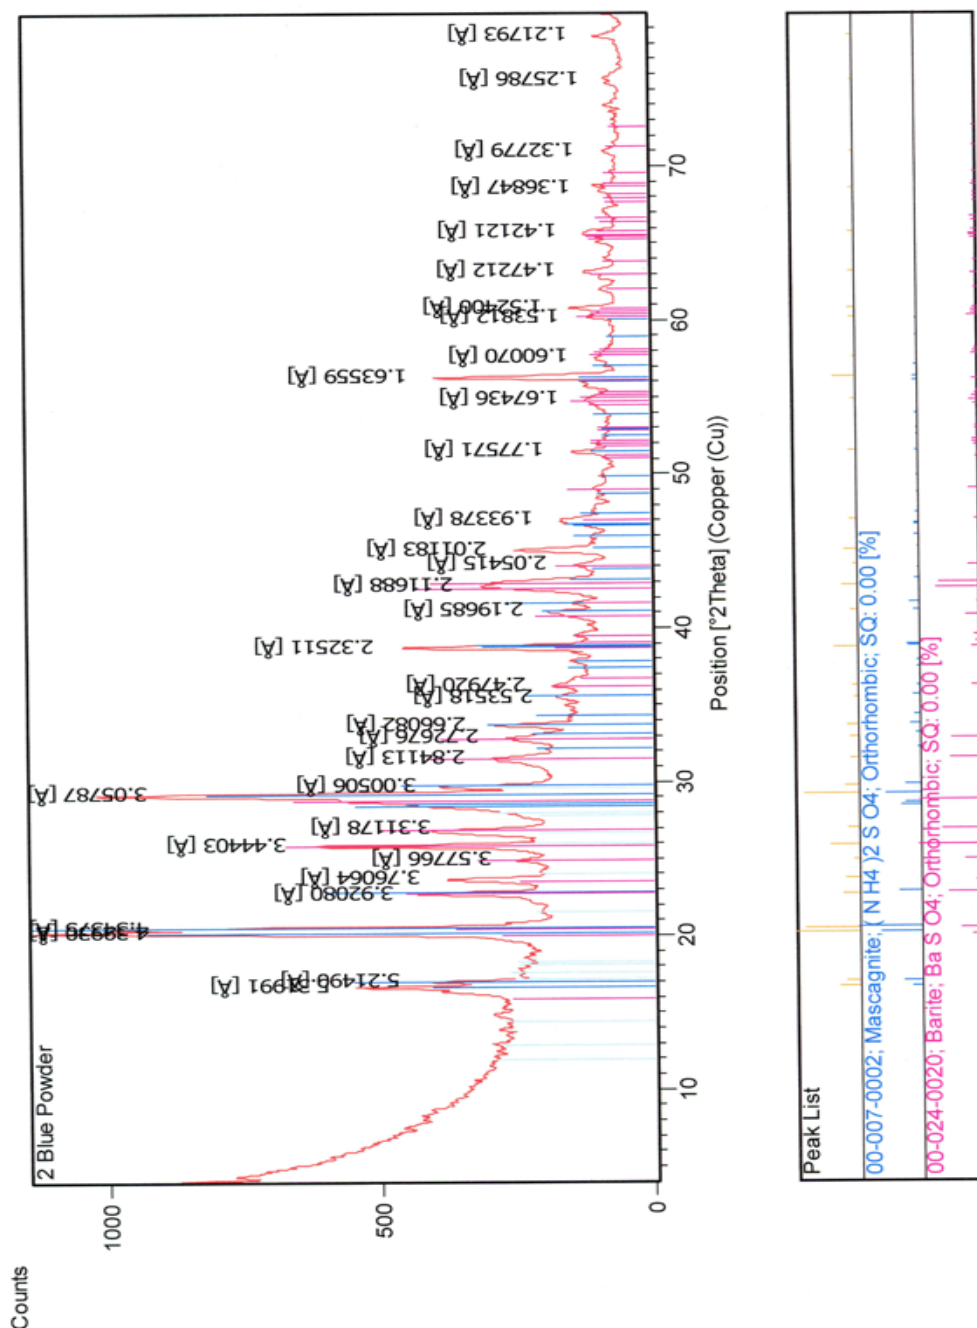
Sample No.2: Blue Powder (Flight Deck R.H.S. SU-GBP)

The test results showed that the blue powder is mainly consists of Mascagnite $(\text{NH}_4)_2\text{SO}_4$ and Barite BaSO_4 .

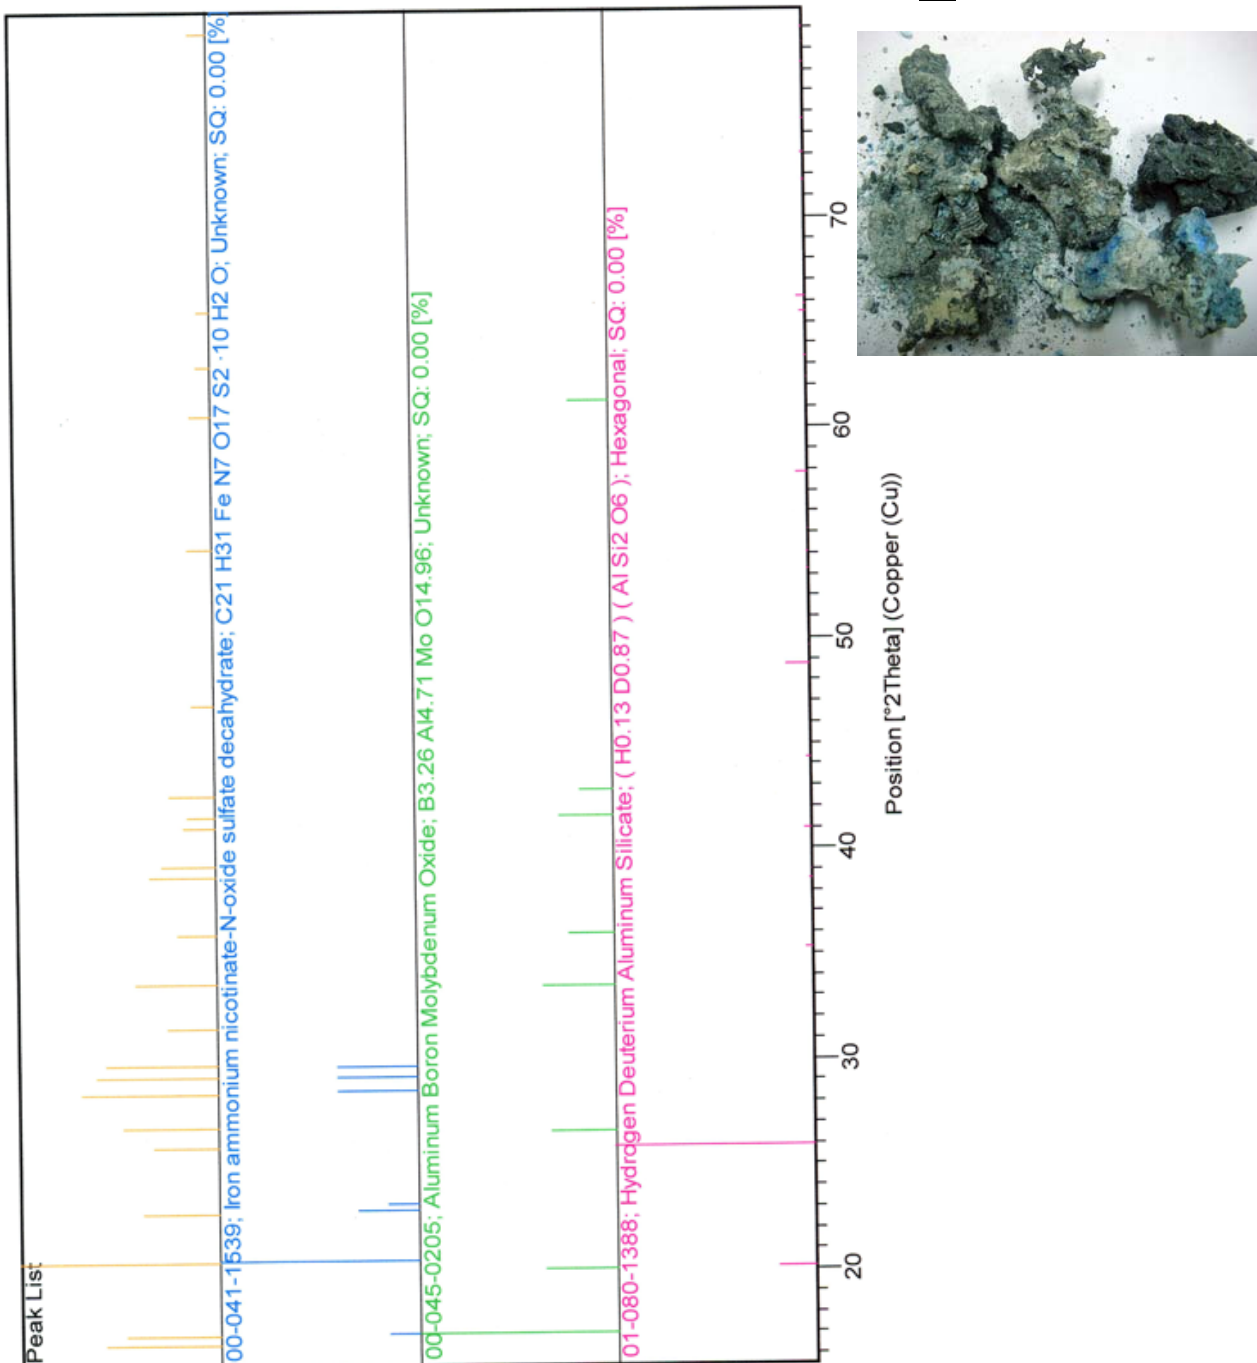
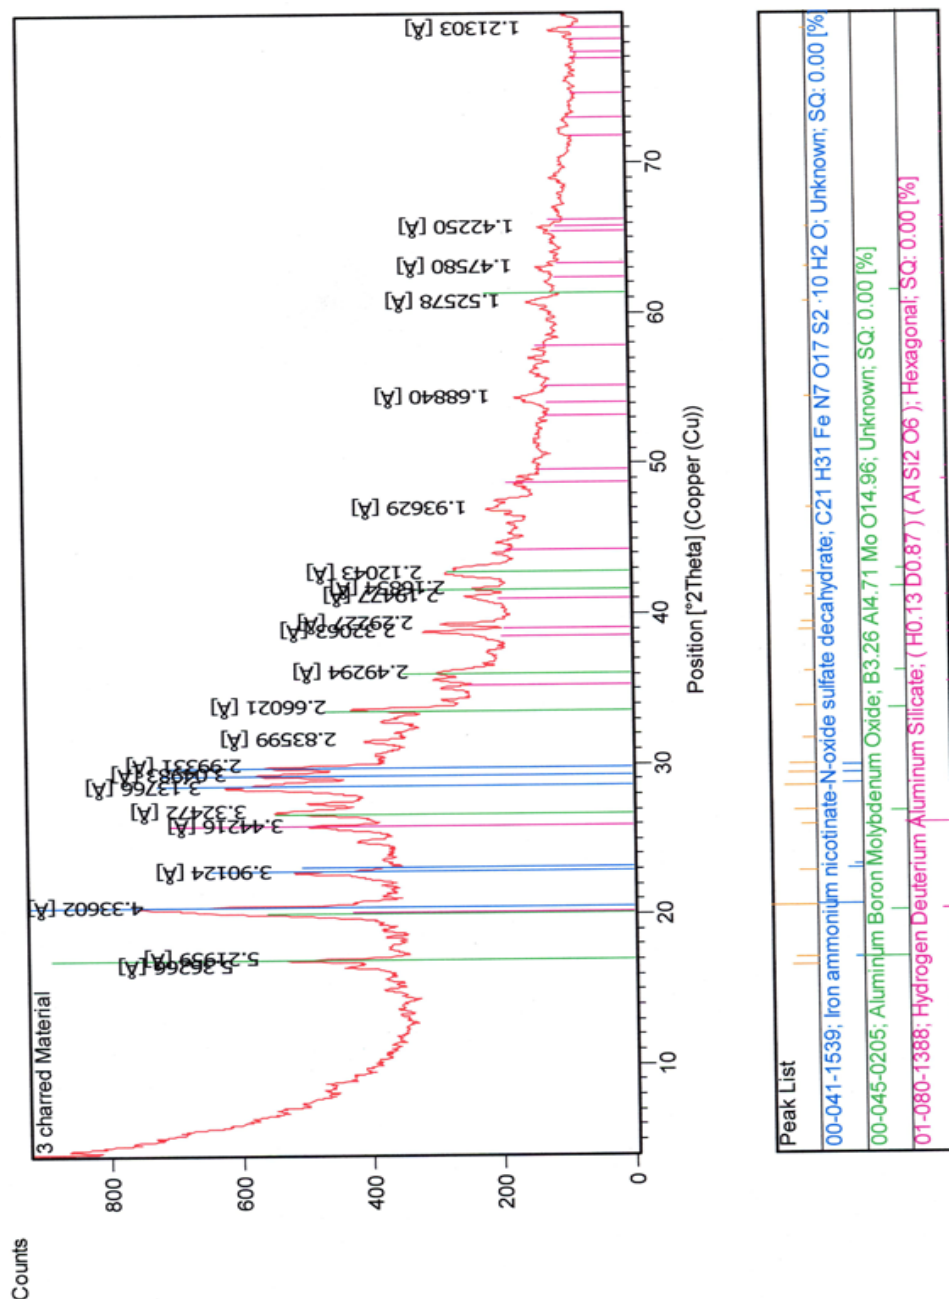
Sample No.3: Charred Material and Powder (R.H.S. SU-GBP)

The test results showed that the charred material is mainly consists of Iron ammonium Nicotinate N-Oxide Sulfate Decahydrate C₂₁H₃₁FeN₇O₁₇S₂·10H₂O, Aluminum Boron Molybdenum Oxide B_{3.26}Al_{4.71}MoO_{14.96} and Hydrogen Deuterium Aluminum Silicate (H_{0.13}D_{0.87})(AlSi₂O₆).

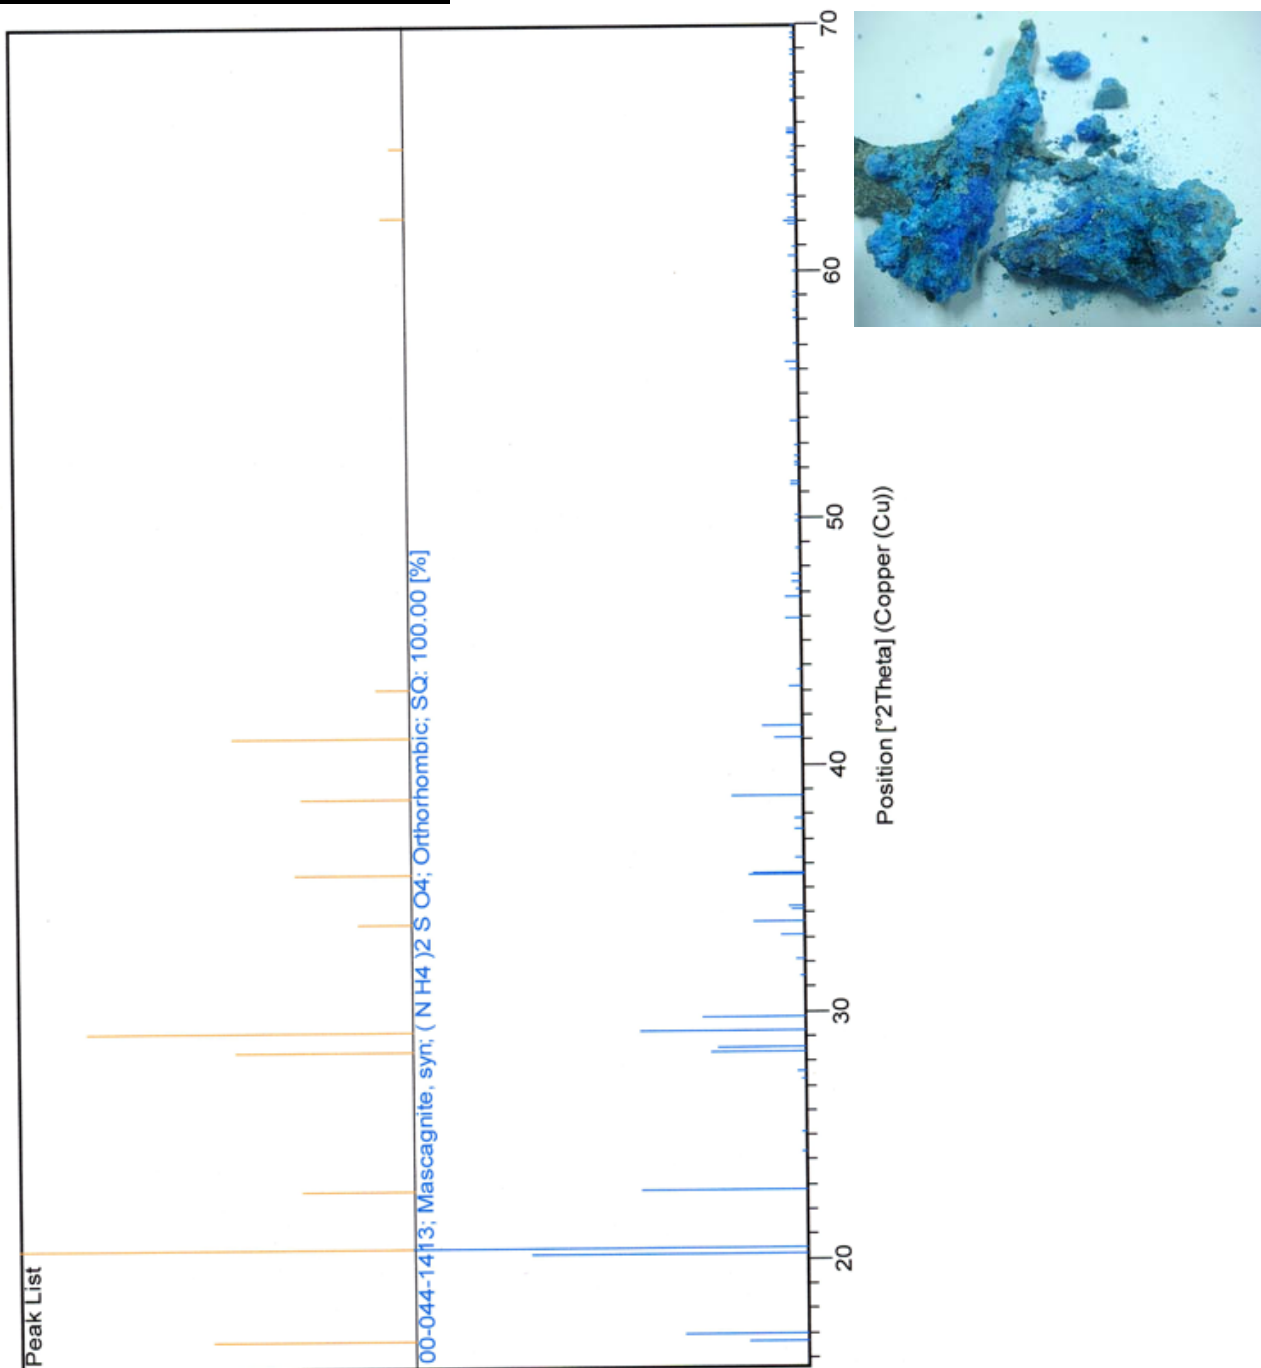
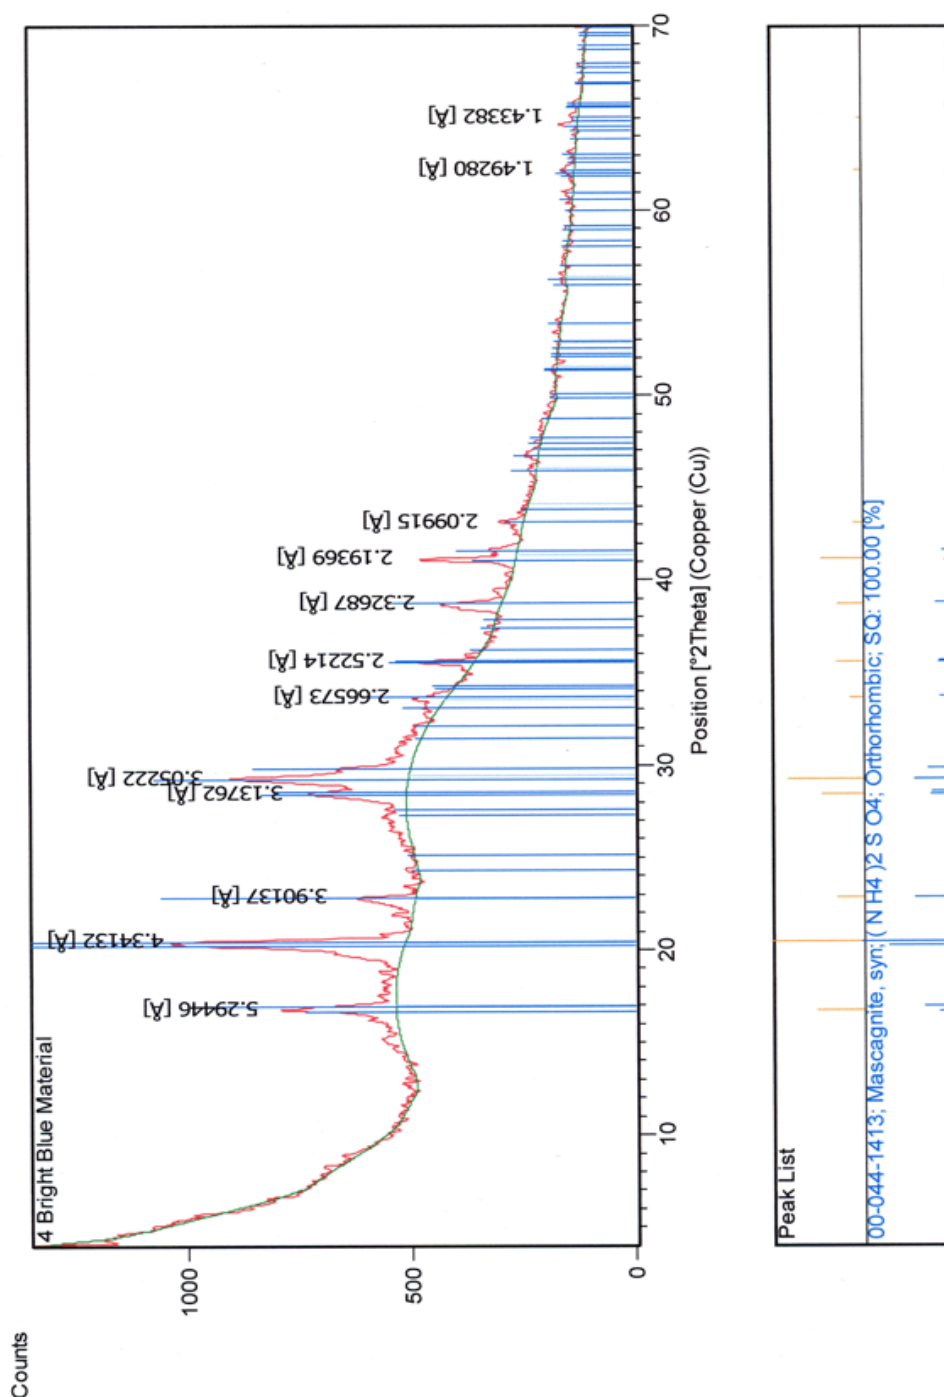
**Sample No.4: Bright Blue Material (Flight Deck R.H.S. AFT of Main hole
Adjacent to Wiring SU-GBP)**

The test results showed that the bright blue material is mainly consists of Mascagnite $(\text{NH}_4)_2\text{SO}_4$.

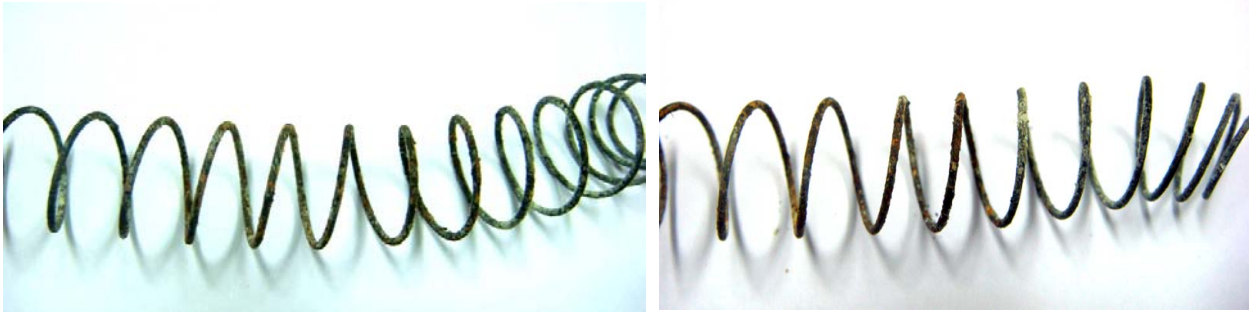
Sample No.5: Anti Kink Spring Supply Hoses Floor to Tee F/O O₂ (Stainless Steel Spring)

The stainless steel spring surface is covered by fire products with some spot rusted area (red color). No direct evidence of a short circuit was found, but most of the wiring near the supply tubing and portions of the tubing were missing.

The only way to cause melting of the stainless steel spring assembly is an oxygen-fuel flame because temperatures that are attained in ordinary fires are not sufficient to melt stainless steel. The source of oxygen to allow for this melting would have had to be located closely to the melted stainless steel spring assembly; thus, the source of oxygen was the flexible oxygen hose connected to that particular spring assembly.

It is supposed that the stainless steel spring had been subjected to high energy level, which heated the internal spring until it became an ignition energy source, causing the flexible oxygen hose to ignite and sustain a fire. The time to failure, may took few seconds depending on the amount of energy supplied to the internal spring.

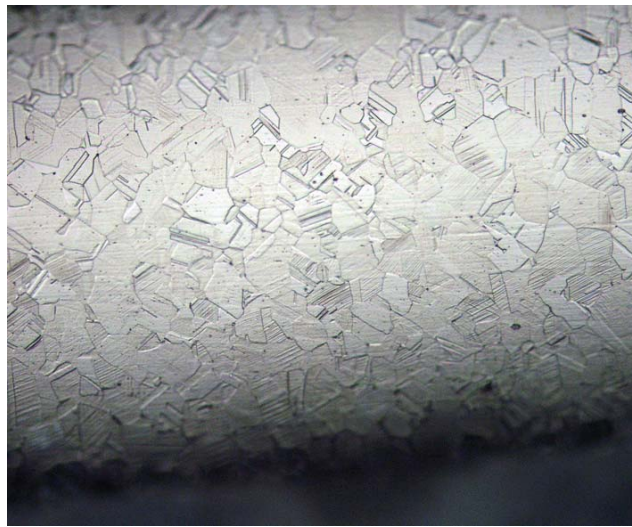
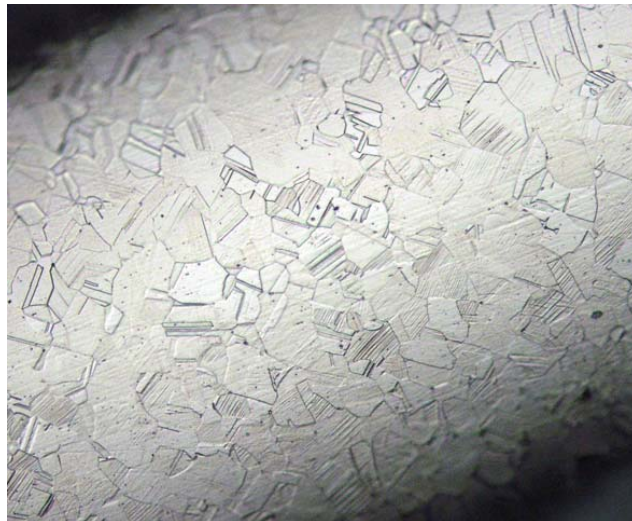
Microstructure of the investigated stainless steel spring, 200X

This could be approved from the metallurgical microstructure of stainless steel wire, investigated at different places. The microstructure is normal for this type of stainless steel with normal grain size and without any precipitates, as shown in the following figure. If the heating of the stainless steel spring took long time the microstructure will be coarser and different type of precipitates will be observed on the grain boundaries, which is not our case.

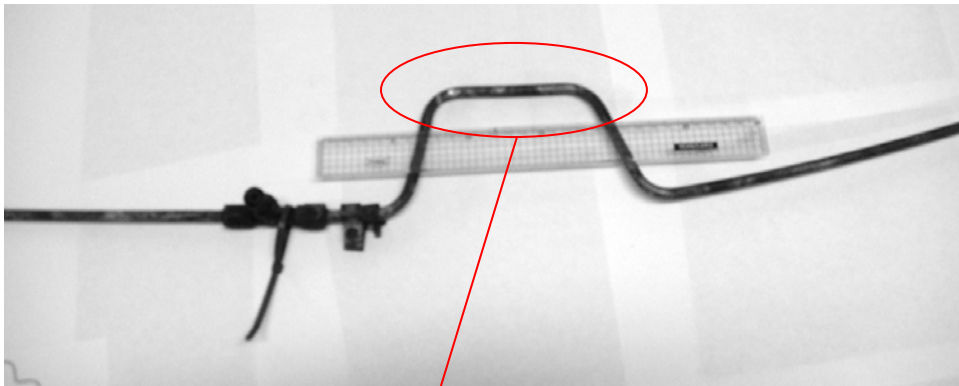
Fig. 1 General View of the received stainless steel supply tube

The tube surface was covered by fire products, as shown in Fig.2, and some areas have rough surface. The deposited molten metal shown in Fig.2, was send to chemical analysis. The molten metal is basically aluminum alloy, resulted from the fire.

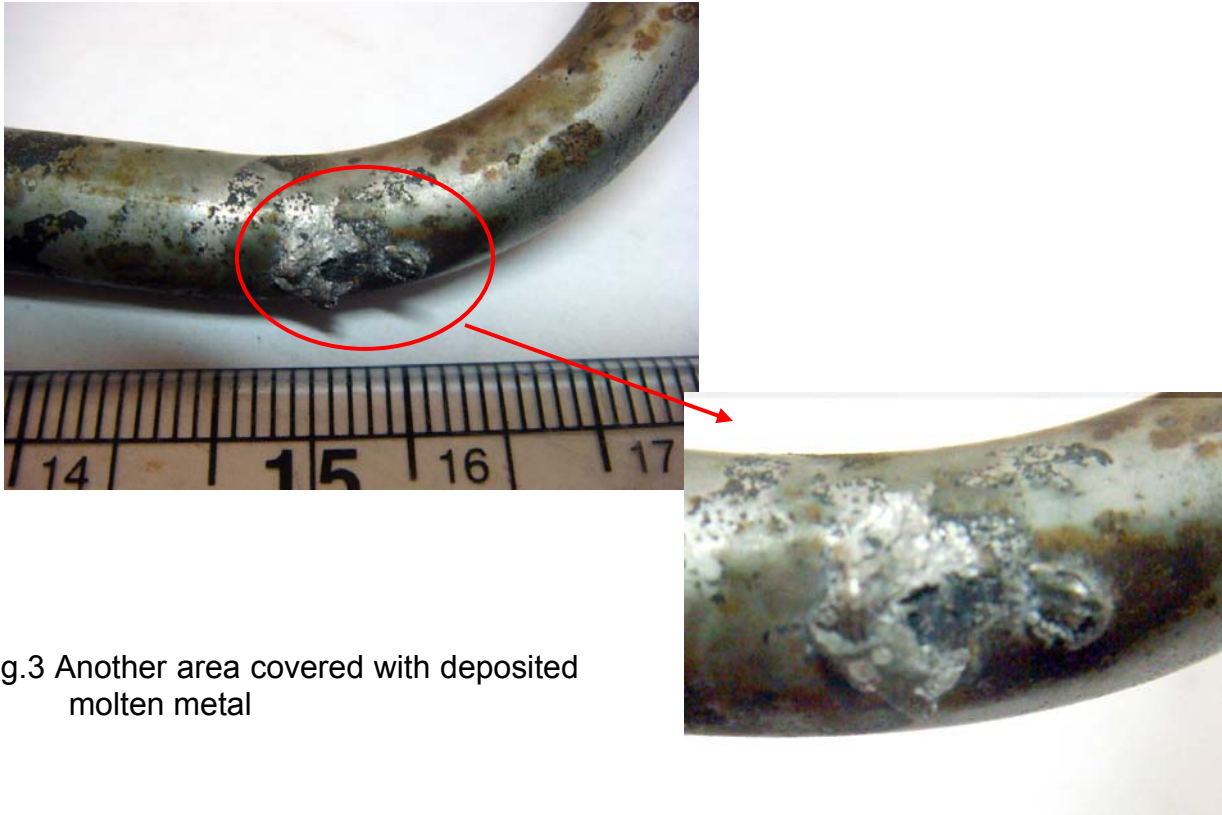
Fig.3 Another area covered with deposited molten metal

Another area was noted as shown in Fig.3, with suspected spot as an arc strike. Detail investigation showed that this is also covered only with deposited molten metal.

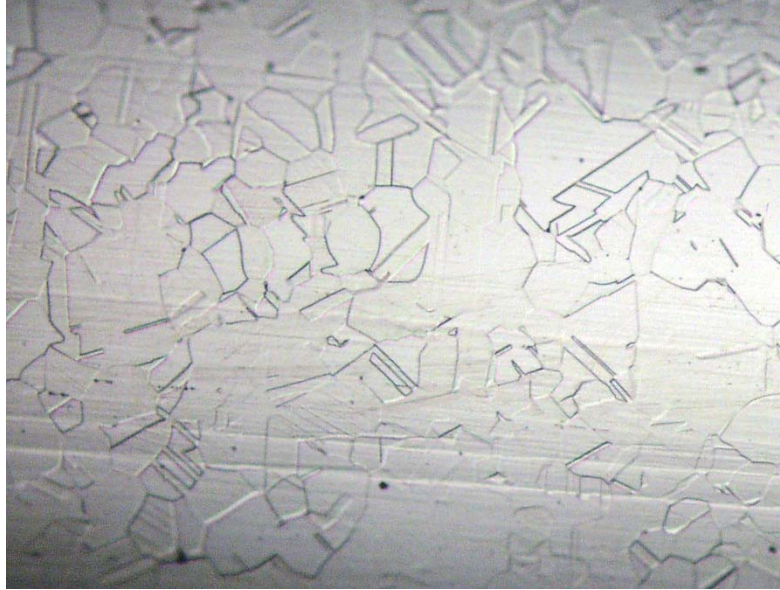
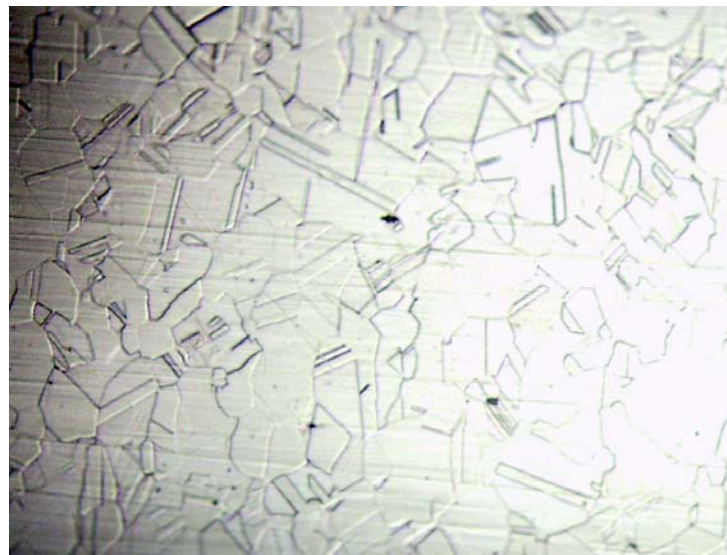
Microstructure of the investigated stainless steel spring, 200X

This could be approved from the metallurgical microstructure of stainless steel wire, investigated at different places. The microstructure is normal for this type of stainless steel with normal grain size and without any precipitates, as shown in the following figures. If the heating of the stainless steel spring took long time the microstructure will be coarser and different type of precipitates will be observed on the grain boundaries, which is not our case.
