KNKT 09.12.04.01

Aircraft Accident Investigation Report

**PT. Aviastar Mandiri
PK – BRD
British Aerospace BAe 146-300
Wamena Airport, Papua
Republic of Indonesia**

9 April 2009

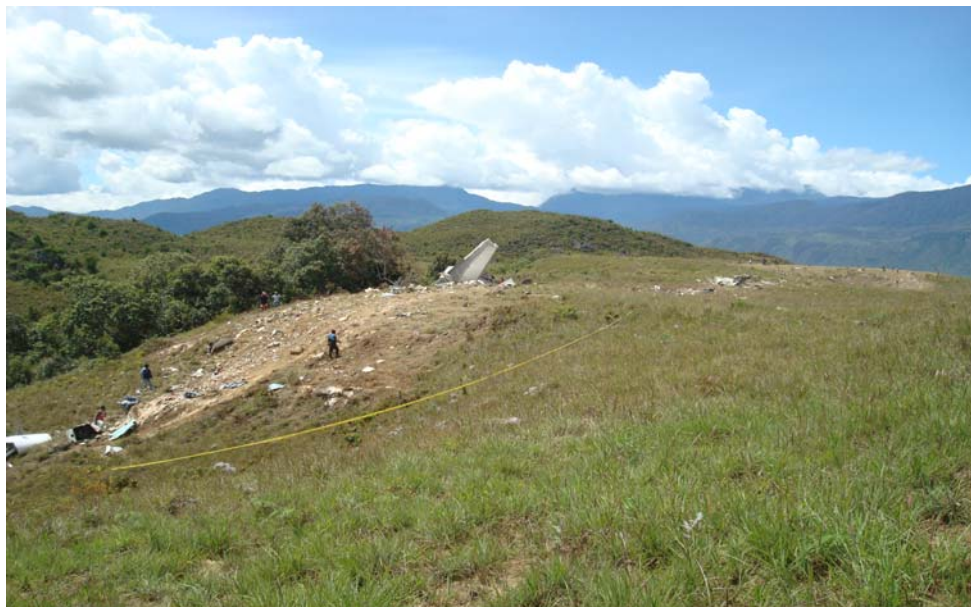
Figure 1: PK-BRD initial impact location

During the manoeuvre for the second landing approach, the aircraft impacted Pikei Hill³ on Tengah Mountain, 3.55 NM to the north west of Wamena Airport at 0743 local time, (2243 Coordinated Universal Time (UTC⁴)). The aircraft was destroyed and the occupants were fatally injured.

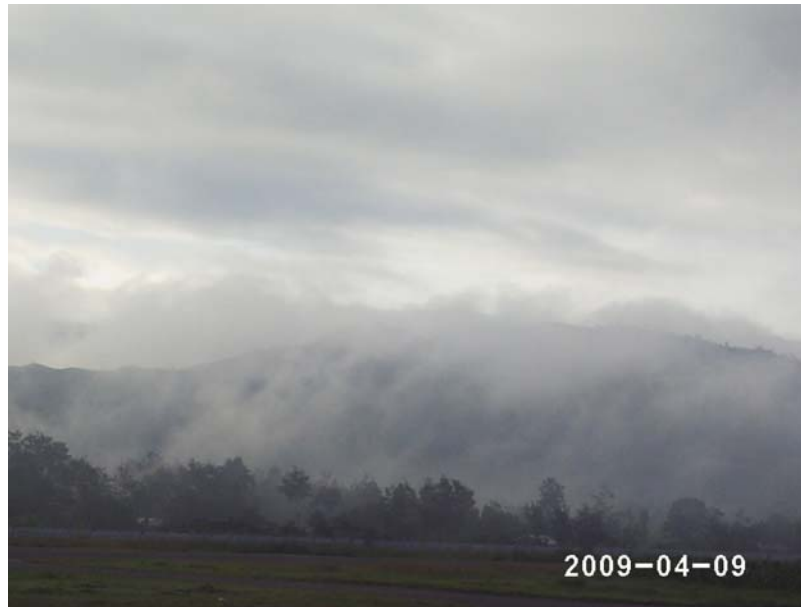
Figure 2: View of weather taken from the Wamena Airport shortly after the accident

The meteorological report for takeoff and landing issued at 2300 (26 minutes after the accident) indicated that the wind was calm, visibility was 9 km. There was haze and broken cloud; base 300 meters. Temperature was 18 degrees C and the QNH 1010.3 hPa.

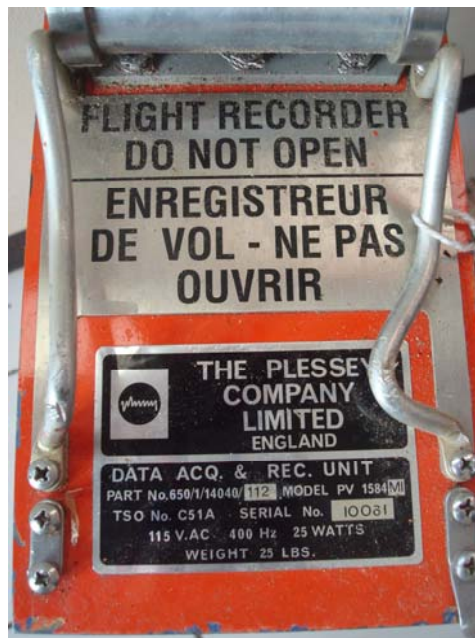
Figure 3: Data plate on Flight Data Recorder from PK-BRD

The FDR tape was not spooled correctly, presumably since previous maintenance on the recorder. However, good quality data was recovered.

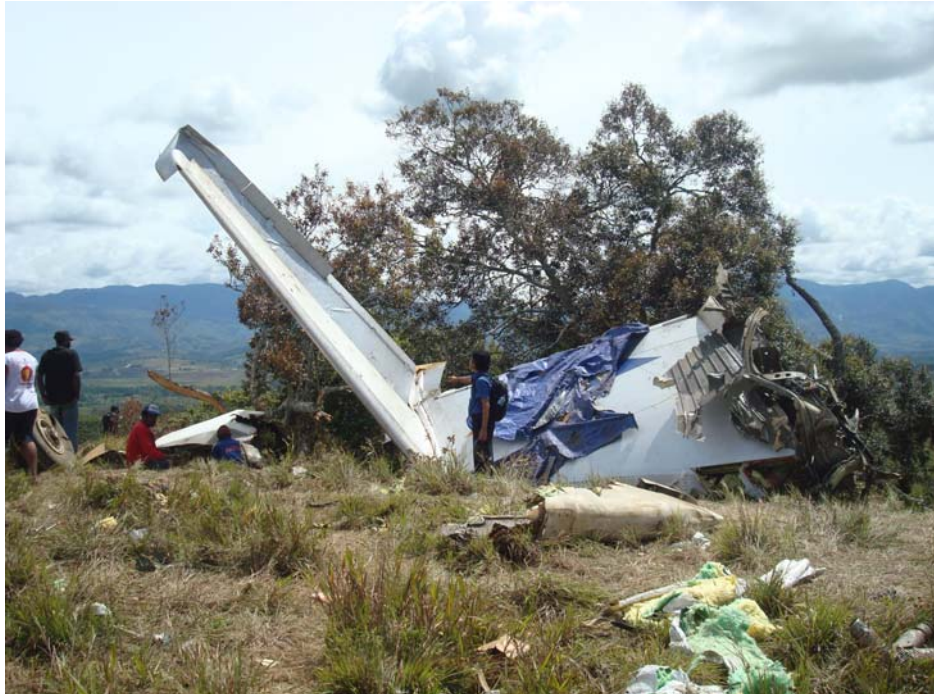
Figure 5: Empennage section of PK-BRD

The impact site was located 3.55 NM to the north west of Wamena Airport. The aircraft was destroyed by the impact forces and the post-impact fuel-fed fire. The wreckage was distributed in the general direction of the last recorded heading of the aircraft prior to its impact with terrain.
