# **AIRCRAFT ACCIDENT FINAL REPORT**

**AIRBUS A 300 B4, F-BVGK**

**SANA'A AIRPORT (YEMEN ARAB REPUBLIC)**

**MARCH 17, 1982**

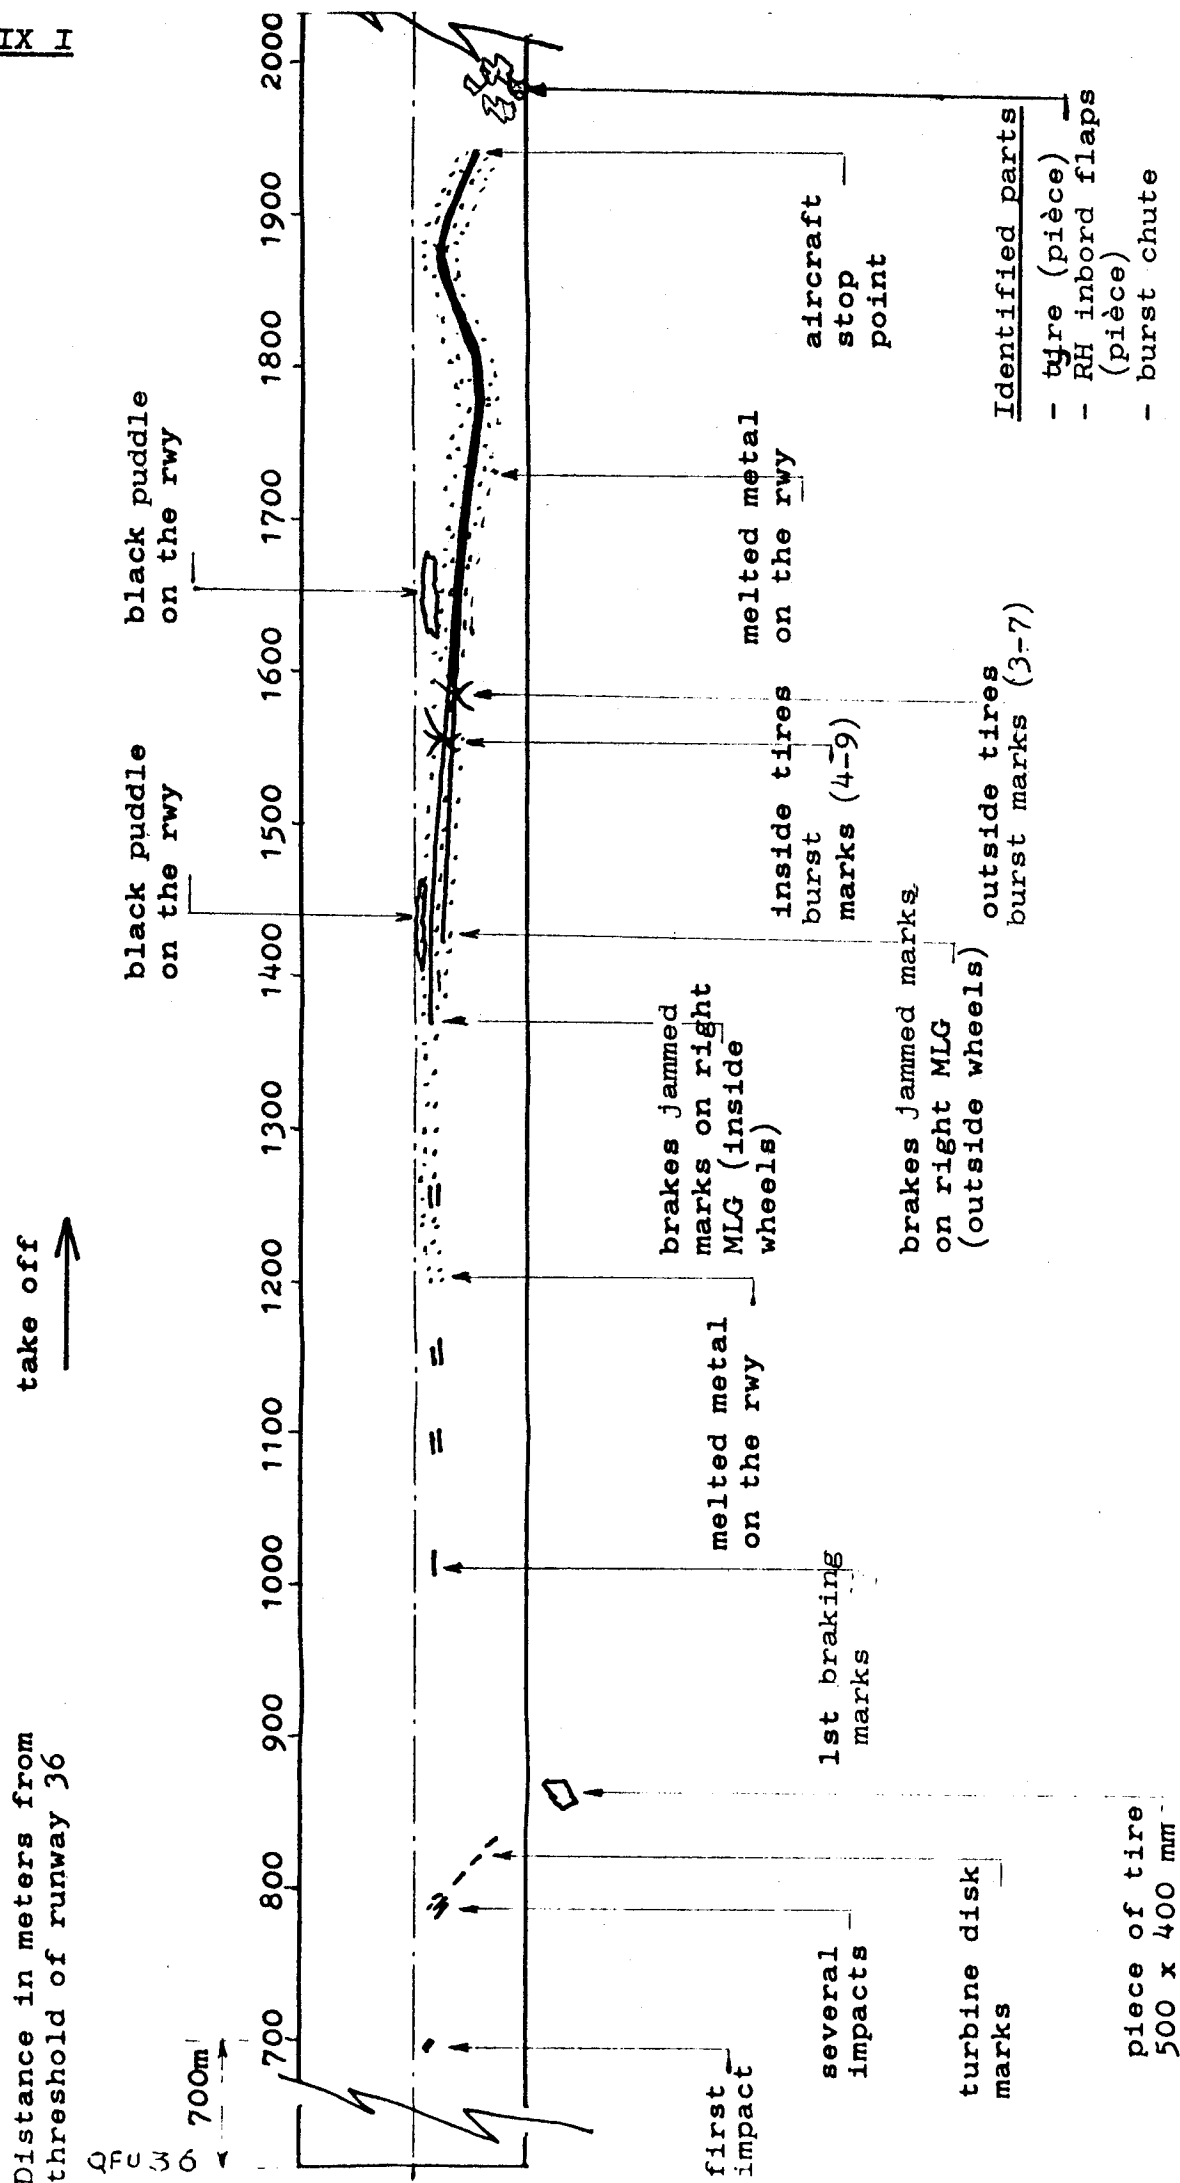
DIAGRAM OF MARKS ON THE RUNWAY

The runway sustained minor damage : the asphalt was burnt at several places, and many metallic components were spread over the bitumen and stuck into the runway.
