FINAL
KNKT.11.12.31.04

NATIONAL TRANSPORTATION SAFETY COMMITTEE

Runway Excursion Investigation Report

PT. Sriwijaya Air
Boeing 737-200; PK-CJD
Sultan Mahmud Badarudin II Airport,
Palembang, Sumatera Selatan,
Republic of Indonesia
24 December 2011

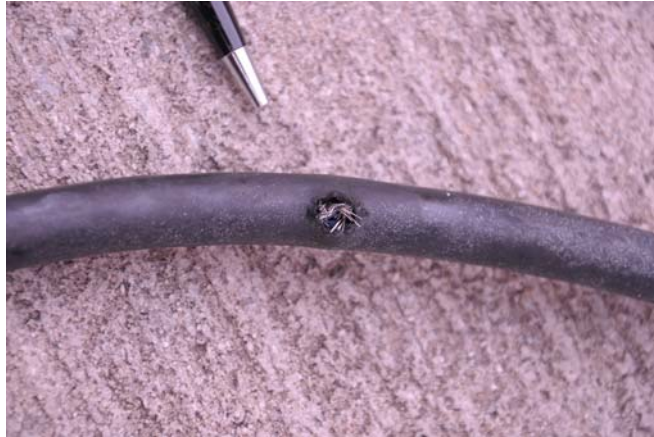
There was no substantial damage to the aircraft except the Hydraulic Hose of RH MLG up-lock actuator at the “Lock Port” position was leak.

Figure 1: Hydraulic Hose shows burst at middle position

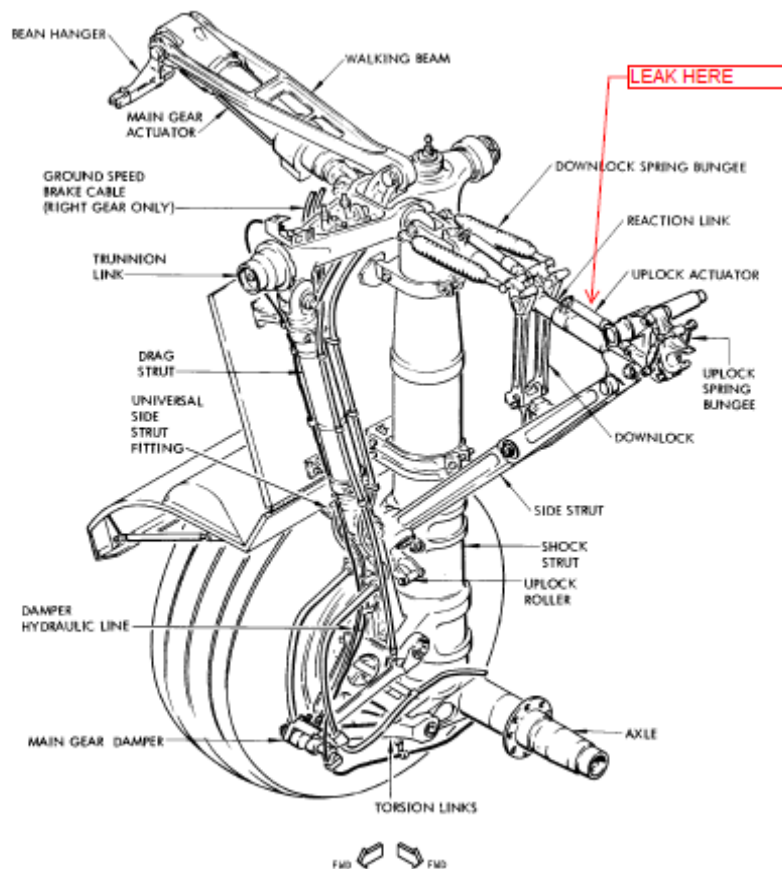
Engineer checked the aircraft and found the Hydraulic Hose of RH MLG up-lock actuator at the "Lock Port" position was leak.

Figure 2: Leak Position on RH MLG

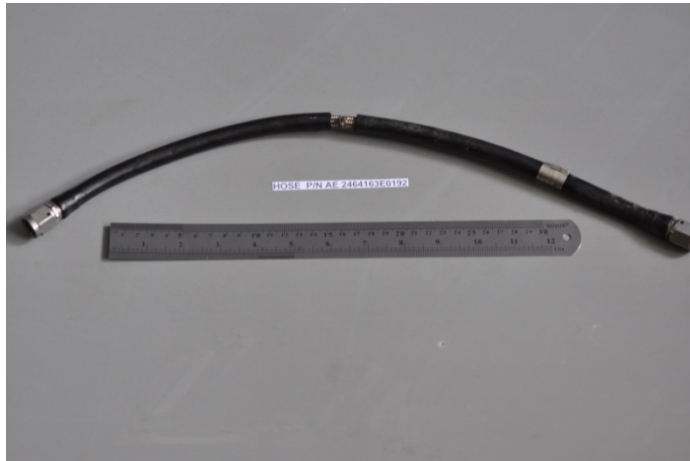
Figure 7: The hose shows damage in the middle

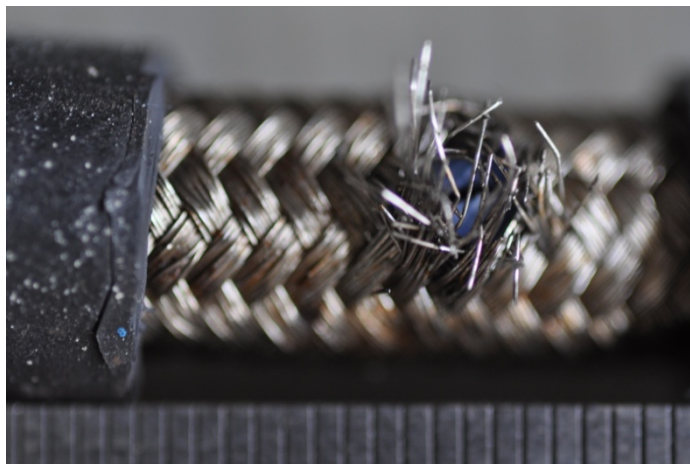
Figure 8: The external rubber was peeled to expose the wire mesh and internal hose

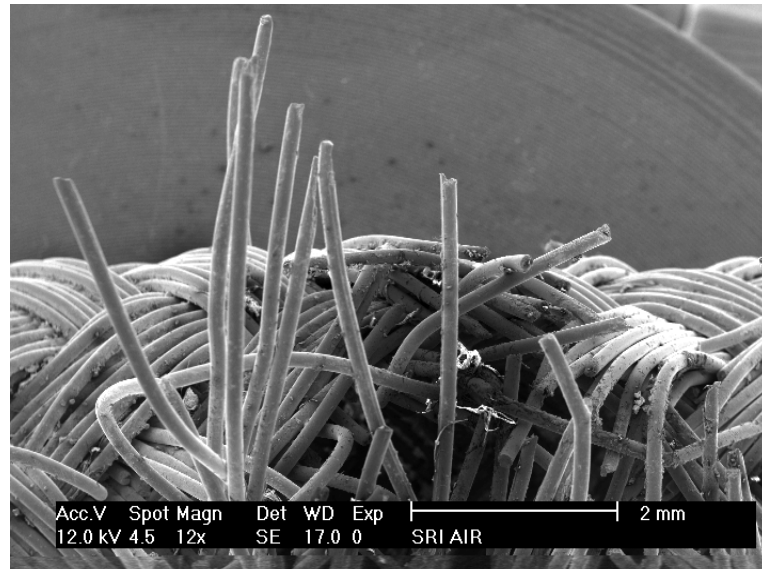
Figure 9: Fracture wire mesh at the burst area

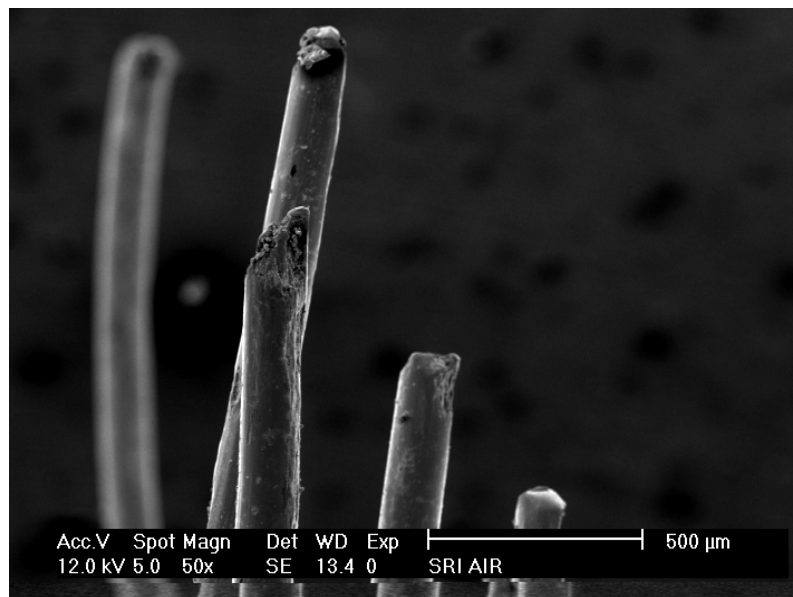
Figure 10: Detail fractures tip

Static fracture characteristics due to tensile load: deformation and an angle of 45 °.

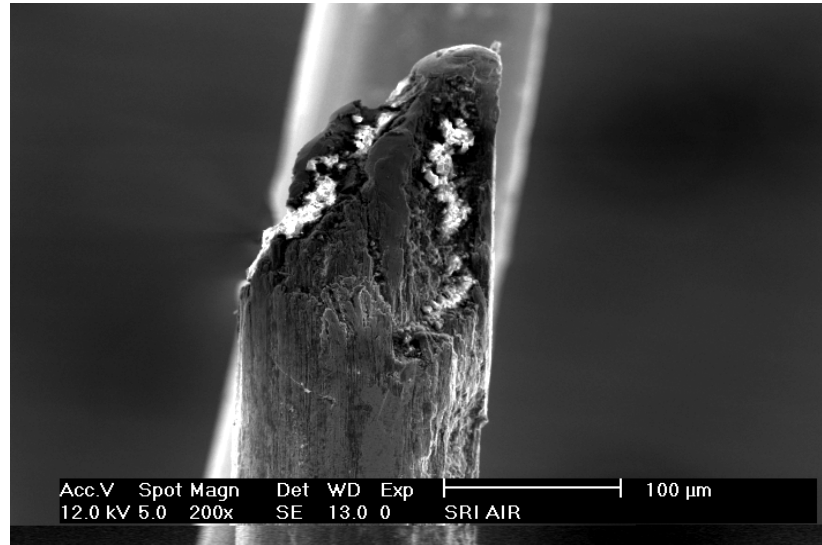
Figure 11: Static fracture characteristics due to tensile load (the deformation with an angle of 45°)

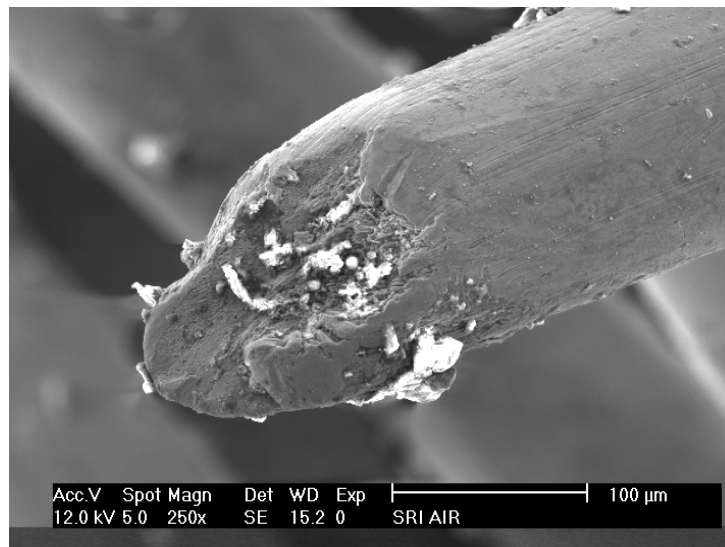
Figure 12: Static fracture characteristics due to tensile load (the deformation with an angle of 45°)

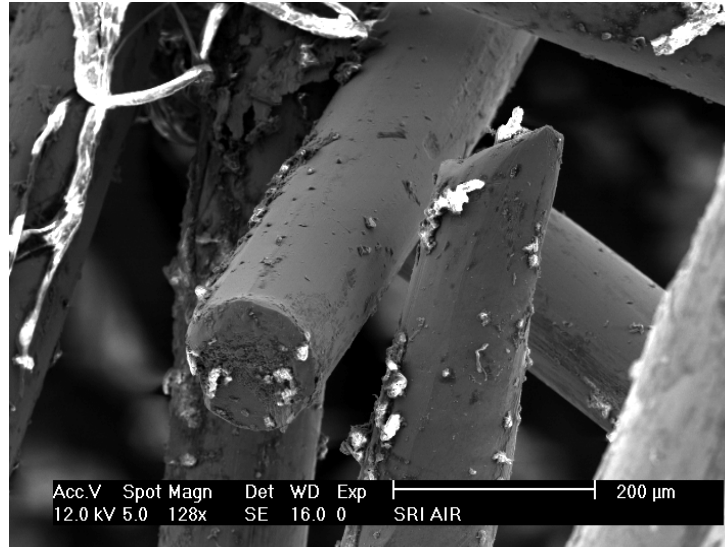
Figure 13: Fatigue fracture characteristic (no deformation and the 90° fracture)

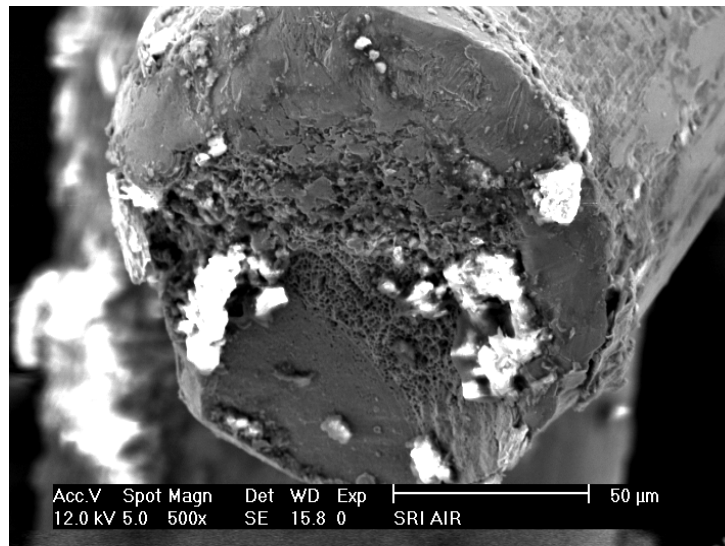
Figure 14: Fatigue fracture characteristic (no deformation and the 90° fracture). The initial fatigue crack is at the bottom part of the wire

As a result of repetitive load of hydraulic operation at the hose and the present of fretting defects due to hose vibration, some wires mesh were fracture because of fatigue. Since there were wires mesh fractures at that location, the integrity of the hose become weak and finally burst. The sudden burst indicated by the presence of deformation on the wires and fractures tip angle about 45°. The hose vibration also led wire broken despite the broken wire was not in burst location.

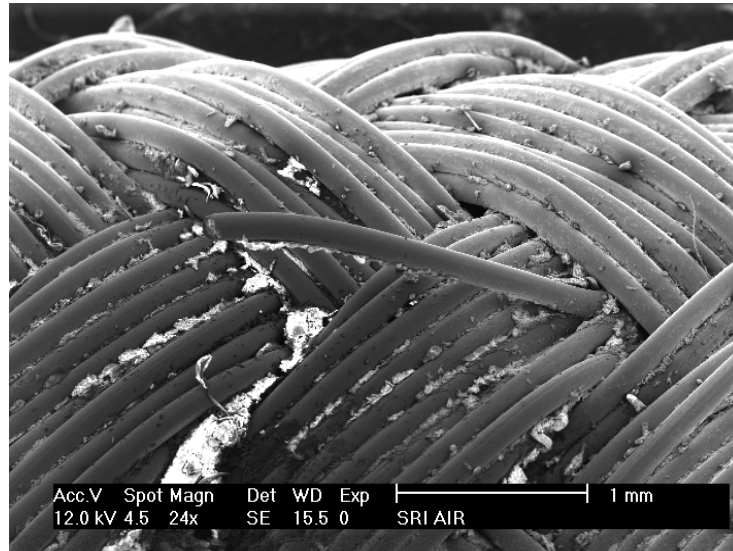
Figure 15: One wire was fatigue fracture at other location near the burst area

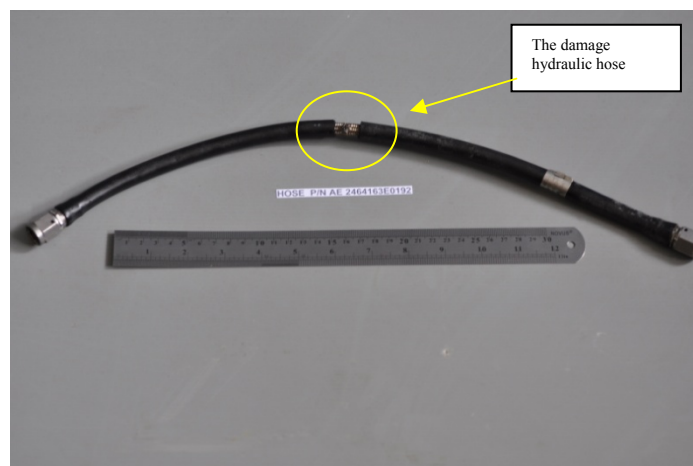
The damage component Hydraulic Hose P/N AE2464163E0192 taken from PK-CJD on 24 December 2011 was part of hydraulic system A and the operating pressure inside the hose was 3000 psi.

Figure 17: The damage hydraulic hose

The burst of the hydraulic hose is likely due to fatigue mode initiated by fretting damage on the wire mesh as a result of vibration.

The defective hydraulic hose was most likely consistent with fatigue mode initiated by fretting damage on the wire mesh as a result of vibration, and it could be happen again to the other similar aircrafts as such, The NTSC recommends that the DGCA has to oversight this recommendation implementation.

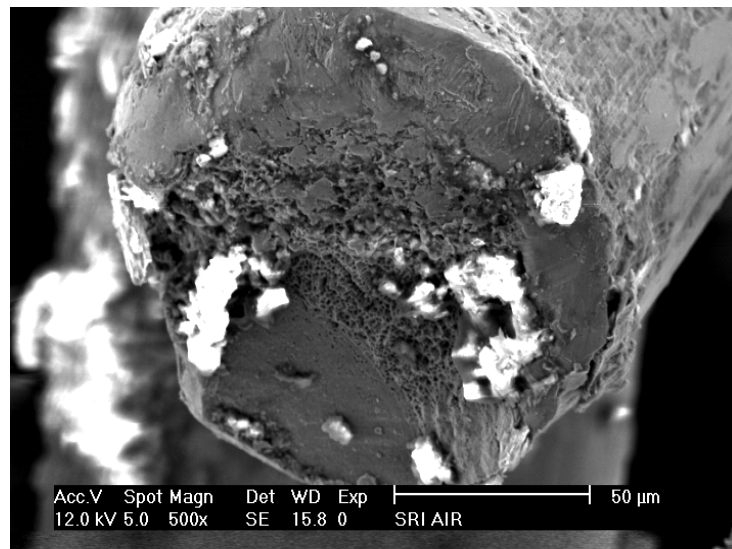
Fatigue fracture characteristic (no deformation and the 90° fracture). The initial fatigue crack is at the bottom part of the wire as shown on the figure bellow.

Figure 19: Shows the initial crack

Fatigue fracture characteristic (no deformation and the 90° fracture). The initial fatigue crack is at the bottom part of the wire.

As a result of repetitive load of hydraulic operation at the hose and the present of fretting defects were due to;

- Most probably frequent Hose vibration.
- Some wires mesh were fracture because of fatigue. Since there were wires mesh fractures at that location, the integrity of the hose become weak and finally burst. The sudden burst indicated by the presence of deformation on the wires and fractures tip angle about 45°.
- The hose vibration also led wire broken despite the broken wire was not in burst location.
