**FINAL**  
KNKT.13.08.22.04

# NATIONAL TRANSPORTATION SAFETY COMMITTEE

**Aircraft Serious Incident Investigation Report**

**PT. Lion Mentari Airlines (Lion Air)  
Boeing 737-800; PK-LKH  
Djalaluddin Airport, Gorontalo  
Republic of Indonesia  
6 August 2013**

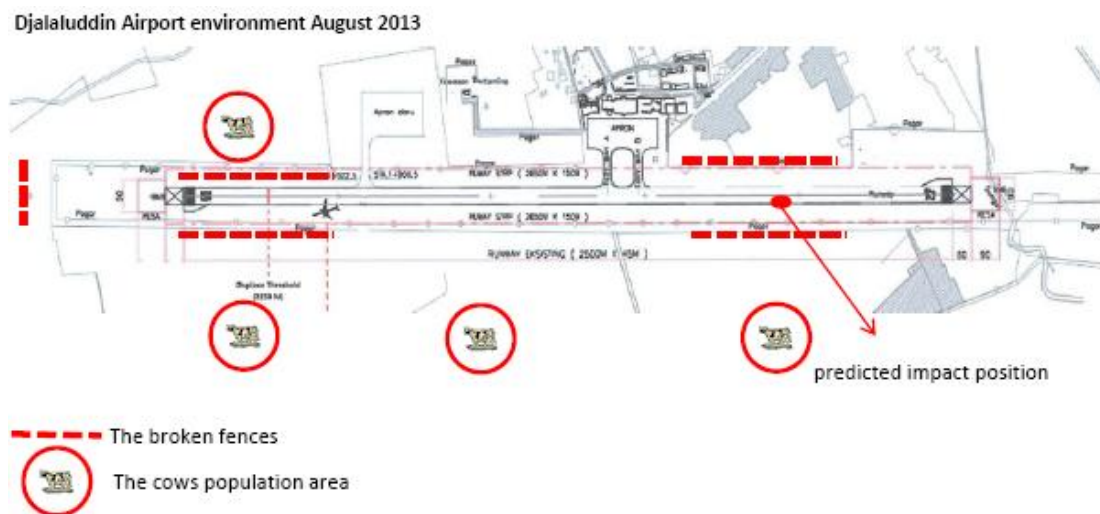
Figure 1. The fences condition and cow population at Djalaluddin Airport on August 2013

- Some fences on the north and south of the runway about 500 meters long were broken and some parts were not installed with the fences.
- The people who living around the airport might enter the airport perimeter and while sometimes might cross the runway through the broken fences.
- Hundreds population of cows were grew and live just outside the airport perimeter, especially along the south of runway.
- The airport management has Bird and animal hazard management as stated in the Aerodrome Manual chapter 4.12.
- The audit by The Directorate of Airport dated 11 July 2013 number: 016/DBU-IK/VII/2013 found that some airport perimeter fences broken and accessible that may increase the wildlife hazard. The investigation could not find any evidence of corrective action program.

The airport layout shows the broken fences and cow's population places are shown in the figure below in the red dash lines and red circles.

The investigation could not find any evidence of corrective action program following the aforesaid audit findings. This was consistent with the observation during the investigation, where some fences at the north and south of the runway about 500 meters long were broken and some parts were not installed with the fences.

- The broken fence that accessible for the animal, person, vehicle to the runway is classified as an extremely hazard. If such condition exists, it is recommended to promptly correcting.
- To ensure the Aerodrome Manual especially chapter 4.12 subject: wildlife hazard management is well implemented.

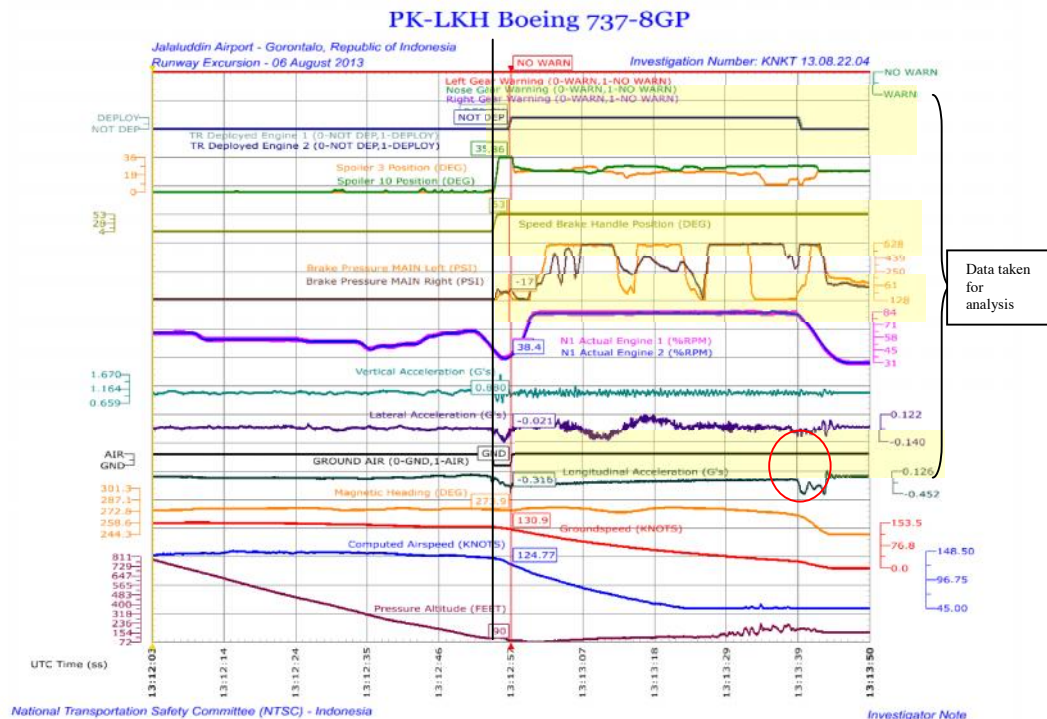
Figure 2. FDR data

- The spoilers, reversers were applied after touchdown.
- The longitudinal acceleration at initial aircraft touchdown was -0.316 G/sec than was gradually reduced to approximate 0.200 when stop.
- And the initial activation, the right brake pressure was indicated 439psi while the left brake was indicated 628psi.

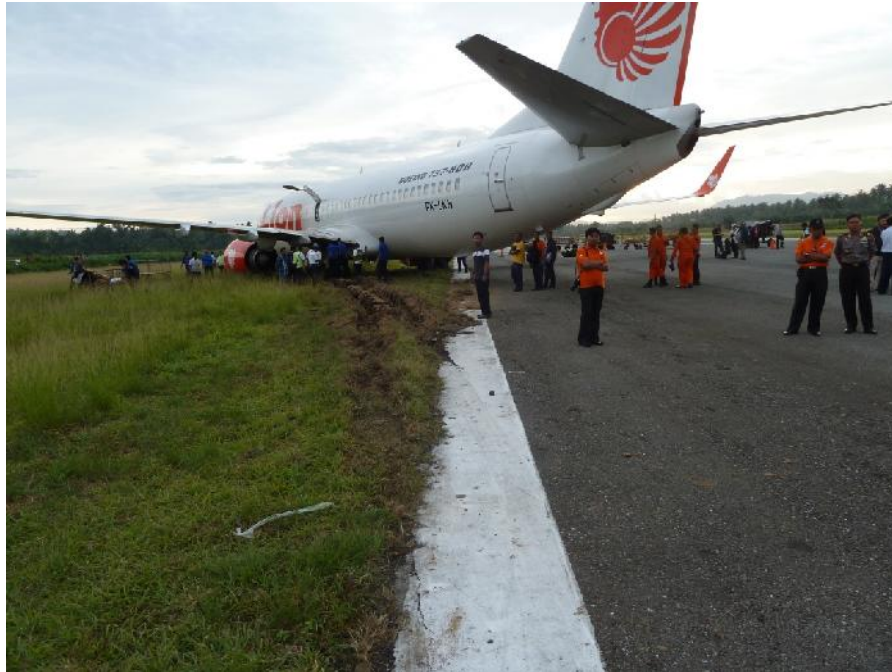
Figure 3. The aircraft out of the runway

Afterward, the pilots felt ineffective of brake respond and then the aircraft veered off to the left and trapped on the left side of the runway shoulder at about 2,100 meters from the beginning of runway 27.

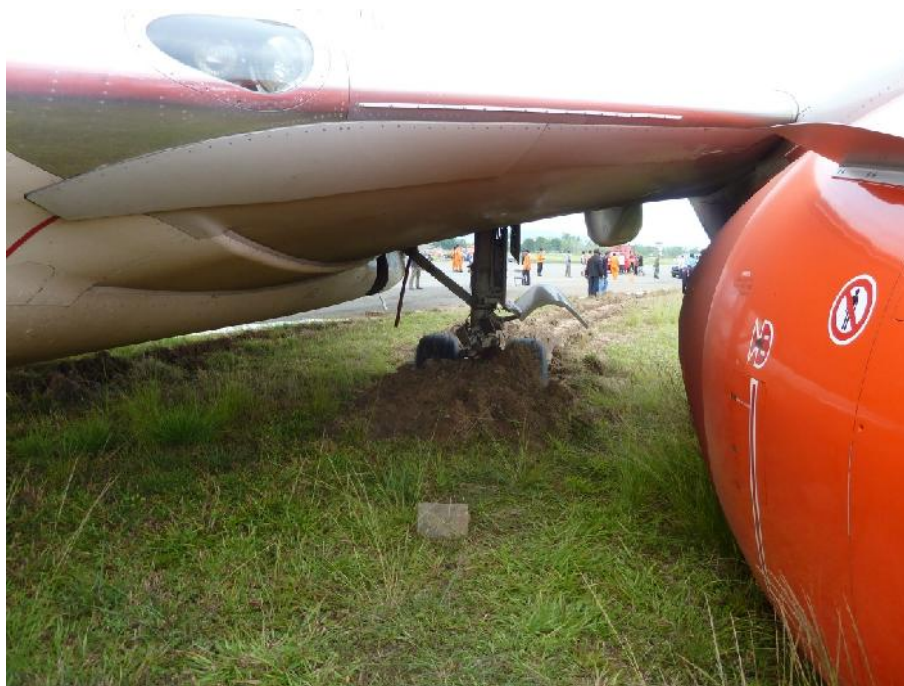
Figure 4. The aircraft wheels trapped on the shoulder

- i. The strength of the shoulder could not support when the aircraft run off the runway.
- j. The people living around the Airport, enters the Airport perimeter and sometimes cross the runway through the broken fences.
