AI2011-3

**AIRCRAFT SERIOUS INCIDENT
INVESTIGATION REPORT**

Japan Transport Safety Board

**KOREAN AIR
AIRBUS INDUSTRY A300B4-600R, HL7240
AT AN ALTITUDE OF APPROXIMATELY 33,000 FT, OVER THE
VICINITY OF HIKARI CITY, YAMAGUCHI PREFECTURE,
JAPAN
AT ABOUT 19:36 JST, JUNE 23, 2009**

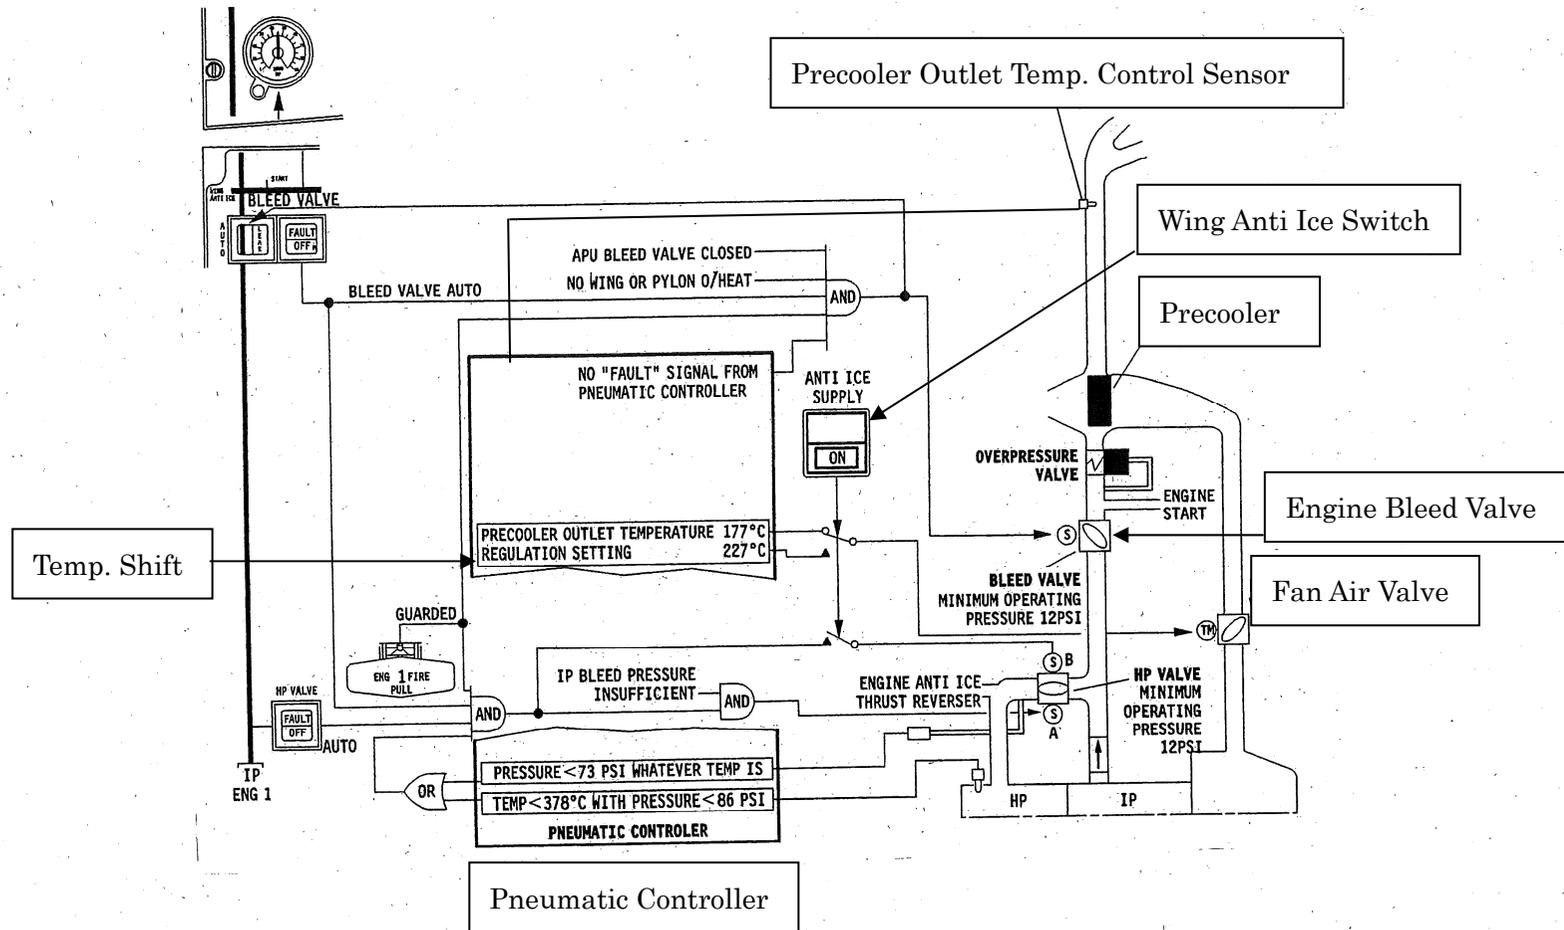
Figure 6 Fan Air Valve Control

- (2) It is considered highly probable that the reason why the “ENG BLEED 2 FAULT” message was displayed on the ECAM is, as suggested by the inspection results in 2.12, that the failure of the No. 2 pneumatic controller on temperature shift made the No. 2 engine bleed valve closed. At the same time, as the manufacturer of the Aircraft stated in 2.14 (4), it is considered somewhat likely that the bleed valve closed as a result of detection of overheating.

Temp. Shift by Pneumatic Controller :

- When Wing Anti Ice OFF : $177 \pm 12^\circ\text{C}$
- When Wing Anti Ice ON or Air Bleed One system OFF : $227 \pm 12^\circ\text{C}$

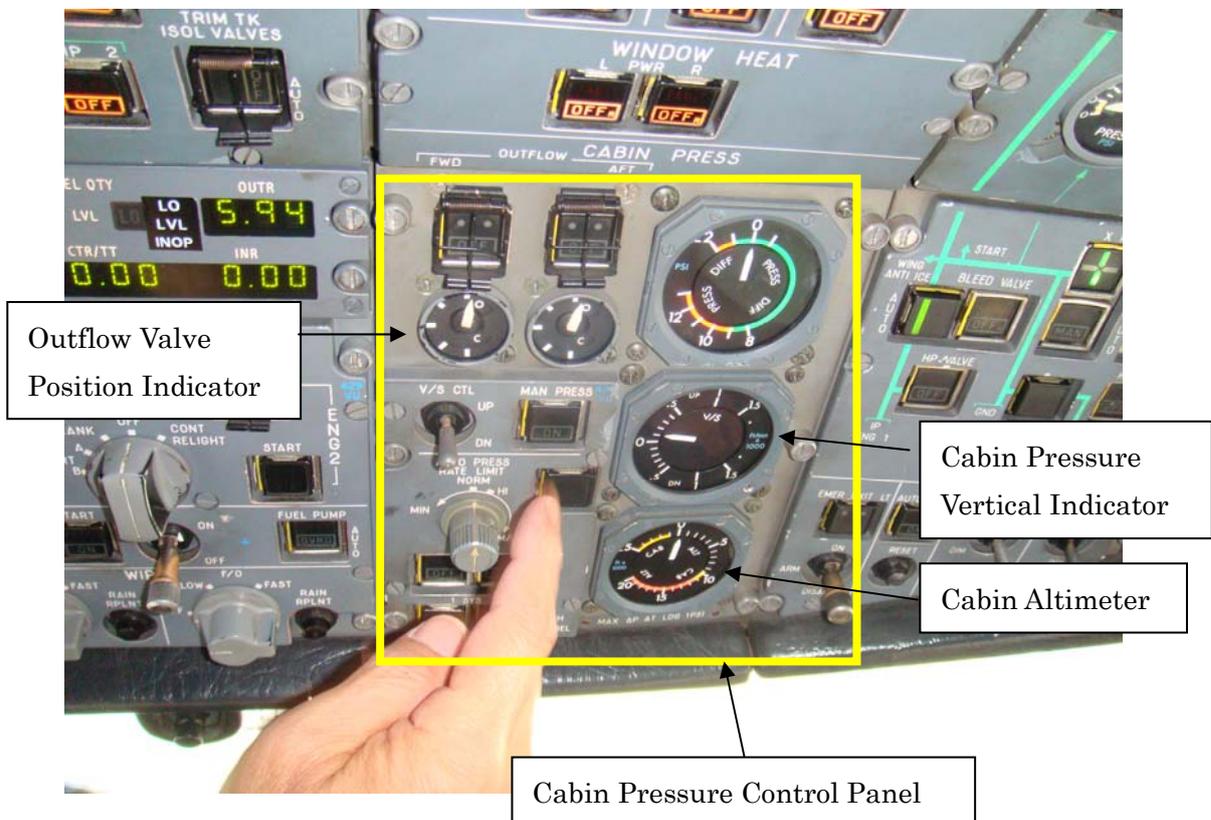
Photo 4 Cabin Pressure Control Panel

descent, the Aircraft's cabin pressurization system returned to normal. Subsequent inspections at Chubu Centrair International Airport and in Korea found no faults in the open/close control system of the outflow valves. The cause of the full-open display of the outflow valves could not be ascertained.

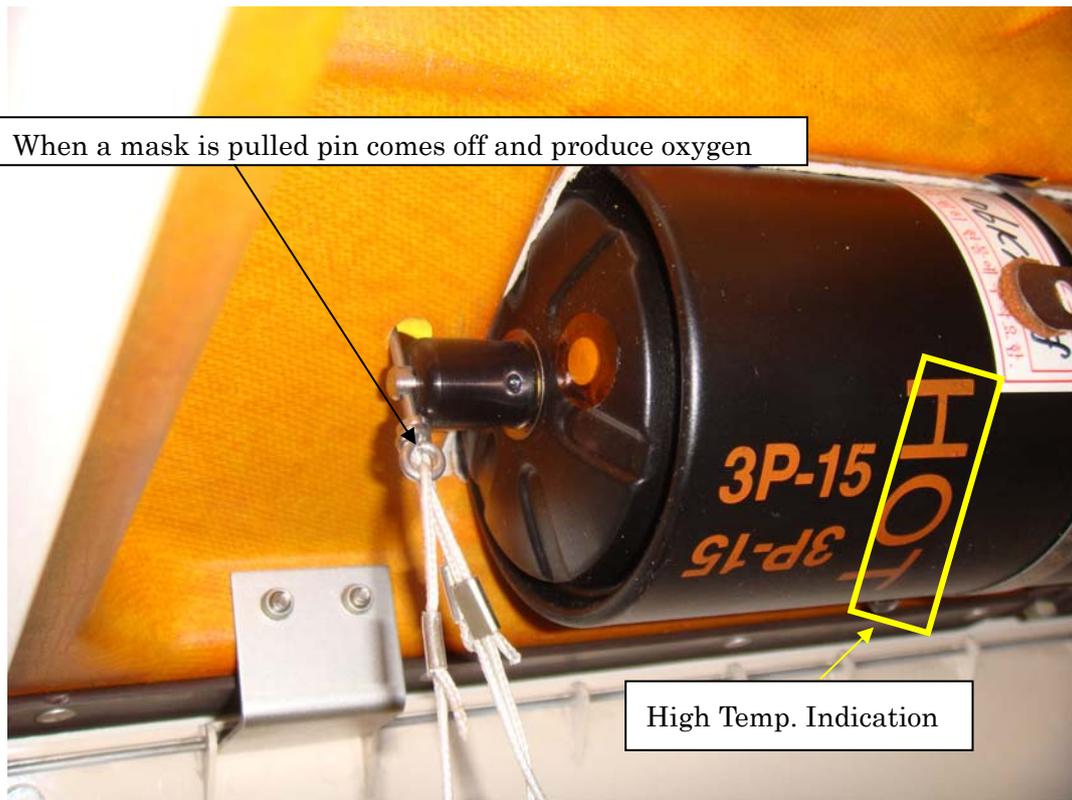
Photo 7 Cabin Oxygen Generation Equipment

One passenger had a headache and was feeling "a little dizzy." This passenger was given a portable oxygen bottle and a cabin attendant sat next to him/her. The second passenger had suffered slight burns on his/her fingers after touching a hot part of the oxygen generator. A glass of water and ice was provided to this passenger in which to dip and cool the affected fingers. This passenger said that he/she did not need any adhesive bandage. When these passengers disembarked, they said they were all right and did not need any further care.

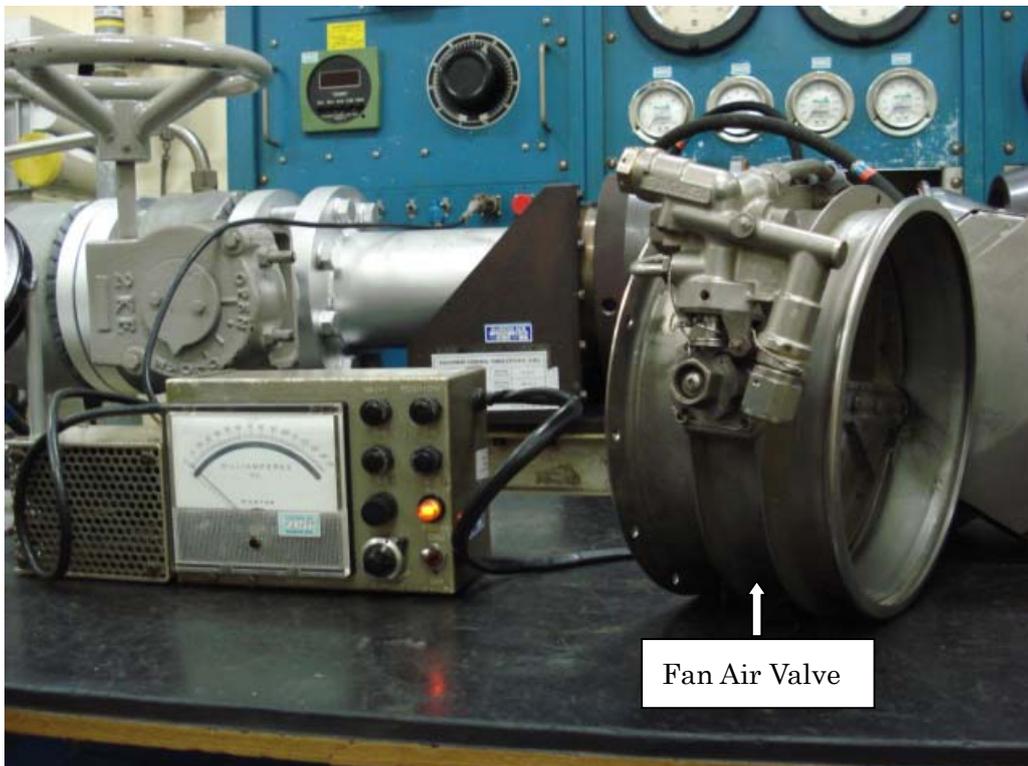
Photo 8 Fan Air Valve

- ① There was no external damage to the receptacle pins.
- ② The valve position light on the control box did not illuminate when the fan air valve butterfly was moved from the "close position" to the "open position."
- ③ Continuity test on the position switch revealed intermittent loss of continuity at Pin C *¹¹.
- ④ When the compound was removed from the connector, a slight gap was found in the weld of Pin C.
- ⑤ There were traces of arcing caused by the poor weld of Pin C.

Based on the above, it was determined that poor continuity caused by the poor weld of Pin C contributed to the display of the "BLEED FAULT" message in the cockpit.

- (1) The “ENG BLEED 1 FAULT” message was displayed on the ECAM soon after the wing anti-ice system was turned on. As described in 2.12, poor welding was found on a connector pin of the No. 1 fan air valve. It is therefore considered highly probable that this poor welding caused the failure of the temperature shift function, which would have changed the temperature setting of the pre-cooler outlet from 177°C to 227°C when the wing anti-ice system was turned on, making the No. 1 engine bleed valve closed, and resulted in displaying of the message on the ECAM. At the same time, as the manufacturer of the Aircraft stated in 2.14 (4), it is considered somewhat likely that the bleed valve closed as a result of detection of overheating.
