**AIRCRAFT ACCIDENT
INVESTIGATION REPORT**

KOREAN AIR LINES CO, LTD.

H L 7 4 7 3

PASSENGER INJURY BY THE SHAKING OF THE AIRCRAFT KOREAN AIR LINES CO, LTD. BOEING 747-400, HL7473 (THE REPUBLIC OF KOREA) AT AN ALTITUDE OF APPROX. 22,000 FT, ABOUT 160KM NORTH-NORTHEAST OF TOKYO INTERNATIONAL AIRPORT AT 20:30 LOCAL TIME, JULY 5, 2012

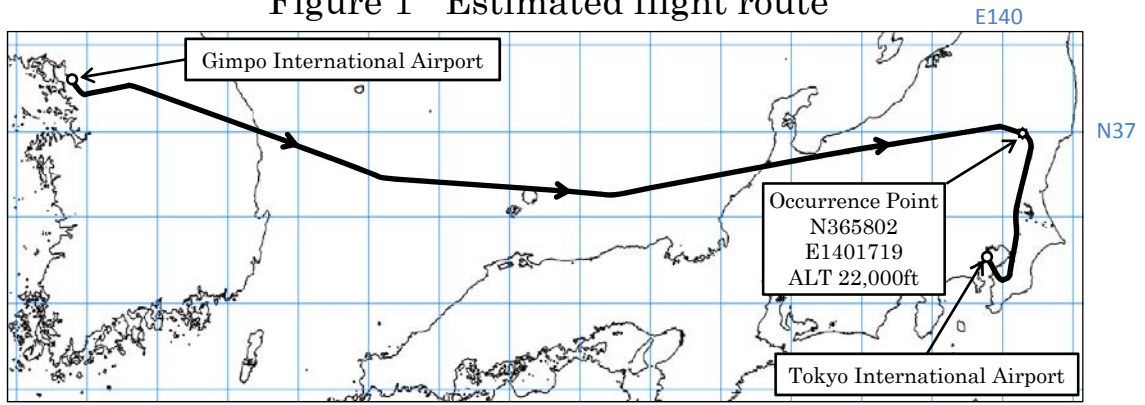
Figure 1 Estimated flight route

The accident occurred around 20:30 at an altitude of approximate 22,000 ft (6,700 m) about 160 km north-northeast of Tokyo International Airport (Latitude 36°58'02" N and Longitude 140°17'19" E). (See Figure 1 and 2)

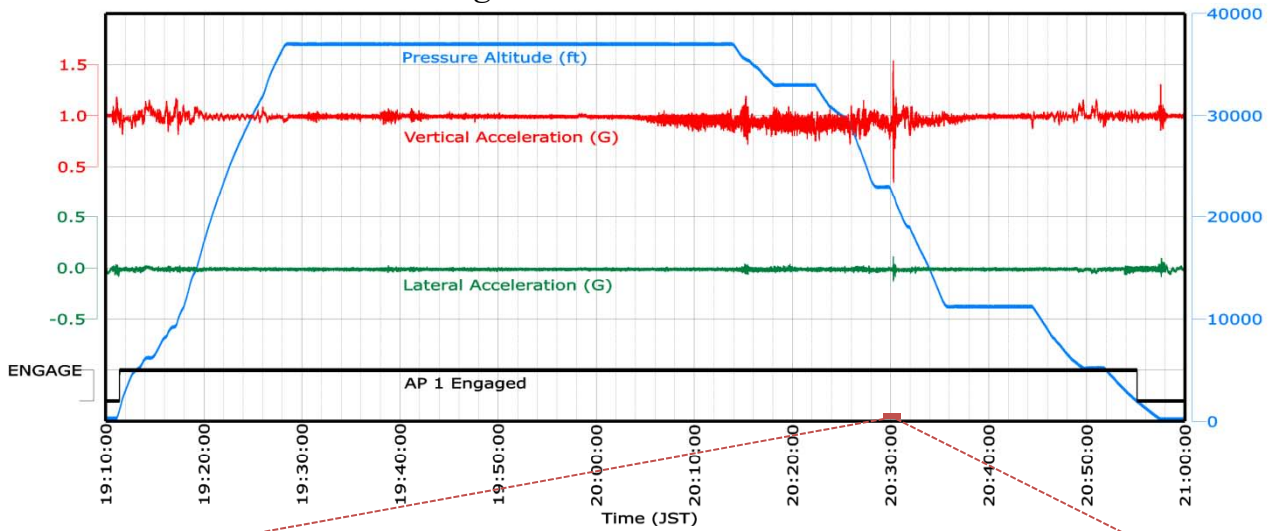
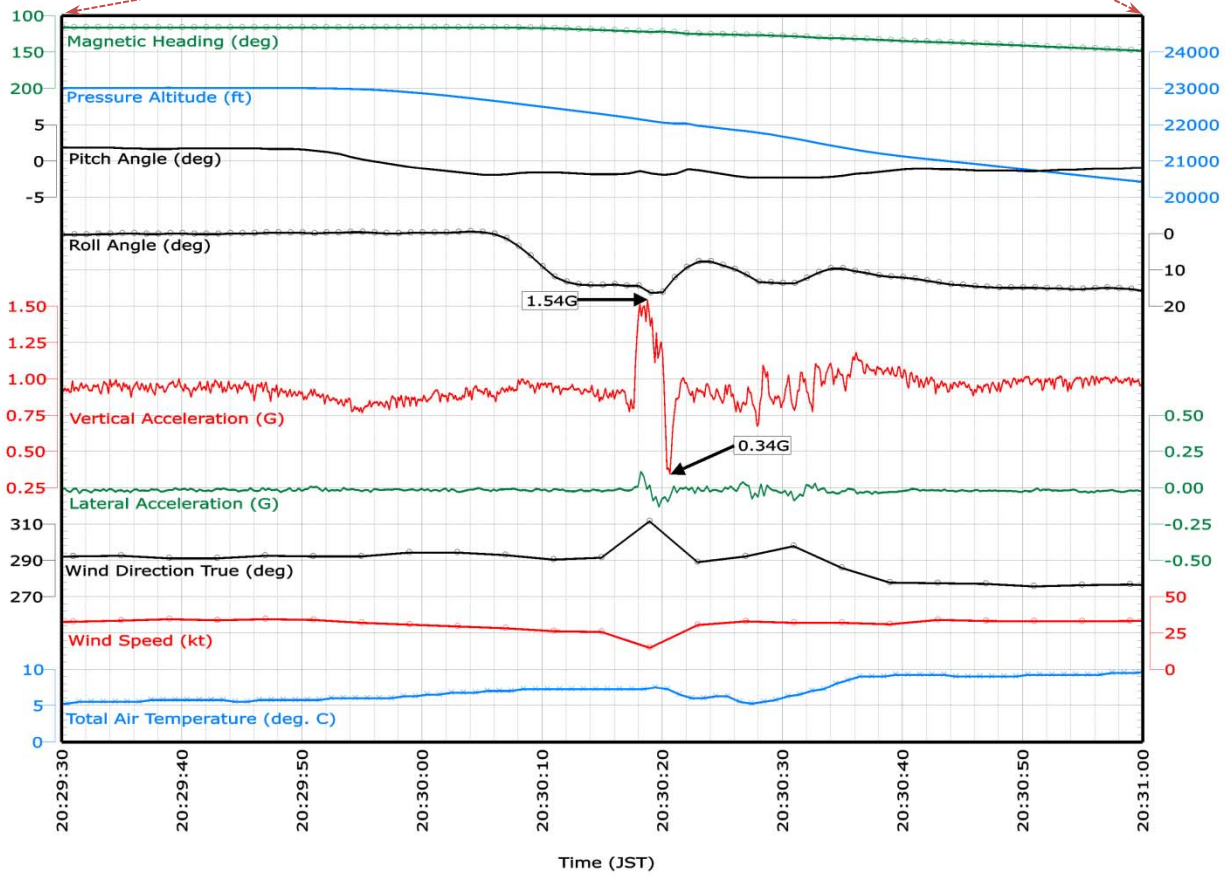
Figure 2 DFDR Records

3.1 Involvement of Weather	Yes
3.2 Involvement of Pilots	None
3.3 Involvement of Airplane	None
3.4 Analysis of Findings	<p>(1) In view of the history of the flight, it is highly probable that the sudden violent shaking of the aircraft corresponds to the sole significant change of the DFDR vertical acceleration data. During this shaking, a passenger standing in the aisle to go to the lavatory was thrown off-balance, bumped into the L4 door on his back, and fell on the floor.</p> <p>(2) According to the hourly analysis chart, the sporadic VWSs had been observed in the vicinity of the accident airspace; therefore, it is possible that factors related to the emergence of the turbulence existed there. According to the statements, no radar echo was observed on the onboard weather radar screen; however, the weather radar imagery by the Japan Meteorological Agency (JMA) showed emerging and enlarging echoes between 20:00 and 20:40, indicating the existence of atmospheric conditions where convective clouds could develop. Further, when the aircraft encountered a violent shaking, the DFDR recorded a</p>

<p>temporary quick change in the wind direction and velocity. Based on these findings, it is probable that the atmospheric conditions in the accident airspace were unstable enough to generate significant turbulence.</p> <p>(3) According to the statement, the descent from the cruising altitude was in VMC with light shaking and there was no echo on the weather radar display. Moreover, the turbulence information reported in the ATIS was the weather condition off the flight route. Furthermore the expected time for a significant turbulence had already passed. It is probable that the crew concluded that they were able to turn off the fasten seat-belt sign under these circumstances.</p> <p>(4) It is somewhat likely that the weather radar setting at that time could not allow detection of the developing clouds below the aircraft altitude.</p>
--	---

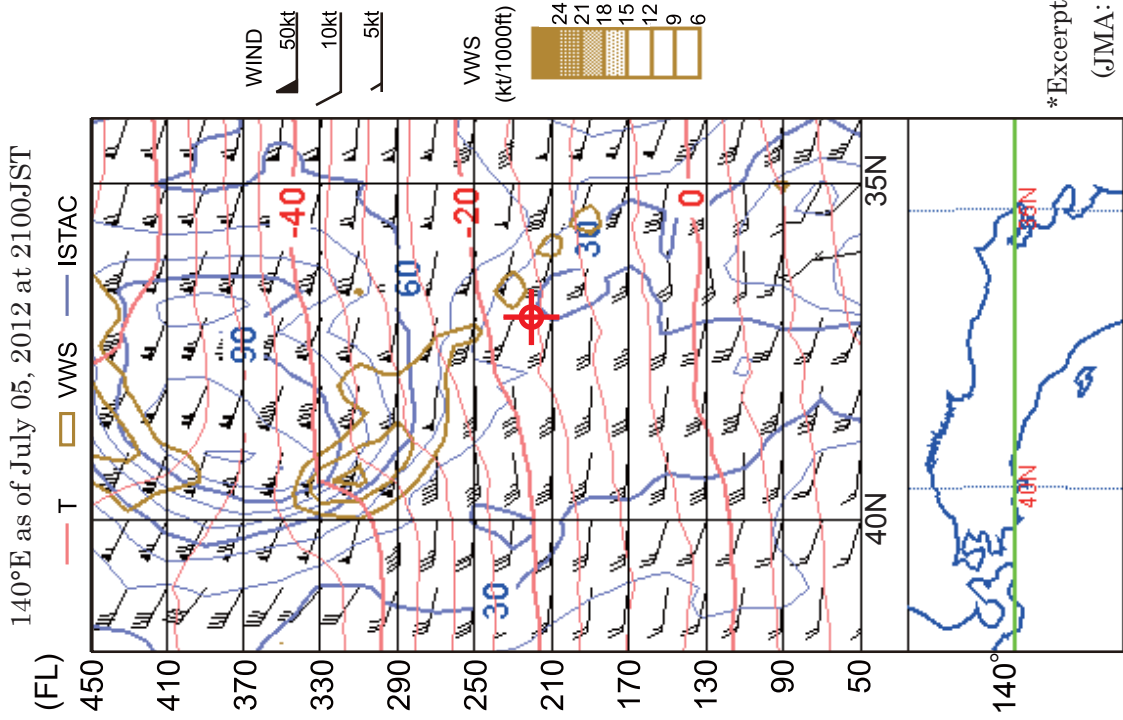
Figure 3 Hourly Analysis Chart
(vertical cross section)

<p>existed at altitudes 37,000-41,000 ft. At altitudes 23,000-26,000 ft, sporadic vertical wind shears (VWS) of 6-9 kts/1000 ft had been forecast.</p> <p>(3) Weather Radar Imagery (Strength and Top Height)</p> <p>According to the weather radar imagery before and after the accident time, no radar echo overlapped the accident airspace as of 20:00, but at 20:20, an echo with top heights of 20,000-30,000 ft and central strength of 80 mm/h overlapped the airspace. The area of the echo further expanded as of 20:40; however, there was no echo to the south where its future course extended.</p> <p>(4) According to the DFDR records, gradual changes in the wind direction and velocity showed a temporal quick wind fluctuation, around 20:30 by 20° in the direction and 10 kts in the velocity.</p> <p>(5) An in-cloud light-plus turbulence, which is weaker than a moderate one denoting shakings demanding attention for cabin walking had been observed regarding its flight route and filed as a PIREP (a weather-related pilot report).</p> <p>According to the PIC, the turbulence information he received from an automatic terminal information service (ATIS) was the weather condition at a point off its flight route: about 100 km south of Tokyo International Airport.</p> <p>(See Figure 2, 3 and 4)</p>
