# **AIRCRAFT SERIOUS INCIDENT INVESTIGATION REPORT**

**KOREAN AIR LINES CO., LTD.  
H L 7 5 9 9**

RUNWAY OVERRUNNING  
KOREAN AIR LINES CO., LTD.  
BOEING 737-900, HL7599  
ON RUNWAY 10 AT NIIGATA AIRPORT  
AT 19:42, AUGUST 5, 2013

January 9, 2015

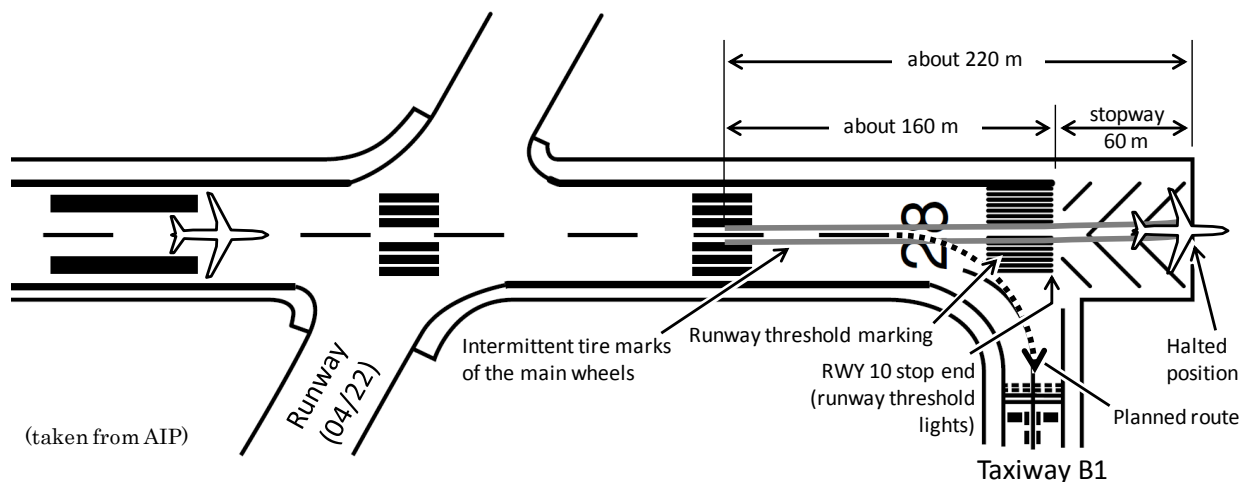
Figure B: Marks left on the runway

The main landing gears of the Aircraft were stayed at the stopway of about 58 m beyond the end of RWY 10, and the nose landing gear came to rest at the spot of about 75 m beyond the end of RWY 10 where was in the grass area. Tire marks in a light color of the main landing gear wheels were found in patches on the runway and the stopway for about 220 m (about 160 m on the runway). One stopway light and three approach lights for RWY 28 were damaged by hitting of the Aircraft wheels.

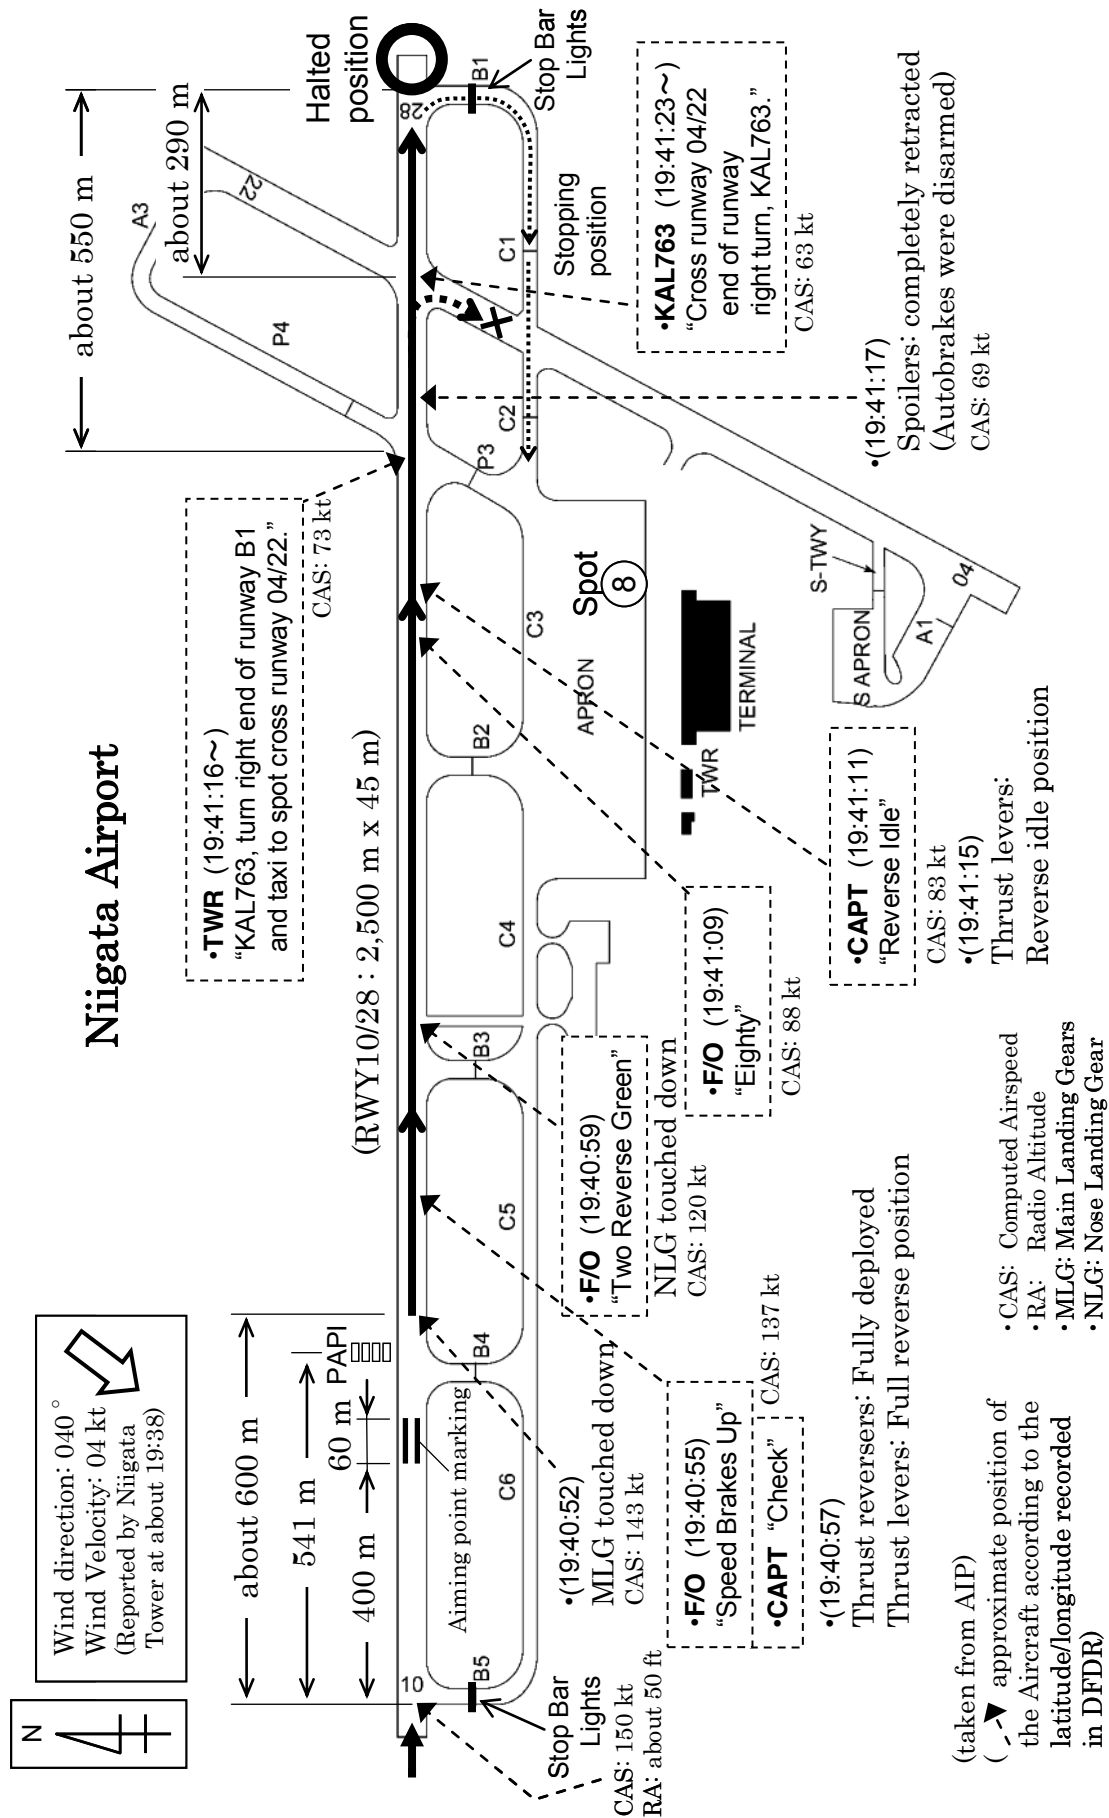
Figure 1 Estimated Landing Roll Diagram

At the time of the serious incident, the landing distance had been grown longer by some factors such as, not strong but light head wind, higher temperature in summer, down slope of the landing runway and heavy landing weight with a lot of fuel loaded, and others. The Captain should have considered the landing configuration of the Aircraft, while being aware of the operation of the speed brake lever which caused disarming the autobrakes and the following manual braking, and should have reduced speed in a proper manner corresponding to the available remaining distance of the runway.

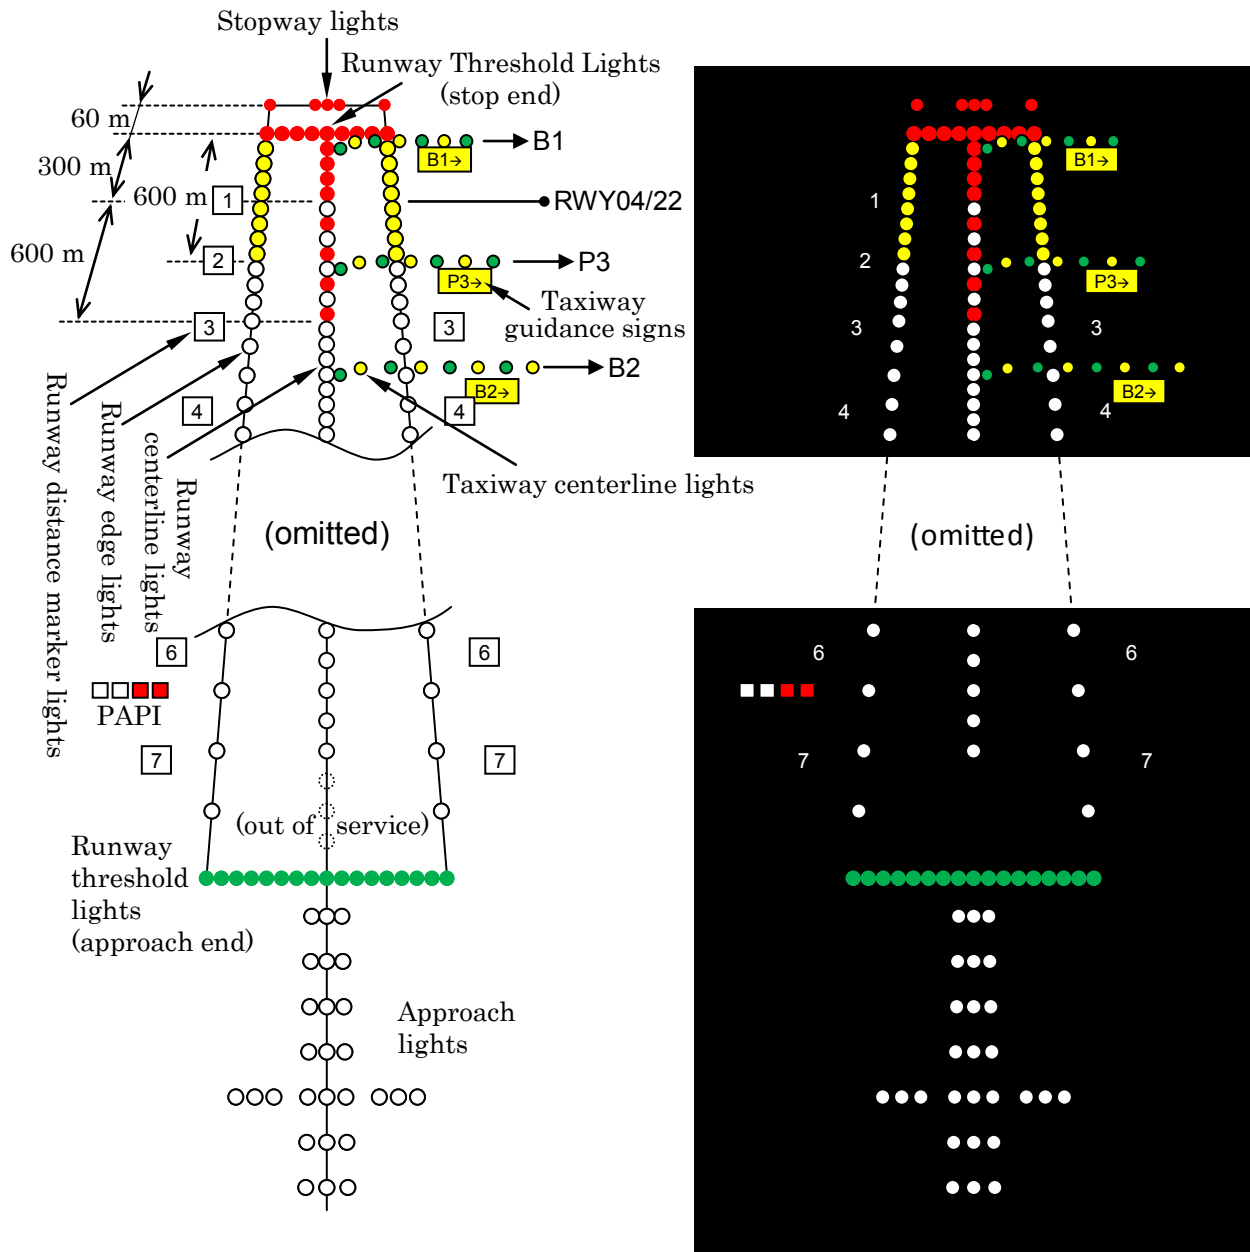
Figure 4 Actual Lighting Status on RWY 10  
at the Occurrence of the Serious Incident

The Captain stated that what he thought to be stop bar lights for RWY 04/22 were actually the runway threshold lights.

It is probable that the Captain and the F/O believed that they were short of the intersection of RWY 04/22 and understood the red lights (runway threshold lights ) that they observed ahead, as the stop bar lights in front of RWY 04/22, associated with the ATC instruction of “cross runway 04/22.”

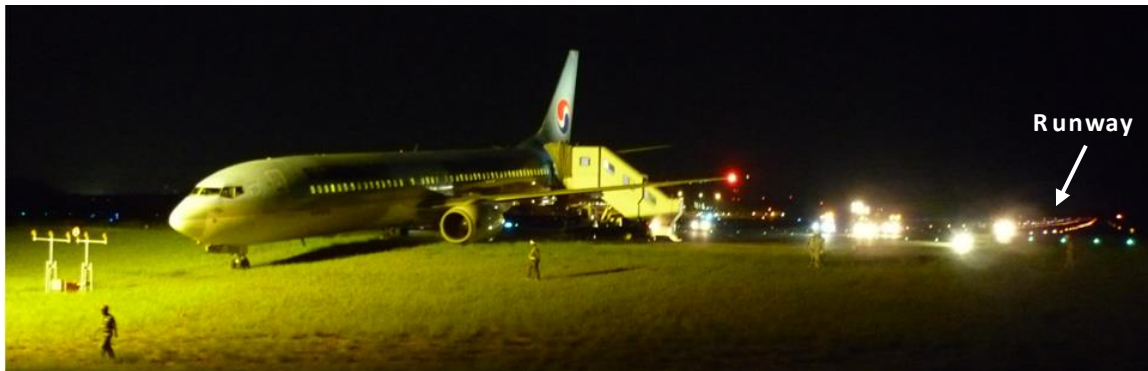
Photo 1 Serious Incident Aircraft

Upon checking the general external condition of the Aircraft, no damage was found on the aircraft, both main and nose landing gears (including the wheels and tires). The depth of tire grooves and the remaining brake pad amount were all within the allowable limits. Self-diagnosis for the anti-skid/auto brake control units was conducted, but no fault was found. Moreover, the thrust reverser operation check was conducted, but no anomaly was found.

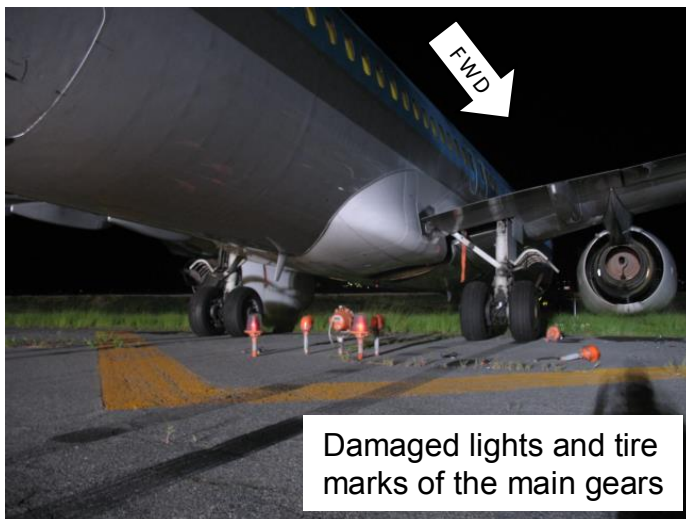
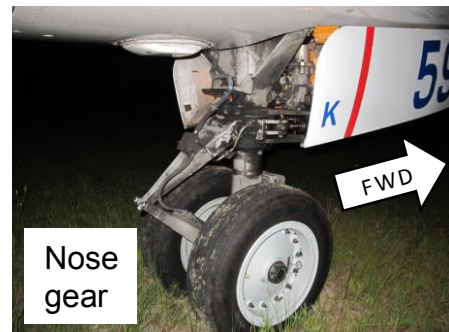
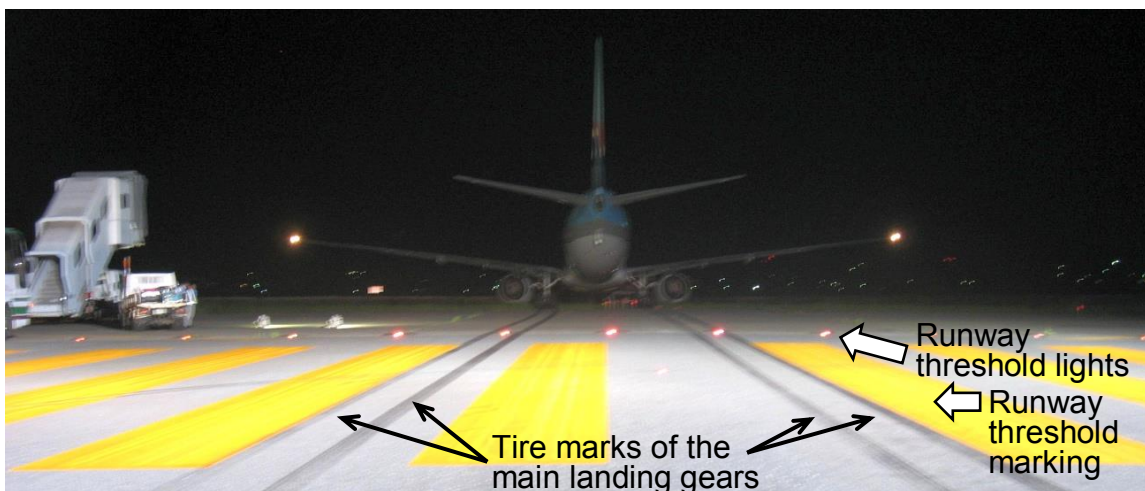
Photo 2 Serious Incident Site

- Three approach lights were damaged
- One overrun light was damaged
