AIRCRAFT SERIOUS INCIDENT INVESTIGATION REPORT

KOREAN AIR LINES CO.,LTD.(REPUBLIC OF KOREA)

BOEING 737-900

AKITA AIRPORT, JAPAN

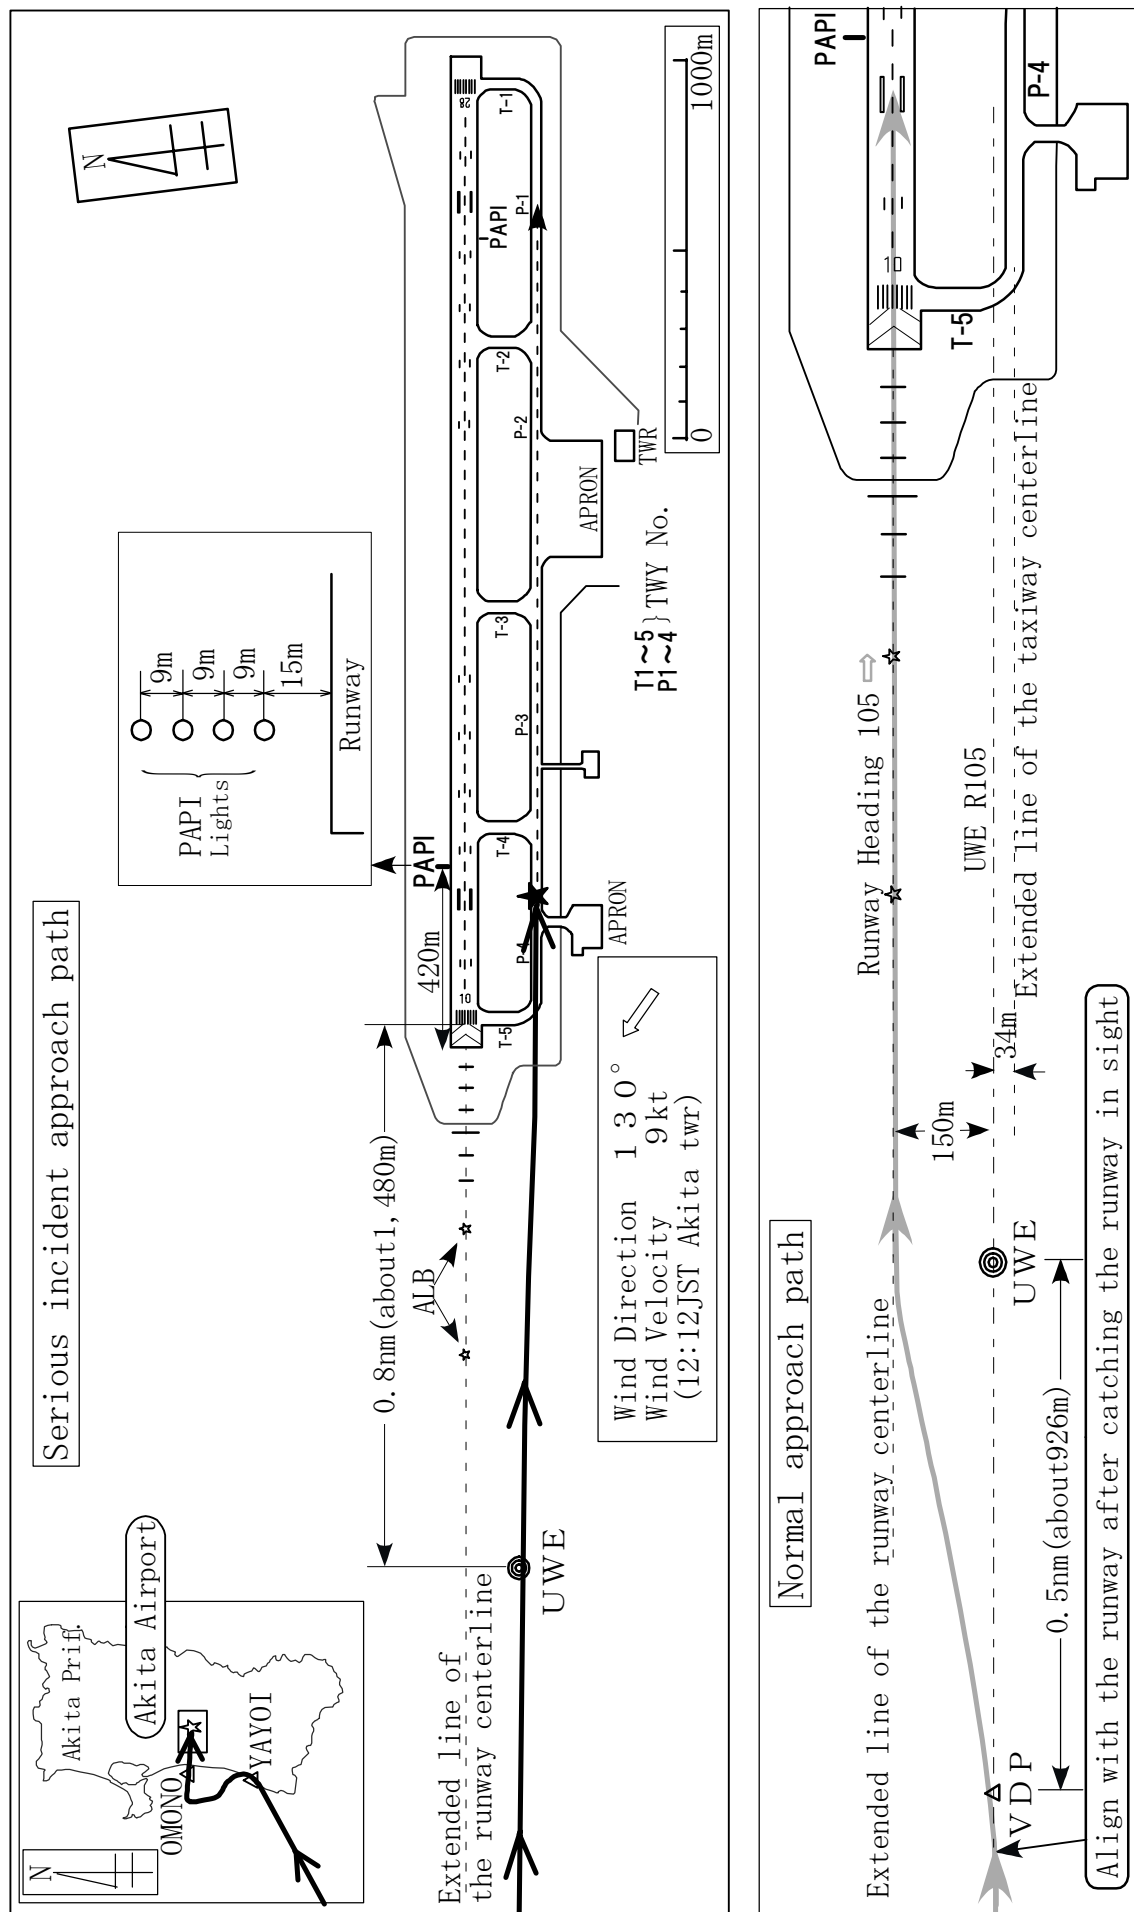
Figure 1 Estimated Flight Path

It is estimated that this serious incident was caused by that the captain and the first officer made a landing by misidentifying the parallel taxiway for the runway.

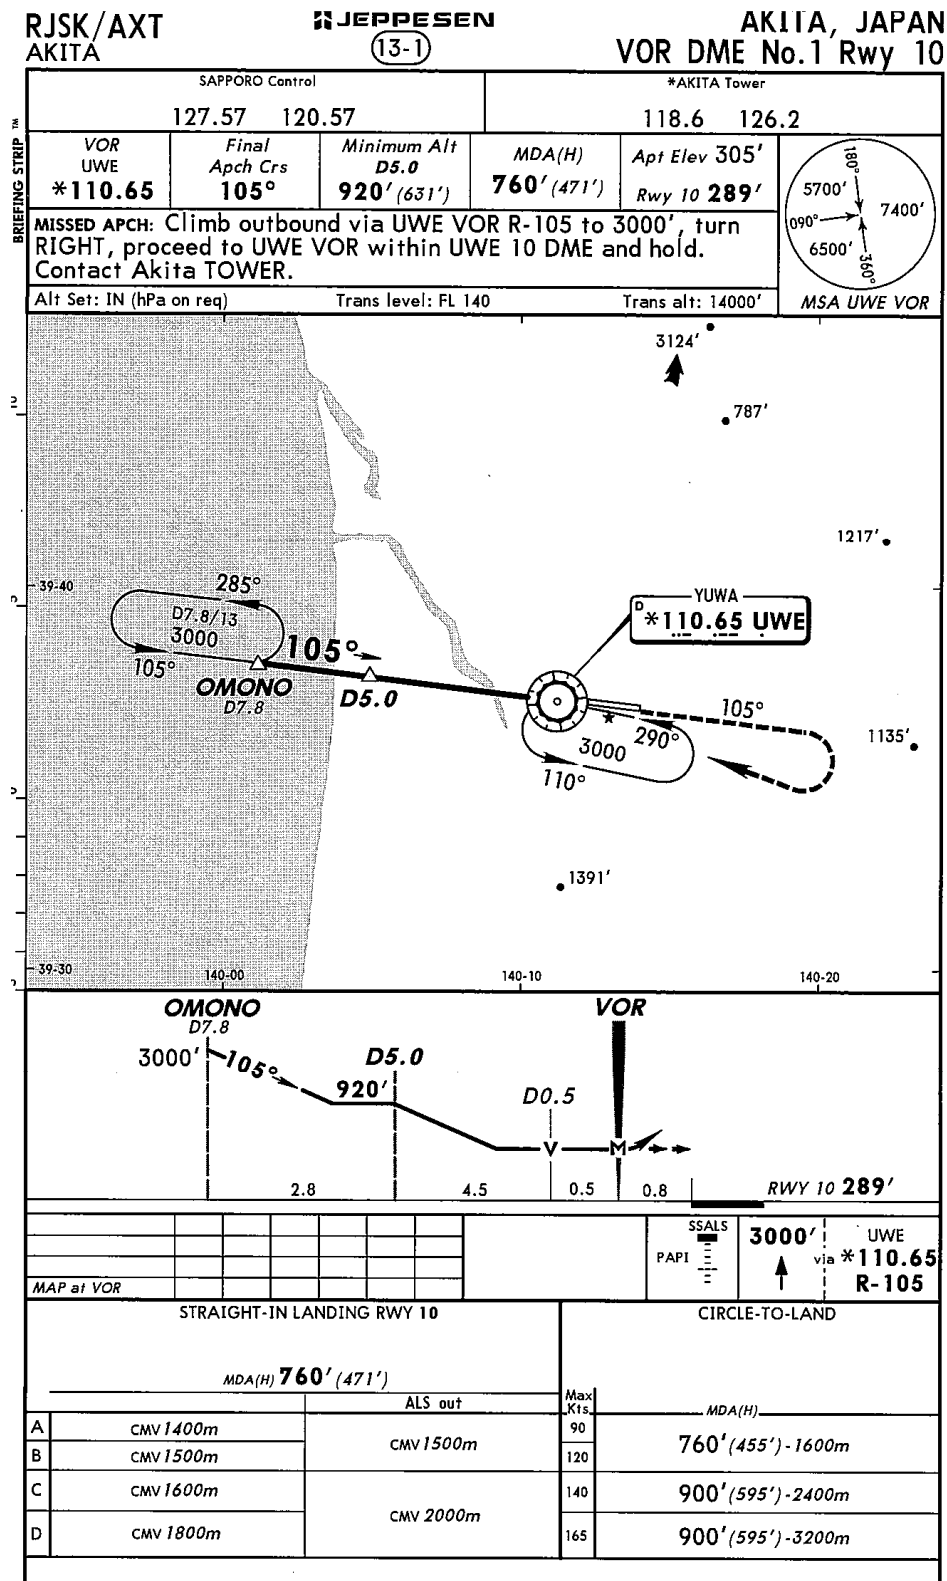
Figure 2 VOR/DME No.1 Rwy 10 Approach Chart

UWE used in VOR No.1 approach is located 0.8nm west of Runway 10 threshold, and offset to the south of the extended centerline of the runway. Therefore, approaching aircraft make a sidestep into the runway when they come close to UWE, or they fly towards the runway from early stage, and which way to choose depends on each pilot.

to be published as “a straight in approach” under the condition that the relative position between the final approach course and the extended runway center line meets certain ICAO standard, and that the approach procedure under the other condition to be published as “a circling approach”. There are no definitions in ICAO standard to require the description on the relative position between the final approach course and the extended runway center line for the publication on both of “straight-in approach” and “circling approach”. “The Design Criteria for flight procedure” of JCAB was established based on the same ICAO standard and the description on the relative position between the extended line of the final approach course and the extended runway center line was not added to the publication on VOR No.1 Approach.

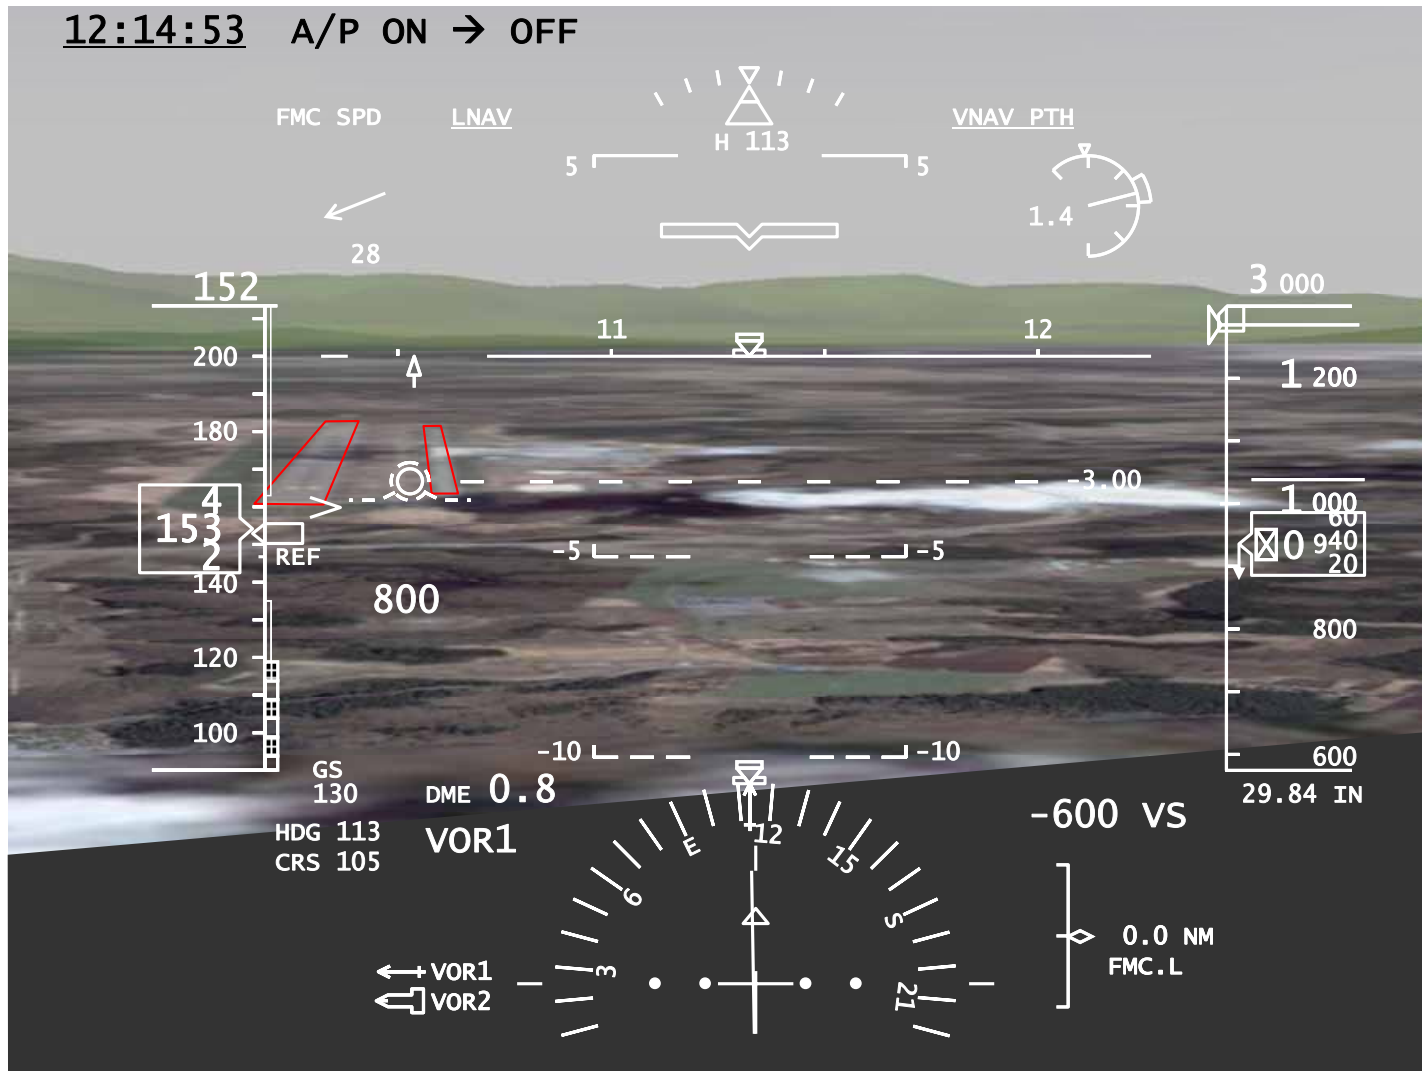
Attachment 3 Runway View and HUD Indication Example

It is considered that the captain entered touchdown maneuver, focusing his attention to align the FPS on the centerline of the taxiway, and it is considered that he failed to recognize that the centerline of the taxiway is a fine continuous line, that there were no touchdown zone markings, and so on, thereby he was unable to reach judgment that it was not a runway.

12:14:53 A/P ON → OFF

Drift Angle : -7.6deg, Heading : 113.2deg

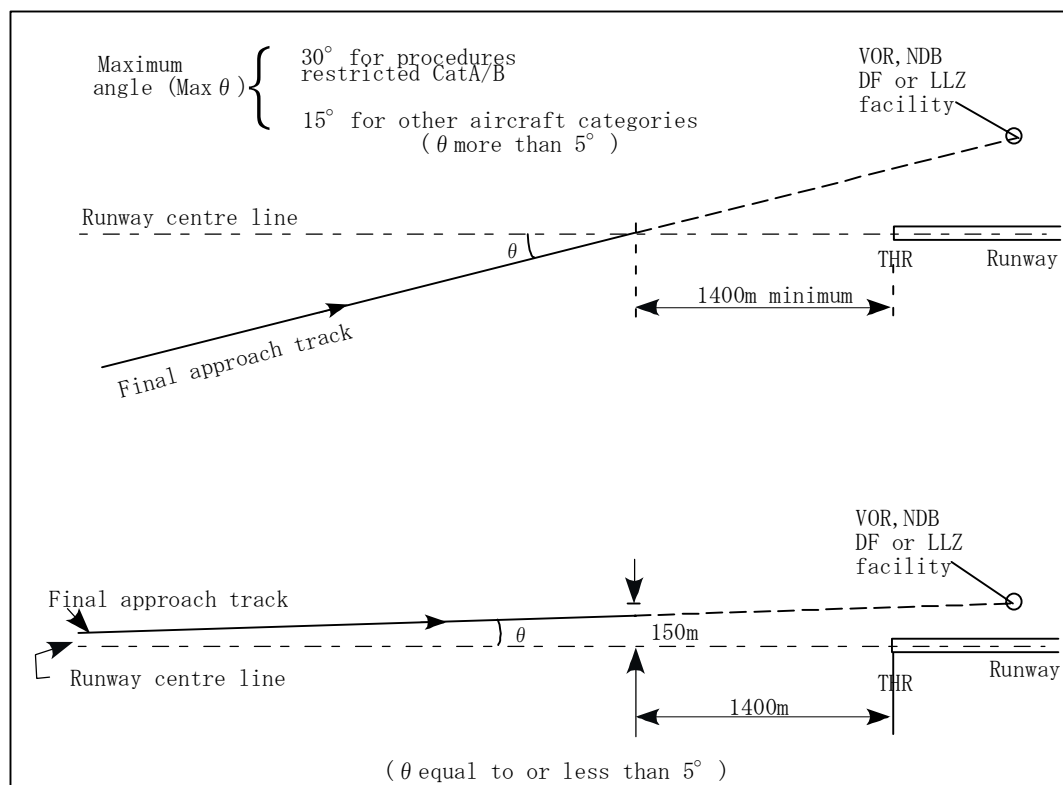
Figure I-4-5-1 Final straight-in approach alignment

5.2.2.2 *Final approach with track not intersecting the extended runway center line.* A final approach which does not intersect the extended center line of the runway may also be established, provided such track lies within 150 m laterally of the extended runway center line at a distance of 1,400 m outward from the runway threshold. However, the inner angle (θ) between the final approach track and the extended runway center line shall be equal to or less than 5° . (See Figure I-4-5-1)
