Interim Report

Type of Occurrence:	Serious incident
Date:	5 November 2014
Location:	12 NM north-west of Pamplona, Spain
Aircraft:	Airplane
Manufacturer / Model:	Airbus Industrie / A321-231
Injuries to Persons:	None
Damage:	None
Other Damage:	None
Information Source:	Investigation by BFU
State File Number:	BFU 6X014-14
Published:	17 March 2015

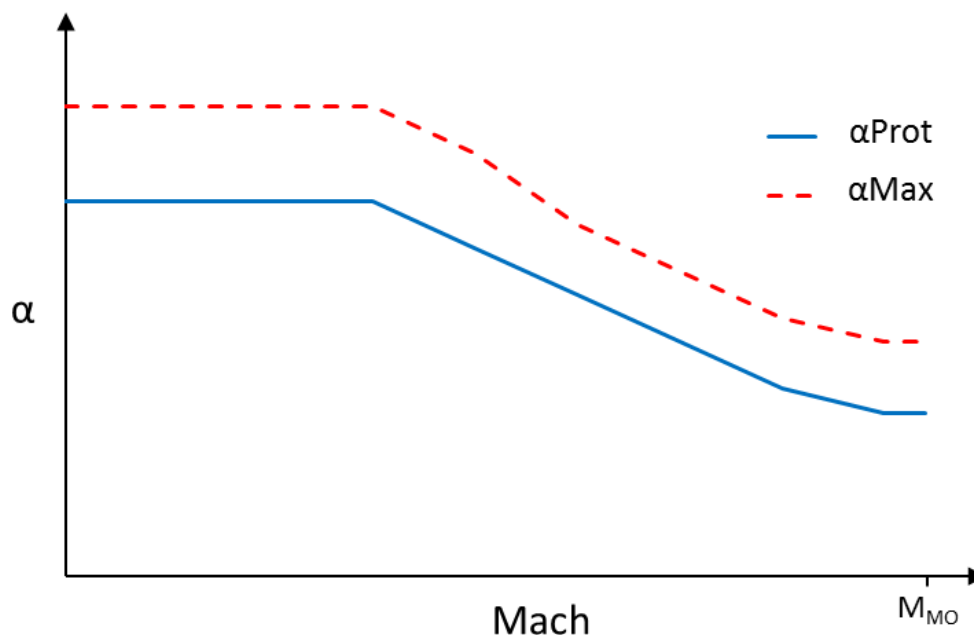
AlphaProt and AlphaMax depend on the Mach number of the aircraft, among other factors. When the Mach number increases AlphaProt and AlphaMax decrease.

Dependence of AlphaMax and AlphaProt from the Mach number

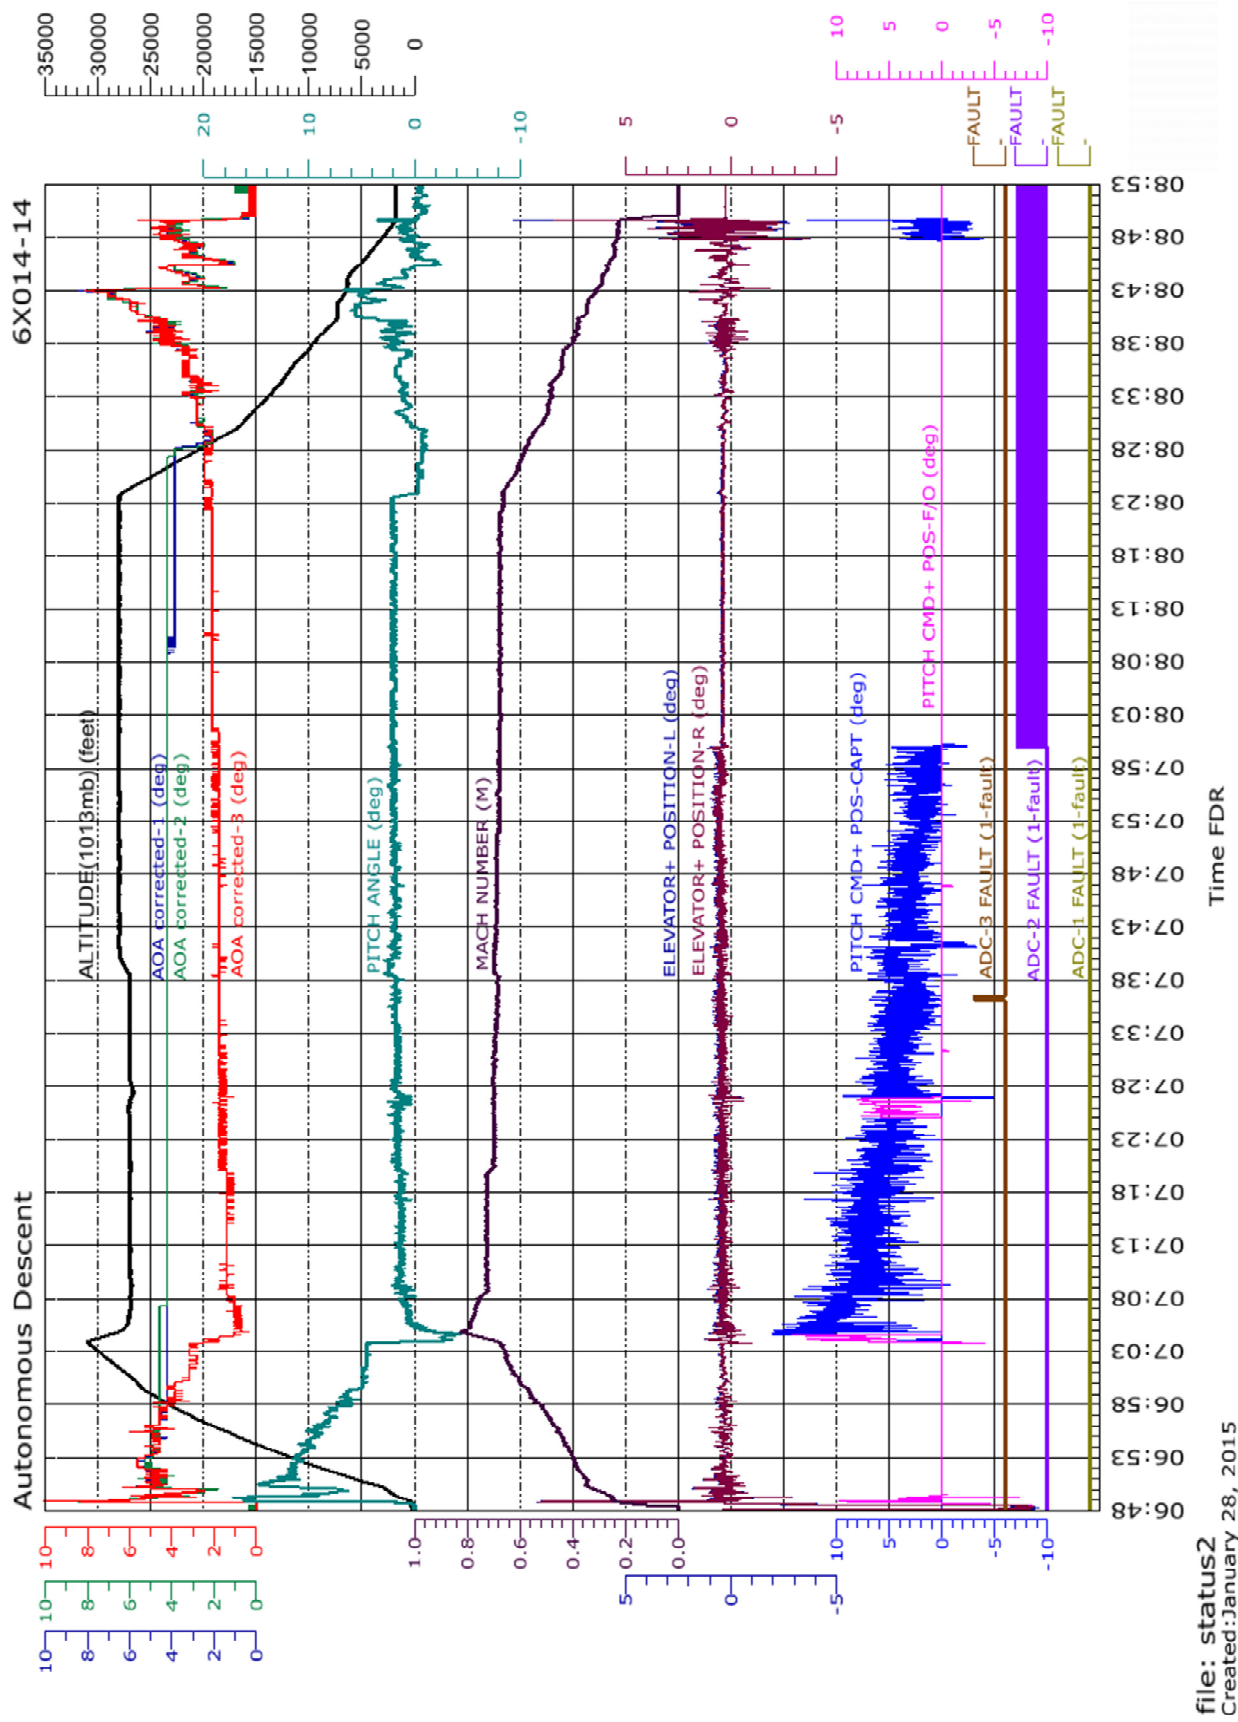
FDR Excerpt

All three AOA sensors functioned normally at take-off of the airplane. Eight minutes after take-off, while reaching FL 195, at an outside air temperature of -35°C (SAT), freezing of the AOA sensors 1 and 2 led to AOAc_{or} recorded at 4.5° . This value remained unchanged for the next approximately 1 hour and 32 minutes until the descent.

At 0803:19 hrs a left-hand turn with a bank angle of 15° was initiated. At 0803:52 hrs the crew disengaged the autopilot. At that time the Mach number was at 0.675, the corresponding value of the AlphaProt was at 4.2° and the one for the AlphaMax at 5.8° . Since the angle of attack the system had calculated was 0.3° higher than AlphaProt the high angle-of-attack protection was active as soon as the autopilot was disengaged and the system ordered a nose down movement. Progressively and for 15 seconds the co-pilot gave backward sidestick inputs up to 3/4 of the way to coun-

teract this movement. The pitch changed from 4.5° to -3.5 and the rate of descent increased to 4,000 ft/min. At 0804:54 hrs the ELAC rejected ADR 3 as the AOA 3 value deviated from the other two by more than the monitoring threshold. From 0805:20 hrs on the airplane once again flew stabilised with Mach 0.79 in FL 270 with 2/3 continuous backward sidestick input (pull).
