AIRCRAFT ACCIDENT INVESTIGATION REPORT

JAPAN AIRLINES CO., LTD.

J A 7 0 1 J

**DAMAGE DUE TO TAILSTRIKE DURING GO-AROUND
JAPAN AIRLINES CO., LTD.
BOEING 777-200, JA701J
ON RUNWAY 34L OF TOKYO INTERNATIONAL AIRPORT, JAPAN
AT ABOUT 16:08 JST, MARCH 31, 2012**

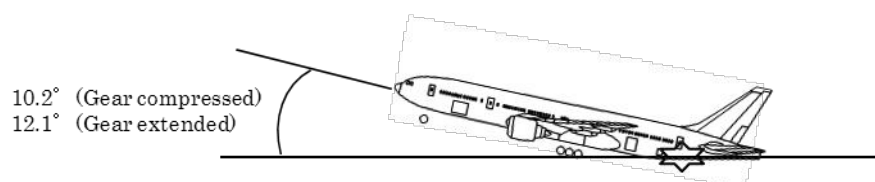
Figure C: Tail Strike Pitch Angle

The aft fuselage of the Aircraft touches the ground at a pitch angle of 10.2 degrees when the shock absorbers of the main landing gears are compressed completely and at a pitch angle of 12.1 degrees when they are extended completely.

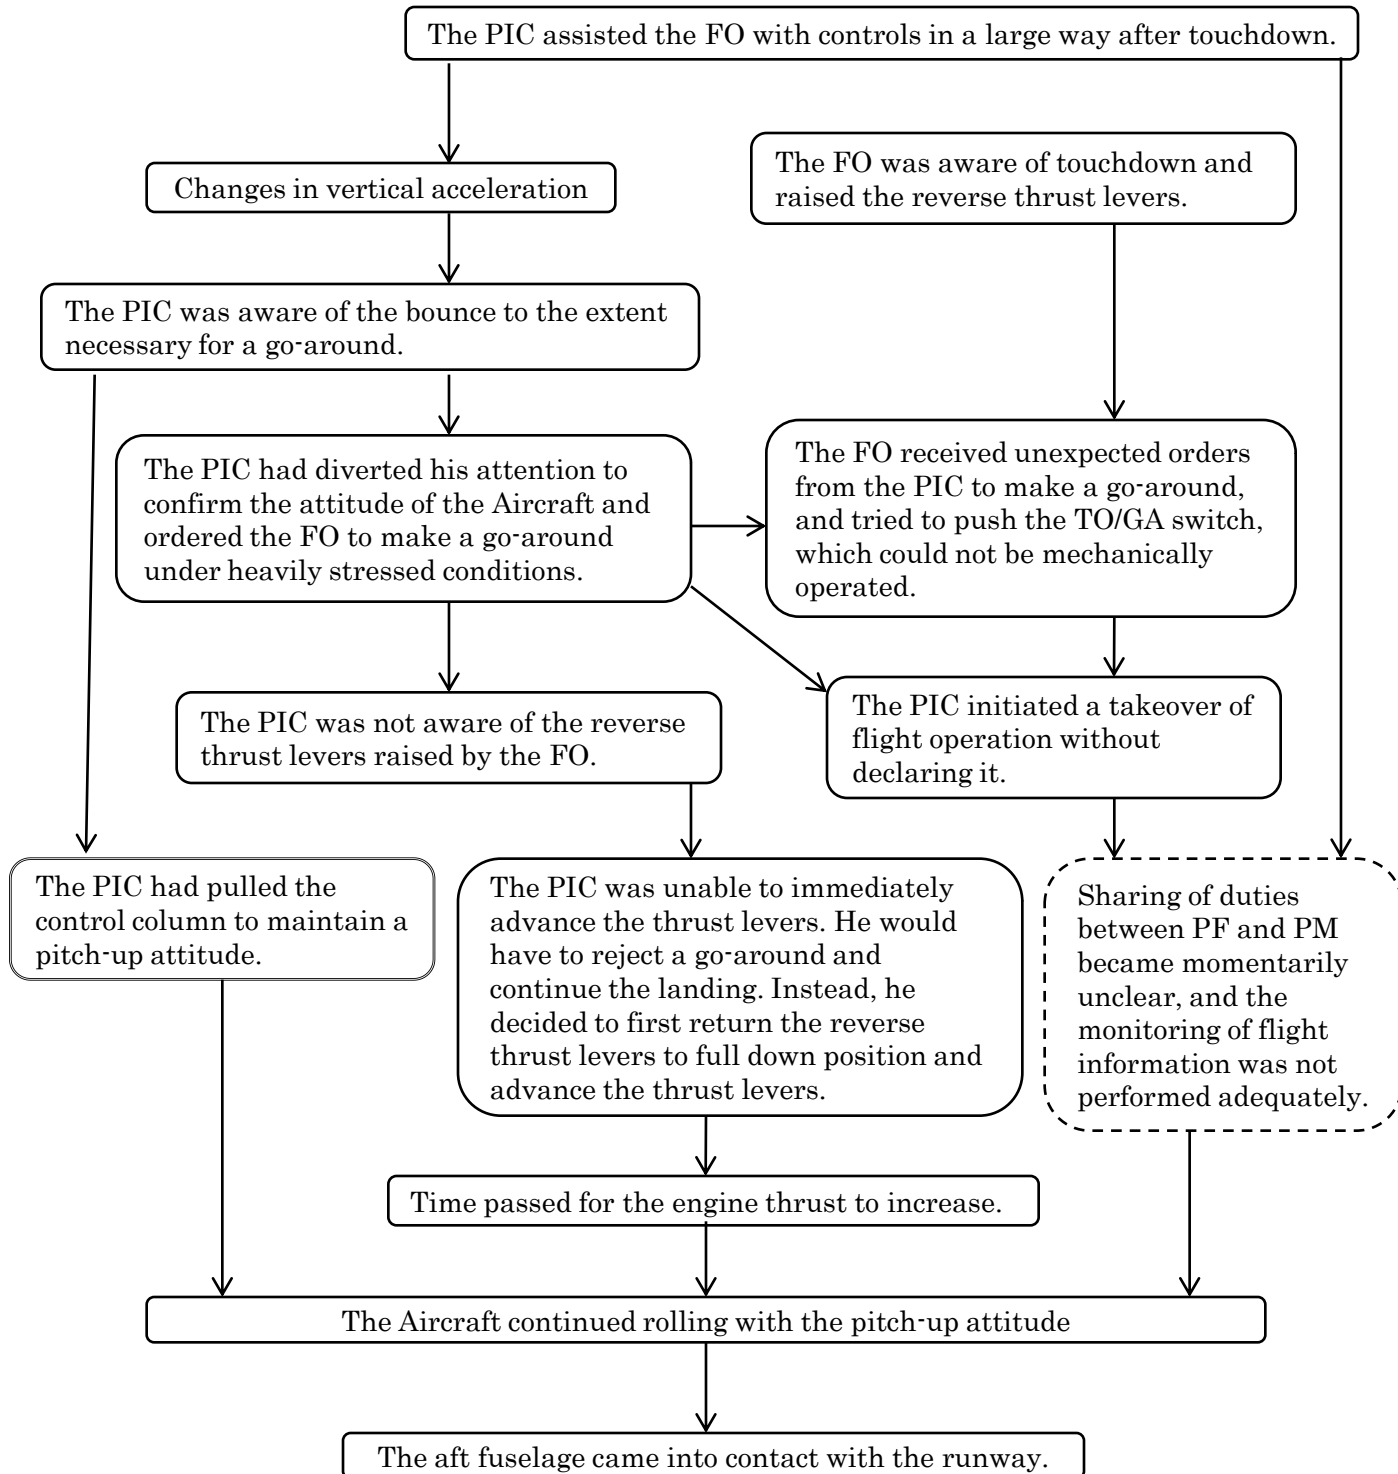
Figure 2: Chain of Probable Causes of the Accident

angle after the Tail Strike Caution had been issued at 16:08:21, as indicated in Figure B. Therefore, it is highly probable that the aft fuselage had been continued dragging for around seven seconds until the Aircraft became airborne again.
(See Figure 2 “Chain of Probable Causes of the Accident”)

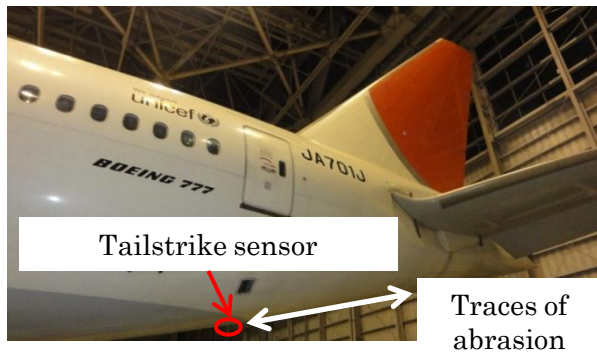
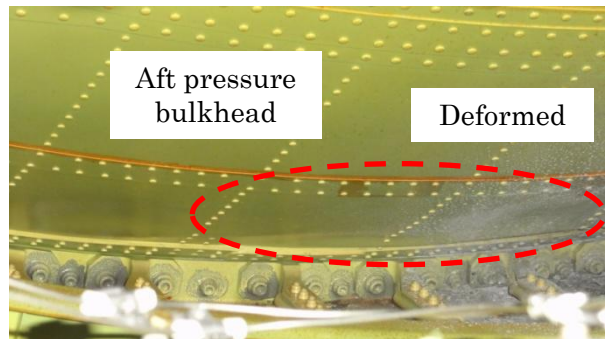
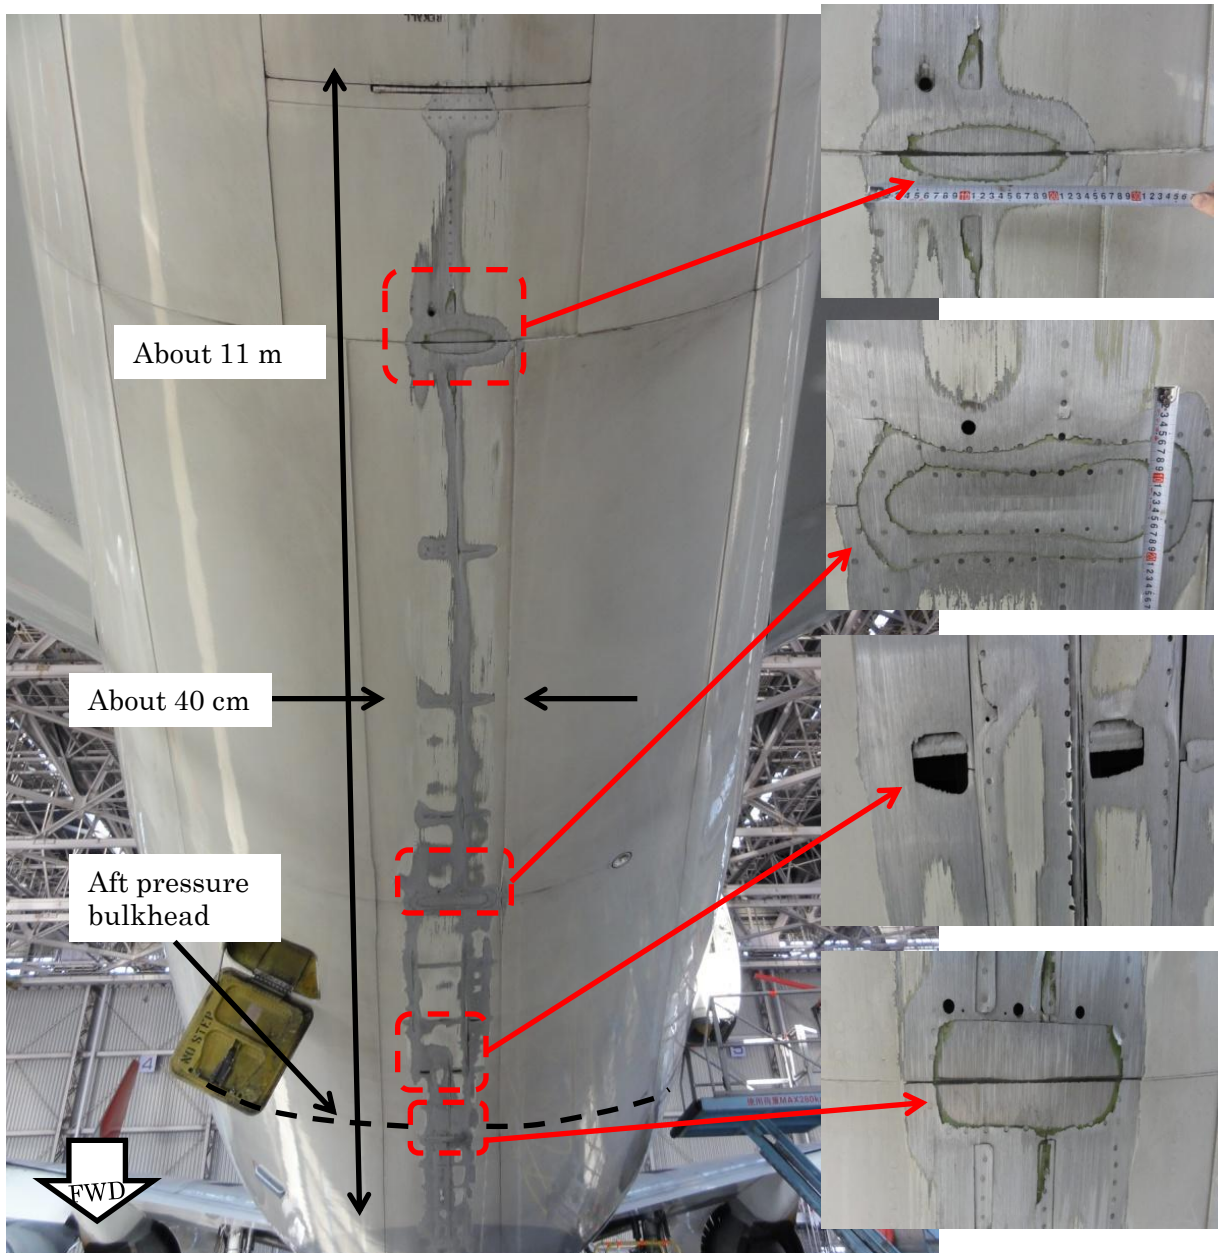
Photo: Damage to the Fuselage

On the external skin for the lower part of the aft fuselage, there was an abrasion of about 11 m in length and about 40 cm in width, with holes and cracks. The frame within this area was exposed and damaged. Tail strike sensors had been stripped off. And the lower part of the aft pressure bulkhead was slightly deformed.
