**Statens haverikommission**  
Swedish Accident Investigation Authority

***Final report RL 2012:21e***

**Serious incident on 16 of January 2010 to  
aircraft EP-IBB at Stockholm/Arlanda  
Airport, Stockholm county, Sweden**

Ref.no. L-02/10

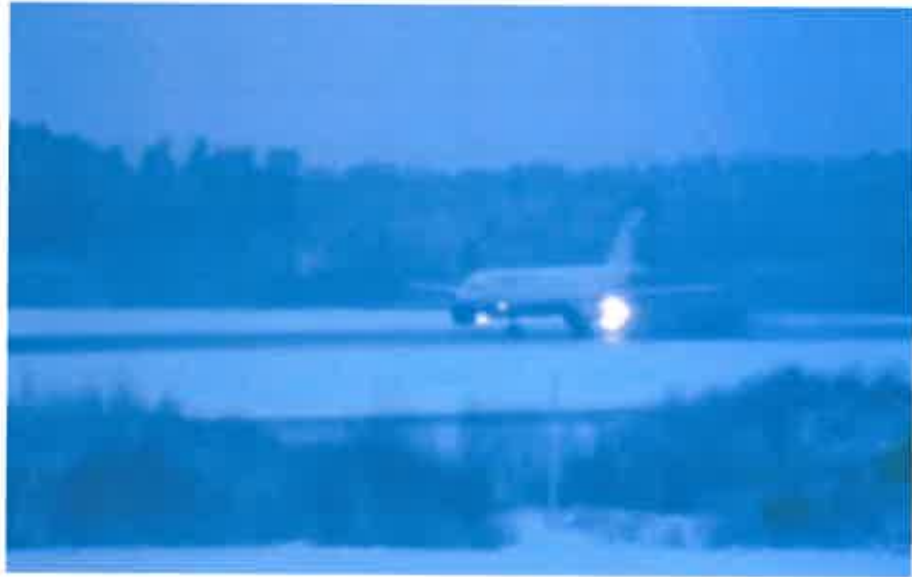
Fig. 2. Image from video. Photo: Saeid Cedighi Chafjiri.

The speed when the engine failure occurred was approximately 54 knots, but the aircraft continued to accelerate to approximately 59 knots (110 km/h). The incident occurred after rolling approximately 250 metres along the runway. The image in Figure 2 above has been obtained from a private video taken from the viewing terrace at Arlanda Airport during the sequence of events. The engine failure started with a puff of smoke and was quickly followed by three flames of varying size within the space of 0.77 seconds.

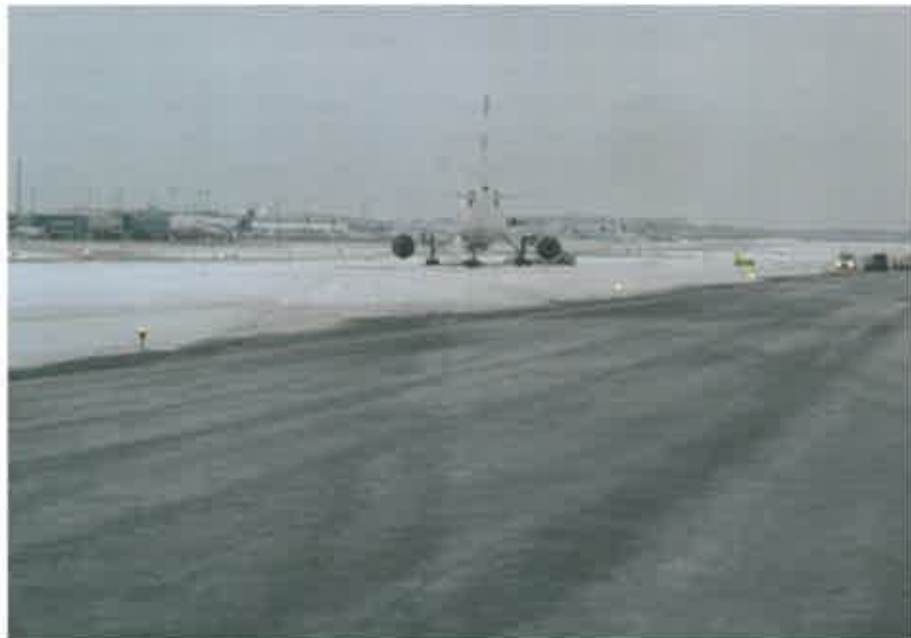
Fig. 3. The aircraft after the excursion. Photo: Swedavia.

The first stage of the take-off sequence was normal, with a synchronous acceleration rate of the engines. When the engine power had reached the set values (approximately 103%), a muffled bang was heard. According to the commander, the aircraft began to veer to the left, more or less immediately after the bang. Neither of the pilots had at this stage understood what had happened, but thought that the aircraft had collided with something or that a tyre explosion had occurred.

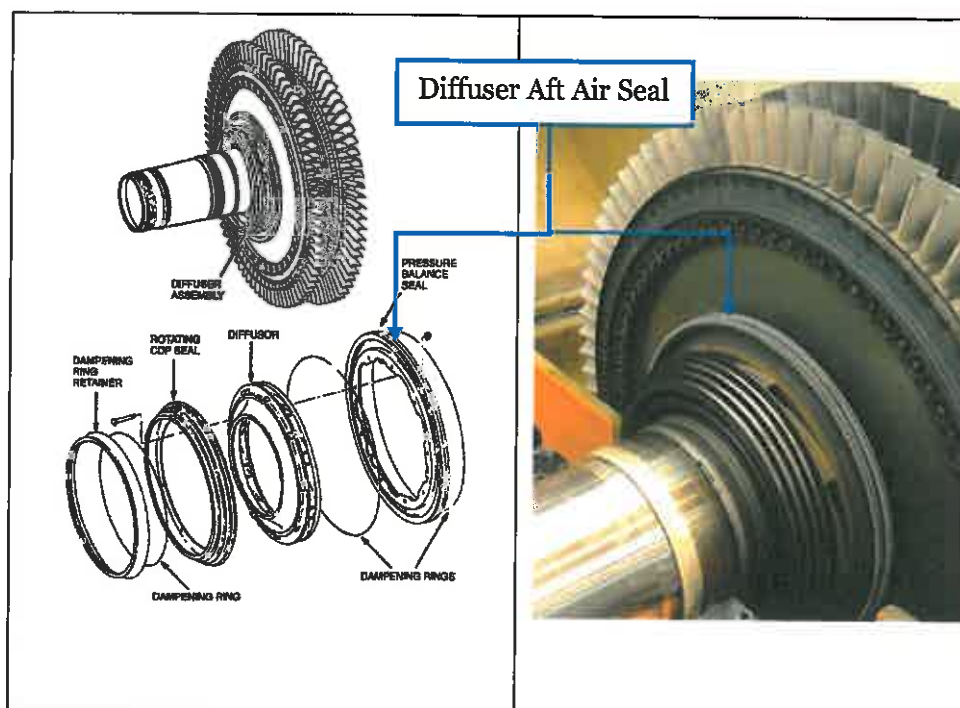
Fig. 13. Diffuser Aft Air Seal.

The seal teeth on the air distributor's aft seal (Diffuser Aft Air Seal), termed Pressure Balance Air Seals (see Fig. 13.), become worn and can in some cases be repaired. Engine Manual section 72-53-07, repair 003, provides a Dabber TIG Weld Repair of the aft seal teeth which adds material to the teeth edges in the form of weld beads on the flange, which are then turned down on a lathe to the correct tooth dimensions. Section 1.18.1 describes the procedure schematically.

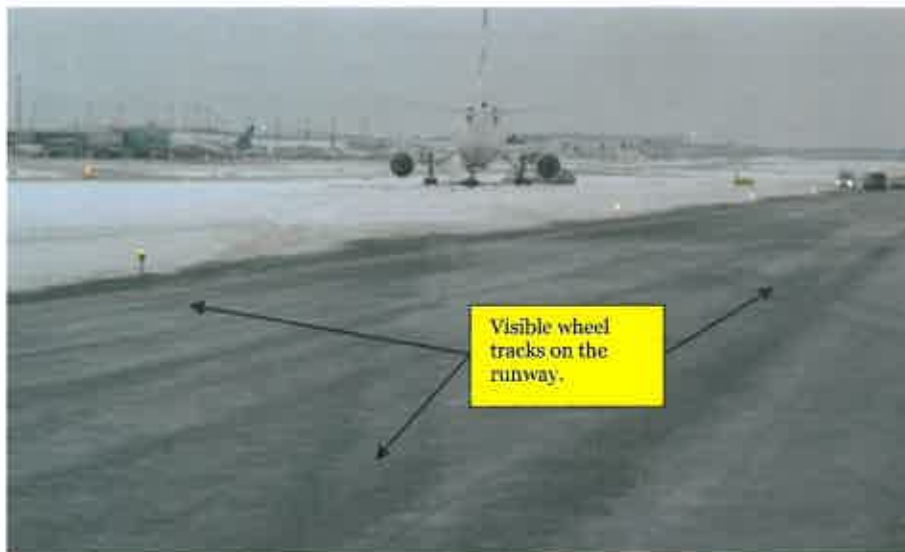
Fig. 35b. Tracks on the contaminated runway surface. Photo: Swedavia.

Both SHK and the airport staff have photographed the runway and the aircraft after the incident, see figs. 35b and 50. Judging by the images, the runway seems to have been covered with a grey contamination, in contrast to the appearance of the runway in the video recordings. Tracks from the aircraft's wheels are clearly seen in the contamination on the runway and in the snow outside of the runway. The landing gear is fitted with wheels mounted in pairs with a common axle and the main landing gear each has two pairs of wheels mounted in tandem. Double wheel tracks from main landing gear and nose landing gear can be seen on the runway surface in the images.

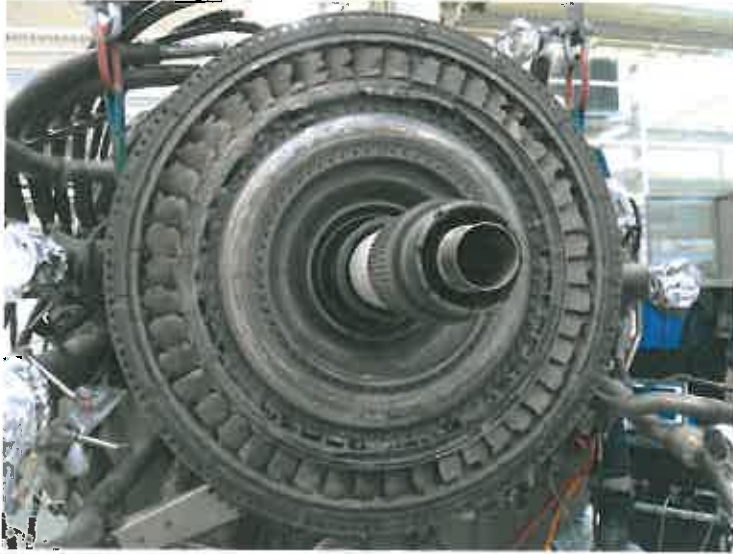
Fig. 36. HPT guide vanes stage one. Photo: SHK.

All HPT nozzle guide vanes had extensive impact damage from the “turbine side”. Its rear edges were severely mangled and partly torn away. Extensive mechanical impact damage was also found on the sheet-metal windage covers, which cover the guide vanes’ mounting bolts and hold them in place. Section 1.16b.9 discusses the parts of the diffuser aft air seal that were originally located between HPT stage one, guide vanes and turbine.

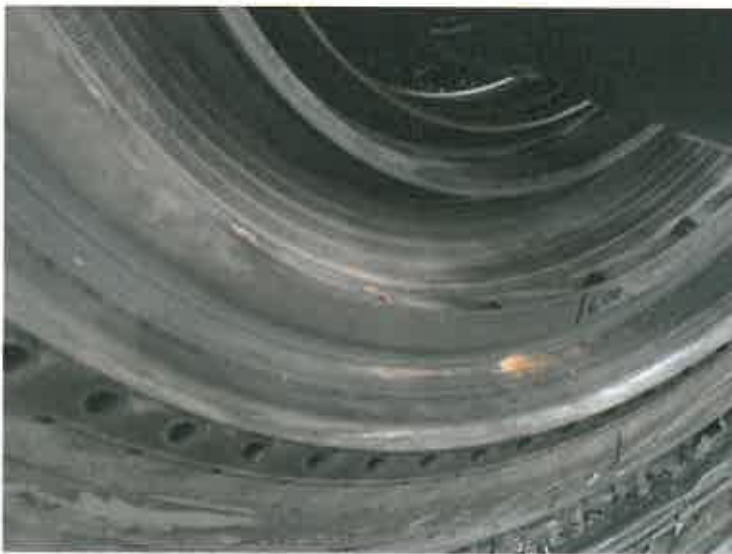
Fig. 37. Stationary seal, forward and aft (honeycomb completely torn away). Photo: SHK.

Sealing surfaces for the diffuser's forward seal (Diffuser Front Seal) were intact and had normal wear. Sealing surfaces in the form of the stationary honeycomb for the diffuser's aft seal (Diffuser Aft Air Seal) were torn away. The bolts which hold together the forward and aft seals against the diffuser were overstressed and sheared off. The edge of the seal normally lies parallel with the engine's longitudinal axis, but in this case it was angled outwards at 45°. Extensive impact damage was ascertained on the parts of the module that were directed towards the HPT disc stage one.

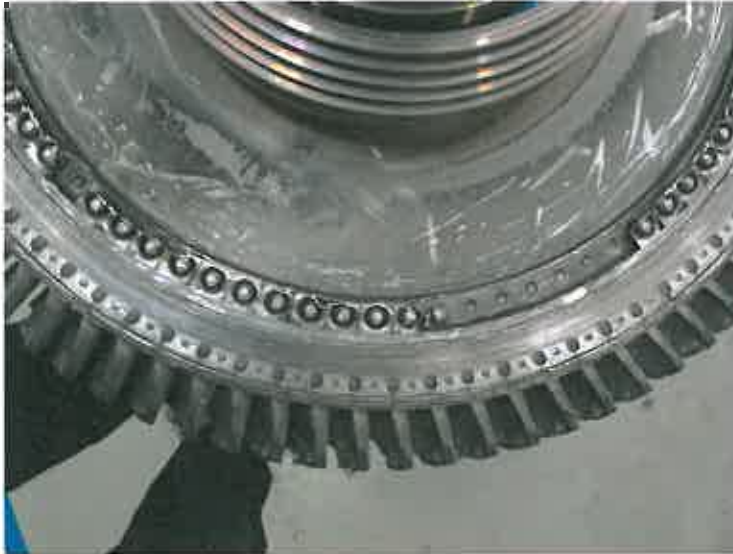
Fig. 38. HPT disc and turbine stage one with Diffuser Front Seal.  
Photo: SHK.

All blades were damaged through mechanical impact. The tops of the blades were entirely or partly torn away.

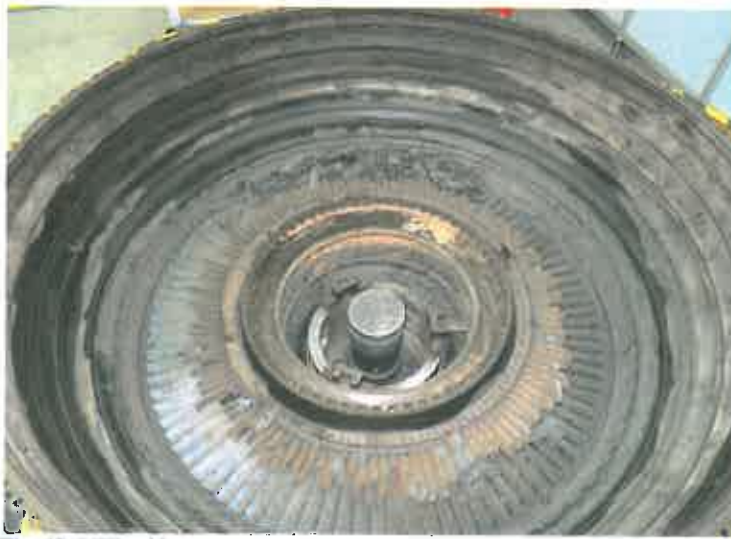
Fig. 40. LPT guide vanes and turbine blades stage two. Photo: SHK.

Throughout all five stages of the low pressure turbine, impact damage to both the low pressure turbine blades and guide vanes were observed. The amount of damage decreased further back in the low pressure turbine module. The low pressure turbine case was examined and found to have penetrations measuring around five by five millimeters. It has not been possible to conclude if debris passed through the holes. The LPT case was also observed with a number of case deformations in the radial direction.

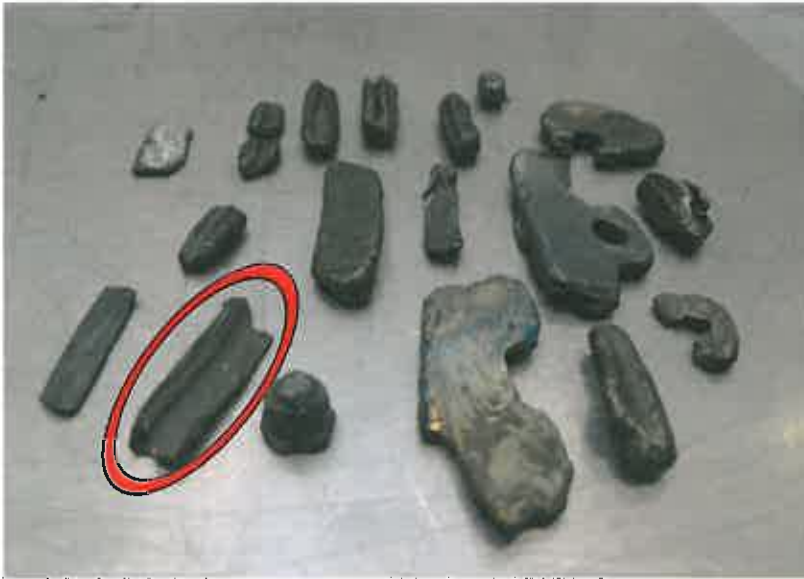
Fig. 44. Fragments analysed by Volvo Aero Corporation. The piece marked in red is a piece of the edge of the diffuser aft air seal. Photo: SHK.

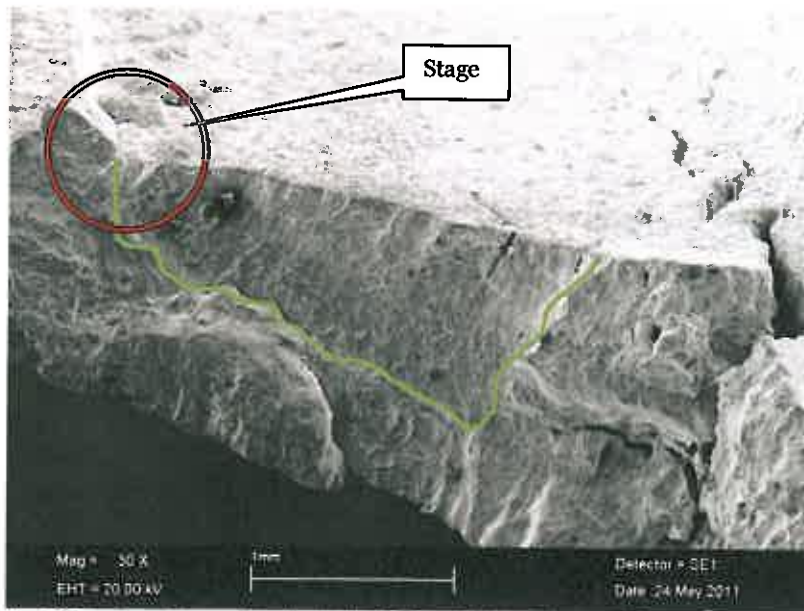
The overall assessment of the investigation results suggests that the fatigue had started in the repaired seam at the diffuser aft air seal teeth. All documented cases of CF6-80C2 diffuser aft air seal failures have been seals that had been previously repaired.

Fig. 45. Section of the knife edge in the diffuser aft air seal – one of four edges. Fatigue zone with crack initiation. Photo: VAC.

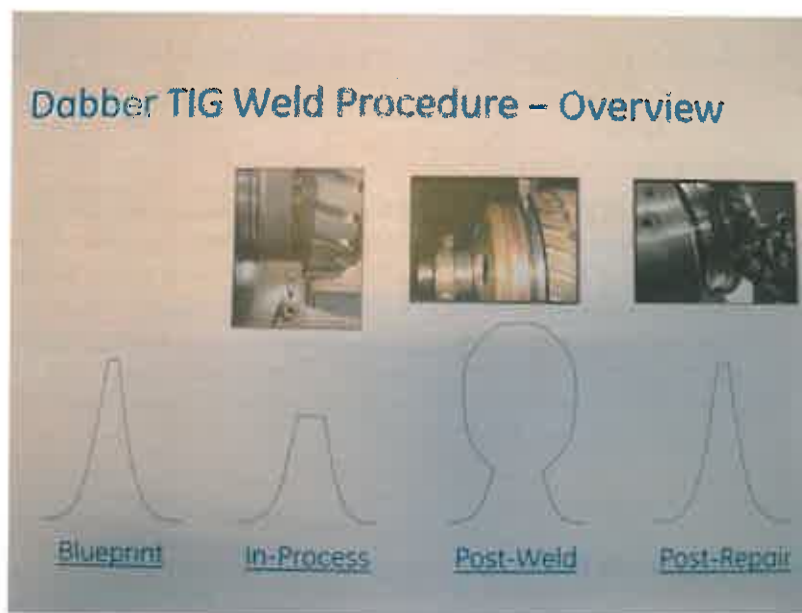
Fig. 48. Repair with the GE method “Dabber<sup>55</sup> TIG Weld”.

The seal material is Inconel 718. During a repair, the seal edges are dabber-welded in an age-hardened state (aged). The risk for crack formation is thereby greater in weld and heat-affected zones. For newly manufactured engine parts using TIG Weld operations, however, Inconel 718 is always welded in a solution-heated state. The material is then more ductile and has lower hardness.

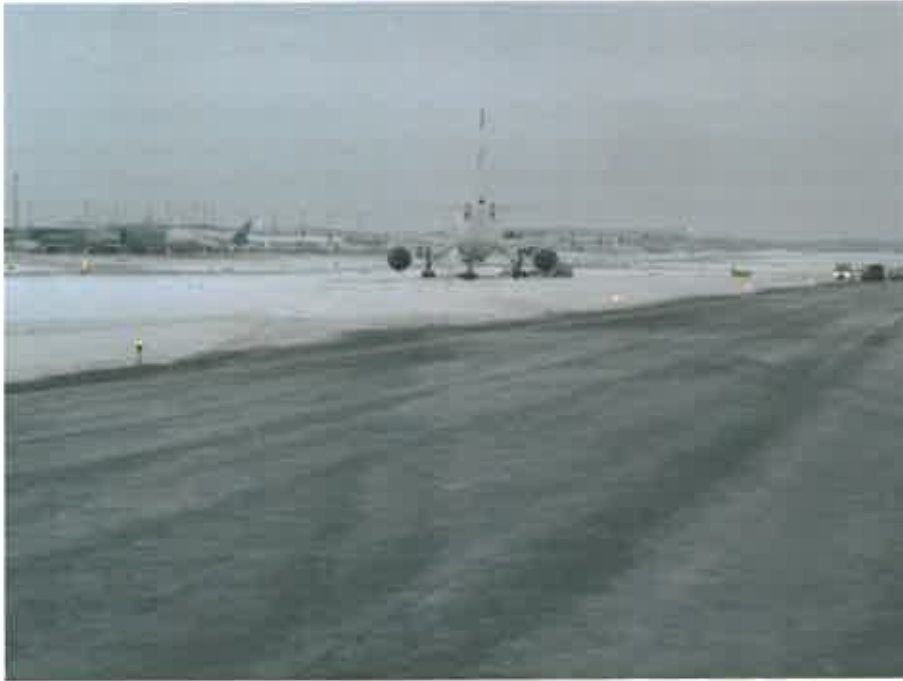
The contaminated surface must be concluded to have affected the friction negatively, however not to the extent of causing aquaplaning since the aircraft speed was too low for that.

Fig. 50. (See also fig. 35b). Tracks on the contaminated runway surface. Photo: Swedavia.

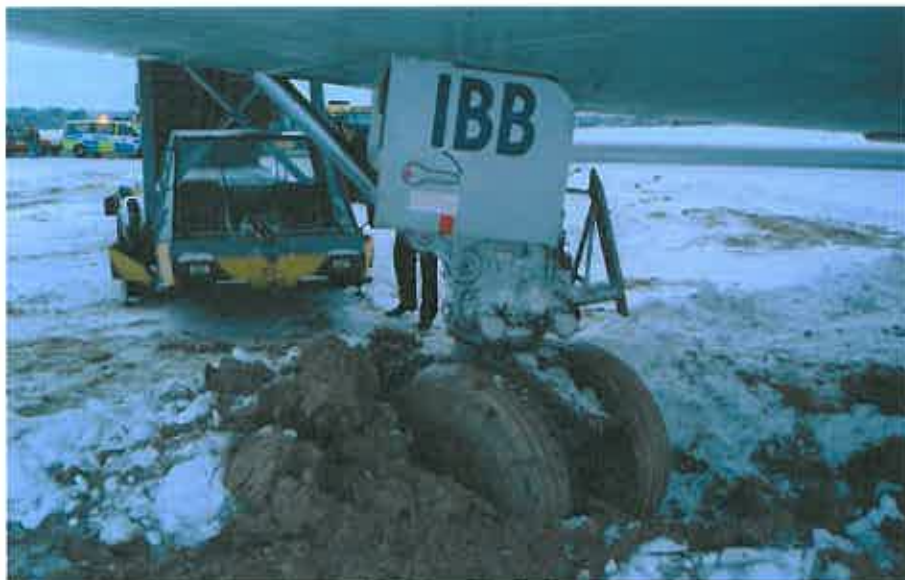
steering wheel (tiller) in the cockpit. These facts are supported by the fact that the aircraft – after having stopped – was found with the nose wheel at an angle fully to the right.

Fig. 51. The nose wheel angled to the right. Photo: Swedavia.

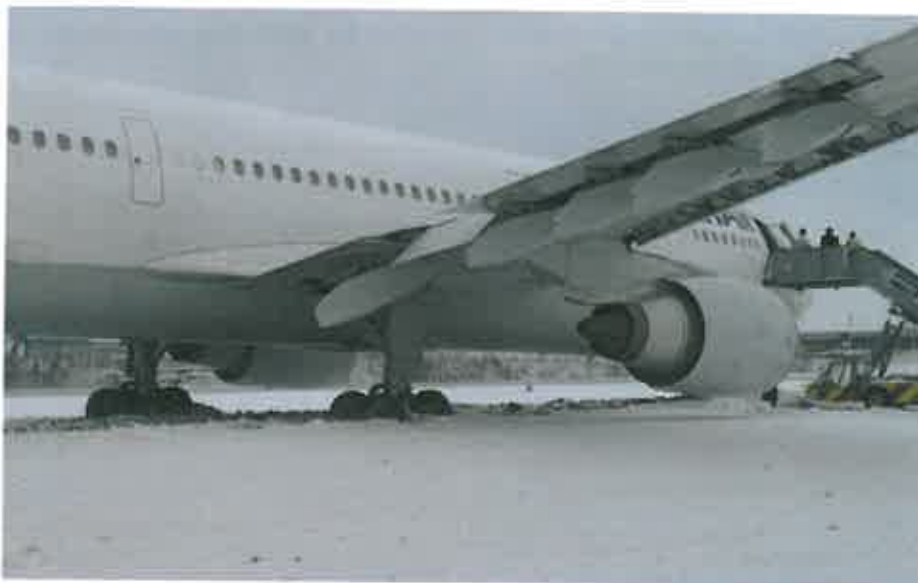
Fig. 52. The aircraft after evacuation. Photo: SHK.

During the final stage of the aircraft’s path, the nose wheel buried itself approximately half a metre into the ground, partly due to the nose wheel being maximally angled to the right. The steering wheel for the nose wheel steering is not intended for use during the take-off sequence as steering via the rudder pedals is considered to be sufficient. However, when an aircraft is about to run off the runway, it is fully understandable that all means are used by the pilots in attempt to prevent an accident.

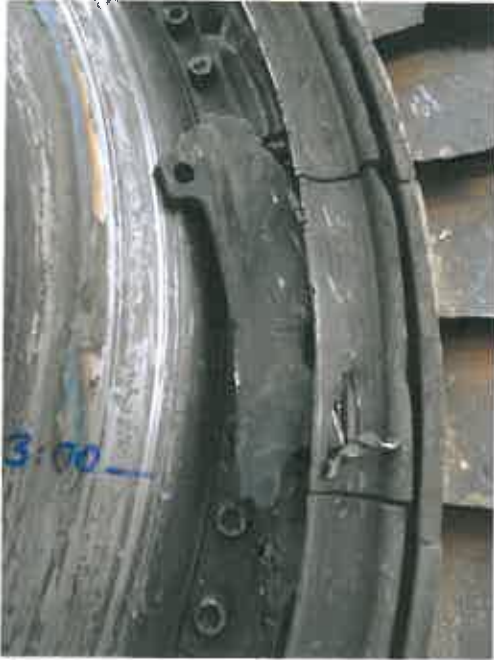
Once the crack was long enough in one or more of the four teeth in the air seal, the loads were transferred to the nine rotating diffuser assembly bolts. Bolts sheared which liberated the aft air seal radially outward contacting the nozzle support structure with debris fragments entering the cavity forward of the stage 1 HPT disk and aft of the stage 1 HPT nozzle. At the time of the aft air seal separation, the HPT rotor speed was approximately 10,000 RPM.

Fig. 57. HPT guide vanes stage one with fragments of the diffuser aft air seal. Photo: SHK.

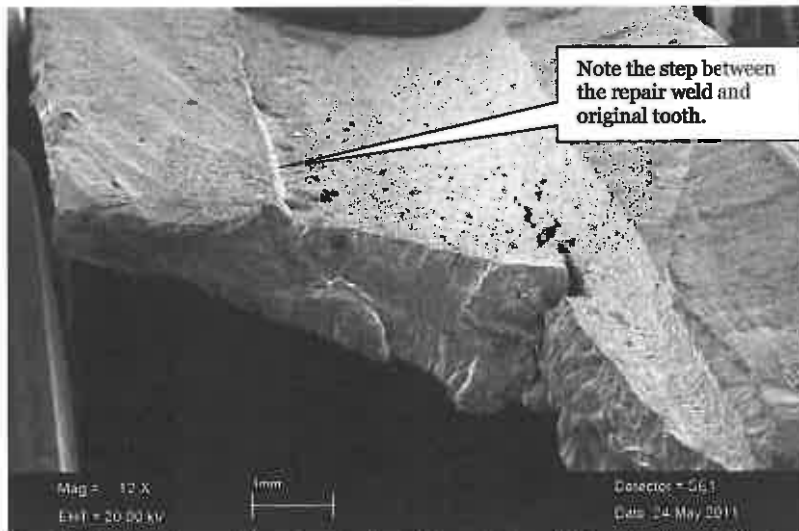
Fig. 58. Section of one of the edges in the diffuser aft air seal. See also fig. 45. Photo: VAC.

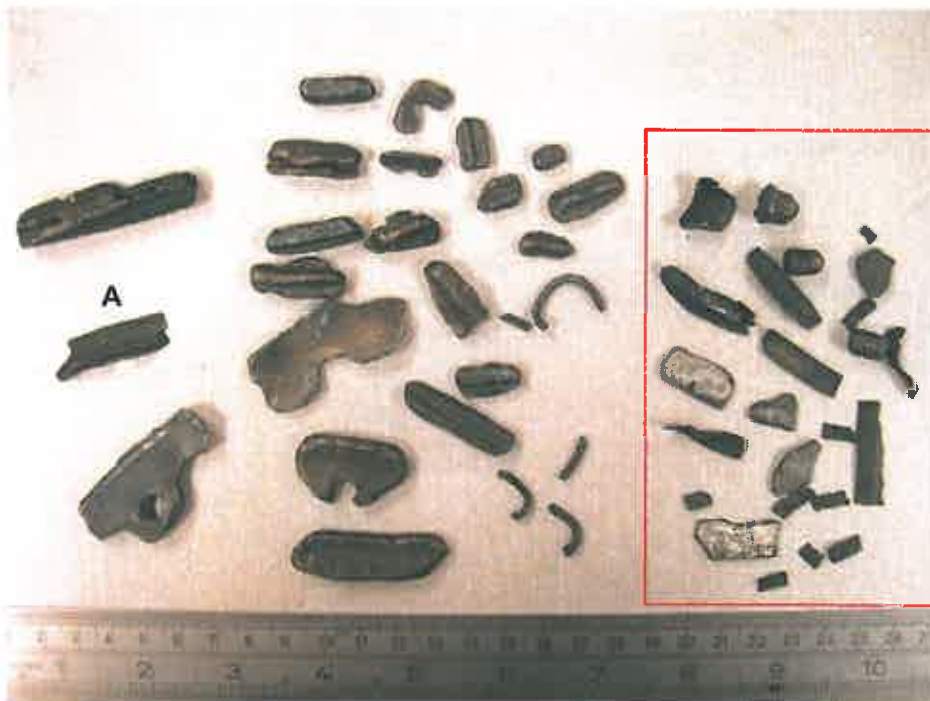
Photo No 1. Content of the plastic bag. The pieces within the red marking are not believed to be from the Diffuser Aft Seal based upon visual appearance and geometry. The piece marked "A" is from the aft tooth of the seal.

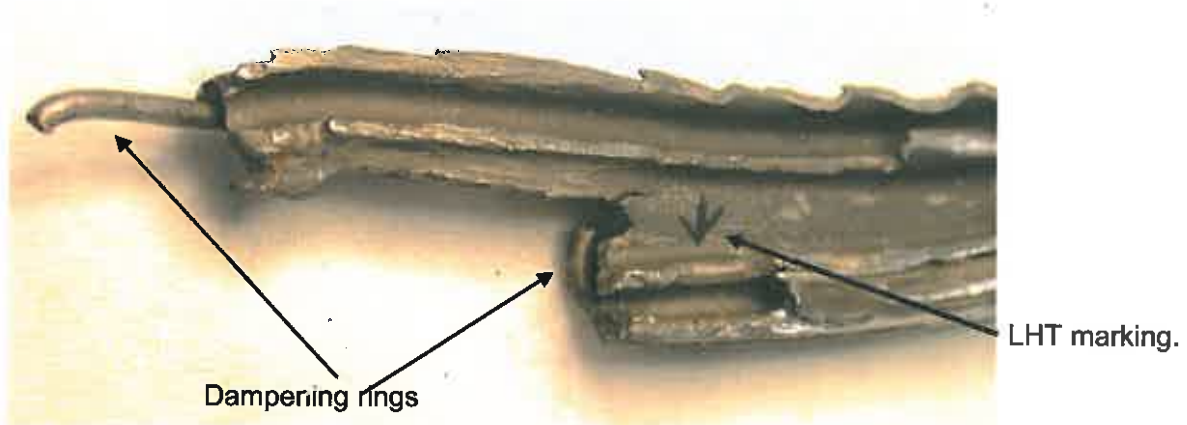
Photo No 6. Both dampening rings were in place at the failure.

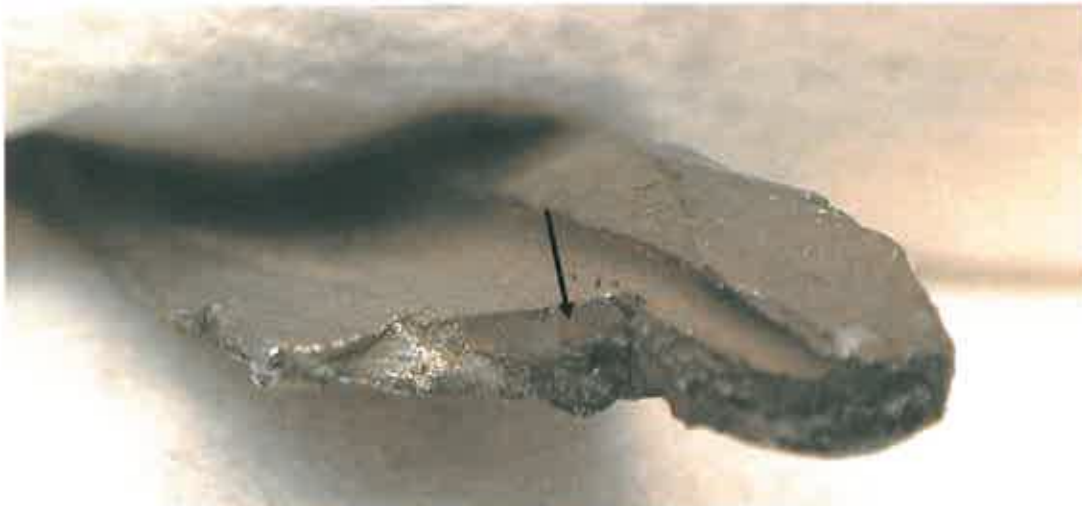
Photo No 8. The left end of the tooth in photo no 7 shows a fatigue crack (arrow). The bright appearance of the crack surface suggests it to be a secondary crack, developed during the engine break down.

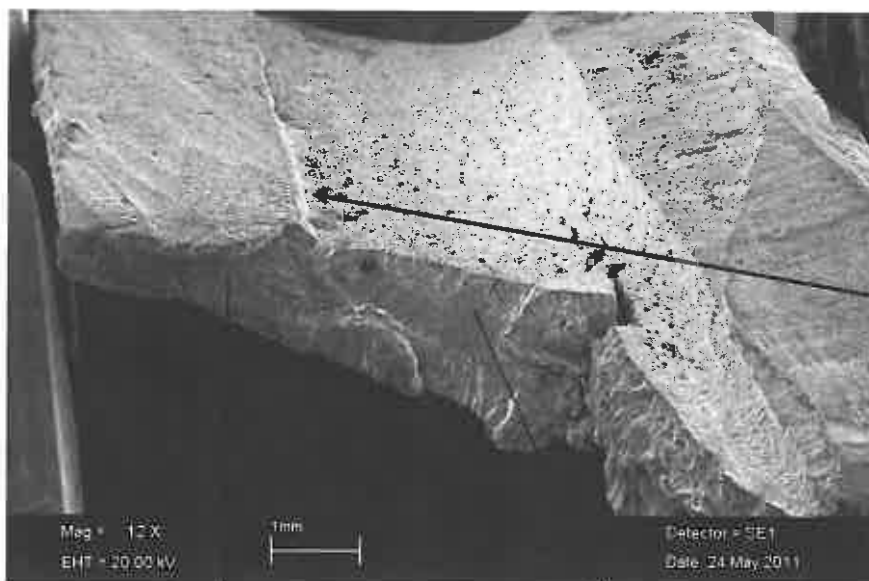
Note the step between the repair weld and original tooth.

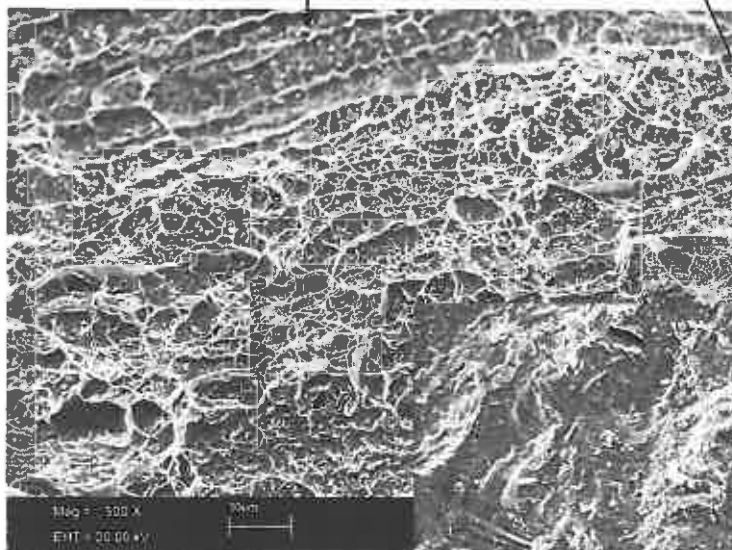
Photo No 10. Tensile overload (weld) structure.

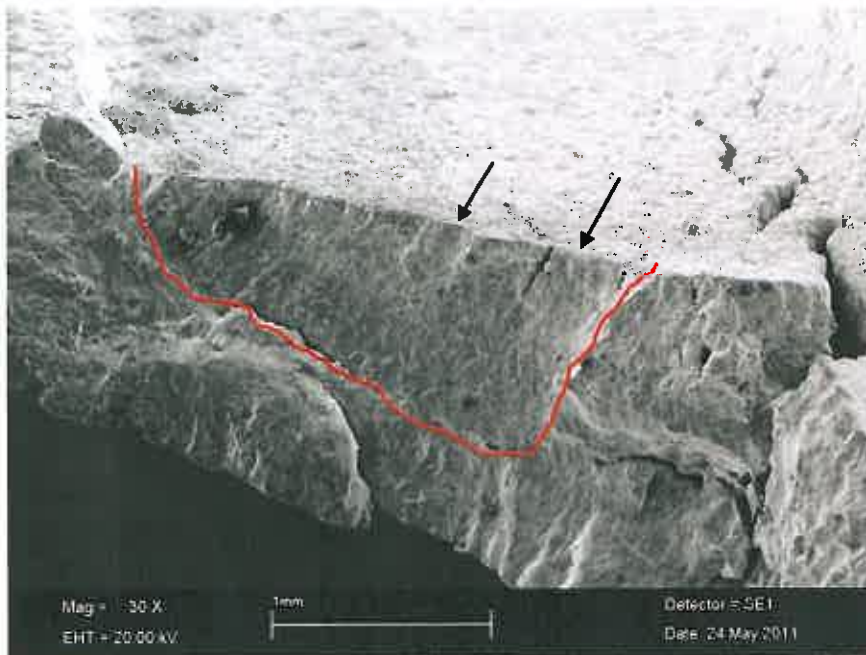
Photo No 12. Fatigue surface outlined with red. Arrows show two crack initiation points.

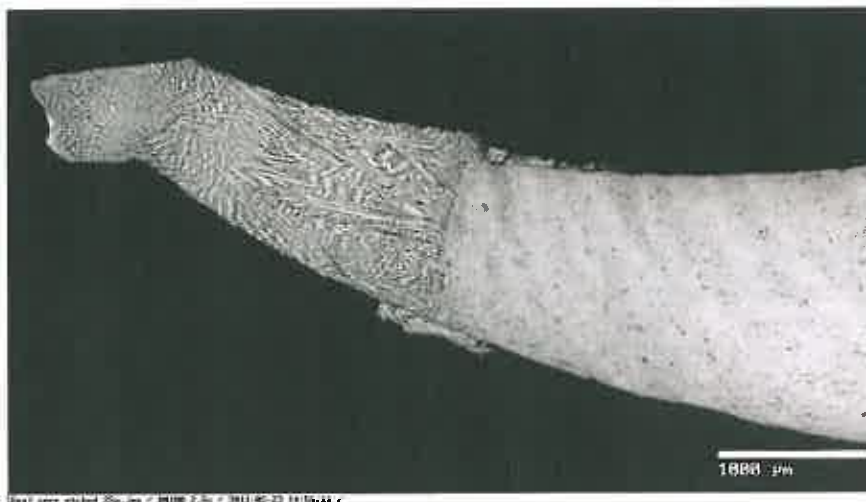
Photo No 13. Cross section, in etched condition, shows the seal tooth with the dabber weld repair.

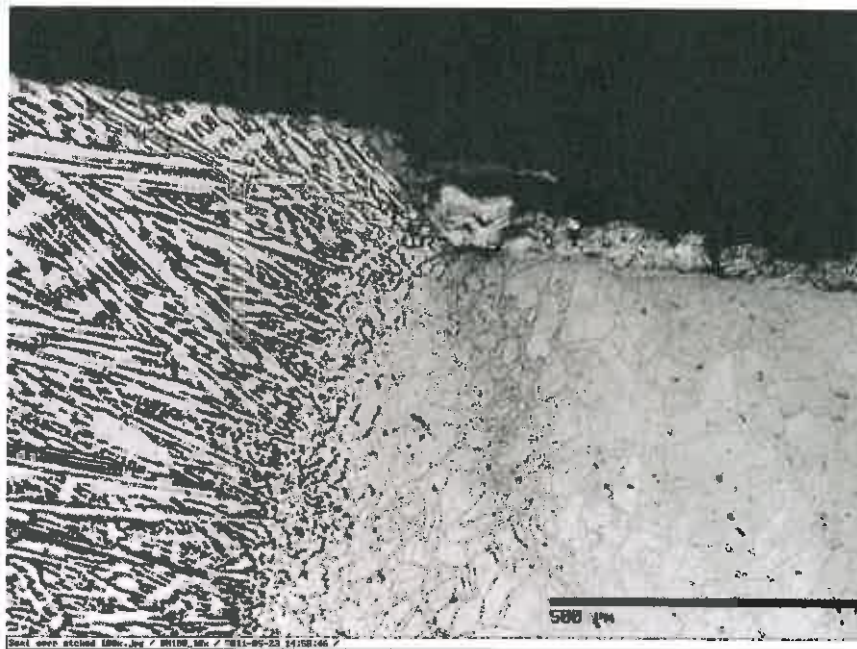
Photo No 15. Higher magnification of the area in the red rectangle in previous figure shows the machining step between the original seal and the repair weld.

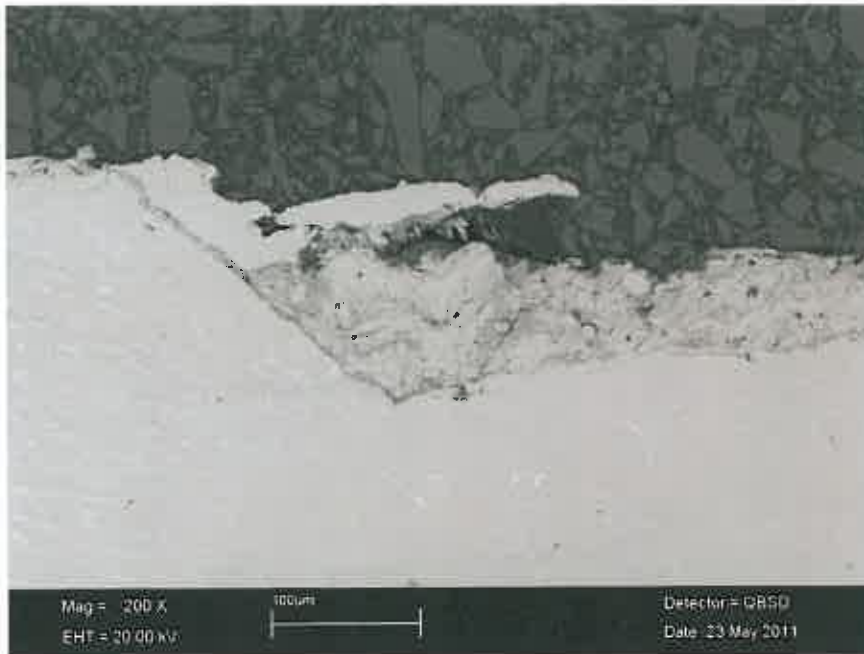
Photo No 16. SEM-photo in 200X shows that the bottom of the machining step between the original seal and the repair weld is considered to be a sharp corner.

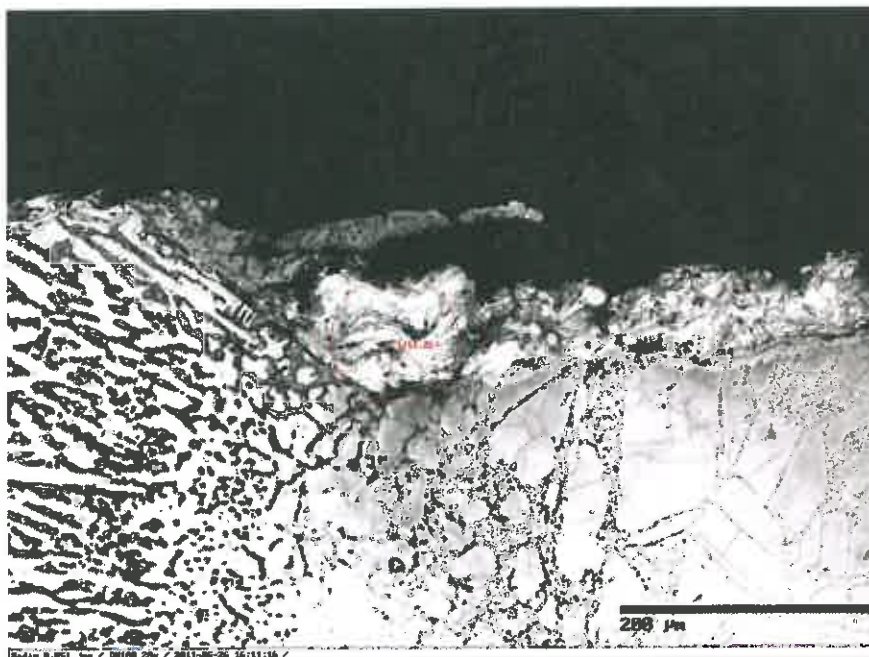
Photo No 17. The radius of the machining step is measured to be 0.05mm.
