## **AIRCRAFT ACCIDENT REPORT**

**UNCONTAINED ENGINE FAILURE/FIRE**

**VALUJET AIRLINES FLIGHT 597**

**DOUGLAS DC-9-32, N908VJ**

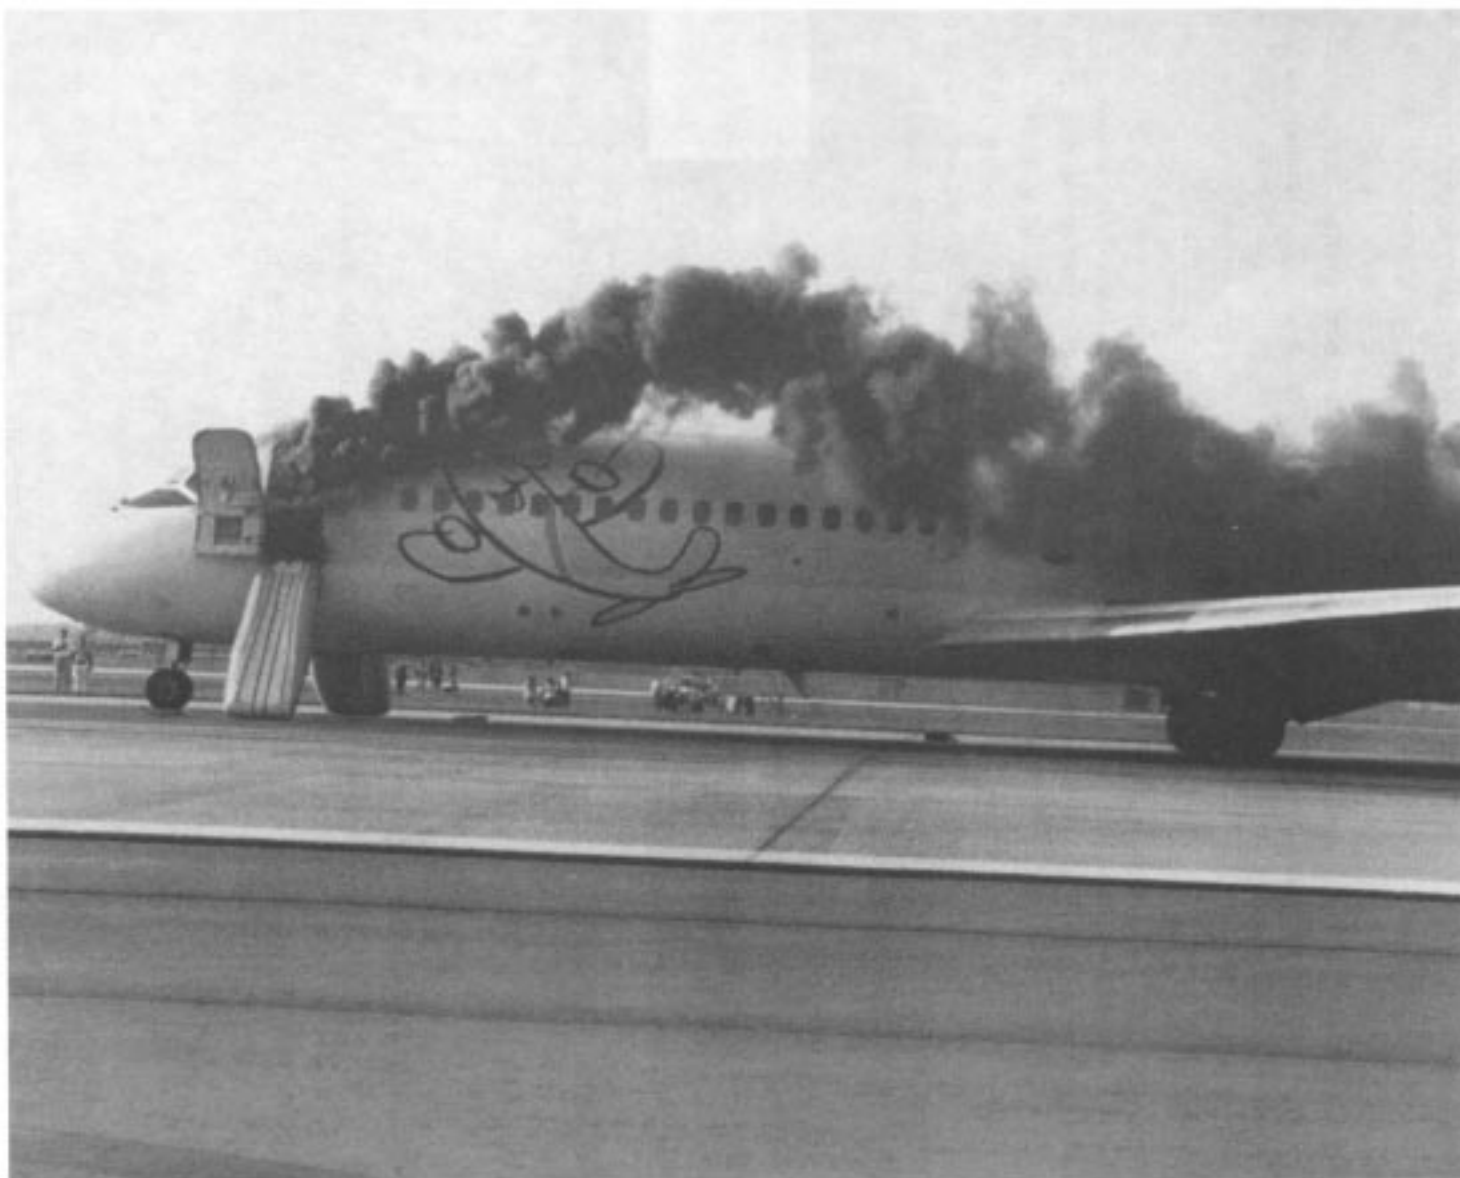
Figure 3—Photograph of flight 597 after uncontained engine failure

The fuselage was destroyed by fire, which gutted the interior, burned through the roof of the forward cabin area of the airplane, and consumed most of the cabin overhead. There was substantial exterior damage with circumferential outward tearing of the right engine cowl and engine case in the plane of rotation of the right engine 7<sup>th</sup> stage high pressure compressor (HPC) disk. There was also shrapnel damage to the fuselage and left engine cowl.

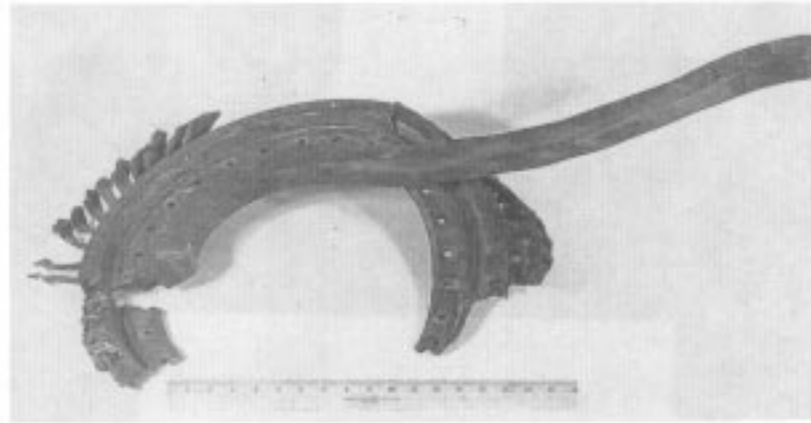
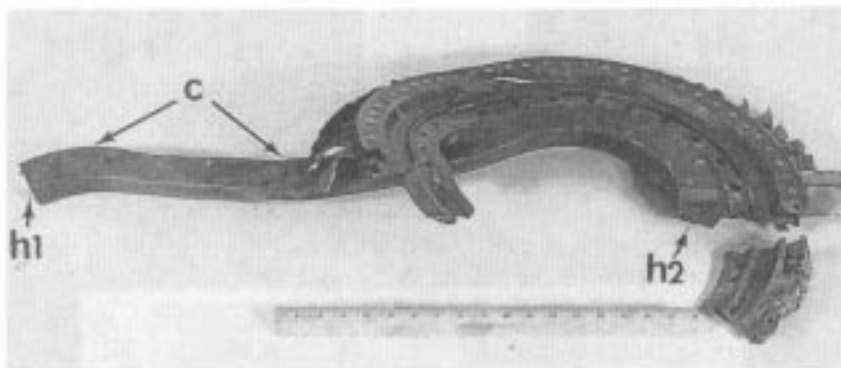
Figure 4—Overall views of 7<sup>th</sup> stage compressor disk as received

The larger piece of the recovered disk was fractured circumferentially (see arrows "c," figure 4), which is typical of overstress. About ¼ of the disk outward (toward the rim) of the bore was separated and not recovered. There was a radial fracture of the disk bore at the position shown by arrows "h1" and "h2" in figure 4. Examination of these fractures showed that they were matching overstress separations and therefore accounted for the complete separation of the bore section of the disk.

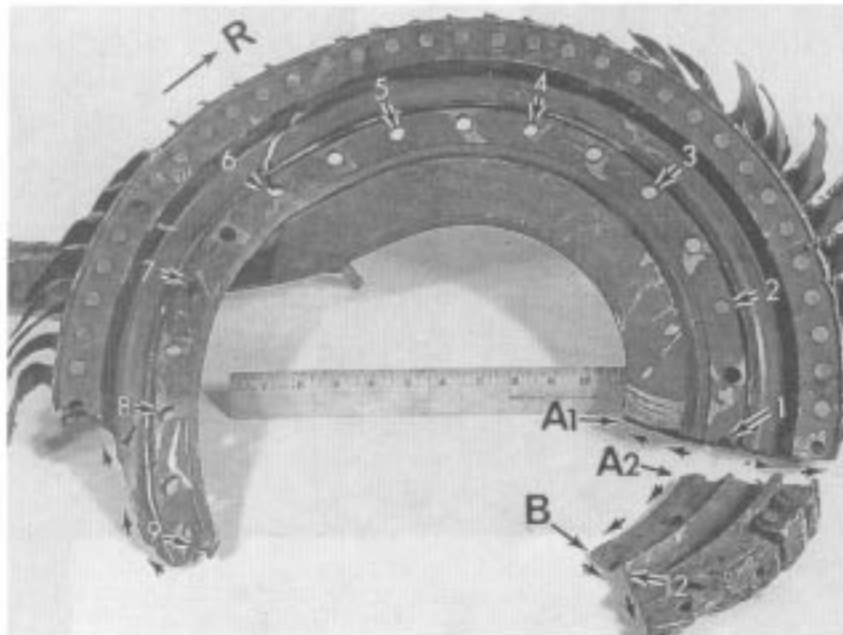
Figure 5—View looking forward showing bulk of the 7<sup>th</sup> stage compressor disk

Figure 5 shows the aft face of the two recovered pieces situated relative to each other by fracture matching. The SR holes are shown by arrows "1" through "9" and arrow "12" in figure 5. The SR hole numbering was arbitrarily begun at the radial fracture plane indicated by arrows "A1" and "A2" in figure 5 and progressed sequentially counterclockwise looking forward around the disk (as shown in figure 5). The missing section of web would have contained SR holes "10" and "11" in the above numbering sequence, and three tierod holes.

Fatigue cracking was also evident radiating outboard from other SR holes, indicated by arrows “4,” “6,” “8,” “9,” and “12” in figure 5. The largest of these fatigue cracks was 5 mm (0.20 inch) outboard from its respective hole. Most of the secondary cracks appeared to initiate at well-defined corrosion pits in the hole wall with the largest and deepest pit measuring 0.01-inch wide at the hole wall and being about 0.003-inch deep. Magnified examination of the cross section of the crack disclosed a surface deposit on the pit cavity wall and hole wall surfaces indicative of the nickel-cadmium plating.

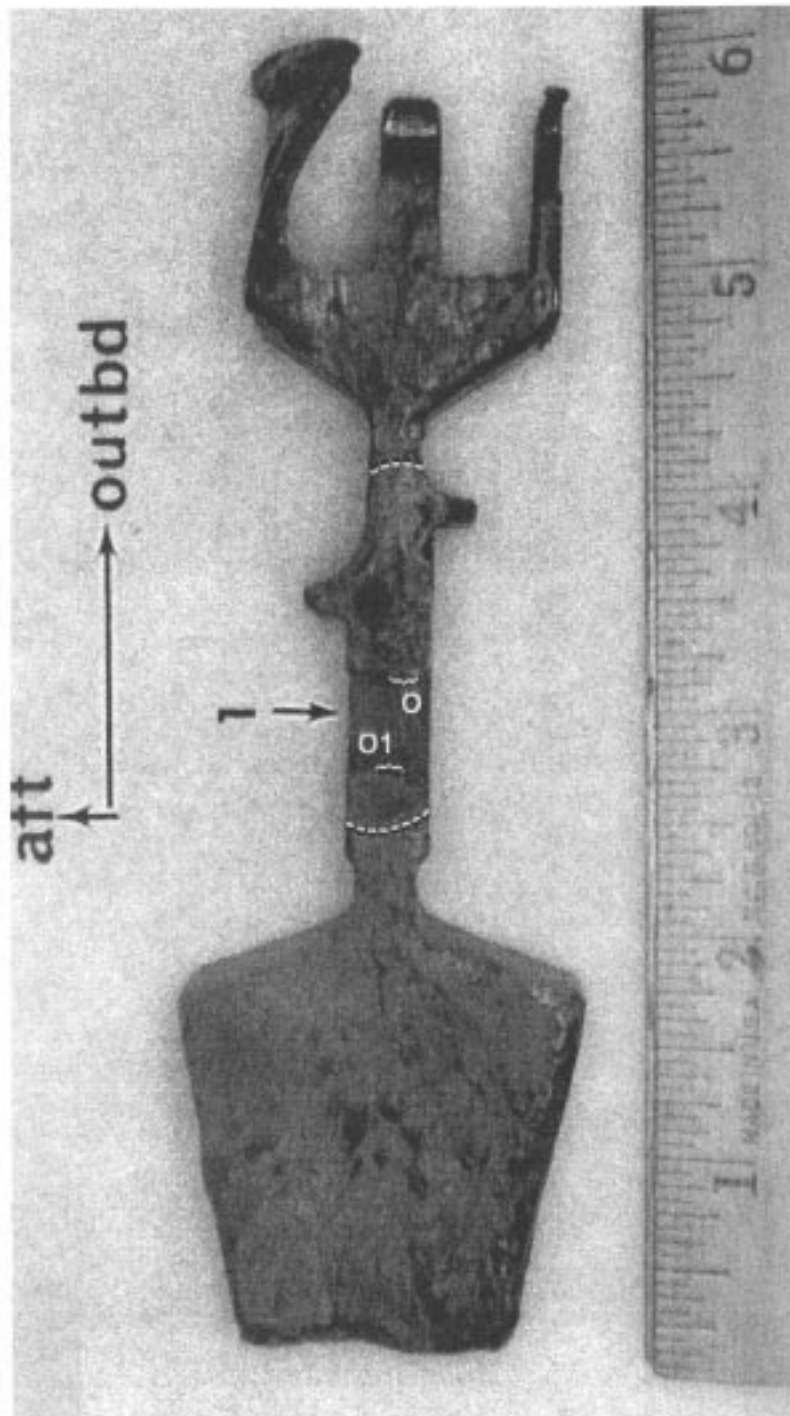
Figure 6—Fracture surface containing the primary fatigue cracking

Scanning electron microscope (SEM) examination established that fatigue cracking originated from numerous pits in the hole wall and progressed radially inboard (toward the center of the disk) from SR hole "1," approximately 6.9 millimeters (mm) (0.27 inch). SEM examination also showed evidence of fatigue cracking outboard (toward the rim) from SR hole "1" that measured 22.25 mm (0.88 inch). Figure 6 shows the fracture surface containing the primary fatigue crack.

Visual and SEM examinations of the outboard fracture surface from SR hole “1” showed extensive post-fracture smearing that obliterated most of the microscopic fracture features on the fracture surface. However, some undamaged fracture areas were found that indicated an origin area at the outboard wall of SR hole “1.” Features outside of the smeared region up to a distance of about 3 mm (0.12 inch) showed a granular appearance with no evidence of striation development. At this point, fatigue striation development was noted that continued outboard approximately 22.25 mm (0.88 inch) from SR hole “1.”

Striation spacing measurements of the fracture surface of SR hole “1” were attempted but hampered by the smearing in the fracture surface. The striation spacing in the granular type fracture regions near the origin were possibly unresolvable or nonexistent. Striation spacings outside of the granular fracture regions and smearing for the outboard fatigue crack from SR hole “1” averaged about 2 microns (0.002 mm) from about 3 mm to the terminus at 22.25 mm. This indicated that at least 9,500 striations (19 mm/0.002 mm per striation) were present along this fatigue region.

The 0.88-inch fatigue crack outboard from SR hole “1” was the longest fatigue region at any of the SR holes. The crack lengths from each side of the hole combined with the diameter of the SR hole (0.410 inch) gave a calculated overall crack length of 1.56 inch for SR hole “1” at the time of disk separation.

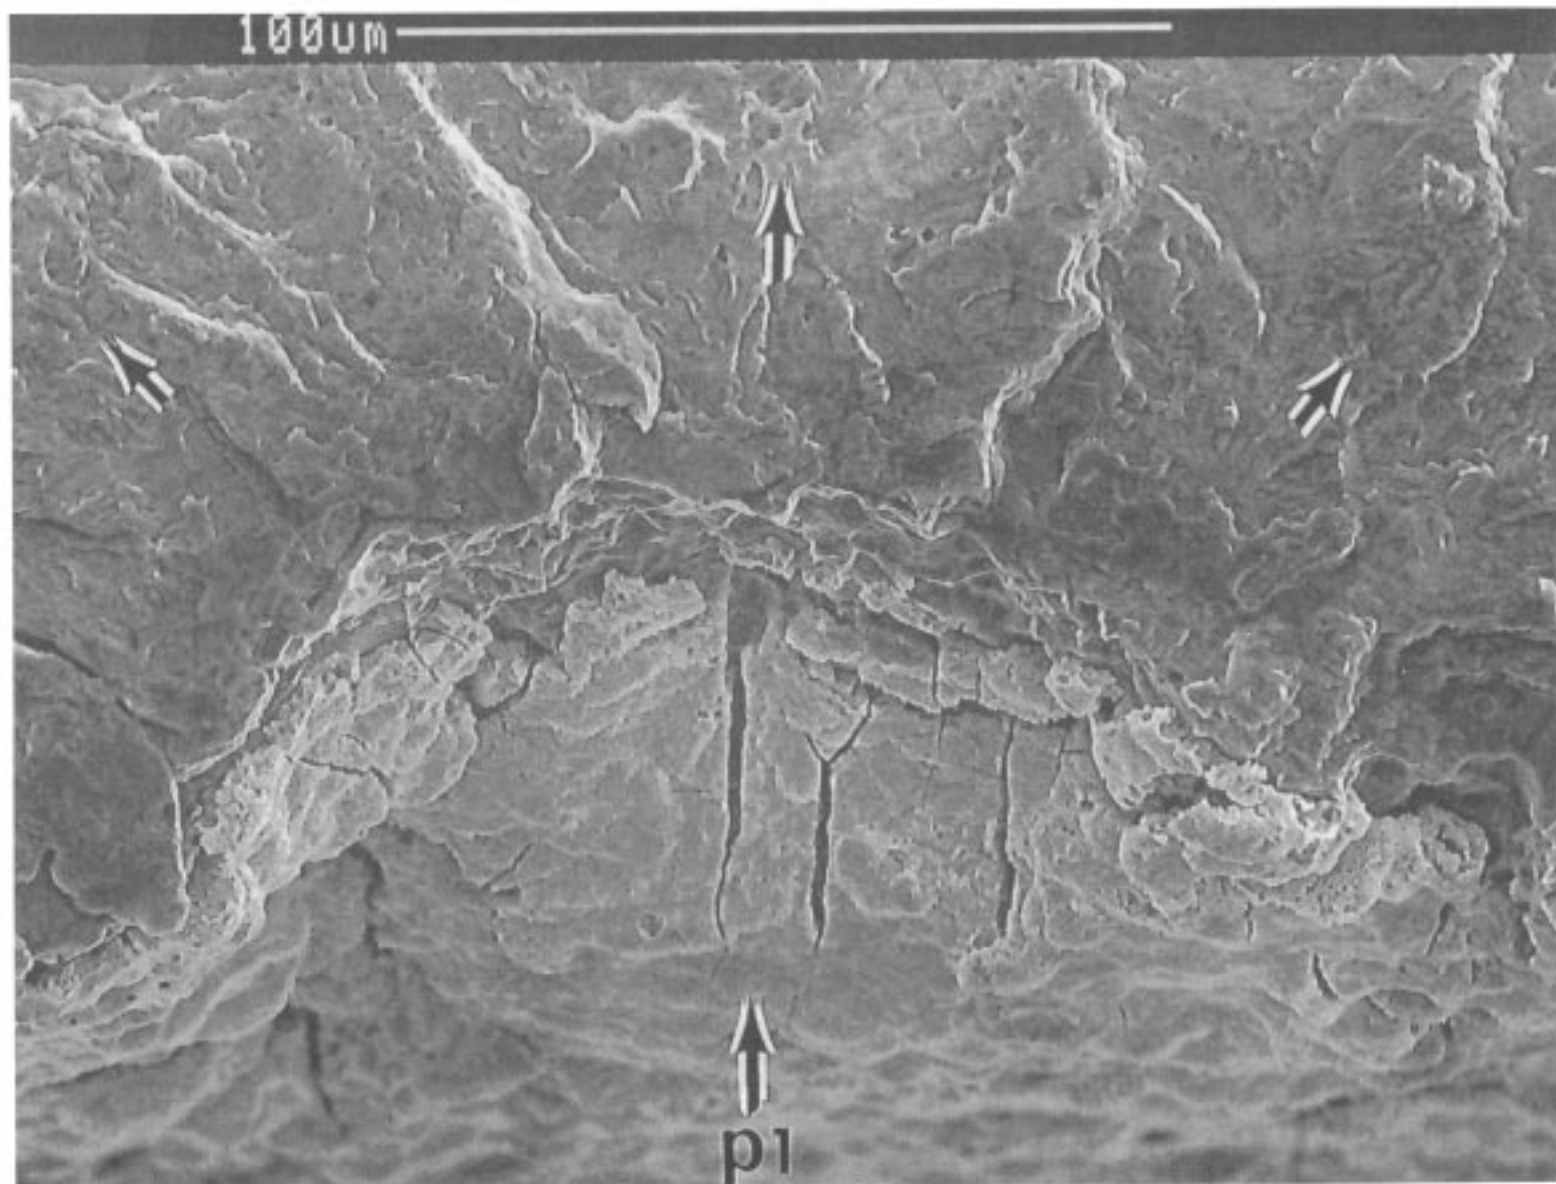
Energy dispersive x-ray analysis of the pits on the hole wall revealed cadmium-rich deposits<sup>16</sup> with some nickel. Cadmium-rich deposits were also found on the fracture surface adjacent to the pits and hole wall.

Figure 8—High-magnification view of a pit (at arrow “p1”) showing that it was filled with a Nickel-Cadmium deposit
