# **FINAL REPORT**

## **AIRBUS A330, REGISTRATION 9V-STO DIVERSION AFTER SMOKE WARNING**

**22 APRIL 2013**

AIB/AAI/CAS.092

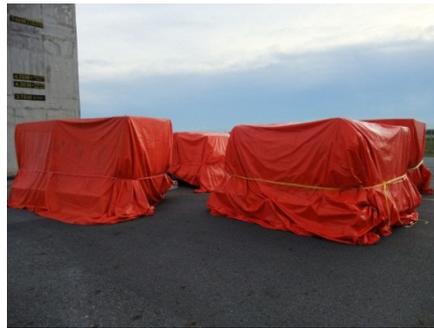
1.7.1.1 After the fire incident, all the cargo containers and pallets from the aft cargo compartment were covered by plastic sheets to protect against weather (see **Figure 1**) and kept in a secure place by the ARFS pending examination by the aircraft accident investigators and fire experts.

Figure 1: Cargo containers and pallets protected with plastic covers pending examination

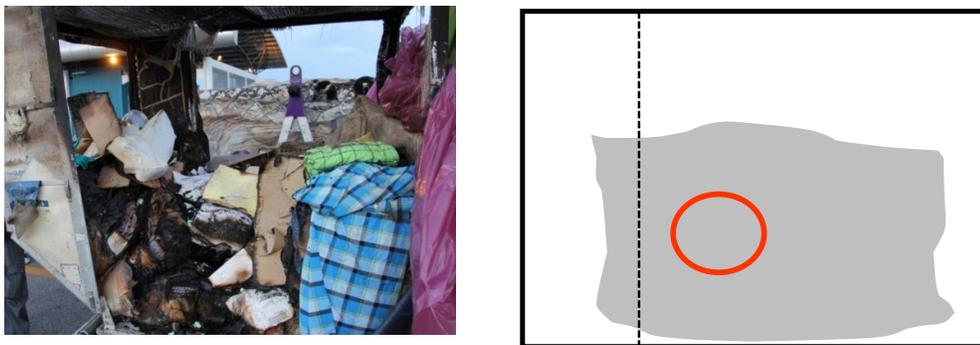
1.7.1.2 The investigators and fire experts examined the cargo containers and pallets on 24 April 2013 and identified an area in the lower middle part of container 42L which they believed was where the fire had originated (see **Figure 2**). Samples of fire debris around this area were collected by the investigators.

Figure 2: (Left) Cargo container 42L and its contents  
(Right) Top view of container, red circle denotes area believed to be the fire origin

2.1.3 The area of fire origin is most likely in cargo container 42L, although it is not possible to pinpoint the exact location, given the extent of the fire damage of the contents of the container.

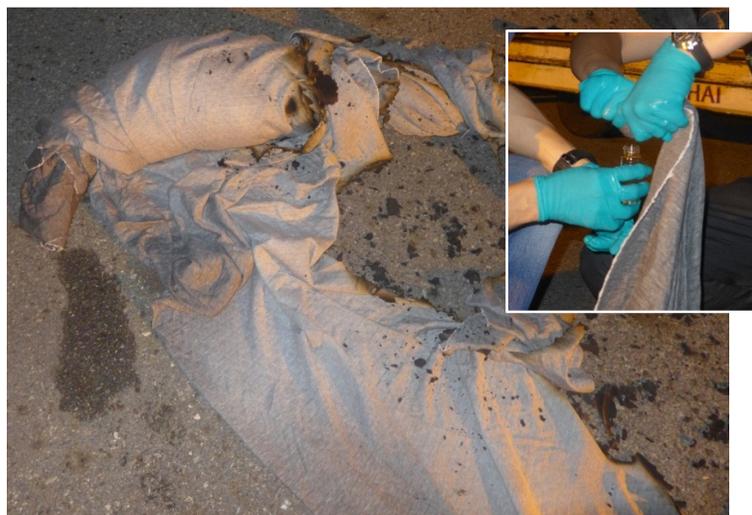
- 1.7.1.3 The investigators also found a damaged bale of fabric that was heavily soaked with an alcohol-like fluid. The investigators cut a sample from the bale and managed to collect a small quantity of the alcohol-like fluid by squeezing the sample (see **Figure 3**).

Figure 3: The bale of fabric heavily soaked in alcohol-like fluid.  
(Inset: Fluid being collected by squeezing the sample of fabric)

- 1.7.1.4 The alcohol-like fluid was subsequently identified by laboratory tests<sup>8</sup> to be ethanol, a flammable material. No other ignitable liquid was found.

2.1.4 While the presence of ethanol, an ignitable liquid which could have fueled the fire, was found by the investigators, the heat source that was needed to ignite the ethanol could not be determined.
