# **AIRCRAFT SERIOUS INCIDENT INVESTIGATION REPORT**

**V N – A 1 4 6**

**Japan Transport Safety Board**

**VIETNAM AIRLINES  
BOEING 777-200, VN-A146 (VIET NAM)  
ON B TAXIWAY AT NARITA INTERNATIONAL AIRPORT  
AT ABOUT 07:44 JST, JULY 30, 2008**

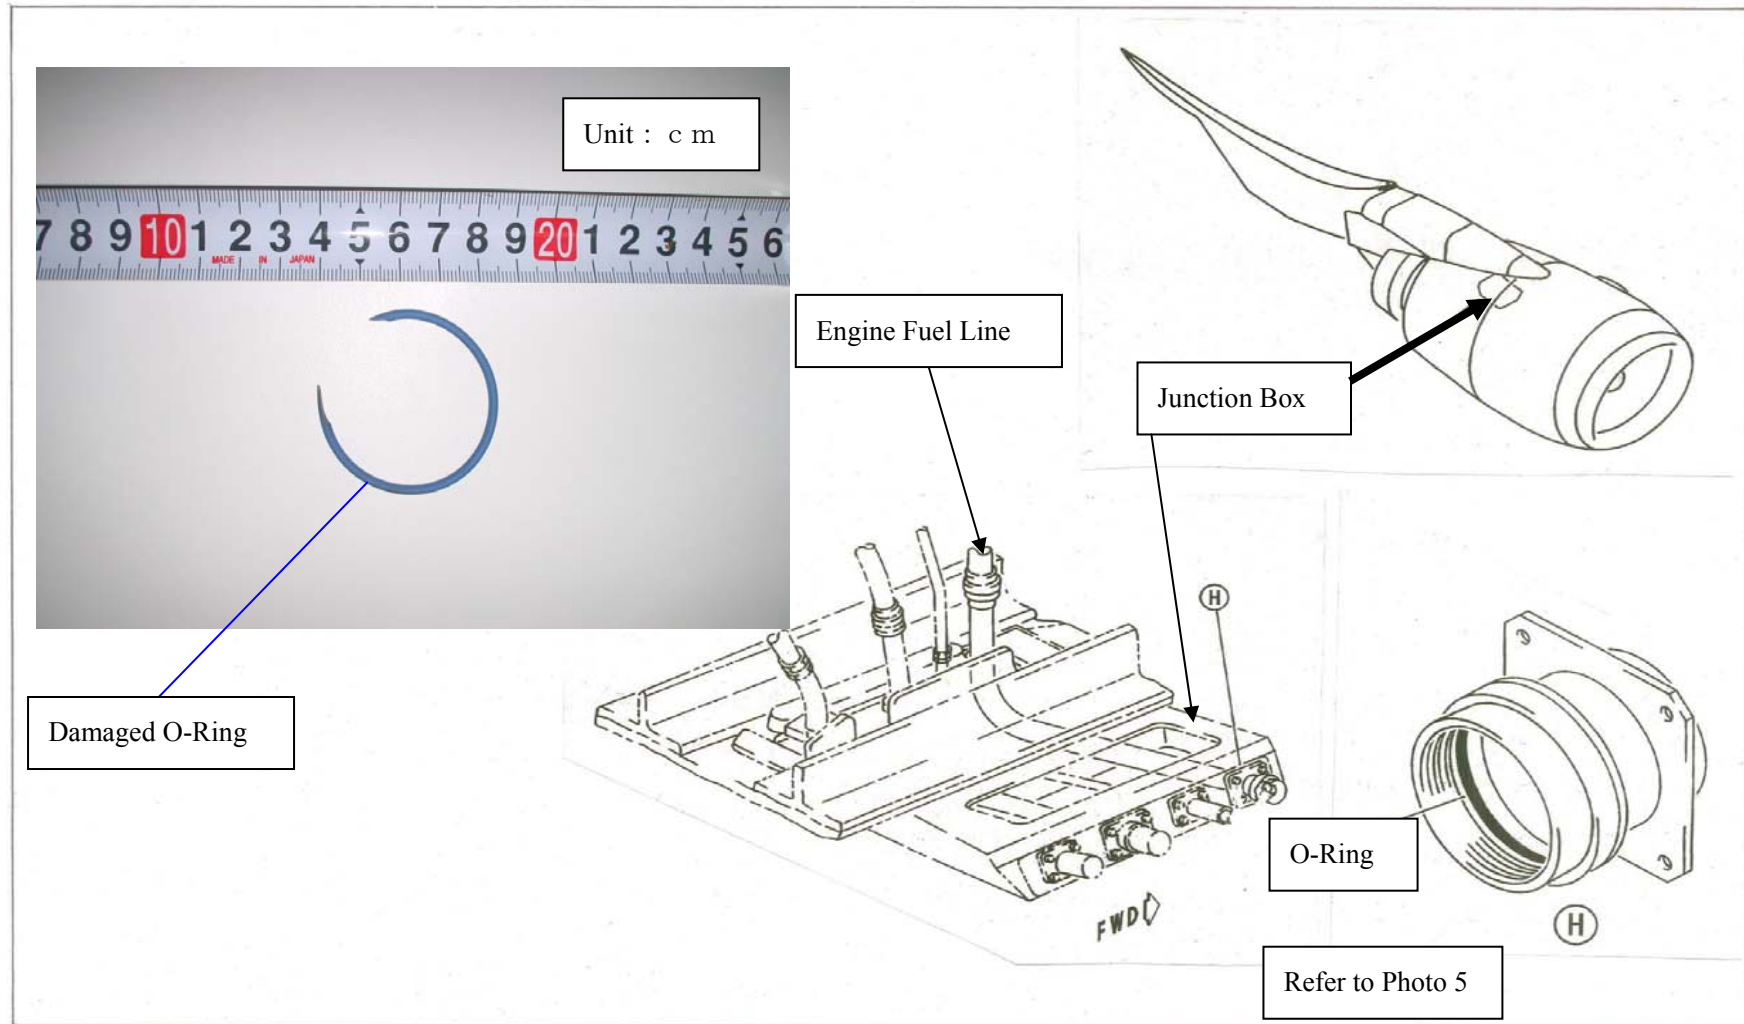
Figure 4 Fuel Supply Hose Coupling

- (1) Inside the engine cowl
  - ① Burn damage was found on the hydraulic pressure hose, hydraulic supply hose and case drain tube.
  - ② The fuel supply hose was burned. Disconnecting the quick disconnect coupling, the O-ring \*<sup>5</sup> was found severed with the ends showing sharply cut surfaces and 25% of its length was missing.
  - ③ Conducting a hardness test on the structural members inside the pylon, reduced hardness was found in almost all of the members.
  - ④ The electrical wiring harnesses were burned.
- (2) The outer surface of the engine case was burned and covered with soot.

- (3) The fractured surfaces of the damaged O-ring showed a sharply cut surface. It is therefore considered probable that the O-ring was pinched and became damaged when the fuel supply hose was connected.

It is considered possible that fuel leaked due to a gap in the O-ring that was created when the O-ring was pinched and severed during installation of the fuel supply hose.

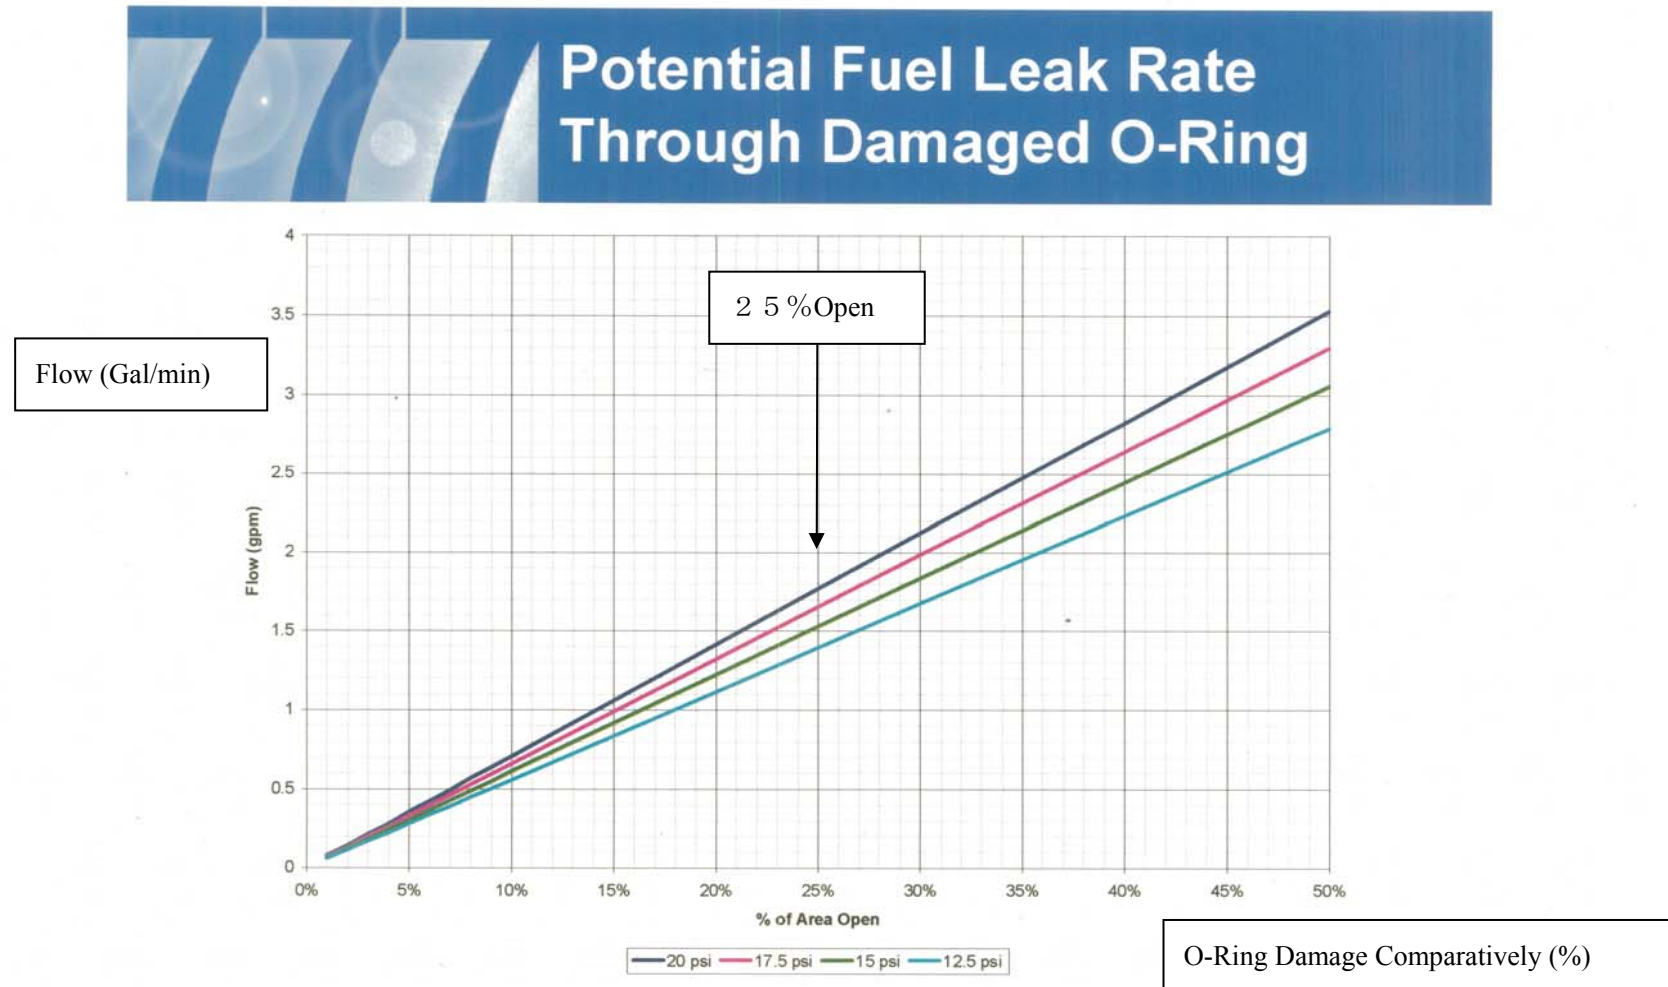
Figure 6 Fuel Leak Rate with the Damaged O-Ring

Using a fuel system tester, a fuel pressurization leak test was conducted using the O-ring removed from the Aircraft. Fuel leakage from the fuel supply hose coupling was detected.

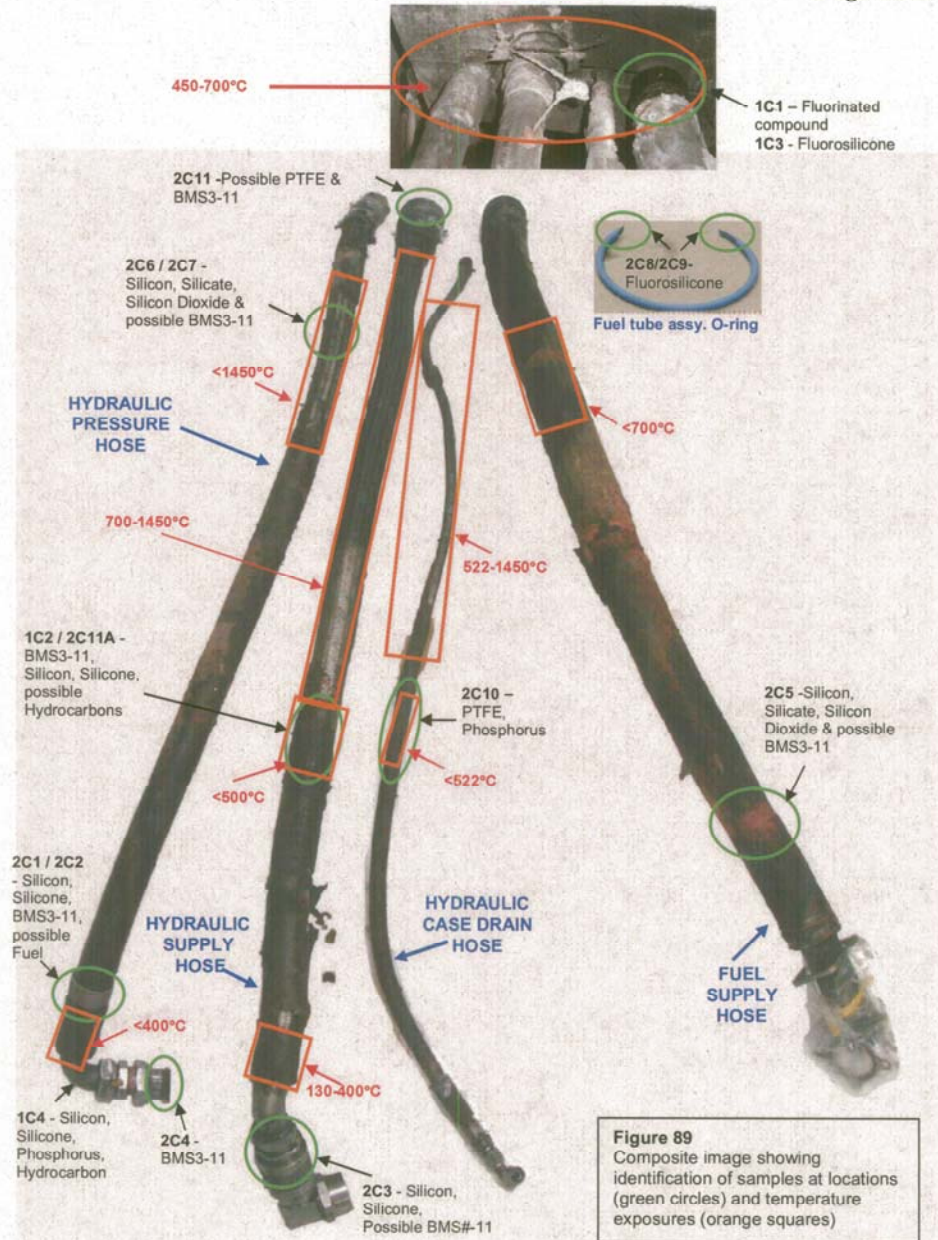
Figure 7 The Examination Results of Burning Temperature, etc.

- (3) Hoses and other components near the junction box for the right engine of the Aircraft  
The extent of burn damage suggested that the temperatures prevailing around the right engine junction box had been between 450°C and 1,450°C.

- ① Hydraulic hoses: Burned (hydraulic pressure hose <1,450°C and hydraulic supply hose 700–1,450°C); fuel components were detected on the surface of these hoses.
- ② Fuel supply hose: Burned (<700°C)
- ③ Other hoses: Burned (case drain tube 522–1,450°C)
- ④ Engine fire and overheat detection system: Partially burned
- ⑤ Engine fire detection card: In good condition

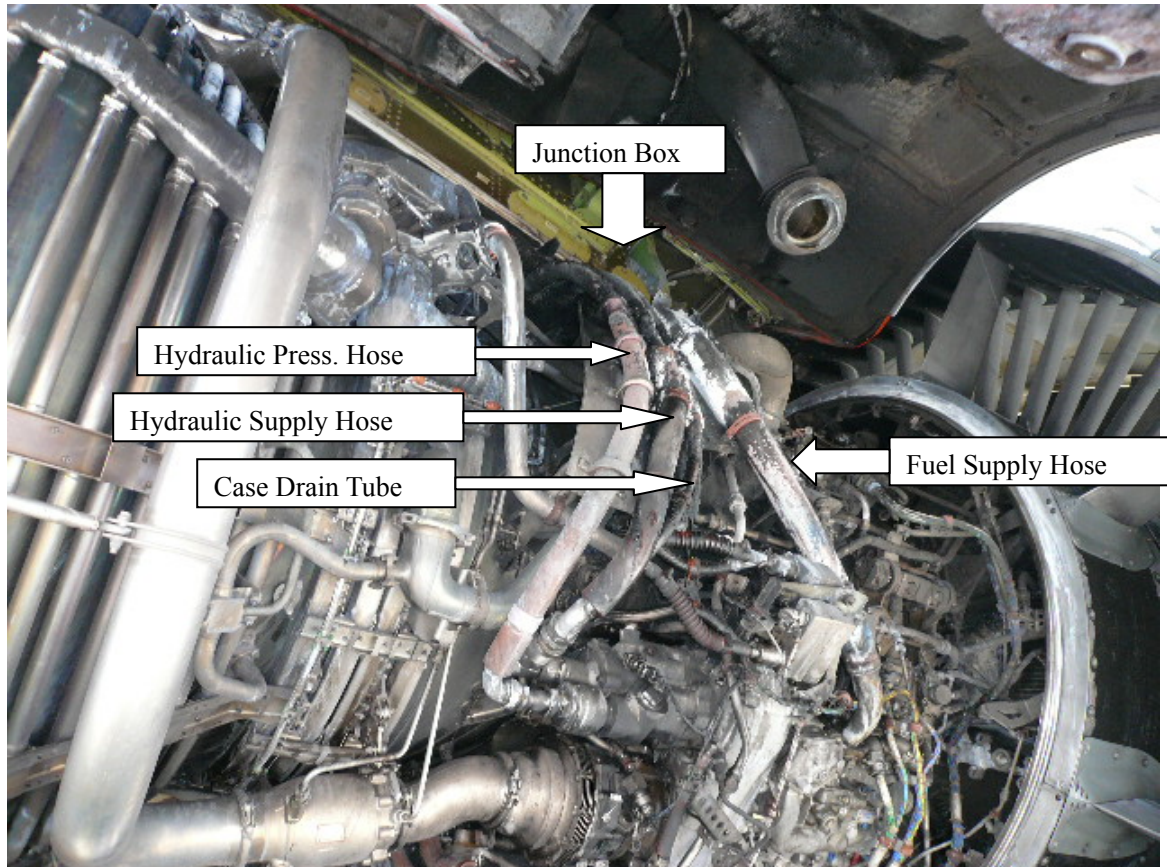
Photo 3 Engine Cowling Interior

When I started opening the aft cowlings next, the heat shield fell down in shatters. It was so heavily burned that I was relieved that no one had been injured.
