# ACCIDENT REPORT

occurred to the aircraft  
ATR72-212A (ATR 72-500)  
registration marks YR-ATS

Rome Fiumicino airport  
February 02<sup>nd</sup> 2013

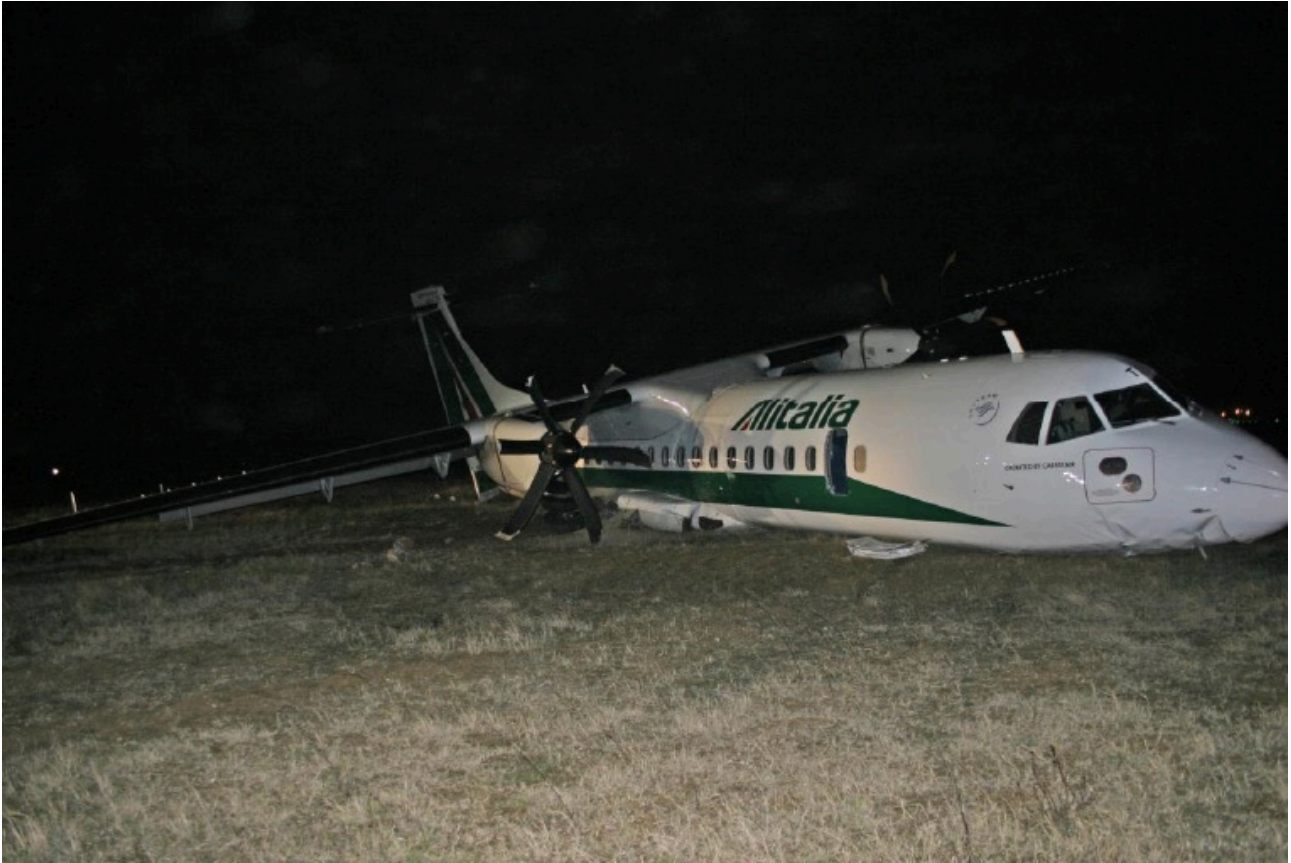
Picture 1: the ATR 72 YR-ATS after the accident

The aircraft was affected by a failure of the front and the main gear, damage to the right propeller and a permanent deformation of the fuselage in such a way that reparability and reconditioning would not be possible.

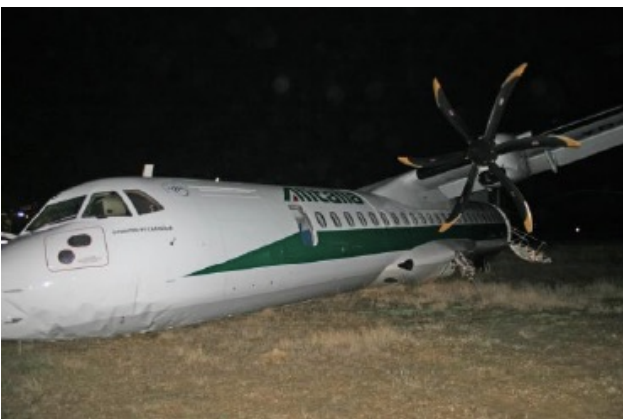
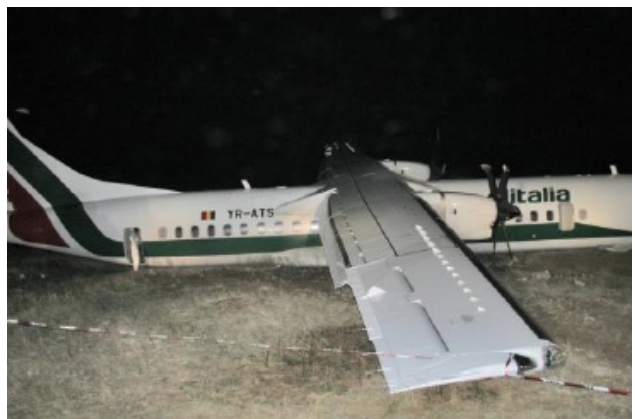
Pictures 2 and 3: the ATR 72 YR-ATS after the accident

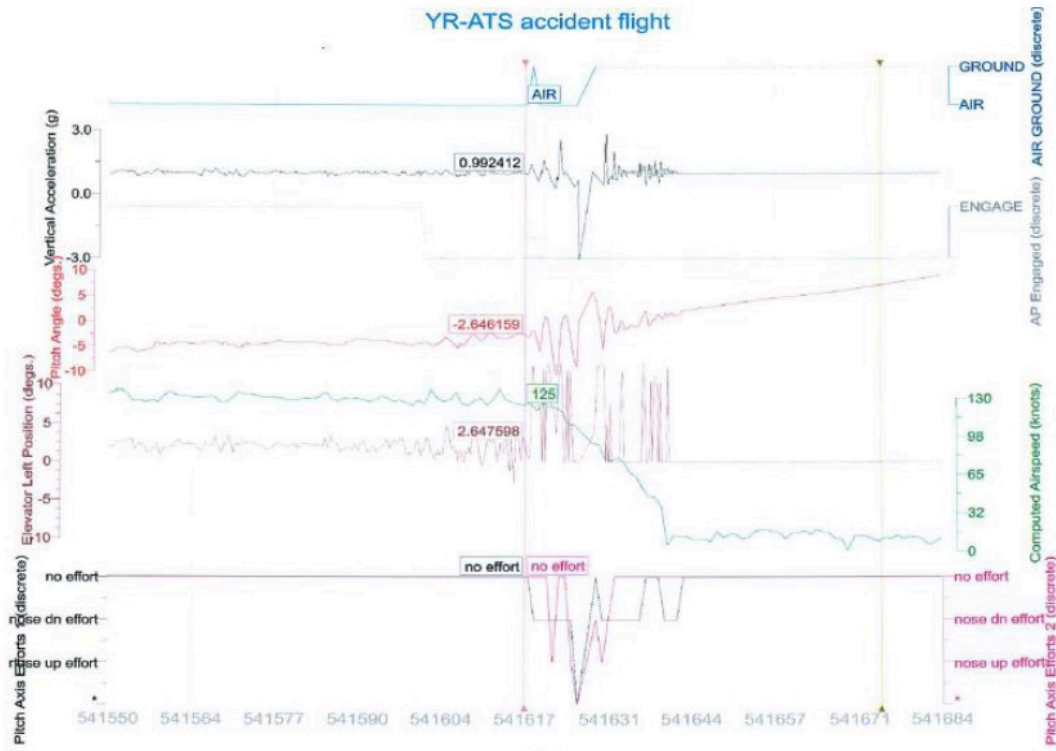
At the time of the first contact with the runway, as it is depicted in *Figure 11* below, the "snapshot" of the selected parameters of interest shows: the AP was not inserted (as expected by the OM of the company to the "minimum" of the instrumental procedure), that the pitch had an angle of -2.6 degrees, the speed was of 125 KIAS and that no evidence of opposites *inputs* by the two crew members was found. The above data indicates that the aircraft touched the runway during a controlled approach.

From the analysis of the parameters after the first contact with the runway (*Figure 11*) and after the first bounce (*Figure 12*) emerged that on the *pitch axis effort*, was set up an opposite input from the two pilots: the PF (Captain) had an input to "pitch down" (*pitch axis effort 1*), while the PNF (copilot) had an input to "pitch up" (*pitch axis effort 2*).

The above-mentioned situation might have caused the activation of the PUM, a device which, by detecting opposing forces on the respective flight controls, unlocks in fact their interconnection in order to avoid the impairment of the aircraft controllability in case of an eventual blocking of only one *control column*.

Figure 11: FDR parameters at the first contact with the runway.

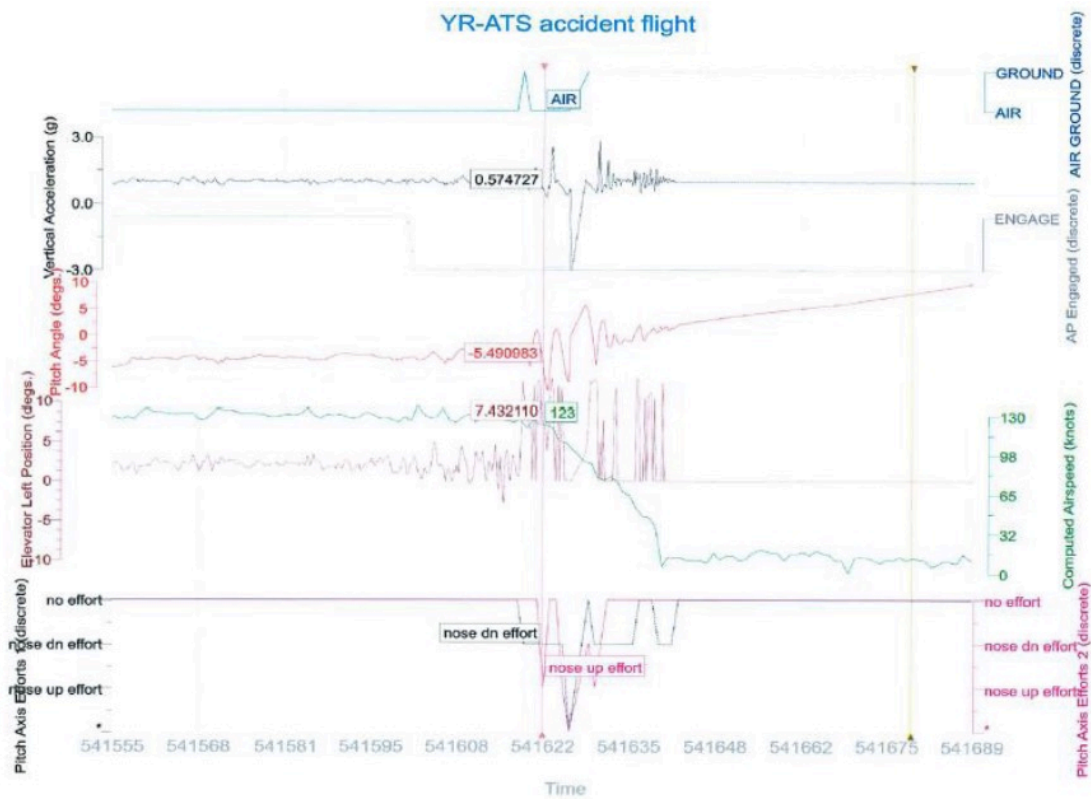
Figure 12: FDR parameters after the first contact with the runway.

At this point, as evidenced by the FDR (in particular from the analysis of the axis pitch effort, or in other terms of the efforts applied on the axis of the pitch control), at the two control columns (PF and PNF's) were applied opposite inputs: an input to “push down” by the PF, and an input to “pull up” by the PNF. This caused the activation of the PMU (see paragraph 1.11.3), causing the decoupling of the respective aircraft flight controls. The latter, subsequently, reaching the ground with a slight tilt to the left in respect to its longitudinal axis, damaged the left main landing gear, bounced with an inclination of about 10 degrees to the right and damaged, at the same time, the right main landing gear (leaning it towards the outside).

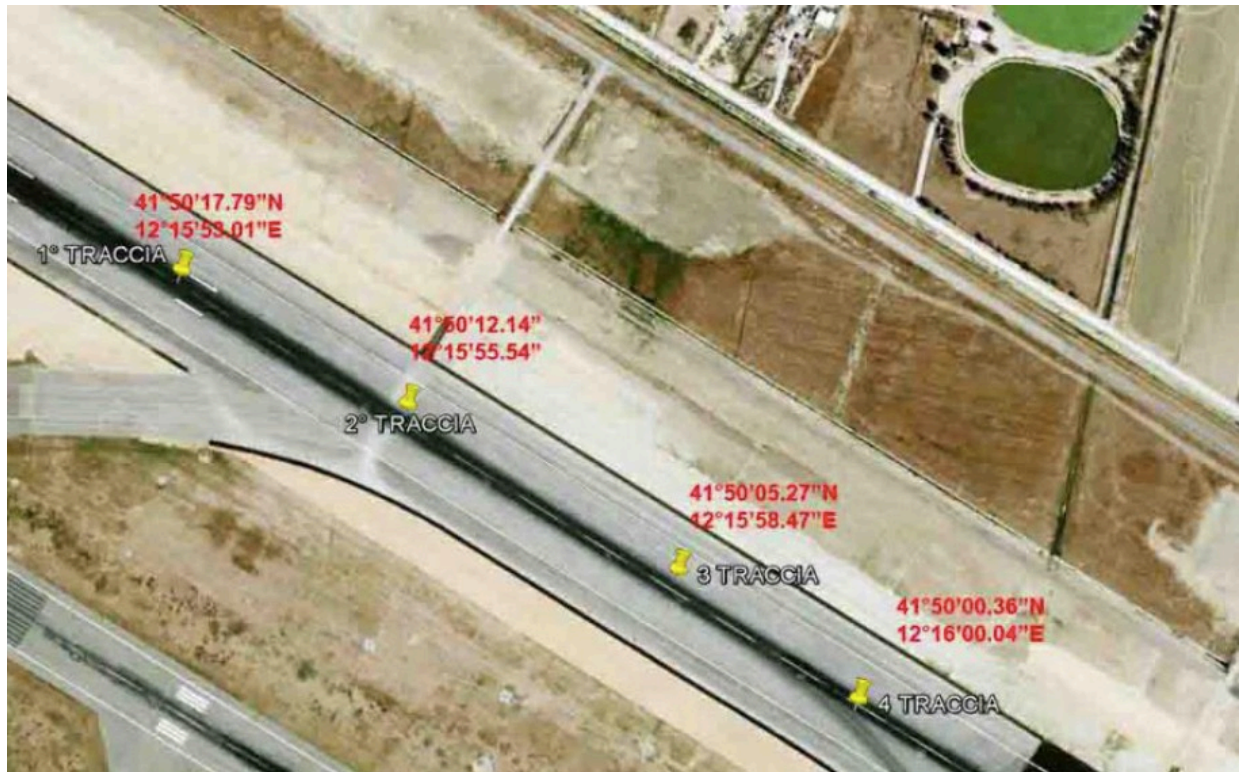
The first marks of the contact of tires were detected at a distance of about 560 m from the runway threshold, followed by other obvious signs of heavy contact of the nose gear and its doors after a distance of 320 m.

The next signs of contact have been found at, approximately, 180 m, 210 m and 170 m; at this point the evidence on the ground showed the ground traces of the fuselage until its exit from the runway for about 400 m. There was not any kind of dispersion of the wrecks.

Figure 13: Contacts tracks and their respective coordinates on the runway

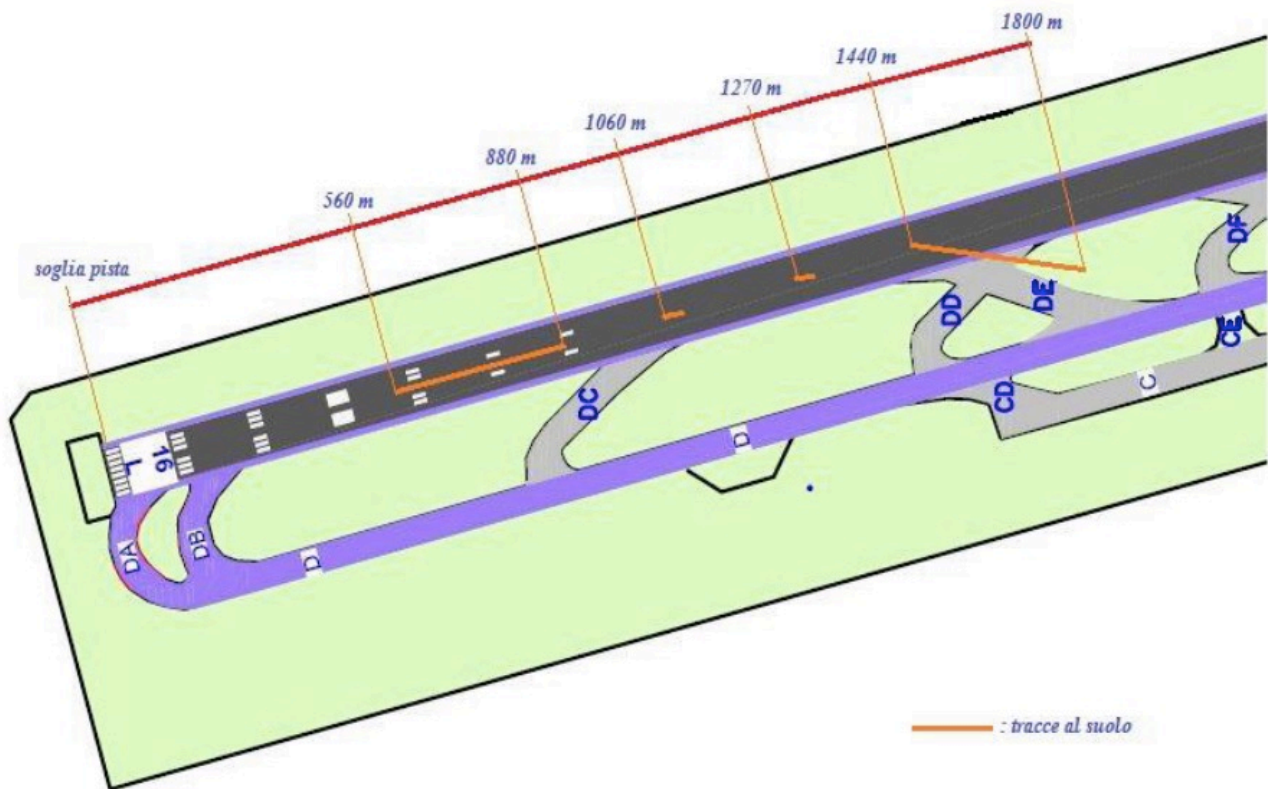
Picture 5: Ground tracks on the runway left by the front gear.

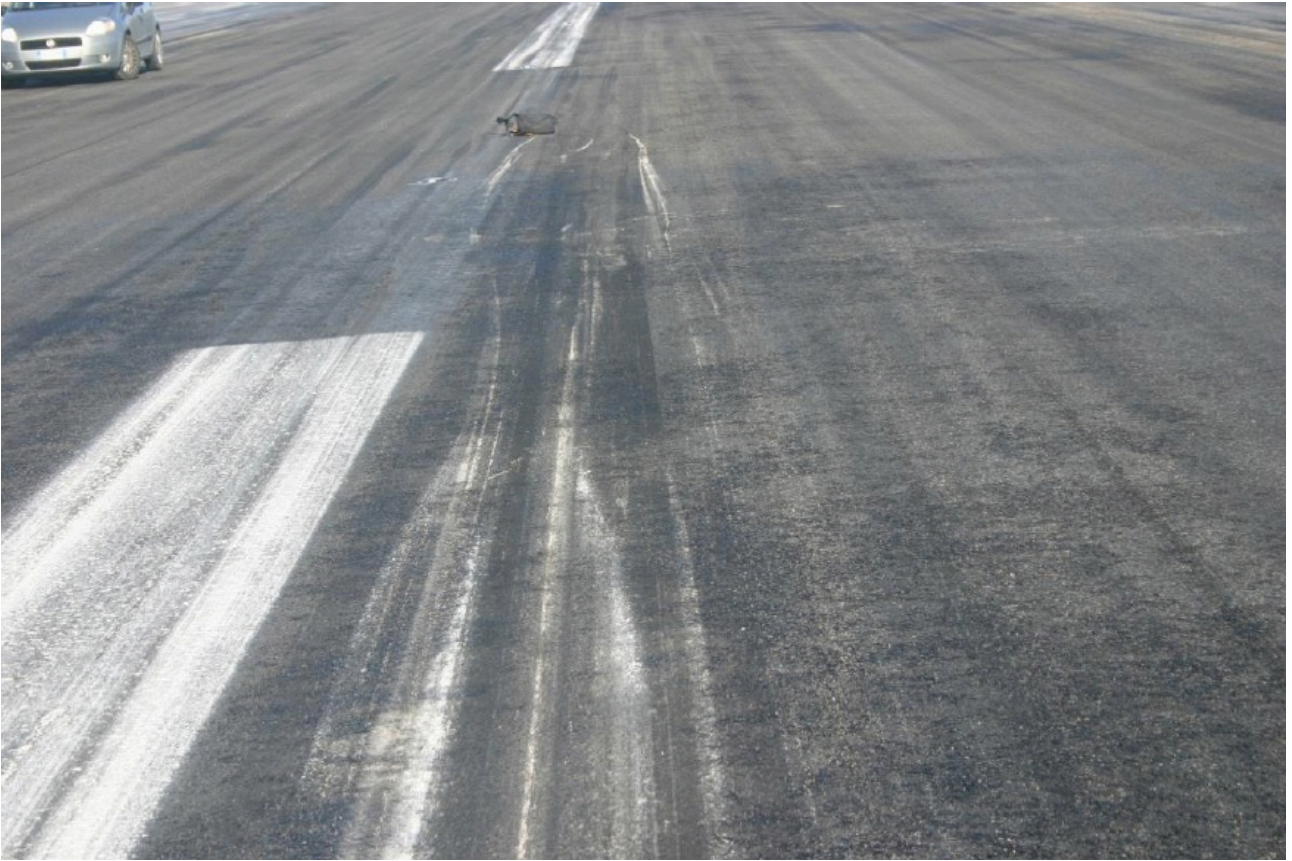
Picture 5 : Trails on the runway left by the nose gear

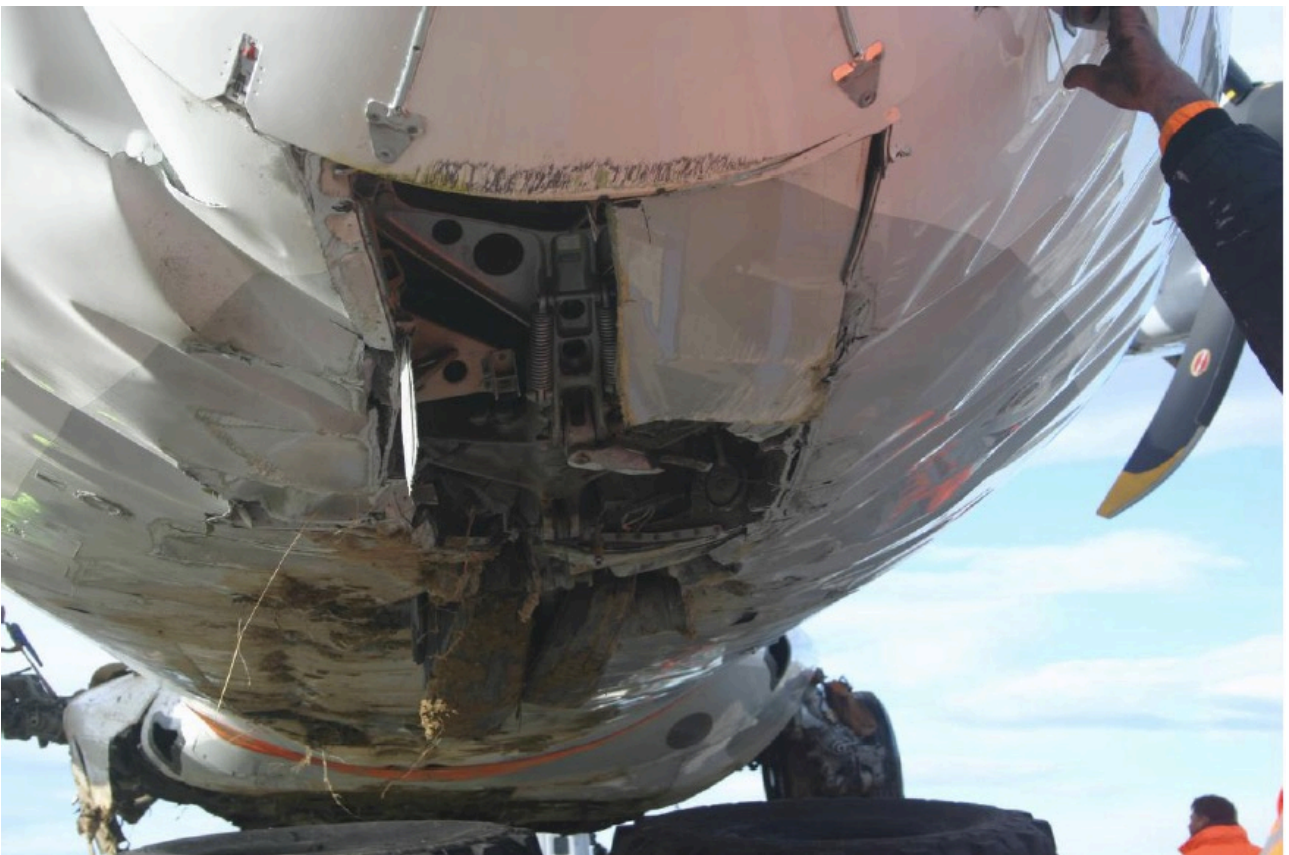
Picture 6: Damage to the aircraft

The aircraft wreckage appeared significantly damaged.

The fuselage appeared lying on the ground with the front landing gear retracted while the main one was retracted partially and greatly damaged. The fuselage appeared, however, substantially intact and accessible.

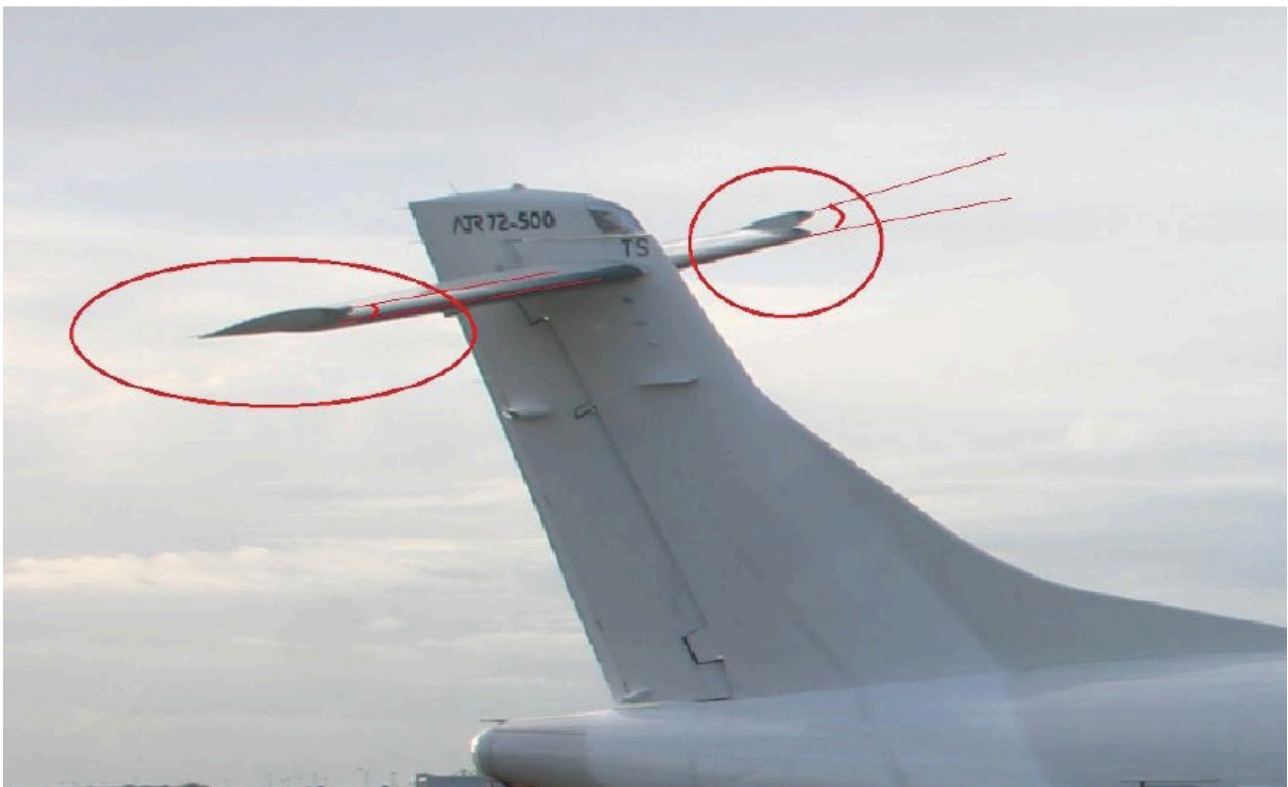
The tail and the wing panels with the relative movable surfaces were substantially intact, except from the tip of the right wing which had touched the ground and as a result was damaged. In particular, the stabilizers appeared not “coordinated”, or with different angles when confronted with the fixed-base parts (*picture 7*).

Picture 7: Empennage (tail assembly)

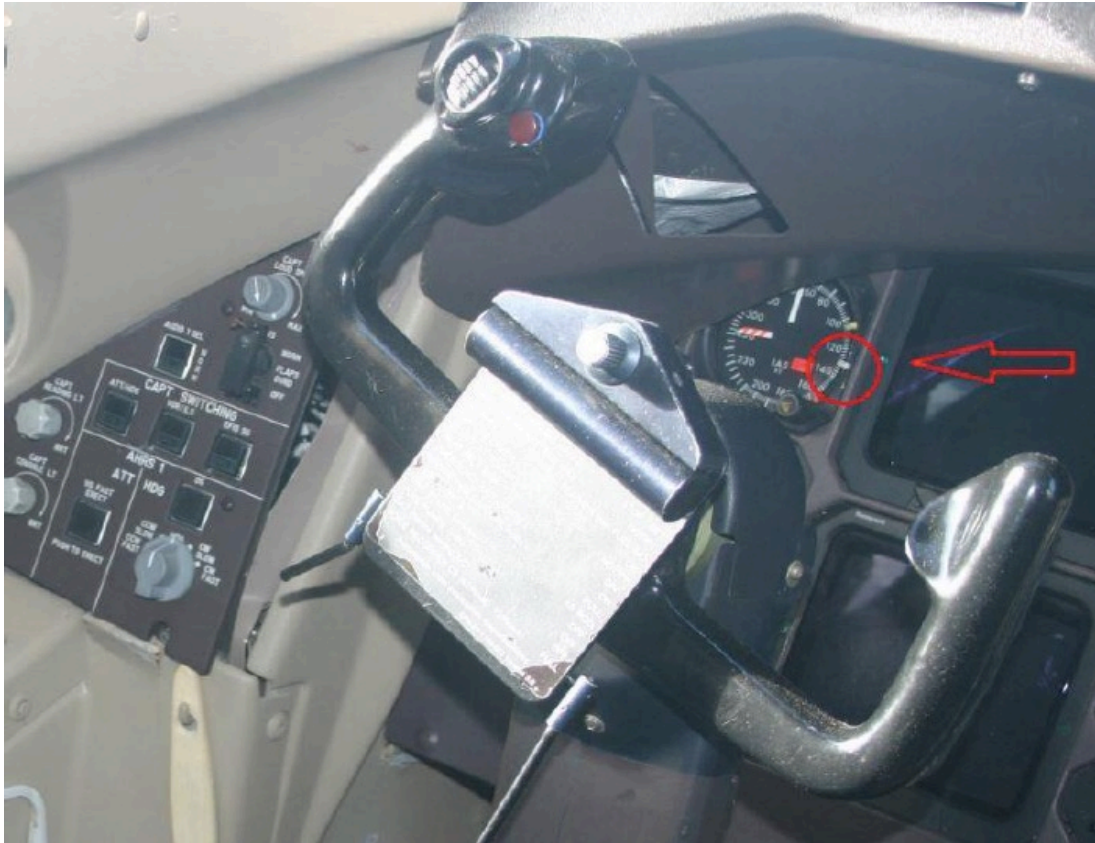
The cockpit appeared in a good condition and accessible; in the anemometers on the instrument panel (captain and co-pilot's side) the *speed* bug of the VAPP was set to 130 KIAS.

**Picture 8:** speed bug of the VAPP (captain's side)

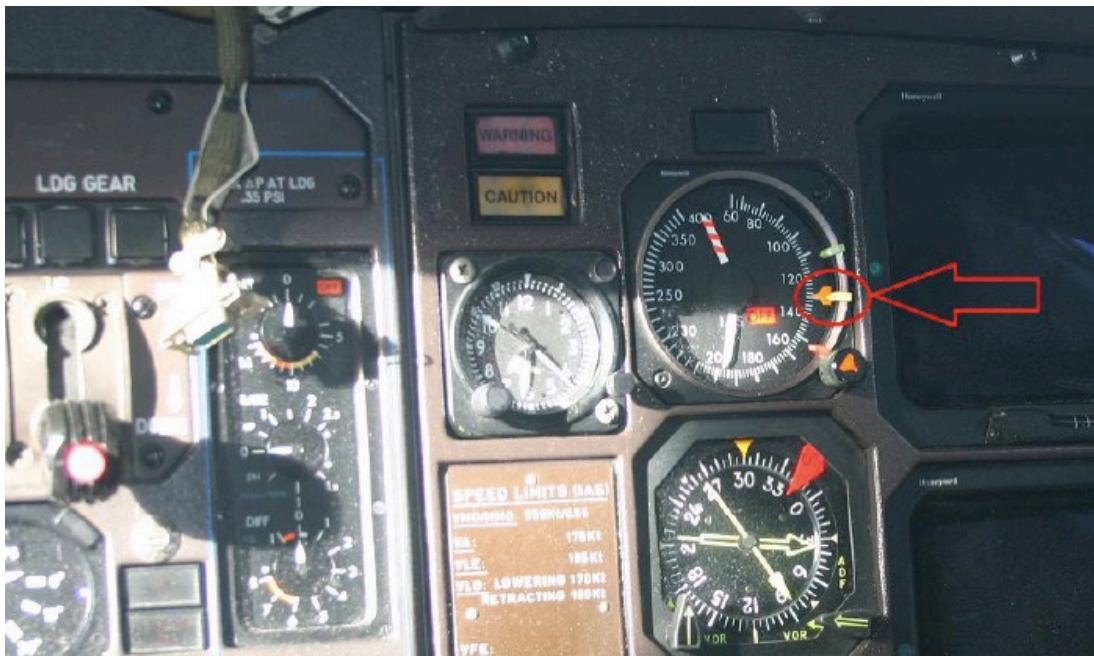
**Picture 9:** speed bug of the VAPP (co-pilot's side)

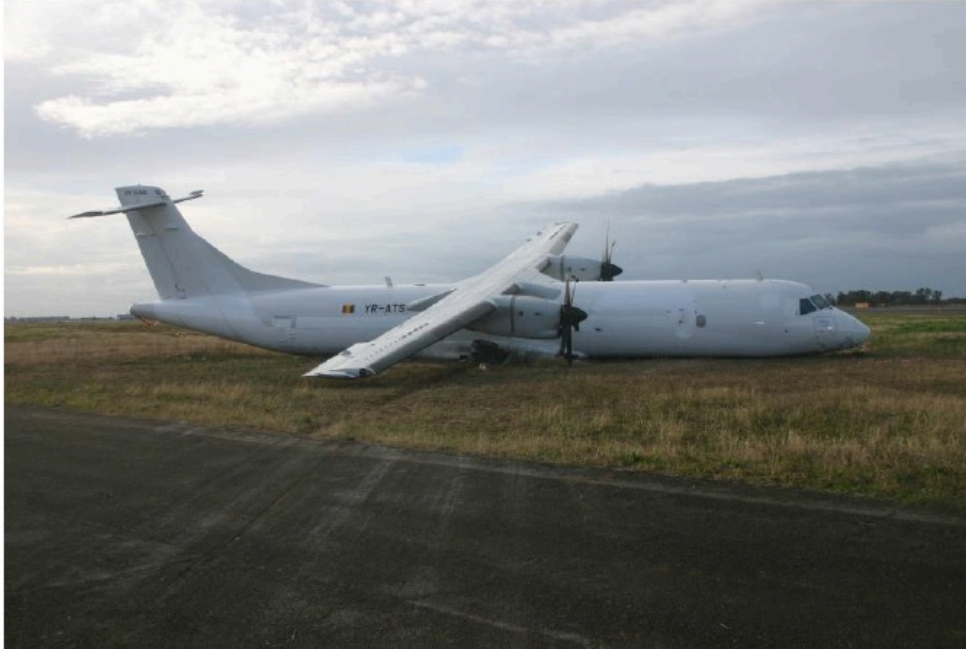
The morning of the 3rd of February, the ANSV staff, returned to the crash site for further operational inspection, acknowledged that, after the first inspection, the livery of the Italian carrier for which the flight had been operating, had been removed from the aircraft leaving out only the identification marks and the flag of nationality.

**Picture 10:** The wreckage of the aircraft the day after the accident with removed liveries.

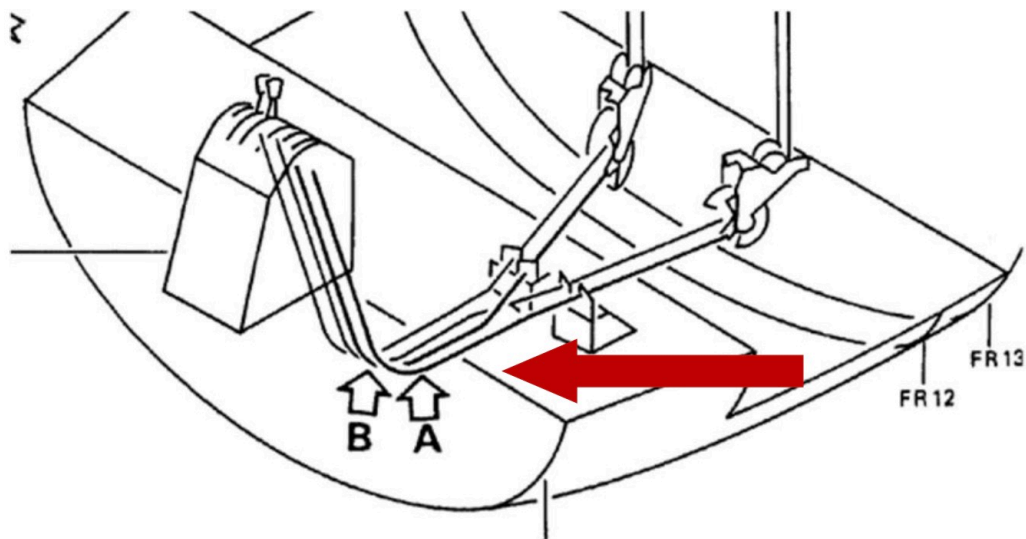
During the second touchdown with the runway, the engines flamed out, as shown from the data extracted from the FDR that indicated a sudden decrease of the propeller revs (NP) and of the exhaust gas temperature (ITT). Within examinations and along with the presence of the aircraft manufacturer, it had been detected that the shutdown was caused by a damaged mechanical linkage of the engine control levers (in particular the ones of the CLA) which were damaged from the collapsing of the front landing gear. As a result, this circumstance made the above-mentioned levers useless, with the consequent engines shut down.

Figure 14: Diagram of the engine control levers and the indication of the breaking point.

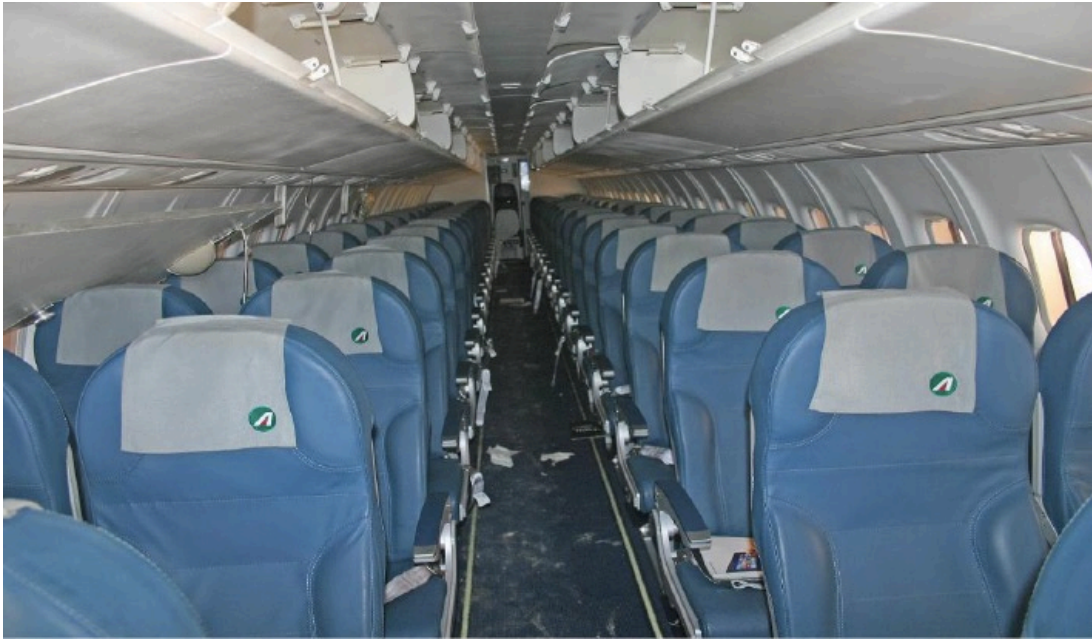
Picture 11: Cabin conditions detected during the operation inspection
