***This document is an English translation of the Preliminary Report on the fatal accident involving the Boeing 747-412F aircraft registered TC-MCL that occurred on January 16, 2017 at Manas International Airport, Bishkek, Kyrgyz Republic.***

**INTERSTATE AVIATION COMMITTEE  
AIR ACCIDENT INVESTIGATION COMMISSION**

**PRELIMINARY REPORT**

Type of occurrence	Fatal accident
Type of aircraft	Boeing 747-412F
Registration mark	TC-MCL
Owner	LCI Freighters One Limited (Ireland)
Operator	ACT Airlines
Aviation Authority	Turkish DGCA
Place of occurrence	Near Manas International Airport, Bishkek, Kyrgyz Republic, coordinates: N 43°03.248' E 074°2.271'
Date and time	16.01.2017, 07:17 local time (01:17 UTC), nighttime

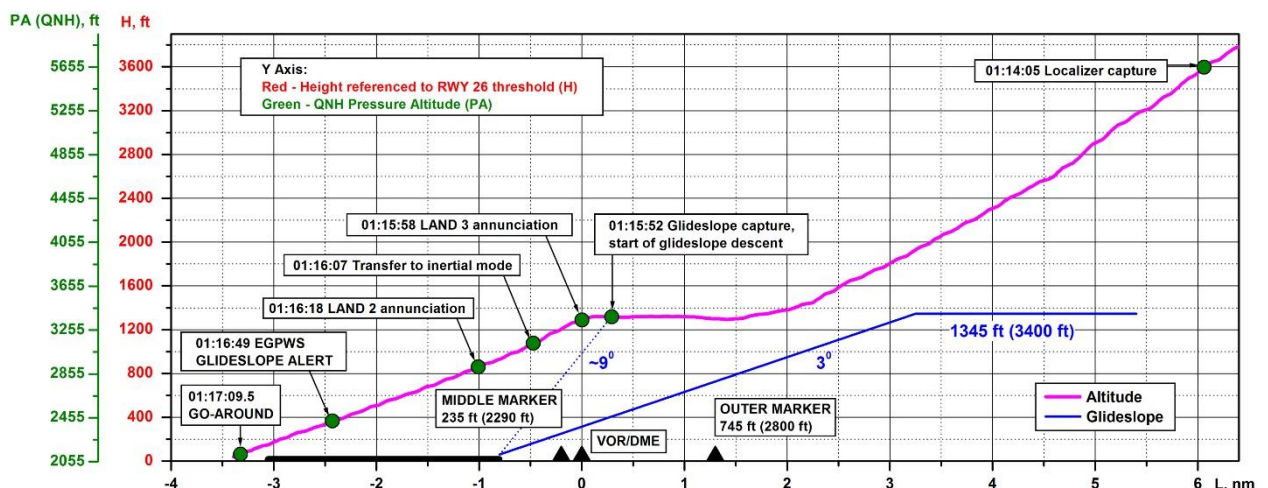
**Figure 1. Vertical flight path of final approach (height is counted from RWY 26 threshold, its elevation being 2055 ft)**

At 01:14:05 the DFDR recorded LOC capture (Figure 1) and start of localizer establishing maneuver. At that time the a/c was at a distance of about 6 nm in descent at an altitude of approximately 5700 ft.

Since that time the flight was performed at a constant altitude along the RWY 26 landing course. The a/c was significantly higher than the glideslope, the glideslope pointer was in full down position. The glideslope mode was armed (G/S MODE ARM), but the glideslope was not captured.

A glideslope signal was captured at 01:15:52, at that time the a/c was almost over VOR/DME MANAS at a distance of approximately 1.1 nm from RWY 26 threshold, at an angle of approximately 9° (Figure 1). However, as per the approach chart, the rated glideslope angle is 3°(Figure 4).

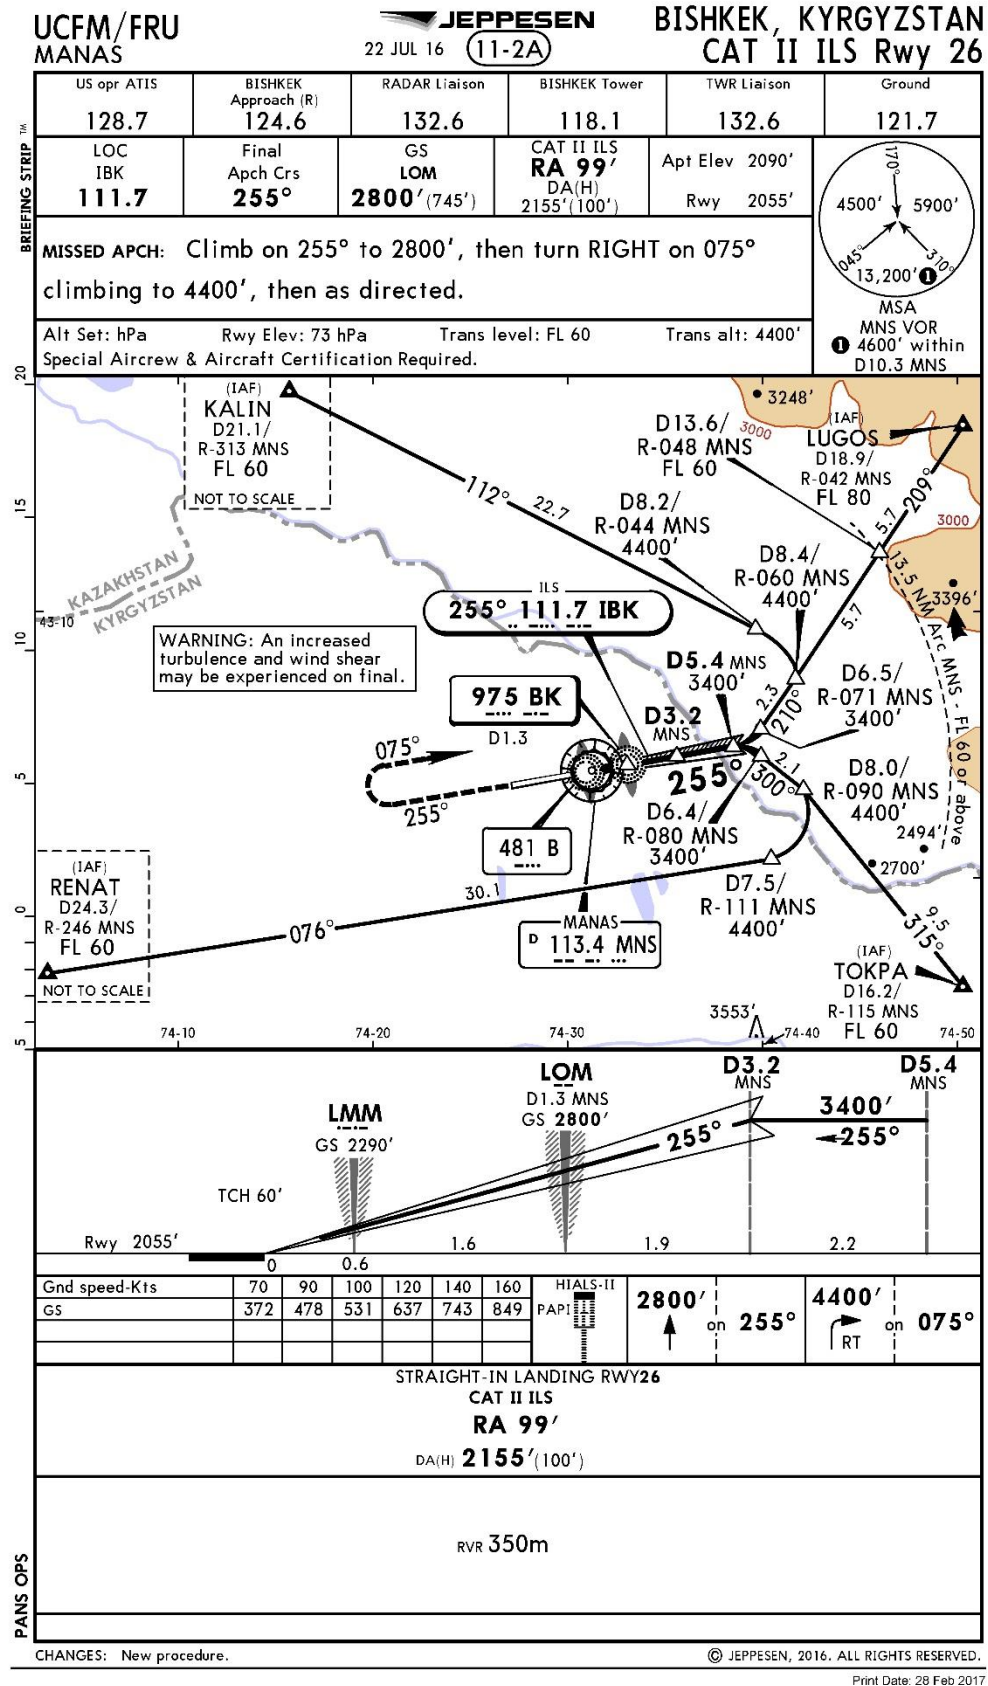
Figure 4. Approach chart for RWY 26

TOKPA reporting point overflight occurred at 01:11:18. The a/c was crossing FL 092 while in descent. According to the approach chart, FL 060 or above should be reached when overflying TOKPA.

At 01:15:31 while the a/c was in level flight at 3400 ft LOM overflight was recorded (as per the approach chart LOM overflight altitude is 2800 ft). The CVR record contained no aural signal of LOM overflight. However, the LOM is indicated to both crew members on the PFD.

At 01:16:01 at 3300 ft LMM overflight was recorded (as per the approach chart LMM overflight altitude is 2290 ft). The CVR record contained no aural signal of LMM overflight. However, the LMM is indicated to both crew members on the PFD.

1. It is recommended that the crews pay attention to following approach charts, monitoring distance and altitude during reference points (FAF, LOM, LMM) overflight when conducting ILS approaches, especially ICAO CAT II and CAT III approaches.

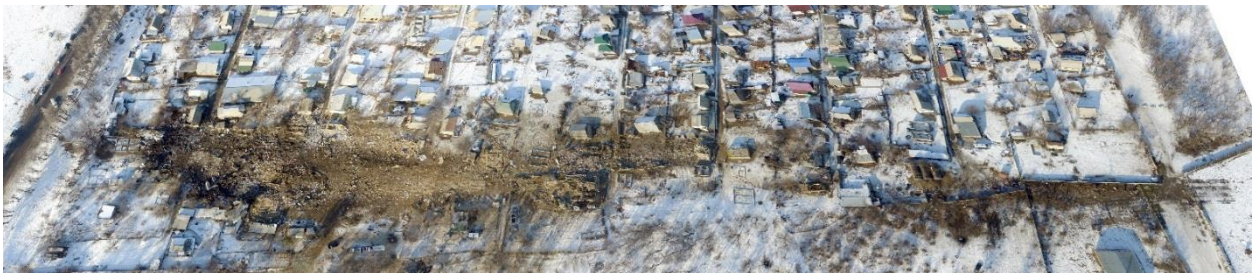
**Figure 5. Debris field**

The airframe was broken into multiple pieces, the largest of them being located within the last third of the wreckage path. The overview of the debris field is shown in Figure 5.

- RH wing parts with flight control elements;
- engine #3 and #4 and their reverser elements;
- main landing gear with wheels;
- pieces of forward fuselage section (skin panels, frame, cargo door);
- nose landing gear with wheels;
- empennage with fin, stabilizer, pressure dome and APU;
- engine #2 with pylon pieces;
- engine #1, pieces of LH flight control surfaces;
- LH wing;

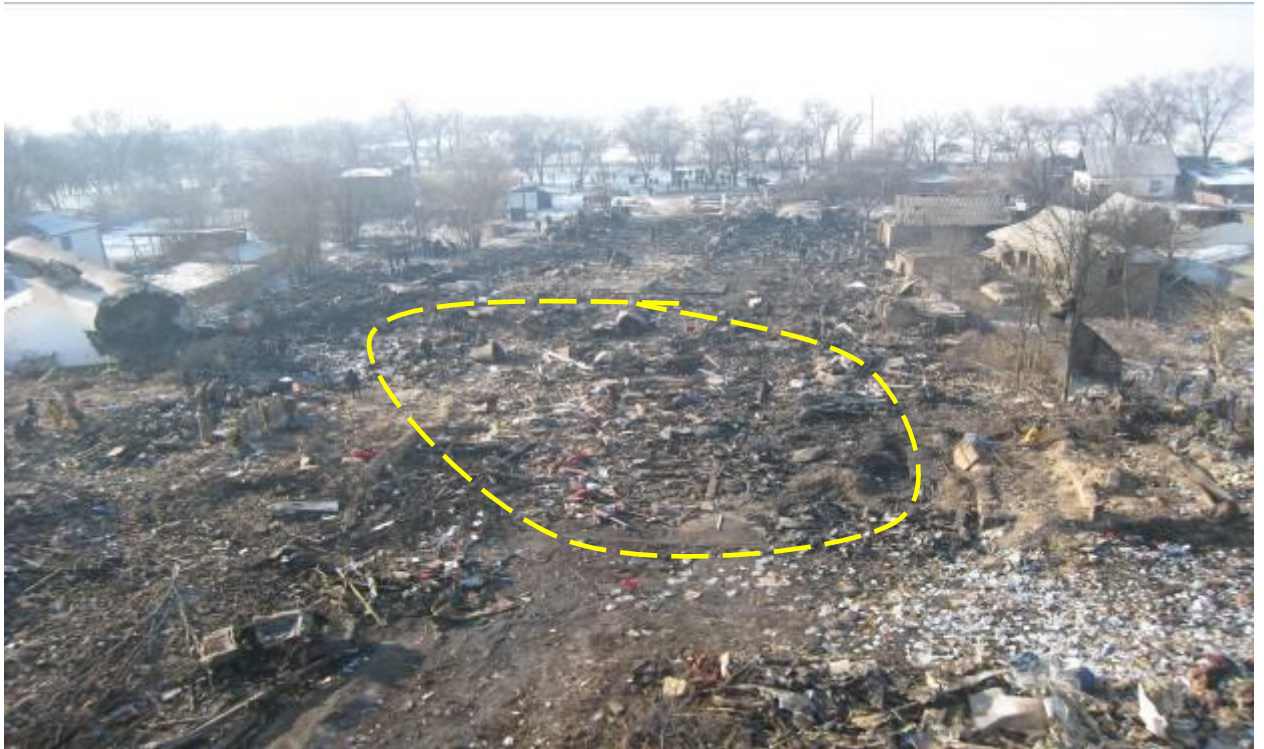
**Figure 6. Main fire cell (circled by dashed yellow line)**

The post-crash fire cell was located in the central fuselage area, between the separated tail and cockpit (Figure 6).

There are no signs of fire or thermal impact on the pieces of fuselage, wing and engines located before the fire cell, either on the outside or on the inside.

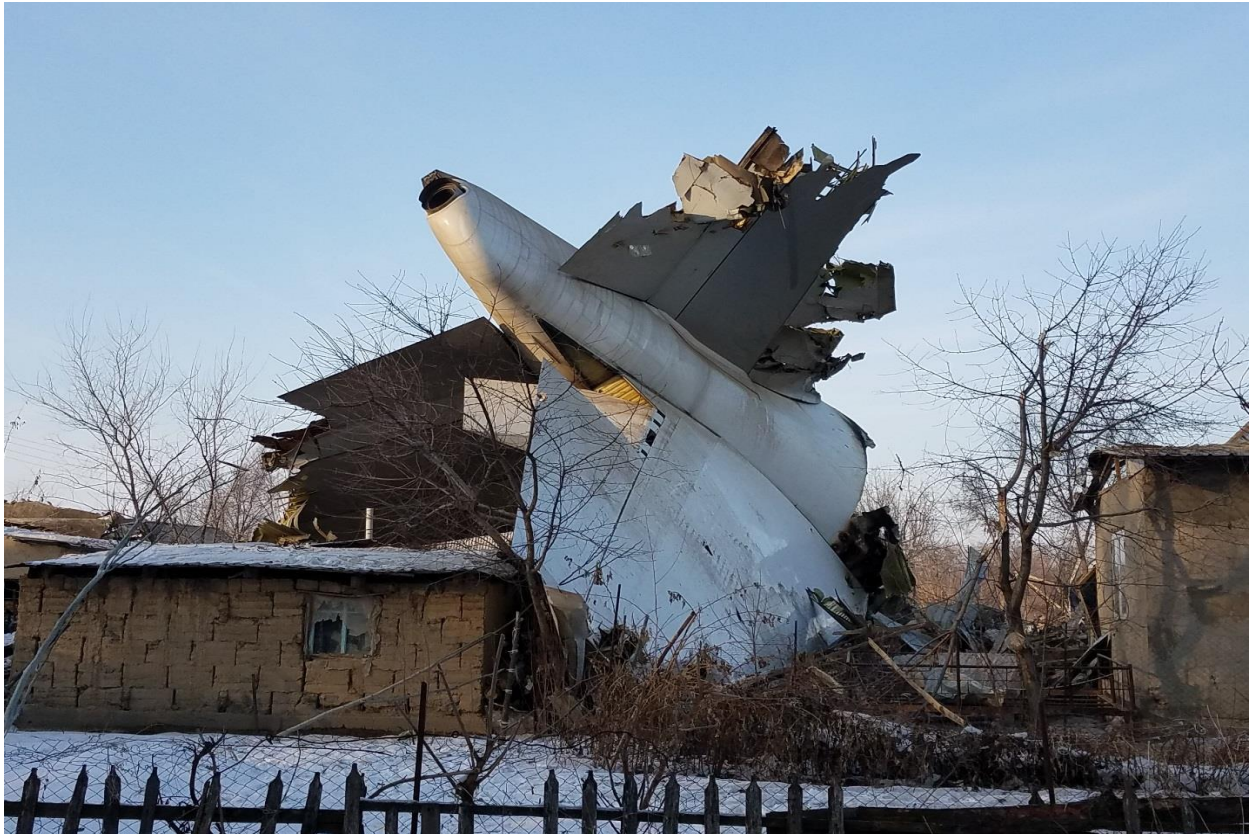
**Figure 7. Empennage**

The vertical fin and horizontal stabilizers (Figure 7) remained attached to the tail part of the fuselage (pressure dome to the APU exhaust). Their final position was inverted. There were no signs of fire or soot on the fin.

The horizontal stabilizer's center section, trim actuator and ballscrew showed no external damage.
