AVIATION INVESTIGATION REPORT A15H0002

Collision with terrain

Air Canada

Airbus Industrie A320-211, C-FTJP

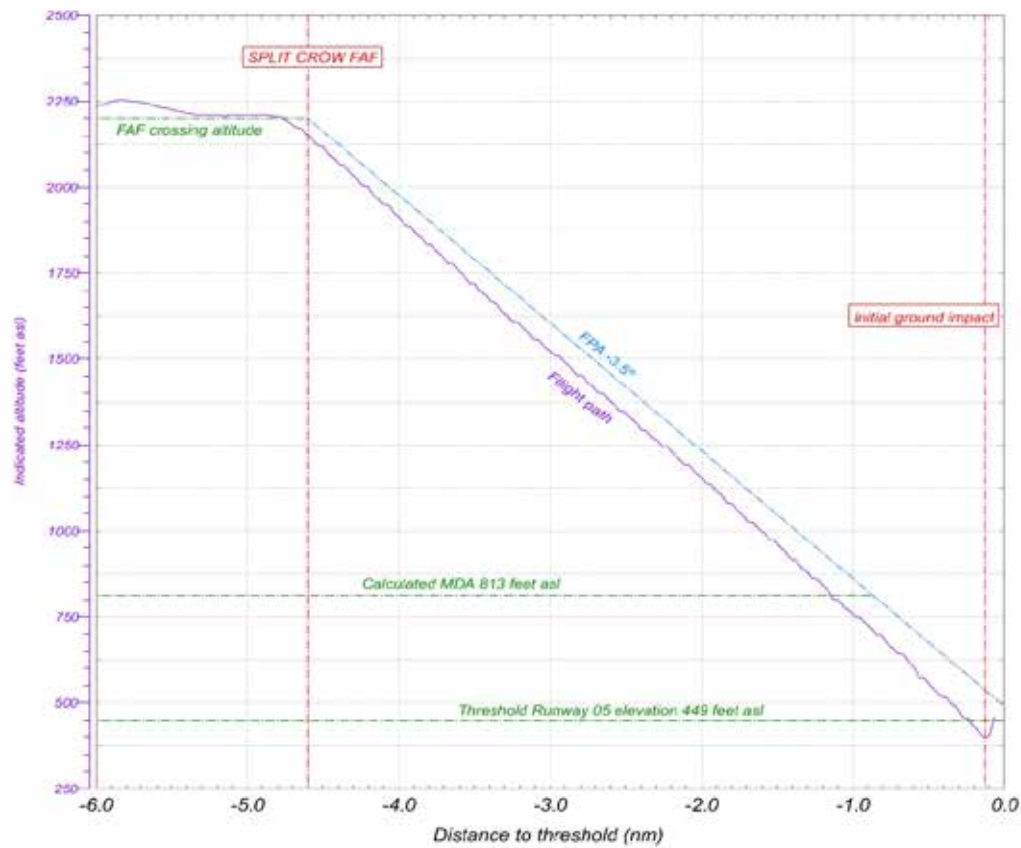
Figure 1. Flight path angle (FPA) versus aircraft flight path

The aircraft started to descend about 0.2 nm from the FAF. The aircraft crossed the FAF at 2170 feet indicated altitude (Figure 1).

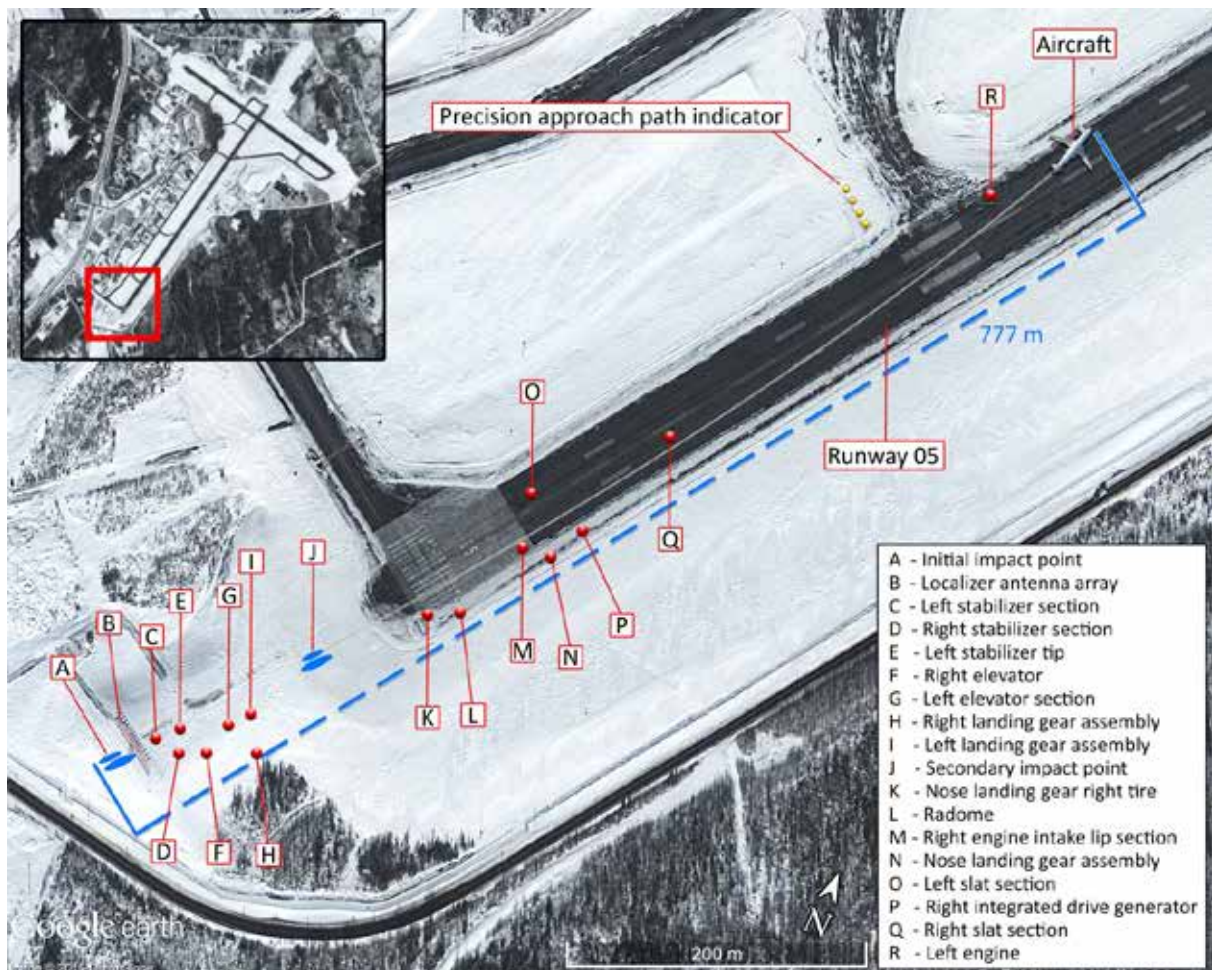
Figure 7. Site survey and wreckage distribution on Runway 05 (Source: Google Earth, with TSB annotations)

The force of the initial impact crushed sections of the lower aft fuselage and caused the lower portion of both main landing gear to fracture and separate. Each separated portion of the

main landing gear struck the corresponding horizontal stabilizer, causing large sections of the stabilizers, as well as the left elevator, to detach. These fragments were found along the debris field before the location of the second impact.

After striking the ILS localizer antenna array, the aircraft continued airborne until the right engine and nose section struck the snow-covered ground. The right engine mounting pylon fractured; the separated engine was retained under the right wing. The nose landing gear collapsed rearward, and its lower portion fractured and separated.

The aircraft then bounced before contacting the runway. The left engine completely detached from the wing and came to rest on the left side of the runway. The aircraft stopped on the left side of the runway in a slight nose-up and left-bank attitude, on an approximate heading of 025°M (Figure 7).

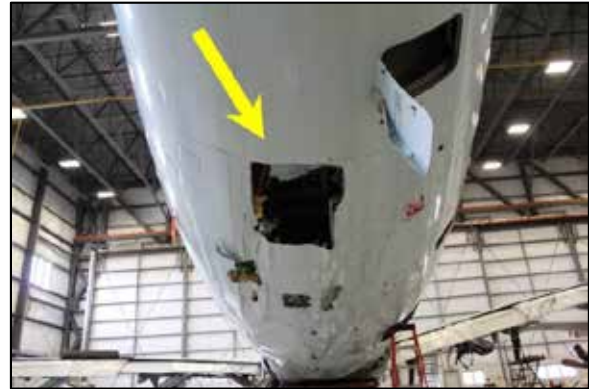
Figure 8. Fuselage damage

The nose wheel well area was forced upward and rearward, buckling and fracturing many of the internal structural components. The fuselage sustained multiple dents, tears, and punctures, including a large hole located just forward of the aft pressure bulkhead, where the fuselage skin and internal structure had fractured when forced up and aft (Figure 8).

The flaps and slats were damaged, and the upper surfaces of both wings had punctures resulting from the impact of debris.

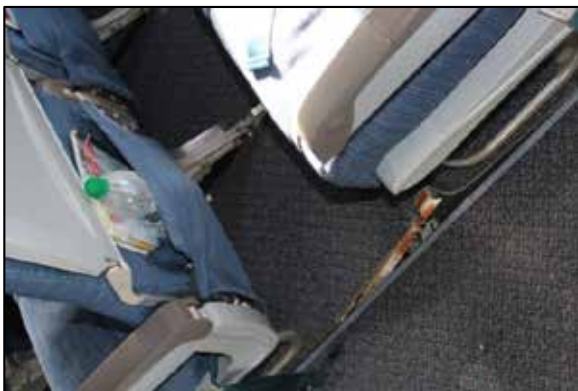
Figure 10. Floor damage forward of passenger seat 31D

Striking the snow-covered ground caused some of the aft lower fuselage stringers and formers to fracture and break, and caused the floor of the bulk cargo compartment to buckle and to be forced upward. The cabin floor was punctured forward of seats 31D and 33D when the stanchions of the forward and aft nets of the bulk cargo door were forced upward (figures 10 and 11).

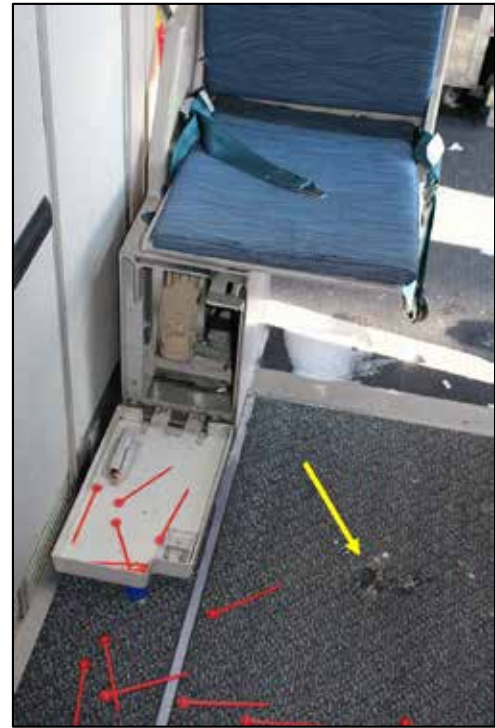
Figure 12. Floor damage above FR65

The cabin floor was also punctured adjacent to the flight attendant's bulkhead-mounted, forward-facing jump seat when the FR65 vertical beam was forced upward (Figure 12).

Neither the net stanchions of the bulk cargo door nor the FR65 vertical beam were deformed.
