Runway Excursion During Landing
Delta Air Lines Flight 1086
Boeing MD-88, N909DL
New York, New York
March 5, 2015

NTSB/AAR-16/02
PB2016-104166

Aircraft Accident Report

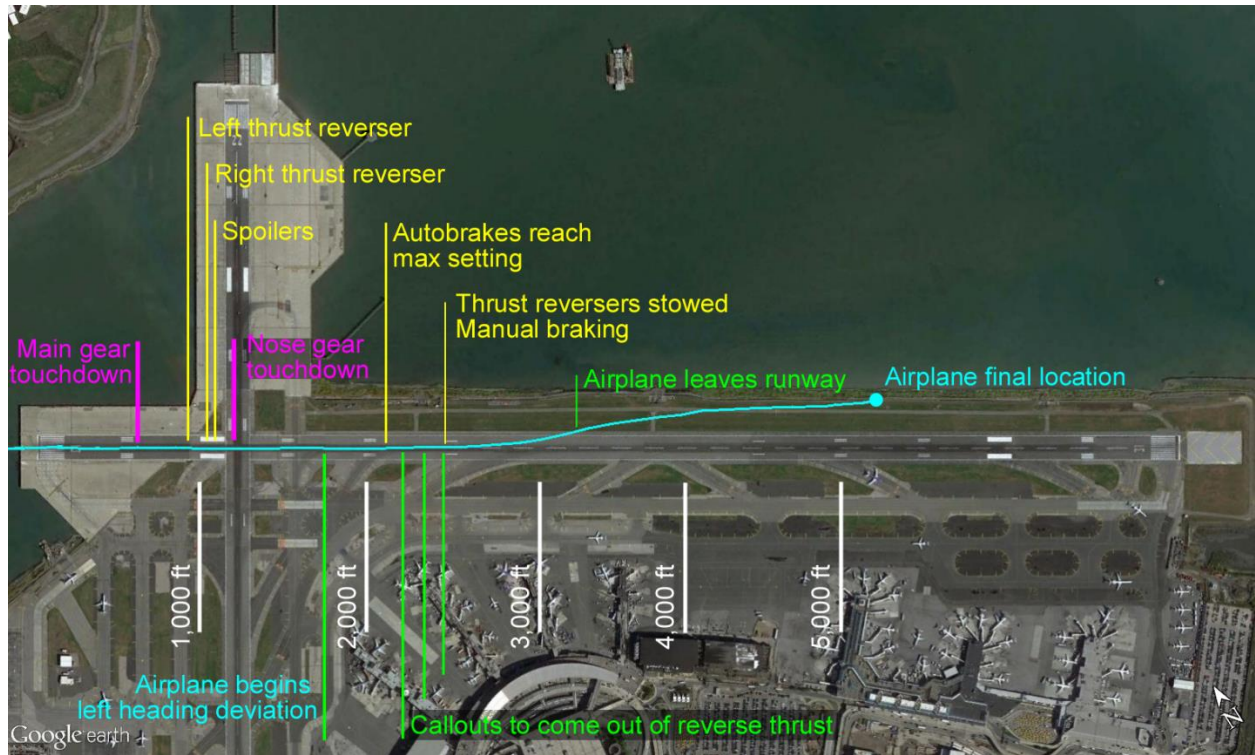
Figure 1. Runway location of events after main gear touchdown.

¹⁵ Main gear touchdown corresponded with a spike in the FDR vertical acceleration data. Surface movement radar data from LGA showed that the airplane touched down within 5 feet of the runway centerline and that the airplane did not deviate from the centerline by more than ± 5 feet until 2,300 feet from the runway threshold (1,700 feet and 8 seconds after main gear touchdown).

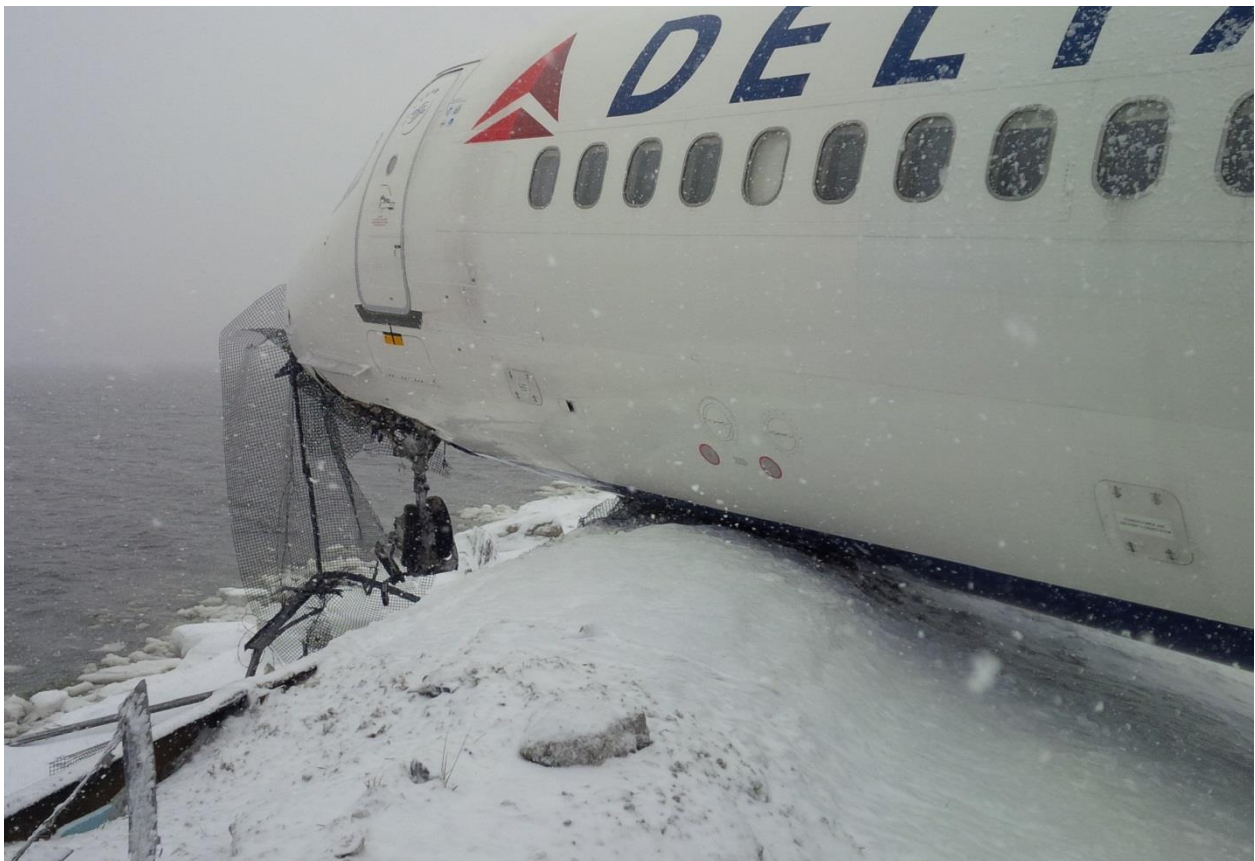
Note: Several pieces of the perimeter fence and support posts are shown.
