Uncontained Engine Failure and Subsequent Fire  
American Airlines Flight 383  
Boeing 767-323, N345AN  
Chicago, Illinois  
October 28, 2016

NTSB/AAR-18/01  
PB2018-100344

# Aircraft Accident Report

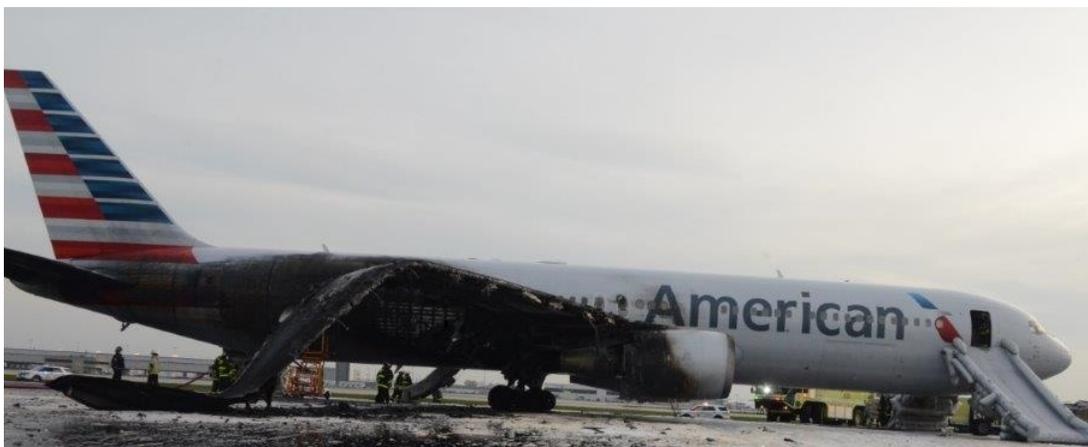
**Figure 1.** Right side of airplane after uncontained engine failure and subsequent fire.

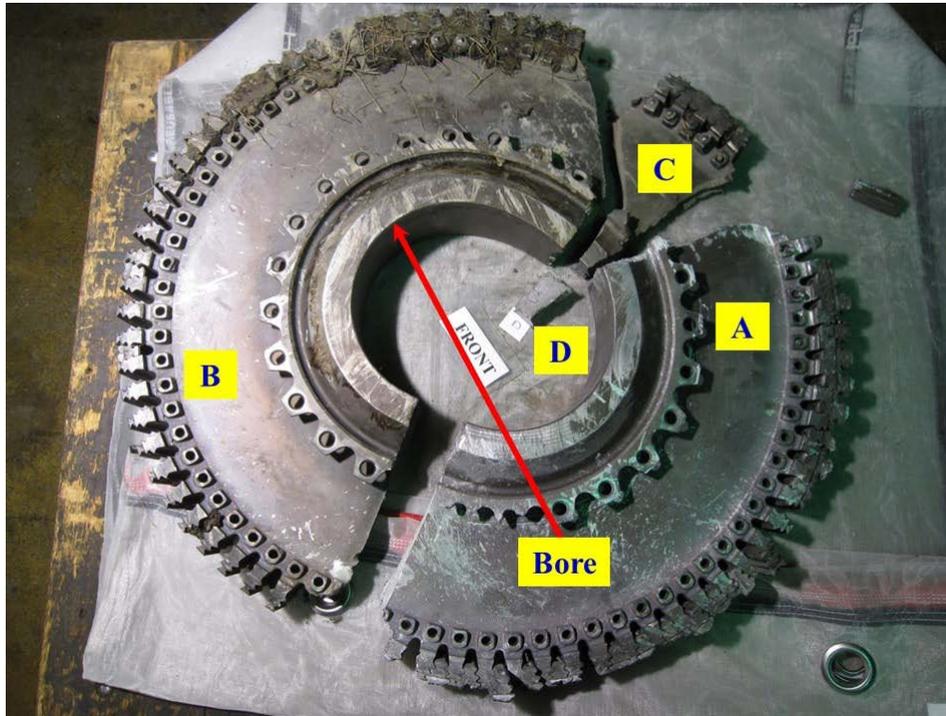
The HPT stage 2 disk of ESN 690-373 (right engine) was recovered on scene in four fragments, as shown in figure 5. About 96% of the disk, including the entire disk bore, was recovered.<sup>36</sup> As mentioned in section 1.1, one disk fragment (labeled "A" in figure 5), which weighed about 56.6 pounds, was recovered on the airport property in a UPS warehouse located about 2,935 ft south of the airplane's position on the runway where the uncontained engine failure occurred.<sup>37</sup>

**Figure 5.** Main fragments of the HPT stage 2 disk (forward side).

The other three disk fragments (labeled “B,” “C,” and “D” in figure 5) were recovered on the airport property north of runway 28R. These three disk fragments were located 475 ft (fragment D), 1,365 ft (fragment B), and 1,500 ft (fragment C) from the airplane’s location on the runway where the uncontained engine failure occurred. Specifically, fragment B, which weighed about 83.1 pounds, was recovered in the grassy area near a taxiway; fragment C, which weighed about 6.6 pounds, was recovered on another taxiway; and fragment D, which weighed about 0.2 pound, was recovered on the overrun area at the departure end of runway 15.<sup>38</sup> Figure 6 shows the disk fragment locations overlaid on a map of the airport.

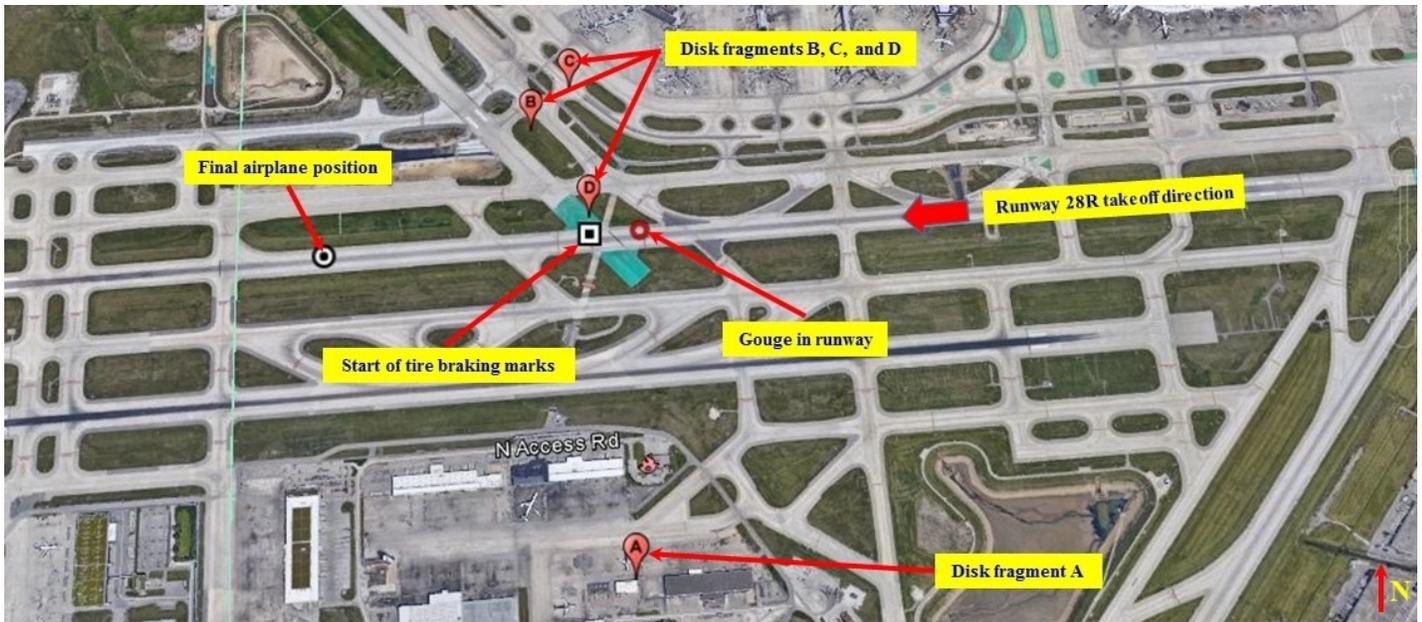
**Figure 6.** Disk fragment locations.

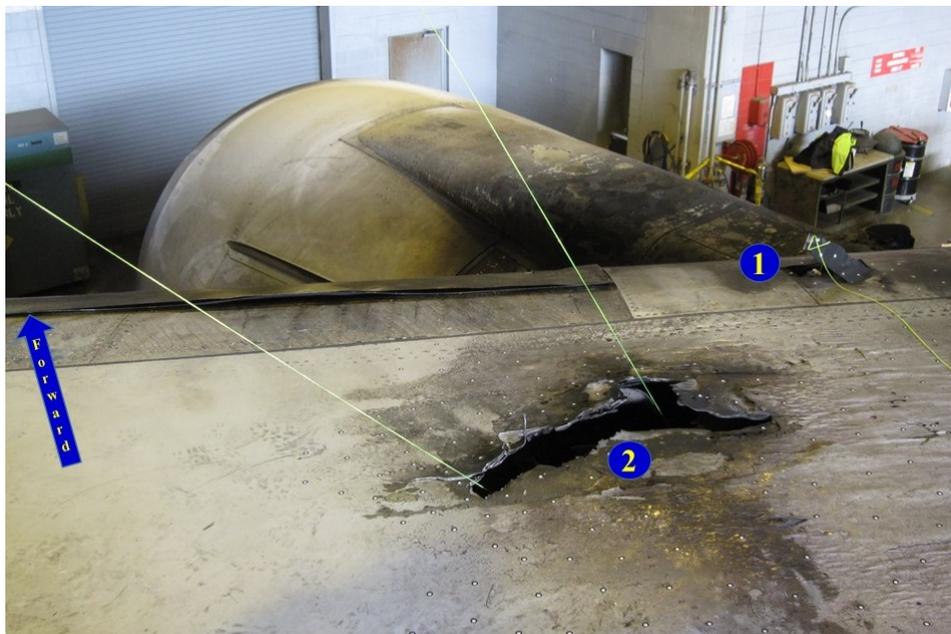
On-scene examination of the right wing (inboard of the right engine pylon) revealed two distinct penetration holes.<sup>39</sup> One hole (referred to as hole 1) was located forward of the front spar in the leading-edge panel; the other hole (referred to as hole 2) was located aft of the wing front spar. Figure 7 shows holes 1 and 2.

**Figure 7.** Holes located forward and aft of the right wing front spar.

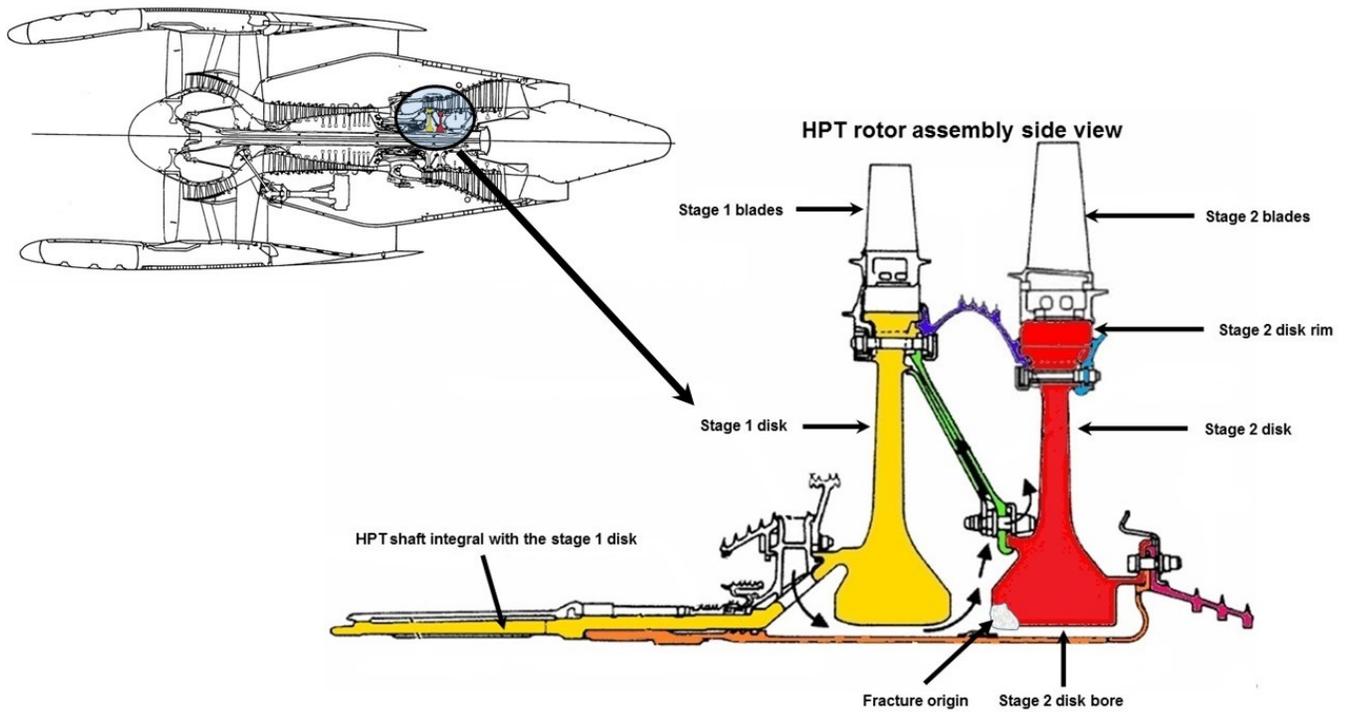
The NTSB's Materials Laboratory in Washington, DC, examined the three largest HPT stage 2 disk fragments (A, B, and C; see figure 5). Visual examination found a discolored (heat-tinted) region on the fracture surfaces separating fragments A and B.<sup>41</sup> The discolored region was at the forward end of the disk bore region, as indicated in figures 8 and 9, and this region was identified as the location where the fracture originated.

**Figure 8.** Engine cross-section and fracture origin location.

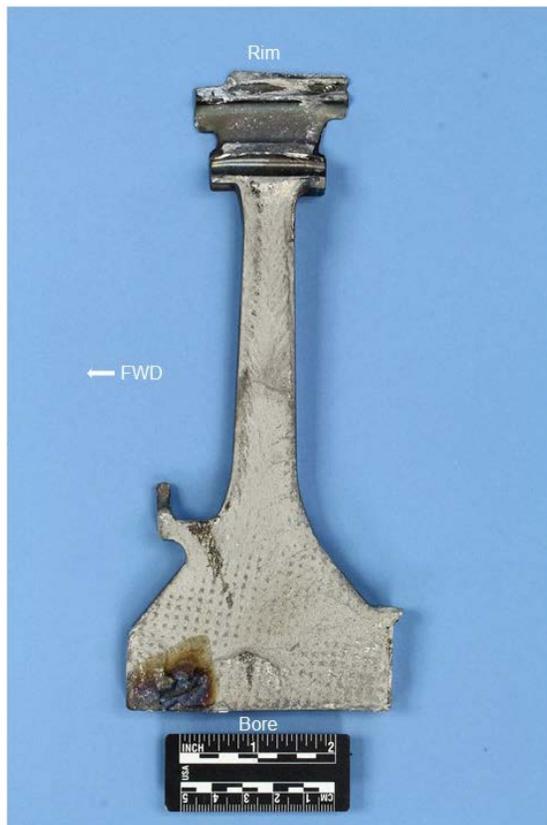
**Figure 9.** Fracture surface from disk fragment A.

Metallurgical examination of the fracture surfaces revealed multiple subsurface microstructural discontinuities with multiple cracks initiating along the boundary of the discontinuities. The discontinuities, which had a dark gray appearance, were elongated in the direction of, and aligned with, the grain structure pattern produced during forging. The discontinuities spanned a total length of about 0.78 inch, with the largest of the discontinuities measuring about 0.43-inch-long by 0.07-inch-wide and having an inclination of about 26° from the bore centerline.

Multiple cracks had initiated along the upper and lower edges of the discontinuities and progressed toward the disk rim and disk bore. Scanning electron microscope (SEM) images of the fracture surface revealed relatively coarse striations at regularly spaced intervals, consistent with crack growth by low-cycle fatigue, followed by a transition to cyclic tensile crack growth and then tensile overstress.<sup>42</sup> The net size of the cracked region immediately before the disk fracture (given the size of the discolored region) ranged from about 0.47 to 0.93 inch in the radial direction and about 0.96 inch to 1.13 inches in the axial direction and encompassed an area of about 0.82 square inch.

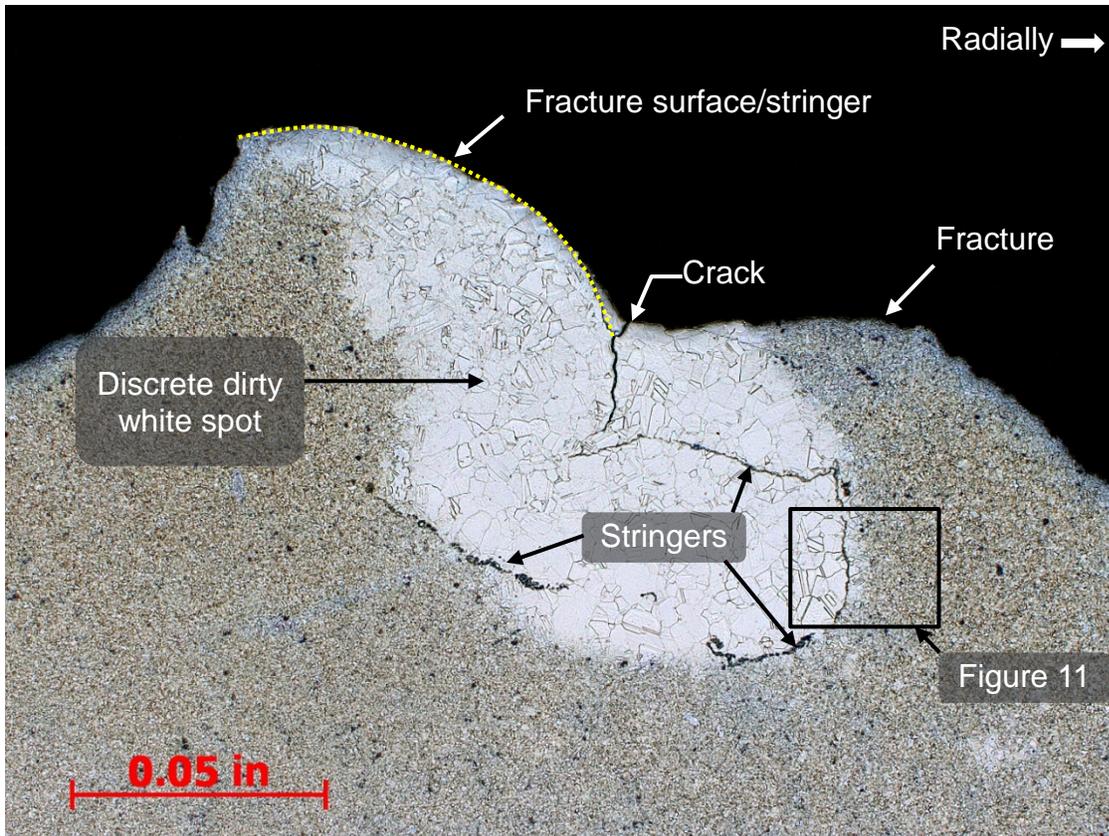
SEM examination of the discontinuities on the fracture surface showed that the discontinuities were regions of discrete micron-sized oxide particles, referred to as stringers, embedded in a material consistent with alloy 718. A polished and acid-etched metallurgical cross-section through the largest of these features showed that these oxide stringers surrounded and were interspersed in a discrete underlying region where the alloy 718 grain size was coarser than the surrounding material. The coarse grain region beneath the discontinuity exhibited a white-etched appearance compared with the surrounding fine grain material due to the acid etch. The stringers and coarse grain region collectively formed a subsurface anomaly referred to as a “discrete dirty white spot” that measured about 0.15 by 0.10 inch.<sup>43</sup> Figure 10 shows the discrete dirty white spot, and figure 11 shows a close-up view of one of the stringers.

Figure 10. Discrete dirty white spot in fracture surface.

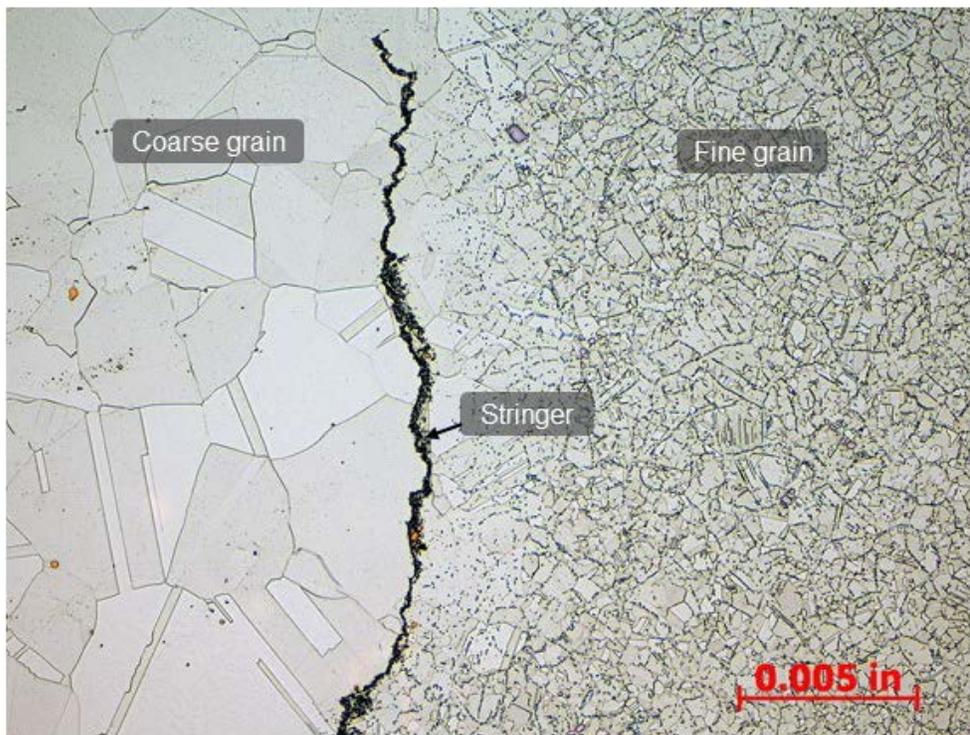
Figure 11. Stringer in material microstructure.

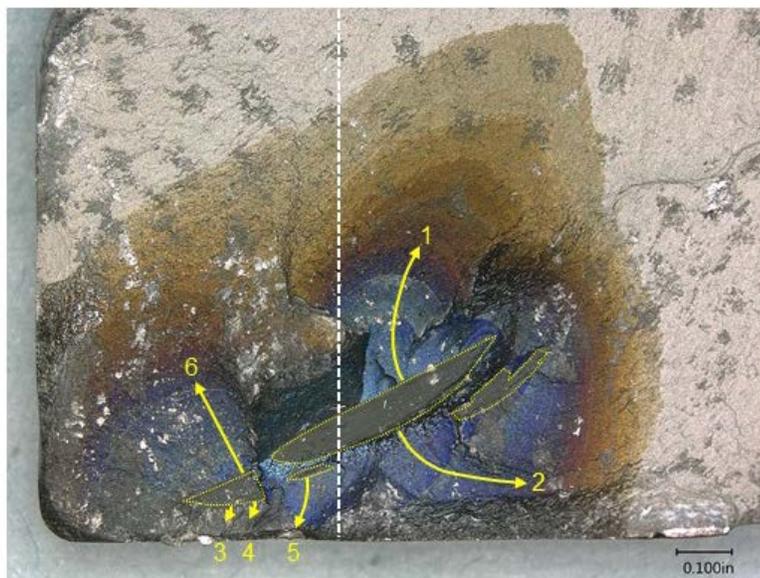
As previously stated, the NTSB documented the presence of multiple fatigue cracks that initiated at a discrete dirty white spot in the forward bore region of the HPT stage 2 disk. The NTSB and GE estimated flight cycles for a total of six cracks, numbered 1 through 6, as shown in figure 12. The cracks exhibited striated features consistent with low-cycle fatigue.

**Figure 12.** Fatigue cracks that initiated from discrete dirty white spot.

The NTSB selected cracks 1, 2, and 6 for a study to estimate the number of flight cycles in each low-cycle fatigue region. (The NTSB focused on these cracks for the study because they did not emerge from the surface.) SEM images were taken for each of the cracks (along the path of crack progression up to the transition to cyclic tensile crack growth), and striation densities were measured on those images to estimate the number of cycles from crack initiation to the HPT stage 2 disk failure. The study assumed that one striation correlated with one flight cycle and that the

forces during takeoff, when the stresses on the HPT stage 2 disk would be at their highest, caused the crack to progress. The study results showed that cracks 1, 2, and 6 progressed by low-cycle fatigue for about 5,700, 5,600, and 3,700 cycles, respectively.

GE made striation density measurements for all six cracks, which showed that the greatest striation count, assuming one striation per mission/flight cycle, was about 7,000 cycles before the disk ruptured in tensile overload. This striation density measurement estimate was for crack 6, which progressed outward and did not reach the bore of the disk. GE's estimates for cracks 1 and 2 were 6,000 and 5,900 low-cycle fatigue crack growth cycles, respectively. (The NTSB notes that striation density measurements can be affected by subjectivity in measuring the striation densities and interpreting the results.) GE's striation density measurement estimates for cracks 3, 4, and 5 indicated that the cracks progressed by low-cycle fatigue for 1,400, 1,200, and 3,200 cycles, respectively.
