INTERSTATE AVIATION COMMITTEE
AIR ACCIDENT INVESTIGATION COMMISSION

FINAL REPORT

Type of occurrence	Accident
Type of aircraft	Airplane, Boeing 737-500 (53A)
Registration	VQ-BBN (Bermuda)
Registered Charterer (according to the registration certificate)	AWAS (BERMUDA) LIMITED, Clarendon House, 2 Church Street, Hamilton HM 11, Bermuda
Operator	Tatarstan Airlines, JSC, Russia
Aviation Administration	Tatar ITO, FATA
Place of occurrence	Russian Federation, Kazan International Airdrome, coordinates: N 55° 36,5291' E 49°16,6111'
Date and Time	November 17, 2013, 15:24 UTC, 19:24 local time, night time

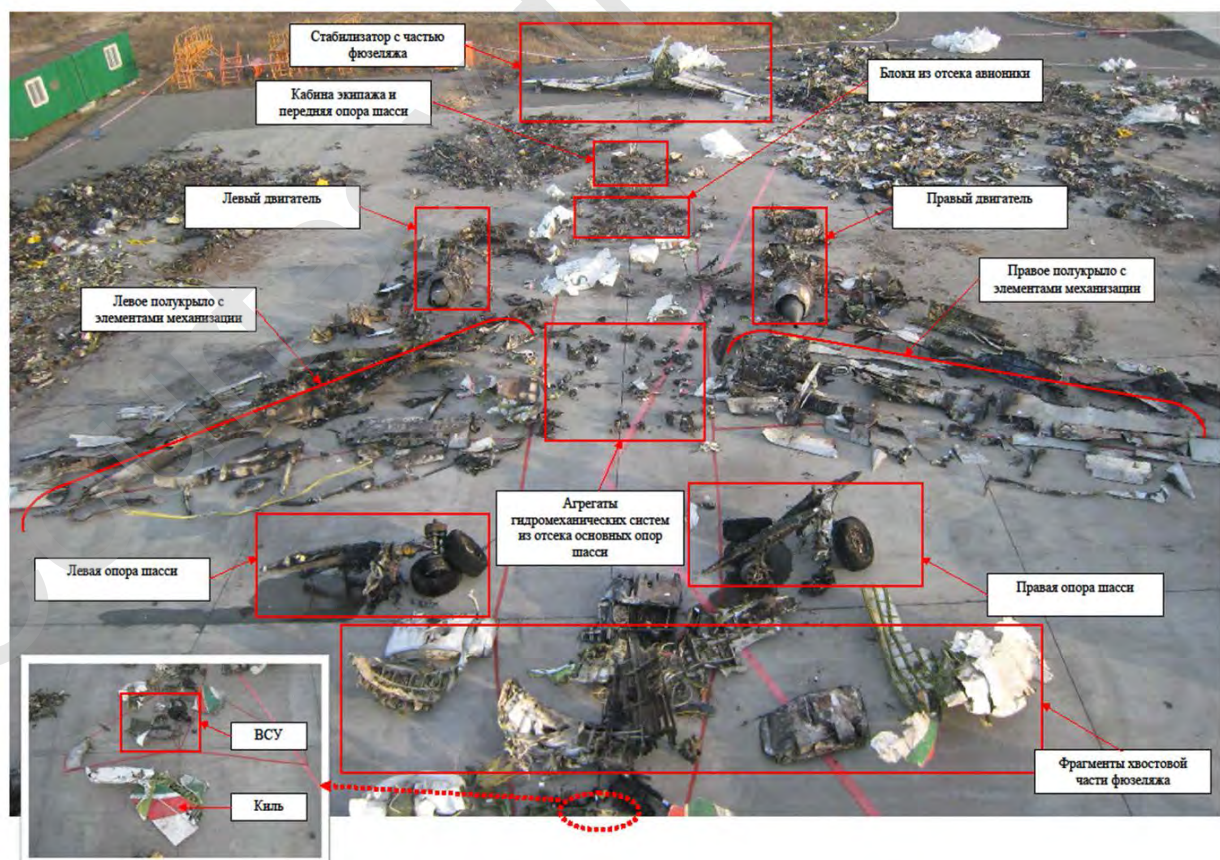
Figure 1 The layout of the remained fragments of the aircraft

The aircraft airframe was broken into a great number of fragmented parts. The biggest aircraft fragments, found at the accident site, are:

On impacting the ground, the aircraft was destroyed and postcrash fire occurred. The seat of fire was located in the area, where the fragments of the cockpit, the center wing section (with the landing gear wheel wells), and also of the left and right wings were found. On the other fuselage fragments, e.g. on the section from frame 360 to frame 500 (left side), horizontal stabilizer and vertical stabilizer, there were no signs of fire found.

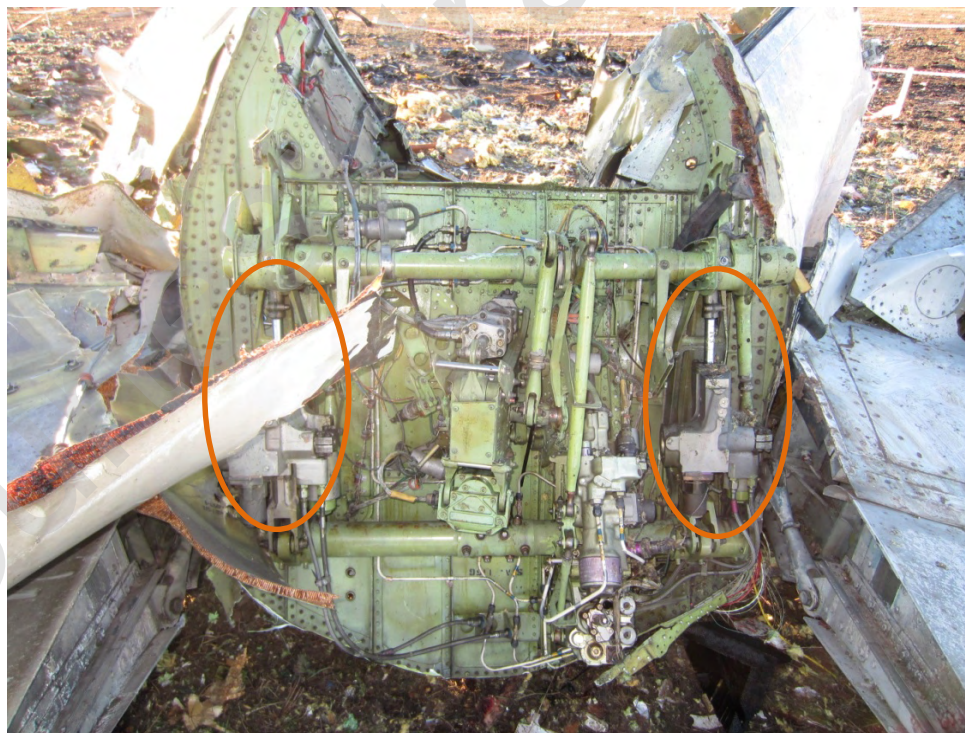
Figure 2 Appearance of frame 1156 on the air accident site (the elevators actuators are circled orange)

Frame 1156, on which elevator control units are located, was remained in satisfactory condition (Figure 2).

The elevators control moving elements, located on frame 1156, have visible deformation, caused by crash of the fuselage structure when the aircraft impacted the ground. There were no disconnections of the control system components and hydraulic lines, located on frame 1156.

- the right elevator PCU housing was not destroyed. The PCU input arm was at the bottom seat. There were no foreign objects found in the clearance, there were signs of dirt and peening;
- the bolts of the left elevator PCU housing head were destroyed, which led to separation of the head from the housing. The PCU input arm was at the bottom seat. There were no foreign objects found in the clearance, there were signs of dirt and peening.

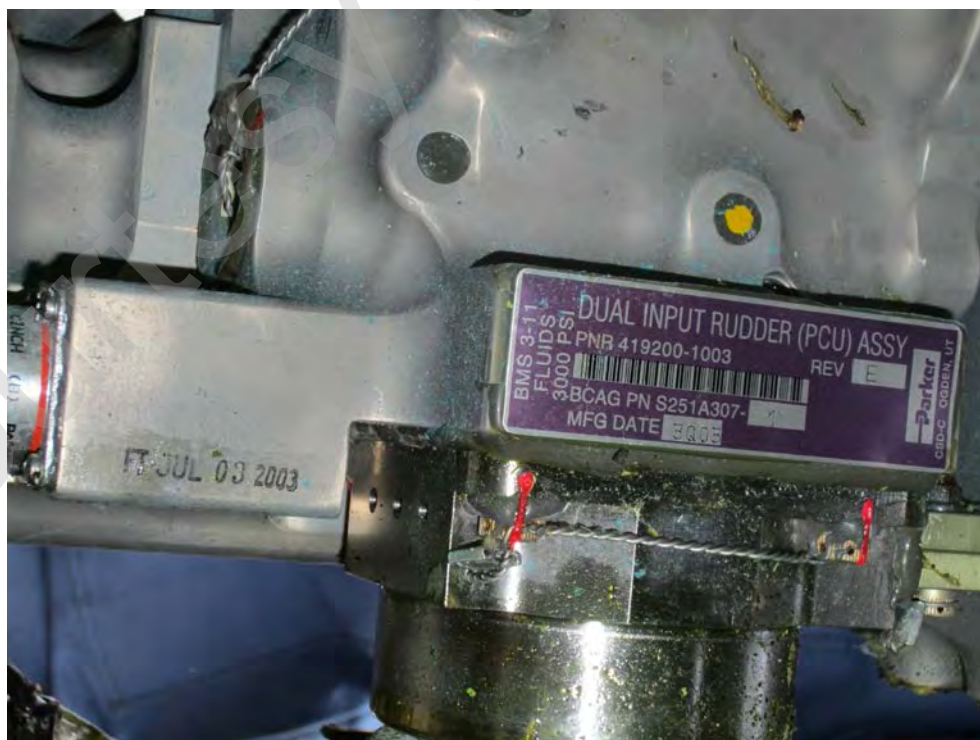
Figure 3 Main rudder PCU

The inspection of the main rudder PCU was performed (Figure 3). The rudder PCU had been torn off from its normal position as a result of the fin destruction. It was established that within the framework of the program of rudder control system modification, in accordance with the US FAA Airworthiness Directive No. AD 2002-20-07R1, the aircraft had been equipped with a new main rudder PCU.

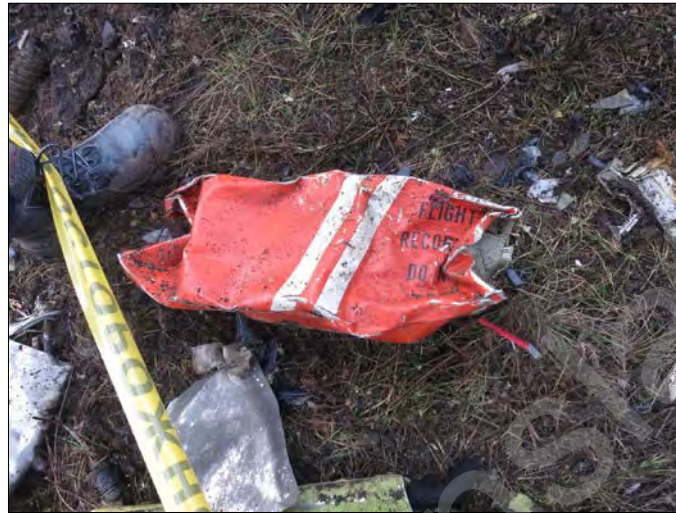
Figure 10 FDR at the accident site

The aircraft was equipped with an FDR manufactured by L3 (Fairchild), model – F1000, p/n S800-2000-00, s/n 02109. It was found at the accident site with severe damage (Figure 10).

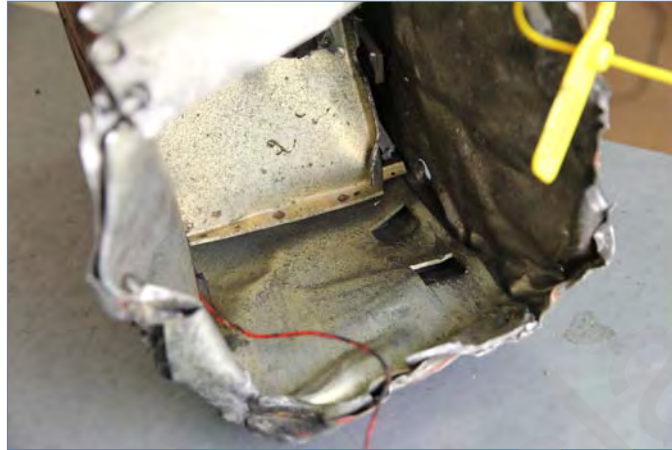
Figure 13 CVR housing without the memory unit

The aircraft was equipped with an A100S CVR manufactured by L3 (Loral/Fairchild). The CVR housing was recovered from the accident site with severe external damage. The protected memory unit was not present inside (Figure 13).

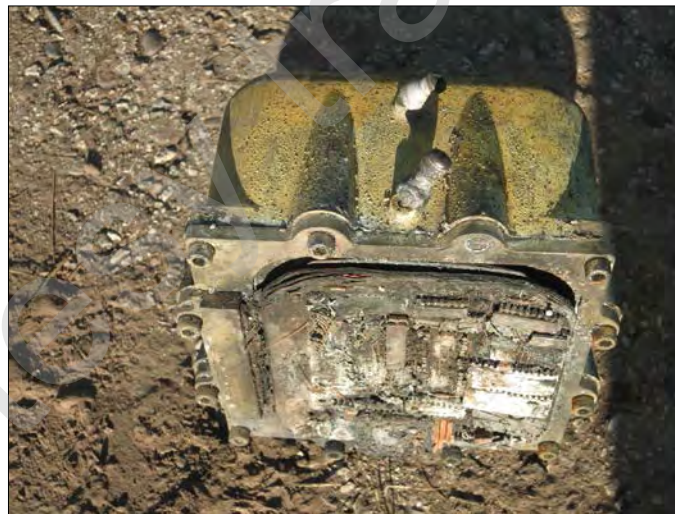
Figure 14 CVR memory unit at the accident site

The protected memory unit was found at the accident site later (Figure 14) and provided to the IAC on November 20.

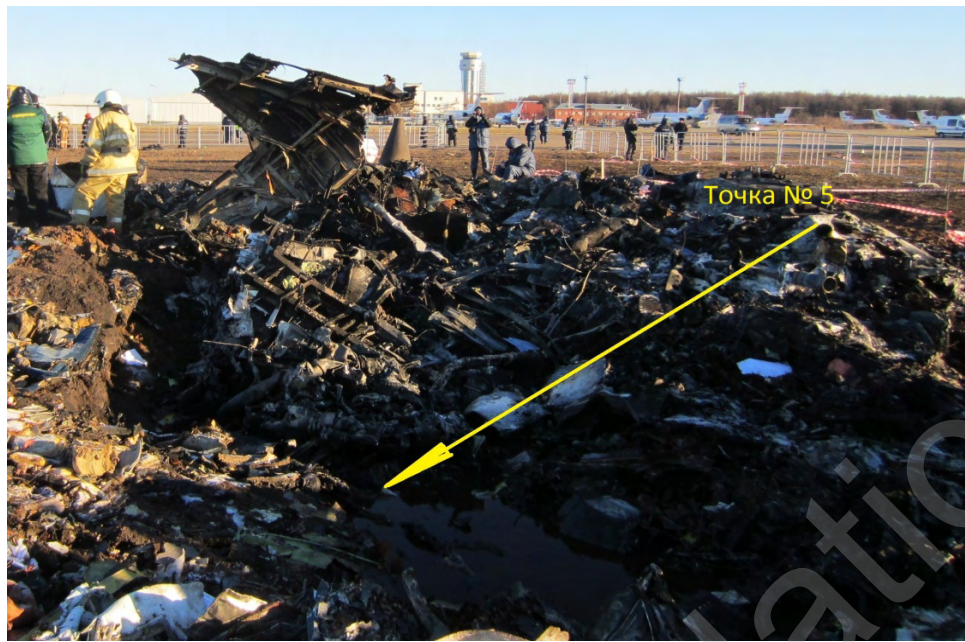
Figure 19 Impact crater

The presence of typical small fragments in the wreckage spread area proves that the ground collision occurred with a large speed (significant energy) and this the most probably caused the fuel tank rupture at the time of the impact, the fuel fire when the released fuel dropped on hot engine parts, and the ground fire.

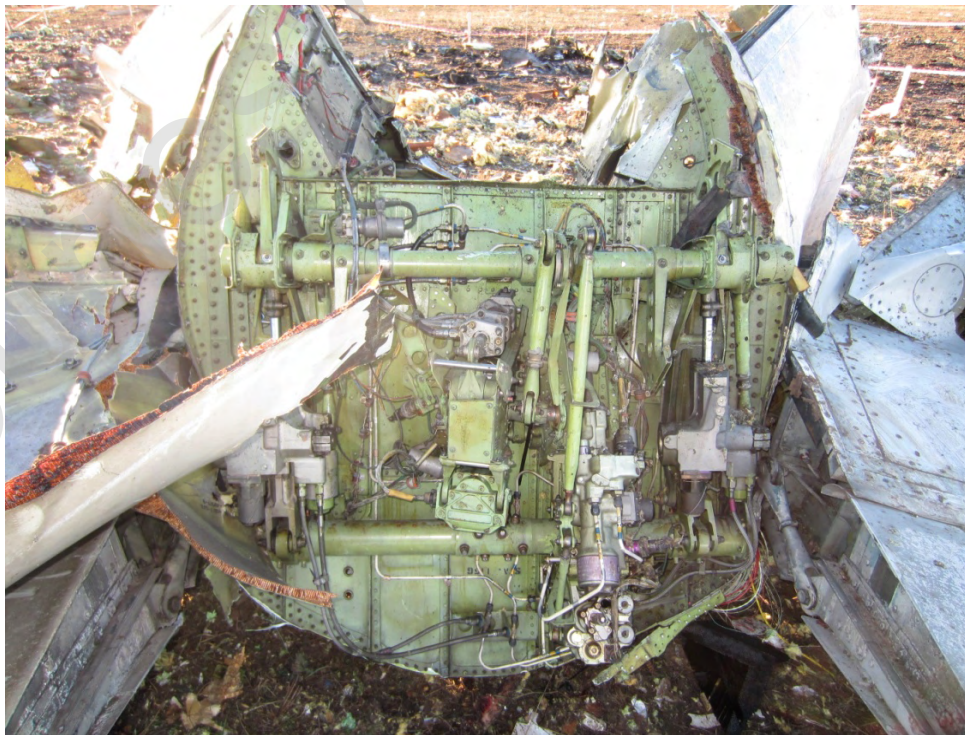
Figure 20 Tail cone fragment

After the impact the fuselage was destroyed with the tail cone detached (Figure 20), the latter being found 20 m ahead of the impact point in the direction where the aircraft was heading (point 8, Figure 18).

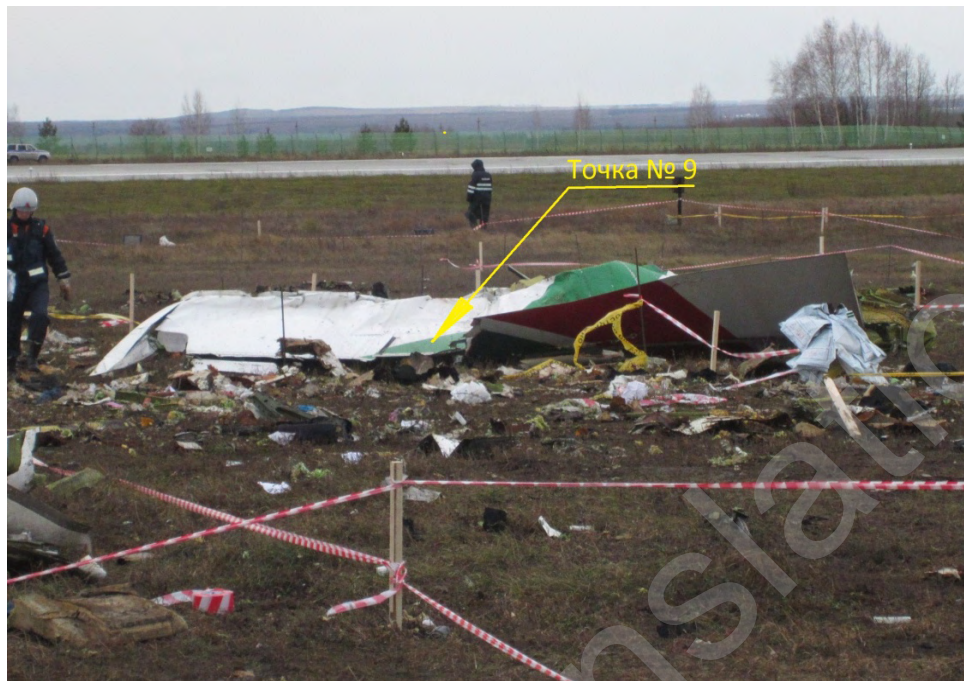
Figure 21 Rudder fragment

Forty meters ahead of the tail cone fragment in the flight direction (point 9, Figure 18) a rudder fragment was found (Figure 21).

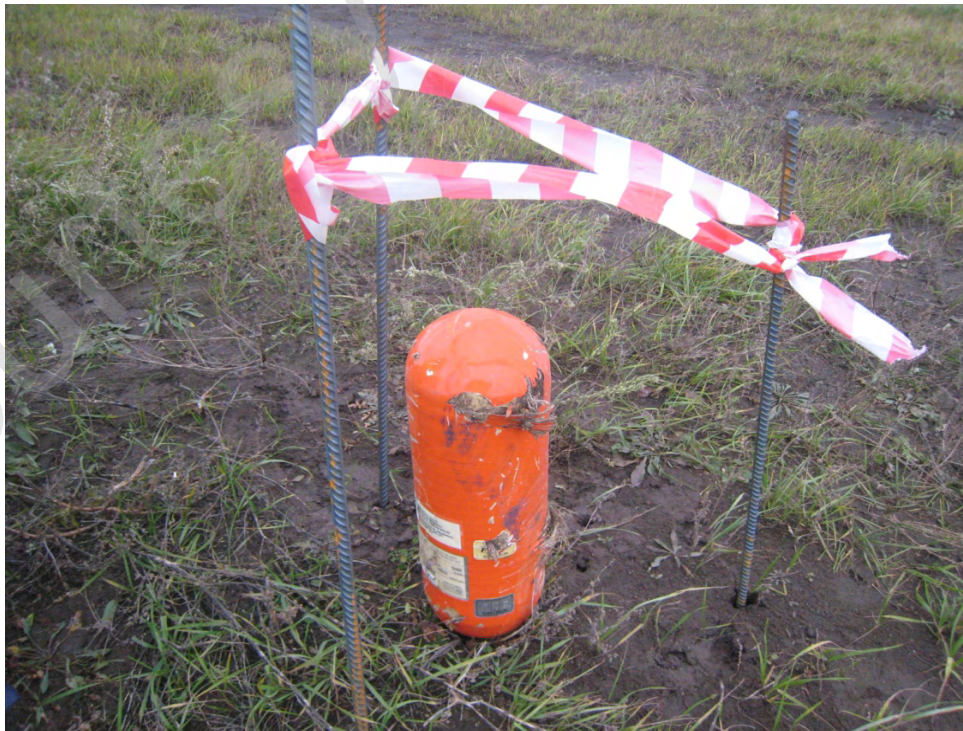
Figure 22 Fire extinguisher bottle

At distance of 120 m from the first impact point and 25 m from the right edge of RWY 29 (runway in use) (point 11, Figure 18) a red fire extinguisher bottle was found (Figure 22). This fragment was the closest one to the runway.

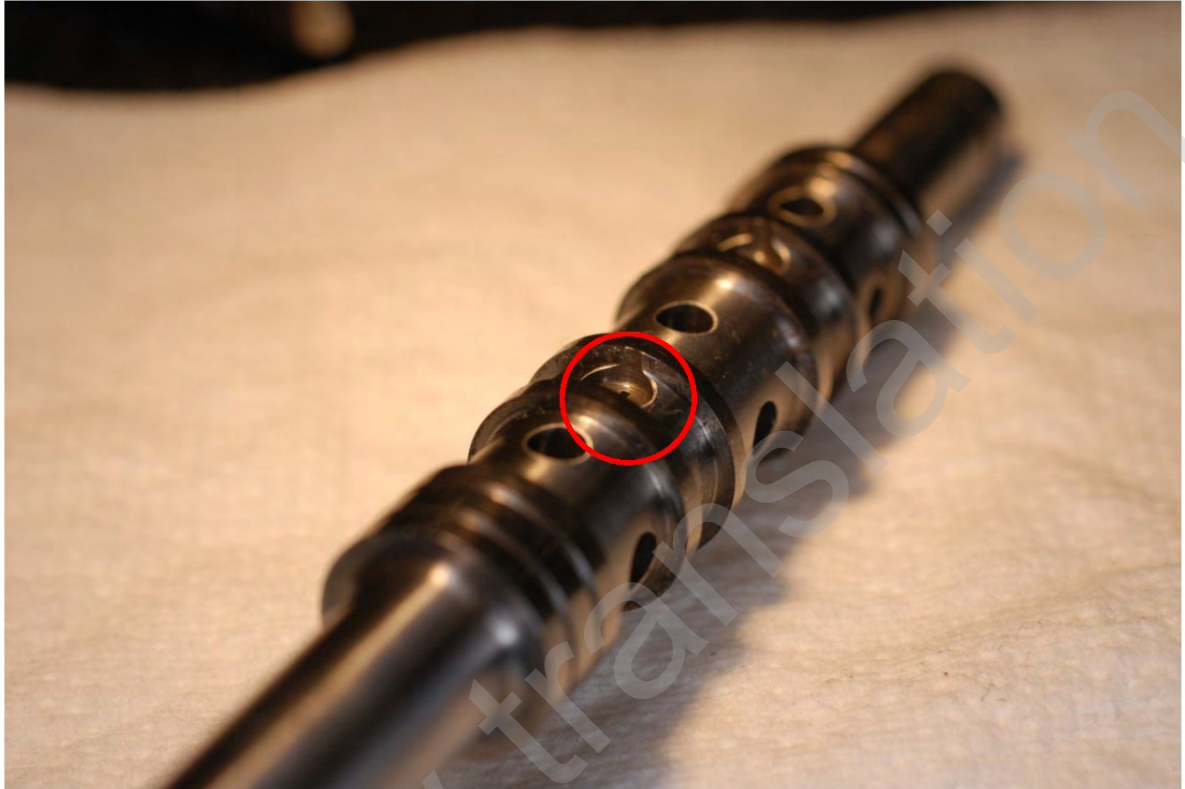
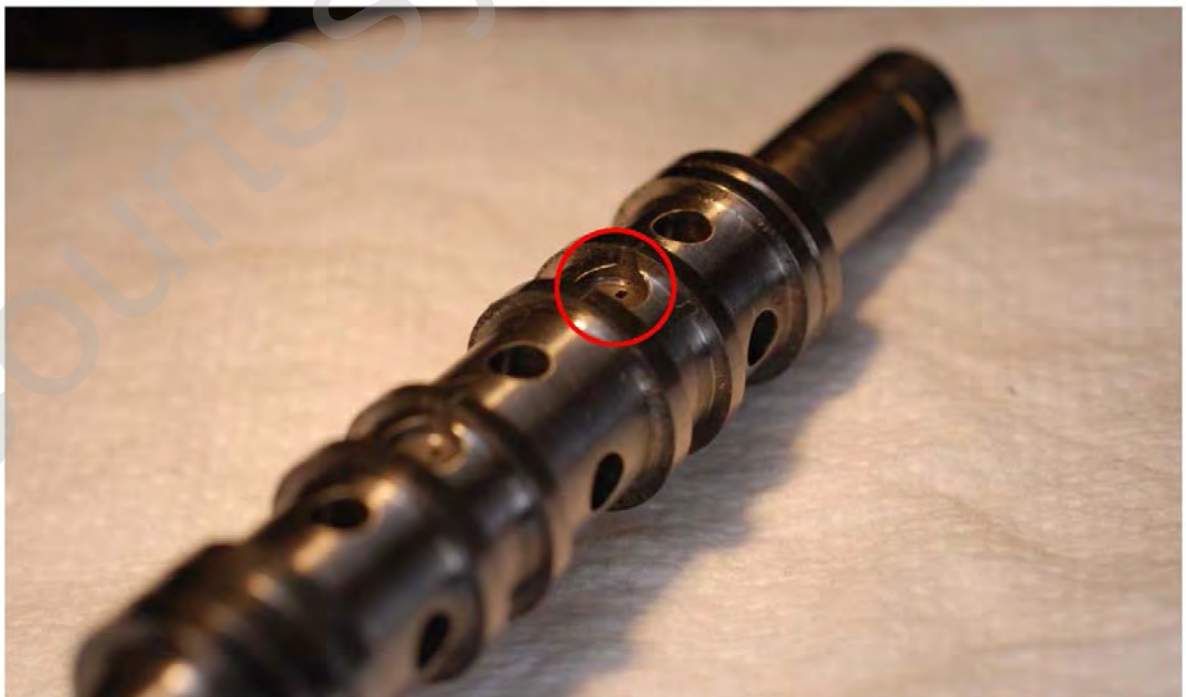
Figure 68 RH control valve secondary slide land edge deformation

Figure 69 RH control valve secondary slide land edge deformation
