ATSB TRANSPORT SAFETY INVESTIGATION REPORT

Aviation Occurrence Report – 200503722

**In-flight upset event
240 km north-west of Perth, WA
Boeing Company 777-200, 9M-MRG
1 August 2005**

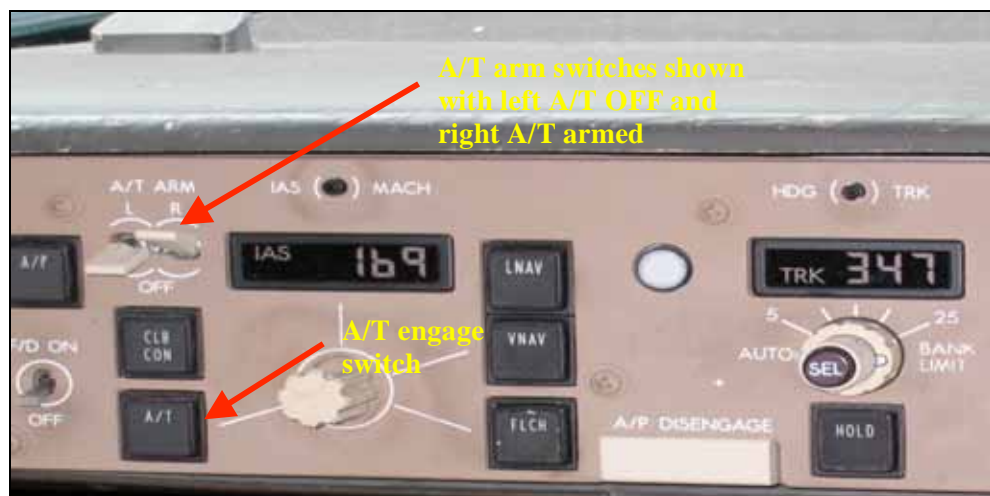
Figure 4: MCP autothrottle arm and engage switches

The aircraft mode control panel (MCP) had three distinct switches which operated the engine autothrottle (A/T). The autothrottle arm switches were located on the MCP and consisted of two toggle switches that armed the selected autothrottle for mode engagement. The autothrottle engage switch was a push-button type switch that was used to engage an autothrottle mode for various aircraft pitch modes, or if no pitch mode was selected, in the speed mode. The autothrottle could be disconnected at the MCP by moving the relevant autothrottle arm switch to OFF (figure 4).

During the occurrence, the autothrottle system remained active or armed, even though the pilot in command attempted to disconnect it by pressing the thrust lever disconnect switch and pushing the autothrottle engage switch. The reason it remained active was because the flight crew did not deselect the autothrottle arm switches from the ARMED position to the OFF position. As a consequence, the autothrottle activated and automatically advanced the thrust levers when it sensed a low-speed condition as a result of erroneous data being provided by the ADIRU.

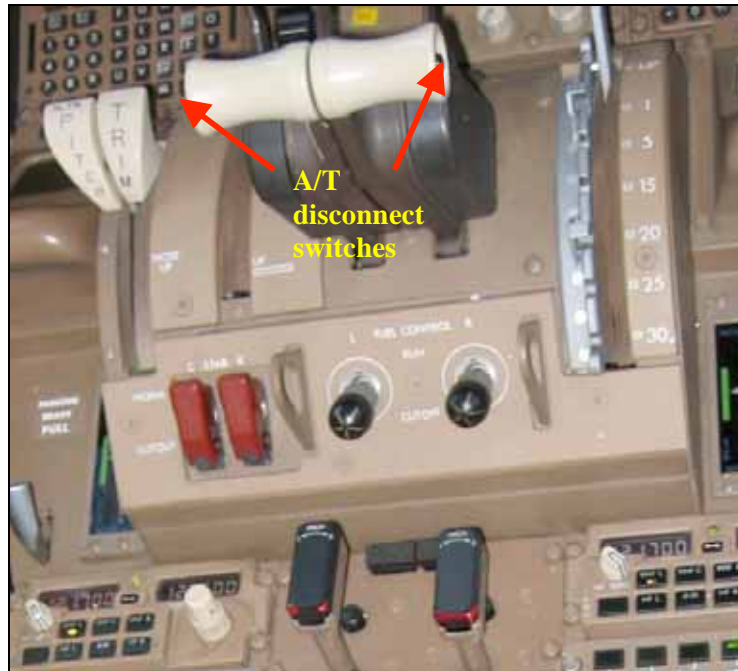
Figure 5: Engine thrust lever autothrottle disconnect switches

In addition, the autothrottle could be disconnected by pushing either of the autothrottle disconnect push-button type switches on the engine thrust levers located on the pilots centre console (figure 5).

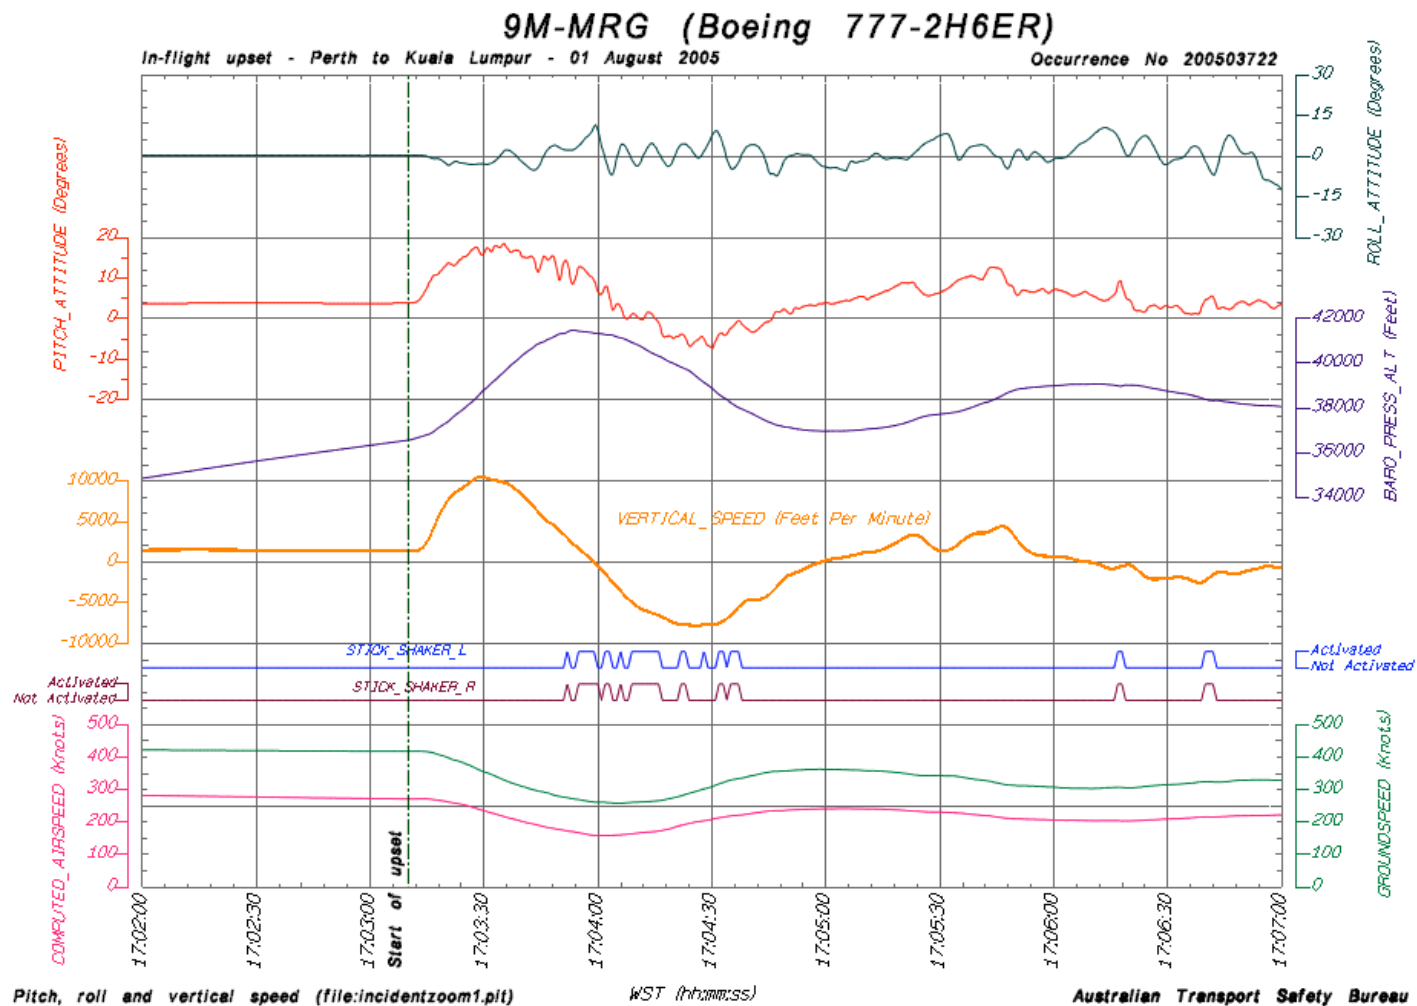
Figure 7: Relevant parameters displayed over a five-minute period

17:03:12 – 17:03:29	9M-MRG pitches nose-up to +17.6° and climbs through 38,590 ft at a vertical speed increasing to 10,560 fpm. A/P overspeed and stall protection activate together and the AFDS pitch mode goes to FAIL resulting in A/T changing to speed mode. The A/P disengages and the thrust levers retard slightly before returning to original 65° position. A/P disconnect is again pressed and thrust levers retarded to 45°. All accelerations maintain their excessive values. Airspeed reduces through 241 kts.

The digital flight data acquisition function (DFDAF) card retransmits the longitudinal and lateral accelerations truncated to a range of $\pm 2g$ and resolution of 0.002g. The ADIRU manufacturer advised that the failed output of the ADIRU in longitudinal acceleration when tested was 2g higher than the FDR recorded value (approximately +3.1g compared with FDR value of +1.1g). The aircraft manufacturer advised that the aircraft response in the upset matched that expected from a longitudinal acceleration of the higher value. The recorded lateral and vertical accelerations matched those measured during tests on the failed ADIRU by the manufacturer.
