**AVIATION INVESTIGATION REPORT  
A07A0029**

**RUNWAY EXCURSION**

**VOLGA-DNEPR AIRLINES  
ANTONOV AN 124-100 RA-82078  
GANDER, NEWFOUNDLAND AND LABRADOR  
31 MARCH 2007**

Report Number A07A0029

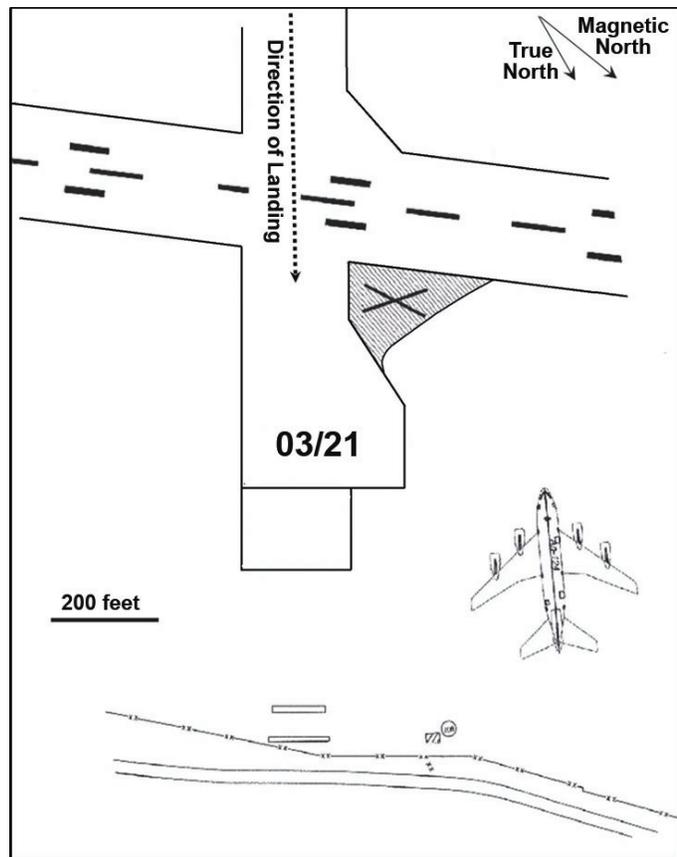
Figure 1. Final position of aircraft

During the latter part of the landing rollout, it became apparent that the aircraft would not stop on the runway. The aircraft was intentionally steered toward the left side of the runway to avoid colliding with ILS equipment located off the departure end of the runway. The aircraft departed the left edge of Runway 03/21, near the runway end at about 35 knots. The aircraft rotated to the left and came to rest approximately 480 feet from the runway end with the aircraft oriented nearly opposite to the direction of landing. The crew conducted an emergency shutdown during which they assessed that an immediate evacuation was not necessary.
