## **FINAL ACCIDENT REPORT**

**AIRBUS A-310/300**

**CS-TEW**

**FINAL ACCIDENT REPORT Nr. 04/ACCID/1999**

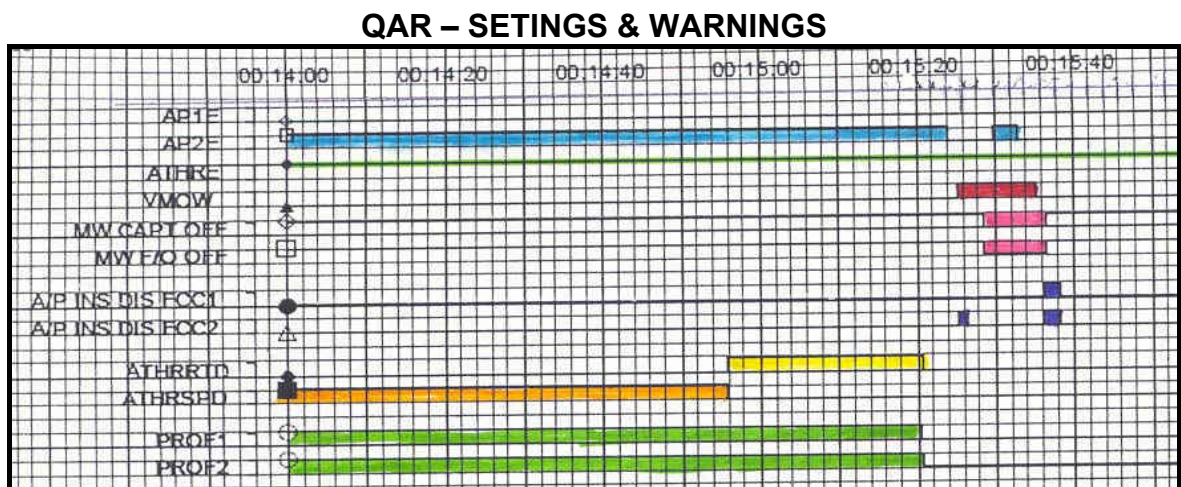
Picture Nr. 3

- a) AP2 was engaged and has been disconnected at 00:15:24;
- b) A/THR was selected in “SPEED” mode until 00:14:56, when it changed to “RETARD” mode;
- c) Between 00:15:25 and 00:15:35 there was a VMO exceedance warning;

- d) There was an AP disconnected warning from 00:15:28 to 00:15:36;
- e) The AP Instinctive Disconnect Switch was activated at 00:15:25 (F/O side only) and 00:15:36 (both sides);
- f) AFS commanded the descent, maintaining "P.DES" mode from Top Of Descent (TOD) until 00:15:00;
- g) Between 00:15:00 and 00:15:24 (when AP was disconnected), PF should try to control speed, selecting "LVL/CHG" and 290kts speed (*these selections were not recorded*);
- h) At 00:14:59 we could notice a significant pitch variation, still with AP2 engaged, which attained  $-6^\circ$  (at 00:15:12);

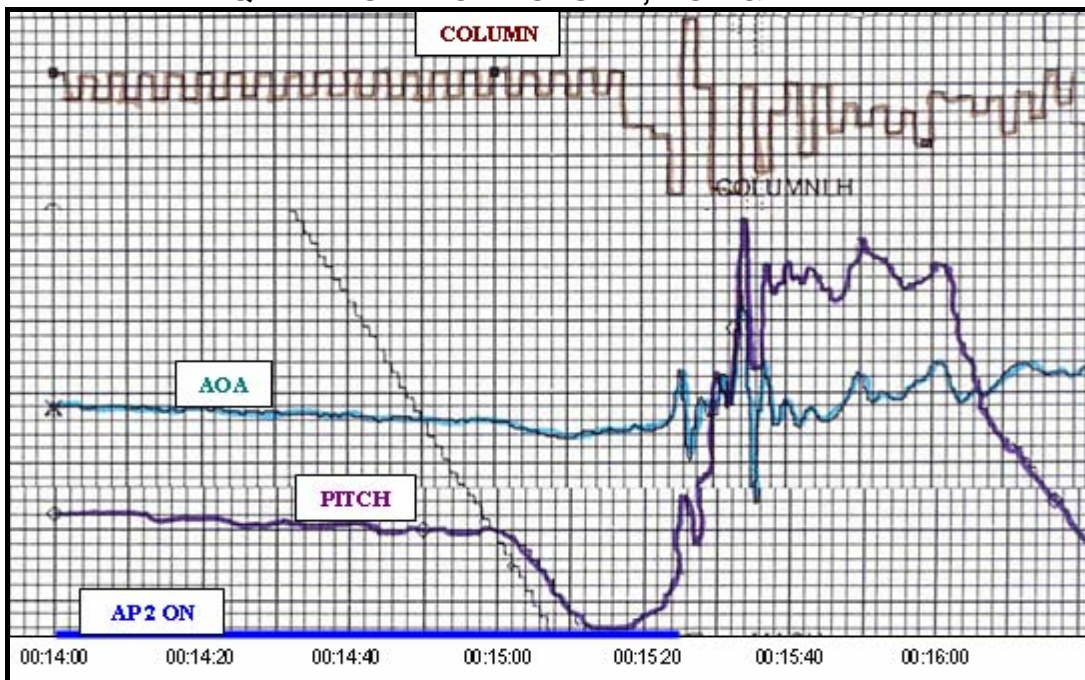
Picture Nr. 4

### QAR – CONTROL COLUMN, AOA & PITCH

Anyway, “Overspeed” protection was activated with AP2 still in “P.DES” mode (*pitch recovering was initiated*). When “LVL/CH” was selected, due AP greater authority, pitch corrective action was improved (*picture nr. 4*).

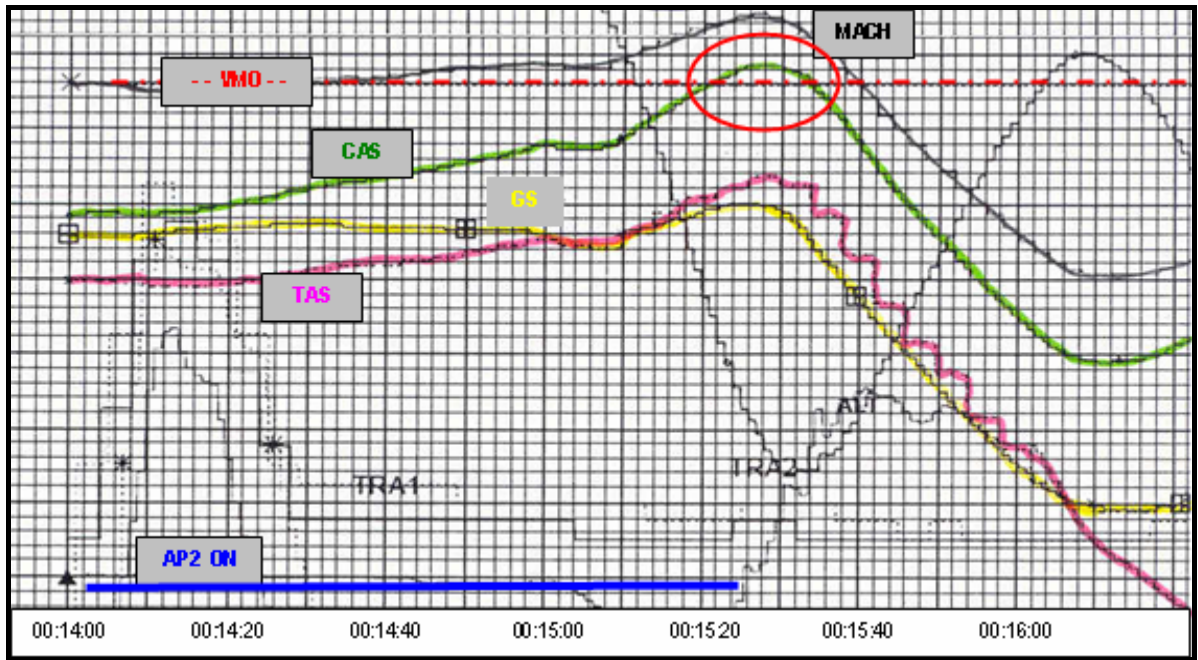
Picture N° 5

- i) At 00:15:00, CAS, TAS and MACH (showing a progressive acceleration from 00:14:20) suffered a momentary stagnation ( $\approx 6''$ ), without GS sensible variation, at the same time the A/THR changed from "SPEED" to "RETARD", regaining an increase tendency with pitch down movement (00:15:08) and GS accompanying that tendency;
- j) At 00:15:20 VMO was attained (and over passed), even if we could confirm a pitch up movement initiated at 00:15:18;
- k) Curiously, when pitch started recovering (00:15:18), there was a control column movement on the opposite sense, and 6" later the AP was disconnected, followed by a nose up movement of control column;
- l) During the first 6" of manual control, there was an asynchronism between control column movement and pitch tendency (*picture nr. 4*), coinciding with vertical acceleration peaks (*picture nr. 6*);

**QAR - SPEEDS**

A probable speed reading delay and the AP reduced authority in “P.DES” mode, may justify the aircraft punctual speed overrun (*picture nr. 5*).

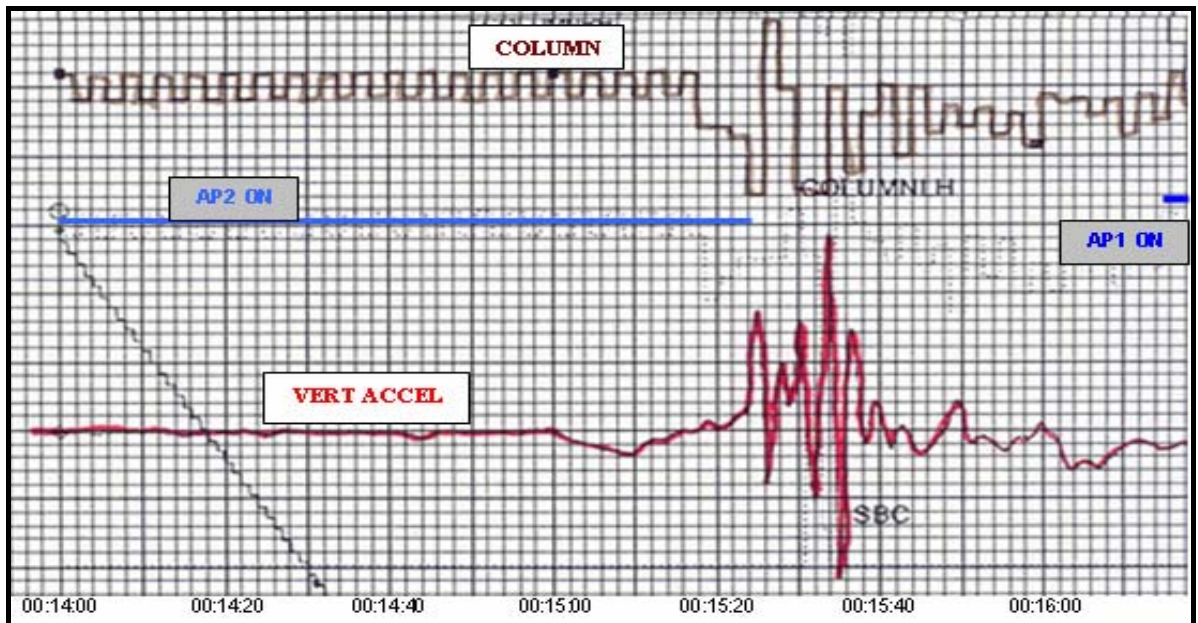
Picture Nr. 6

- m) After 00:15:32, those movements became synchronized and decreasing its amplitude until normalizing and allow AP1 engagement (00:16:14);
- n) Extreme values of control column (-8 / +5), pitch (-6 / +8.6) and vertical acceleration (+2.42 / -0.09) were attained during manual phase of the flight, when speed was at or above VMO.

**QAR – CONTROL COLUMN & VERTICAL ACCELERATION**

That abnormal AP disengagement, the uncoordinated forces applied to control column and the high sensitivity of flight controls at high speeds, caused several longitudinal oscillations of the aircraft with high vertical acceleration values (*peaks of +2.42g and -0.09g in 2*”).

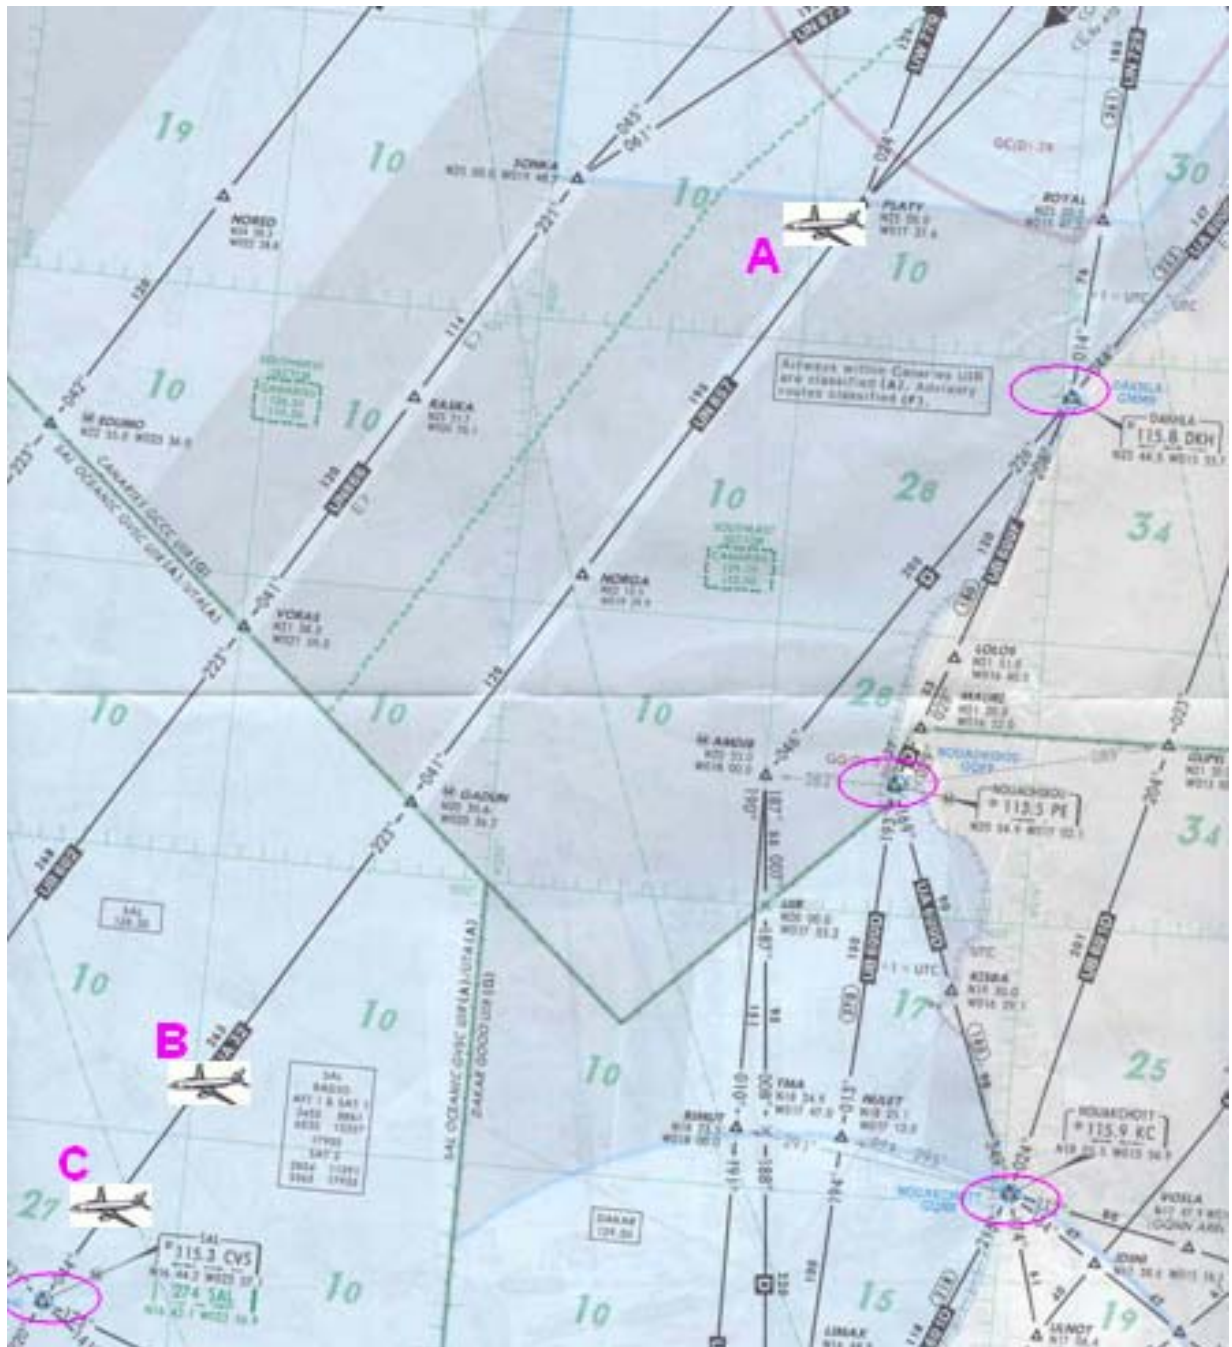
Picture Nr. 7

Along the route flown, there are large areas where enroute aircraft can't receive ground stations VHF NAVAIDS signals with enough quality to be used by FMC (*picture nr. 7*).

Flying the programmed route (*picture nr. 7*), the aircraft flew for a long period out of reaching of suitable such NAVAID signals and, consequentially, unable to make an update of its position.

Between points “A” and “B”, it was almost impossible to get a signal quality capable of provide enough reliability for position update.

Passing position “C”, the AP 2 received that order and commanded a “pitch” down movement, increasing speed and descent rate.
