MINISTRY FOR  
INNOVATION AND TECHNOLOGY  
TRANSPORTATION SAFETY BUREAU

**FINAL REPORT**  
**2016-071-4P**  
**SERIOUS INCIDENT**  
**LHBP**  
**16/03/2016**  
**ATR 72-200**  
**YR-ATI**

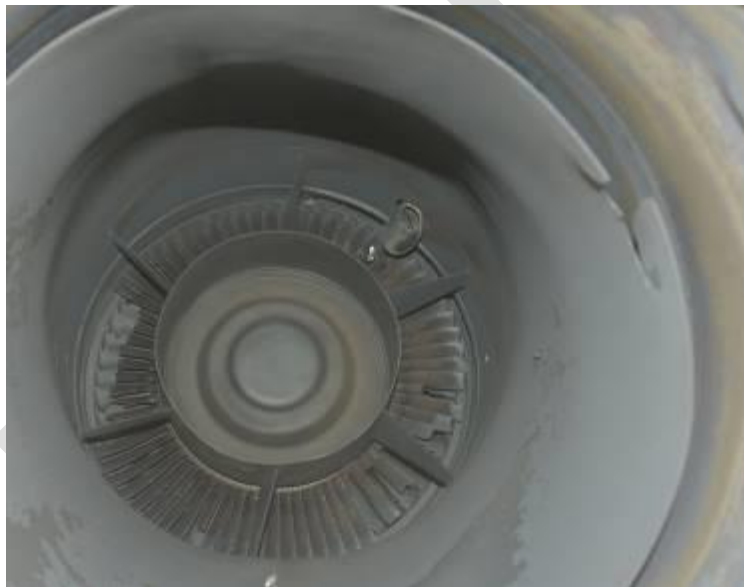
The power turbine stage of the right hand side (№2) engine (Figure 4) and the tail pipe were badly damaged, and the fire caused significant damage to the engine nacelle (Figure 5). Engine failure was contained and no damages have been found outside of the engine nacelle.

**Figure 4:** engine №2 from the direction of the tail pipe, after landing

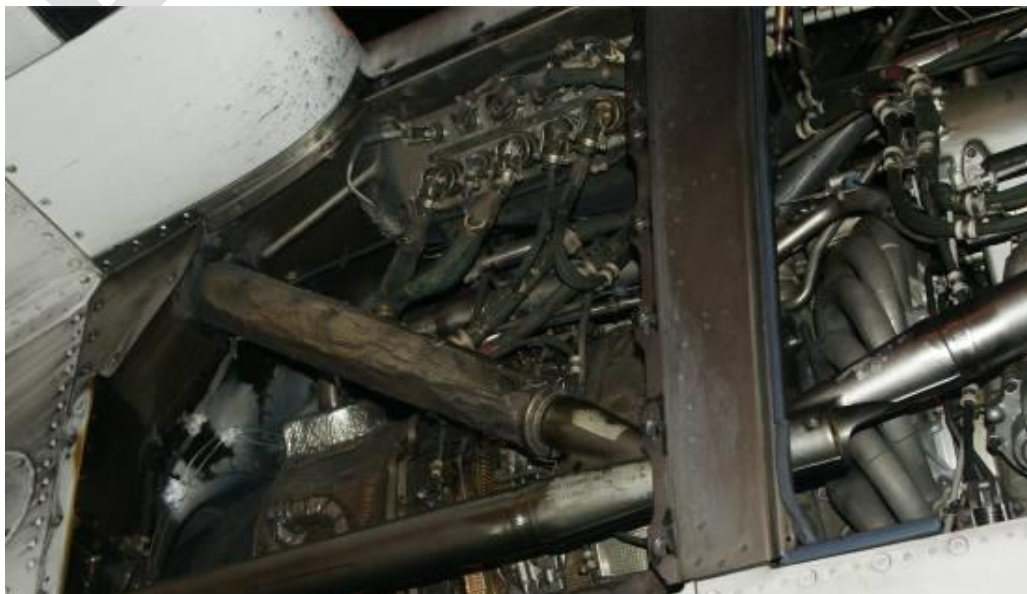
**Figure 5:** Visible signs of the high temperature in the nacelle of the engine №2

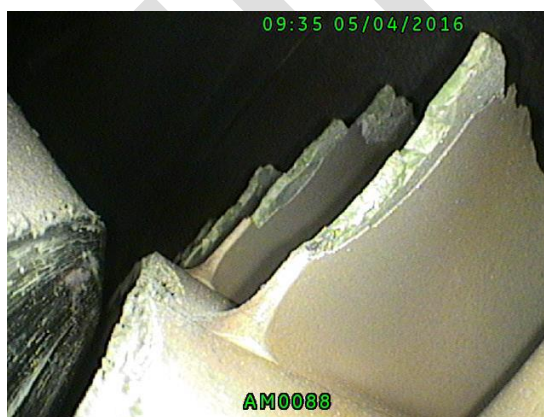
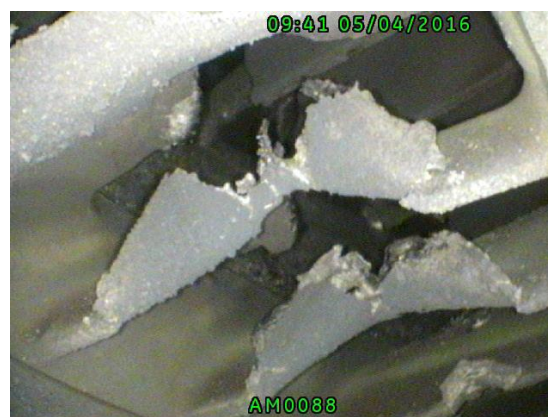
**Figures 13 & 14:** *Boroscope photos of the low pressure turbine and the power turbine (VAF)*

- The blades of the discs of both stages of the power turbine were badly damaged
- The low-pressure compressor showed no sign of damage caused by ingested foreign object.
- The outside of the engine showed the signs of effects of high temperatures.
- Significant quantity of metal debris was found in the oil system
- Both discs of the power turbine were badly damaged.

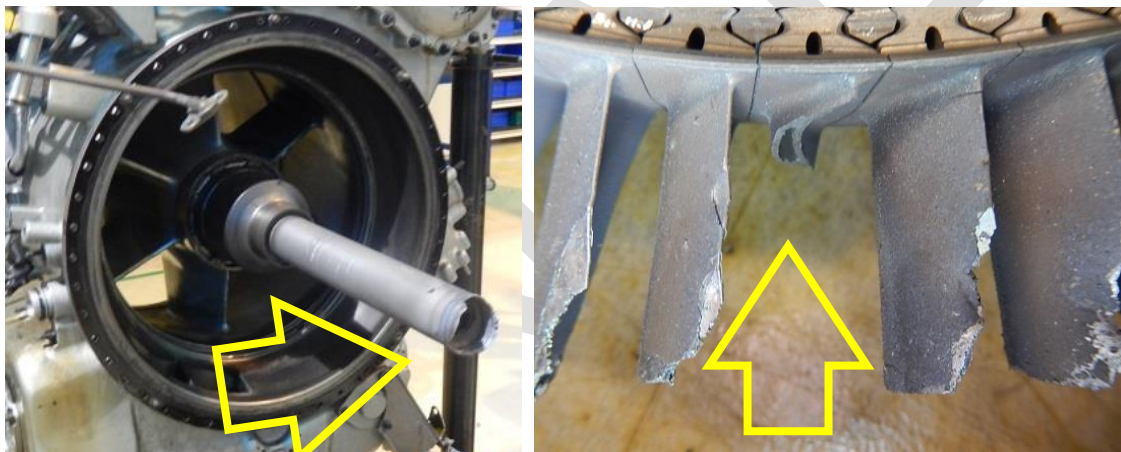
**Figures 15 & 16:** *The fractured shaft of the power turbine, and the stump of the fractured blade which started the process leading to engine failure (Vector Aerospace France)*

The information acquired during disassembly of the engine show that the process leading to the failure of the engine may have been started by the fracture of a blade in the 1<sup>st</sup> Stage PT. The rotor assembly became unbalanced, and the vibration evoked by it probably broke the three oil pipes holding the № 6 & 7 bearing housing. The unsupported bearing housing could not keep the shafts in place, and the spilt oil caught fire. As a consequence of the above events, both the low-pressure and the power turbine rotor assemblies were displaced, and were finally damaged, and the shafts fractured. The damages of the compressors are the consequence of the severe damages of the turbine section.

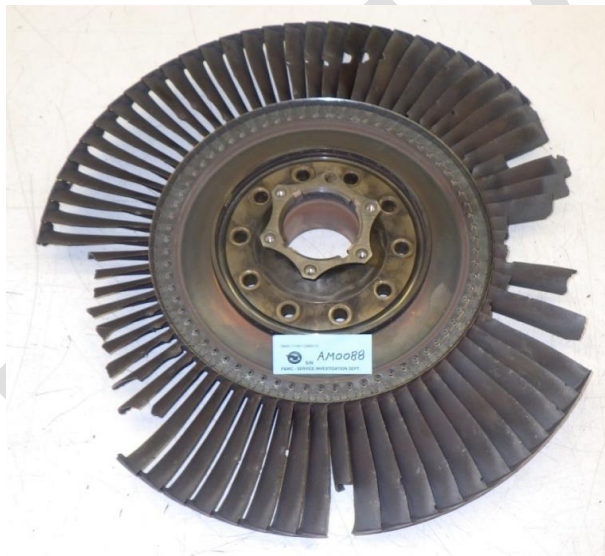
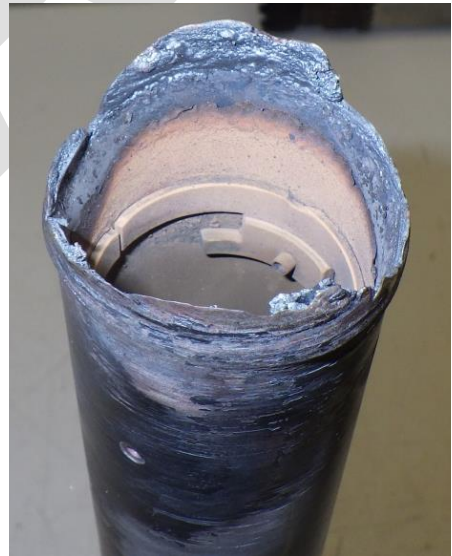
**Figures 18 & 19:** the rotor assembly and the fractured, molten shaft of power turbine, 2<sup>nd</sup> stage (PWC)

- The 2<sup>nd</sup> stage PT stator shows impact damage.
- Several blades of the 2<sup>nd</sup> stage PT rotor assembly fractured at different heights due to single impact.
- The bearing housing № 6&7 was overheated, deformed, its fastening screws fractured; the oil pipes to it also broke and show burn marks as well.
- The PT shaft melted and fractured at the № 5 bearing area.
- The shaft of the LP turbine also fractured at the № 5 bearing area as an effect of friction with the fractured shaft of the power turbine.

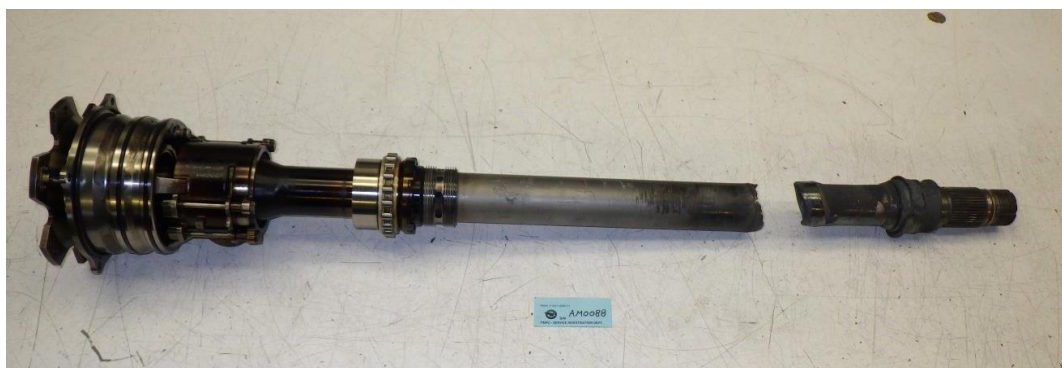
- Several blades of the 1<sup>st</sup> stage PT stator were melted.
- The № 6 & 7 bearing housing disintegrated due to high temperature.
- The shafts of the low-pressure turbines and power turbines melted and fractured.

**Figure 20:** The molten and fractured shaft of the power turbine (Pratt & Whitney Canada)

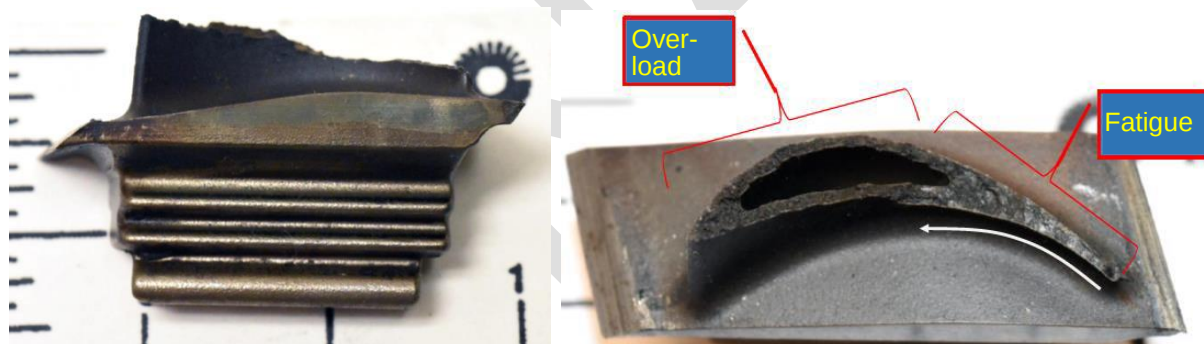
**Figures 21 & 22:** Root of the fractured PT blade and the fractured surface (Pratt & Whitney Canada)

- A fatigue crack started out from the trailing edge of the blade and spread towards the leading edge (Figures 21 & 22, white arrow), as far as half of the chord length. The remaining part fractured due to overloading.
- The composition of the alloy of the blade meets the relevant requirements.
- The geometrical layout of the trailing edge of the blade shows no anomaly.
- The remainders of other blades of the power turbine showed no fatigue cracks.

It may be established on the basis of information from the lab test that a fatigue crack started out from the trailing edge of the trailing edge of a blade of the PT1 and its spreading finally led to fracture of the blade. No defect of material or mechanical damage was found around the area where the crack started out. The damage to other stator vanes and rotor blades of the power turbine was a consequence of the first blade fracture. The power turbine became unbalanced, and its intensive vibration caused fractures of the of the oil pipes and screws which fixed bearing housing № 6 & 7, as a result of which the low- and high-pressure power turbine shafts may have contacted and fractured. The fire fuelled by spilt oil led to thermal damage to or deformation of the 1<sup>st</sup> stage PT stator, the low-pressure turbine, the bearing housing № 6&7, and the oil pipes. The damage to the blades of the high-pressure turbine was due to overheating.

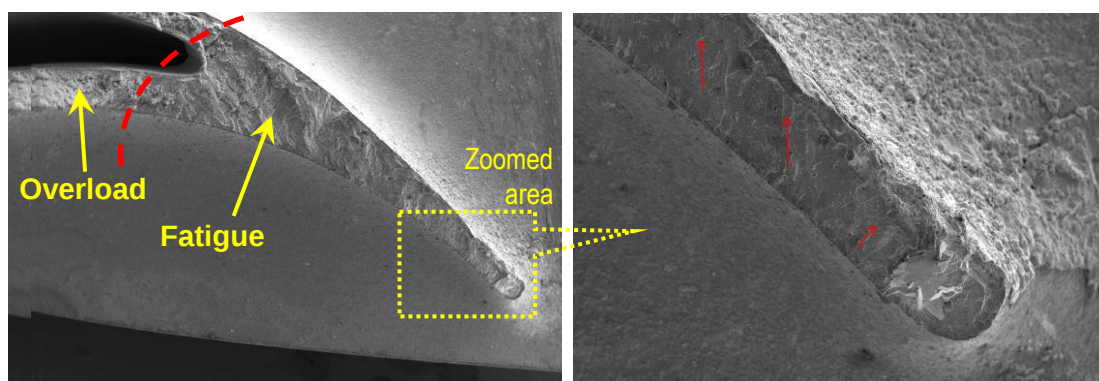
**Figure 23:** Electron microscopy image of the fractured surface at the trailing edge of the blade (PWC)
