**INTERSTATE AVIATION COMMITTEE  
AIR ACCIDENT INVESTIGATION COMMISSION**

**INTERIM REPORT  
(PRELIMINARY REFERENCE INFORMATION)  
ON ACCIDENT INVESTIGATION**

Type of occurrence	Accident
Type of aircraft	RRJ-95 (RRJ-95B)
Registration	RA-89098
Owner	JSC «VEB-Leasing»
Operator	«Aeroflot » PJSC
Aviation authority	Federal Air Transport Agency (Rosaviatsiya)
Place of occurrence	Russia, Moscow region, Sheremetyevo airport, coordinates: 55°58'06.20" N, 37°24'07.20" E.
Date and time of occurrence	05.05.2019, 18:30 local time (15:30 UTC), daytime

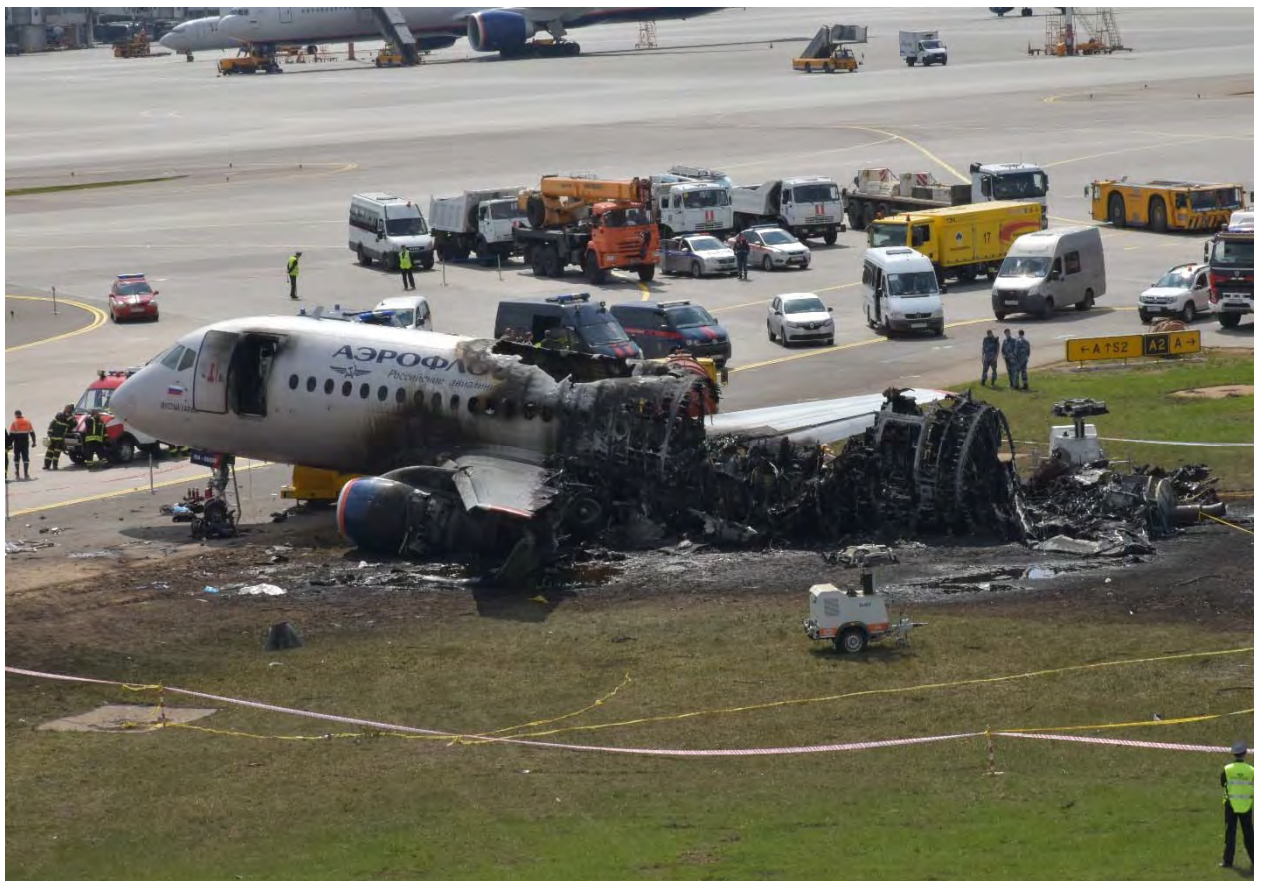
**Fig. 9. Aircraft RRJ-95B RA-89098 after the accident**

Fig. 9 presents the external view of the aircraft after the stop and the fire extinguishment. The wreckage map of the accident site is given on Fig. 41.

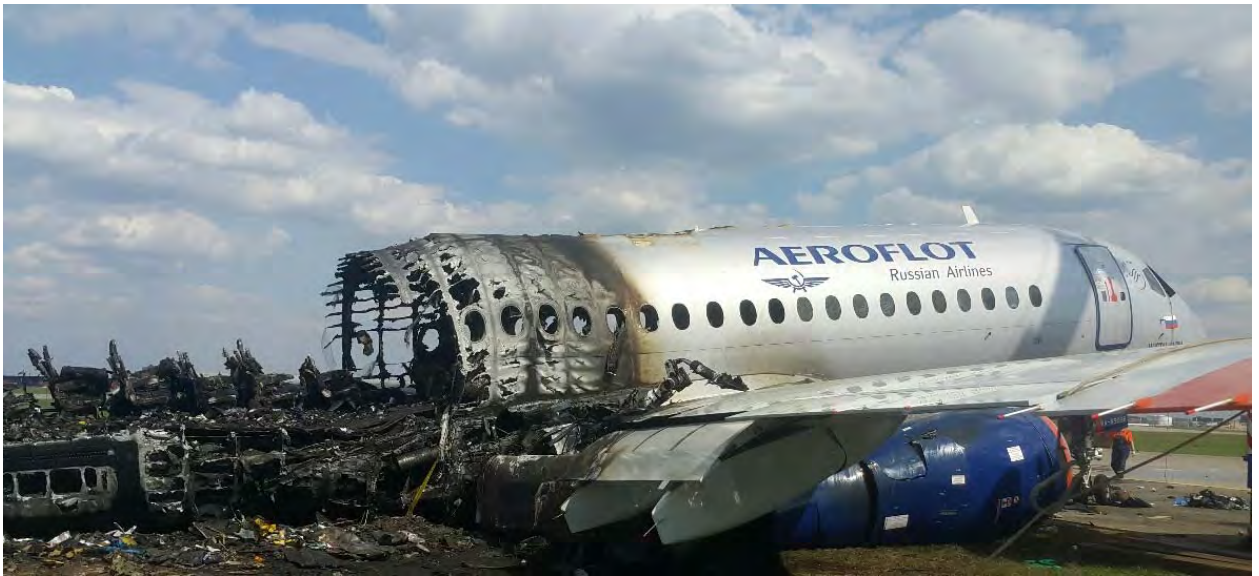
Fuselage sections F1, F2 (ribs 1-24) do not have external structural damage (Fig. 10)..

**Fig. 10. External view of the fuselage front part after the accident**

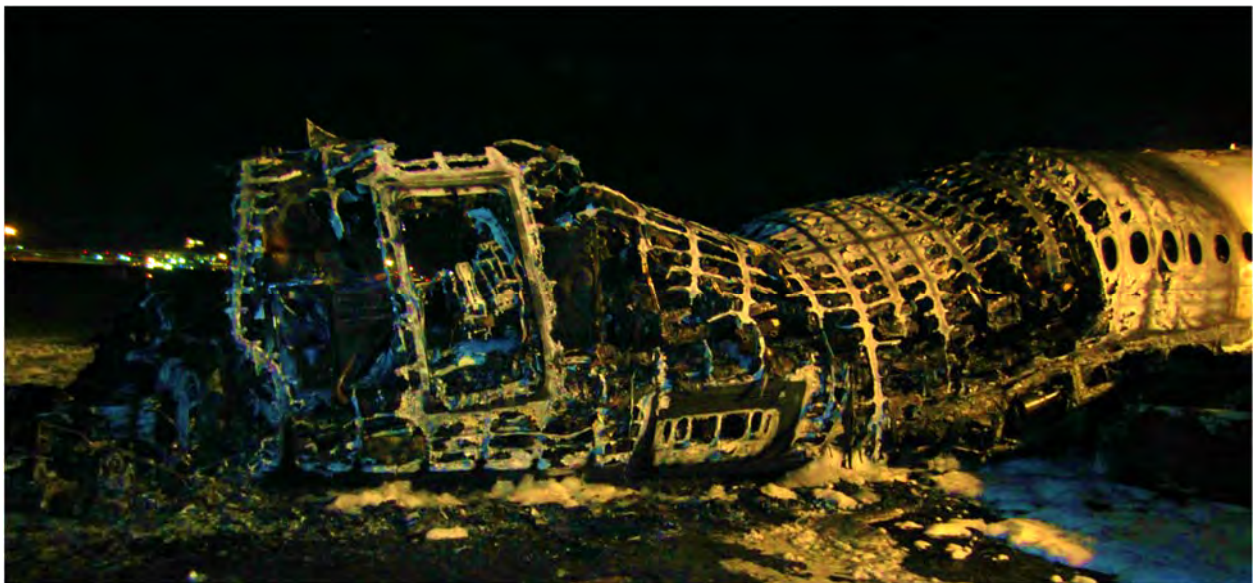
F3 and F4 (ribs 24-51) burned up completely after rib 29 from the floor level and have substantial skin burnout below the floor level (Fig. 11).

**Fig. 11. External view of the middle and rear part of the fuselage after the accident**

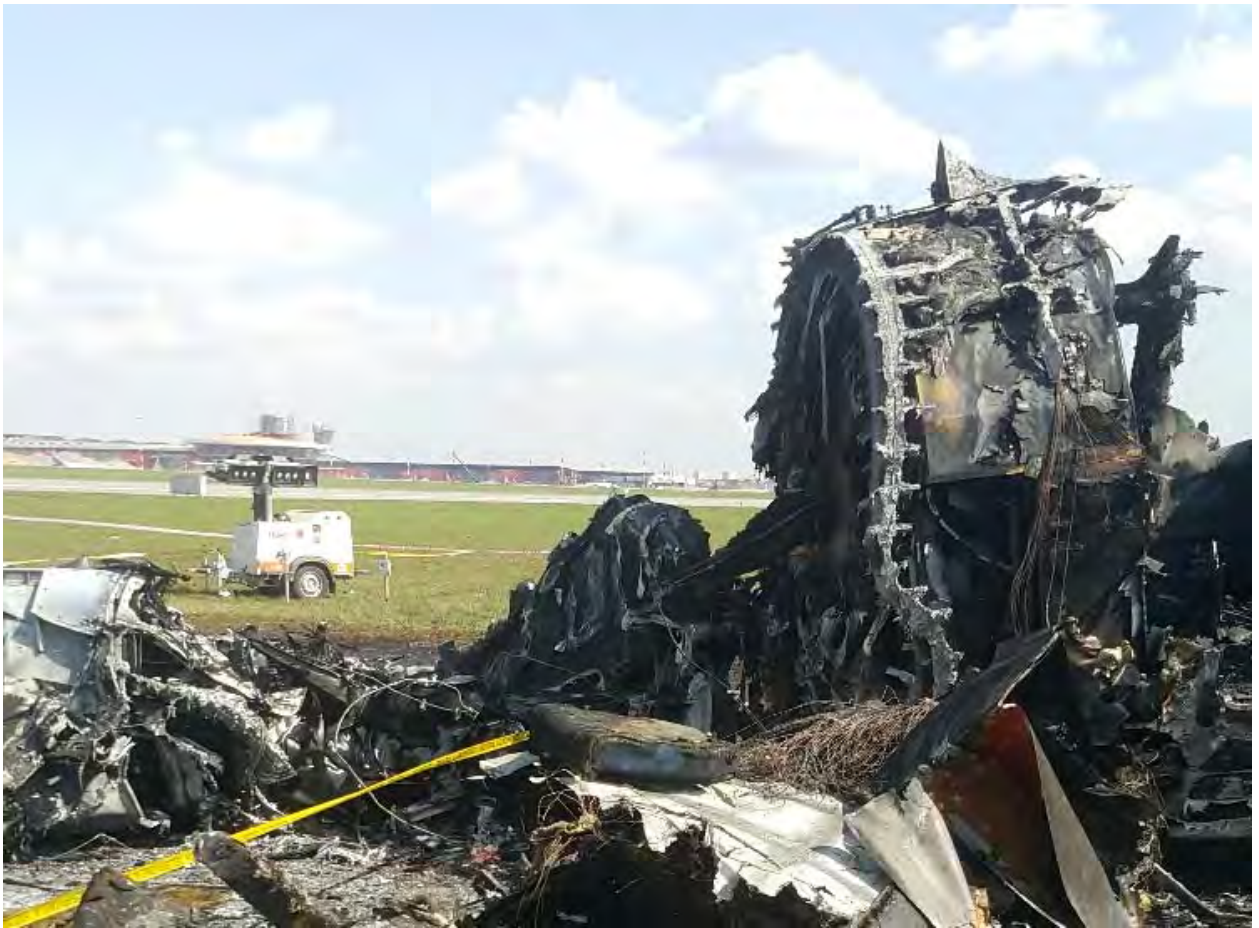
F5 burned out completely, framework and components fragments situated on the floor and around rib 51 on the ground (Fig. 12).

**Fig. 12. External view of the F5 section**

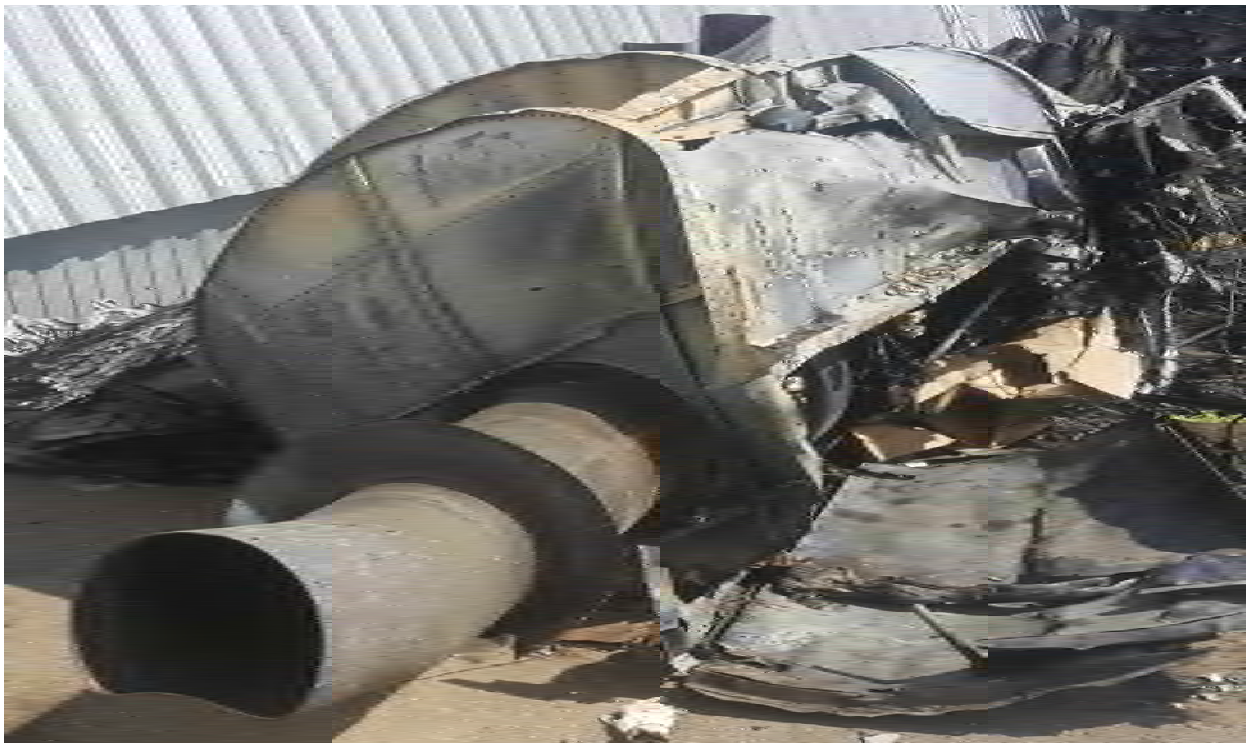
F6 burned despite the details made of steel and Ti-alloys (Fig. 13), framework and components fragments situated on the floor and on the ground.

**Fig. 13. External view of the F6 section**

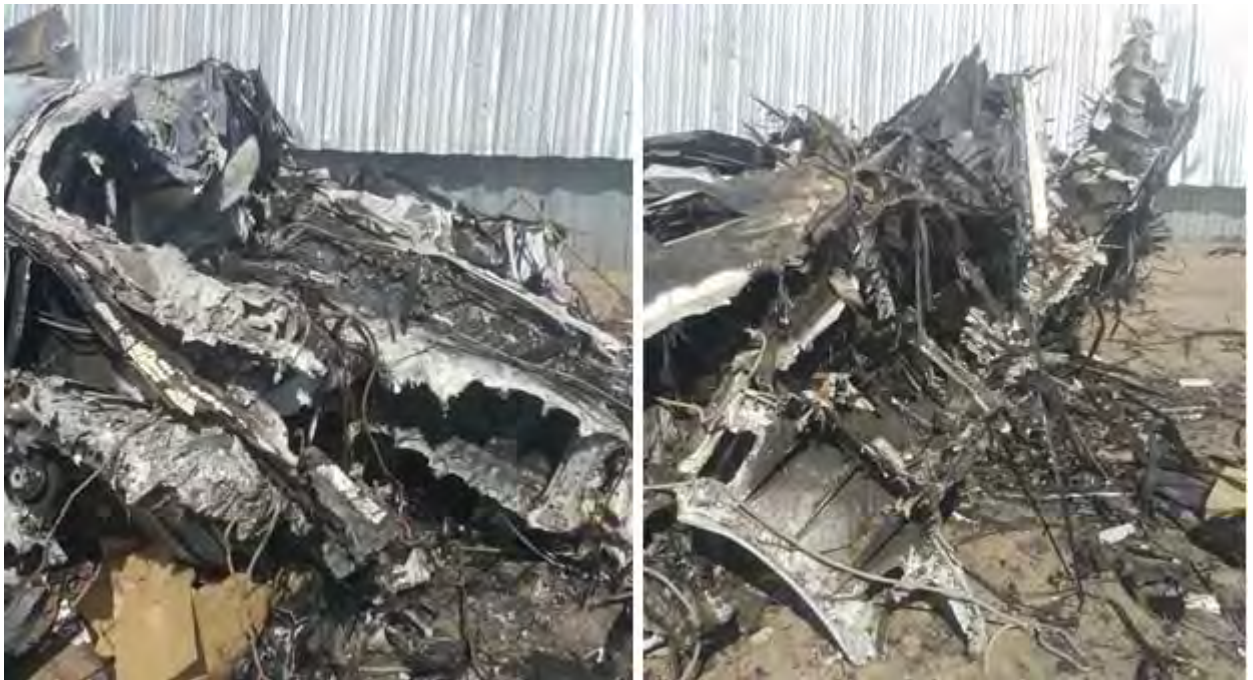
Vertical and horizontal stabilizers burned down (Fig. 14), remaining elements situated on the ground.

**Fig. 14. External view of the vertical and horizontal stabilizers after the accident**

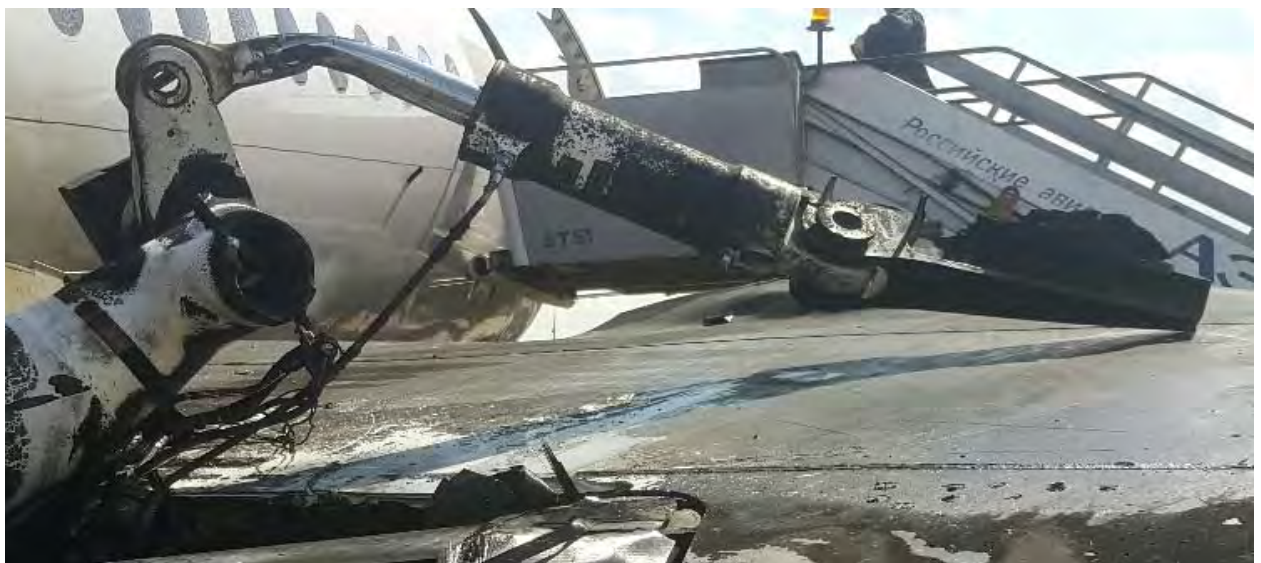
- lower panels of the right-side wing burned out apart from the root segment;
- rear pylon fairing of the right-side wing burnt, flap fairing burned out;
- cylinder bracket of the right main landing gear separated from the rear spar and is situated under the console panel hanging (Fig. 15). After the separation of the cylinder bracket of the right main landing gear there occurred a hole in the spar web, and the fuel spilled through it from the fuel tank of the right-side wing (Fig. 16);

**Fig. 15. External view of the cylinder of the right main landing gear**

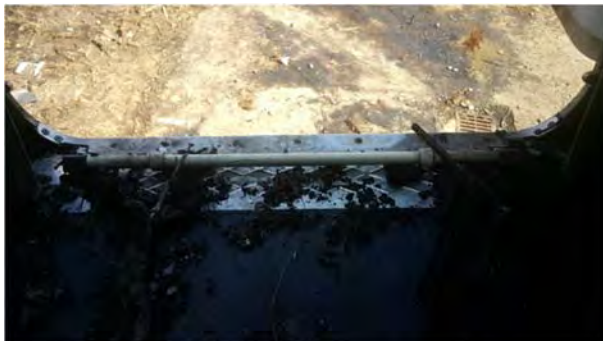
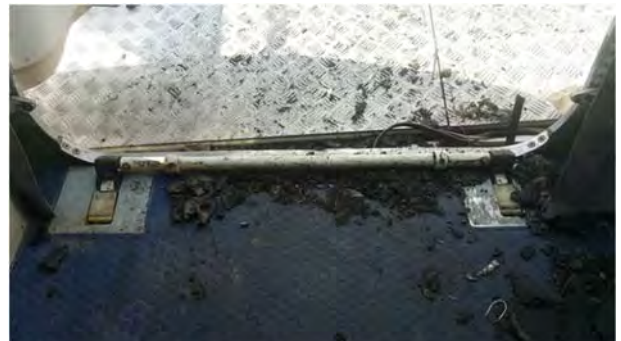
**Fig. 17. External view of the front doors (left, right)**

Front right and left doors of the cabin are opened, bars of the safety slides connected to brackets of door beams (Fig. 17).

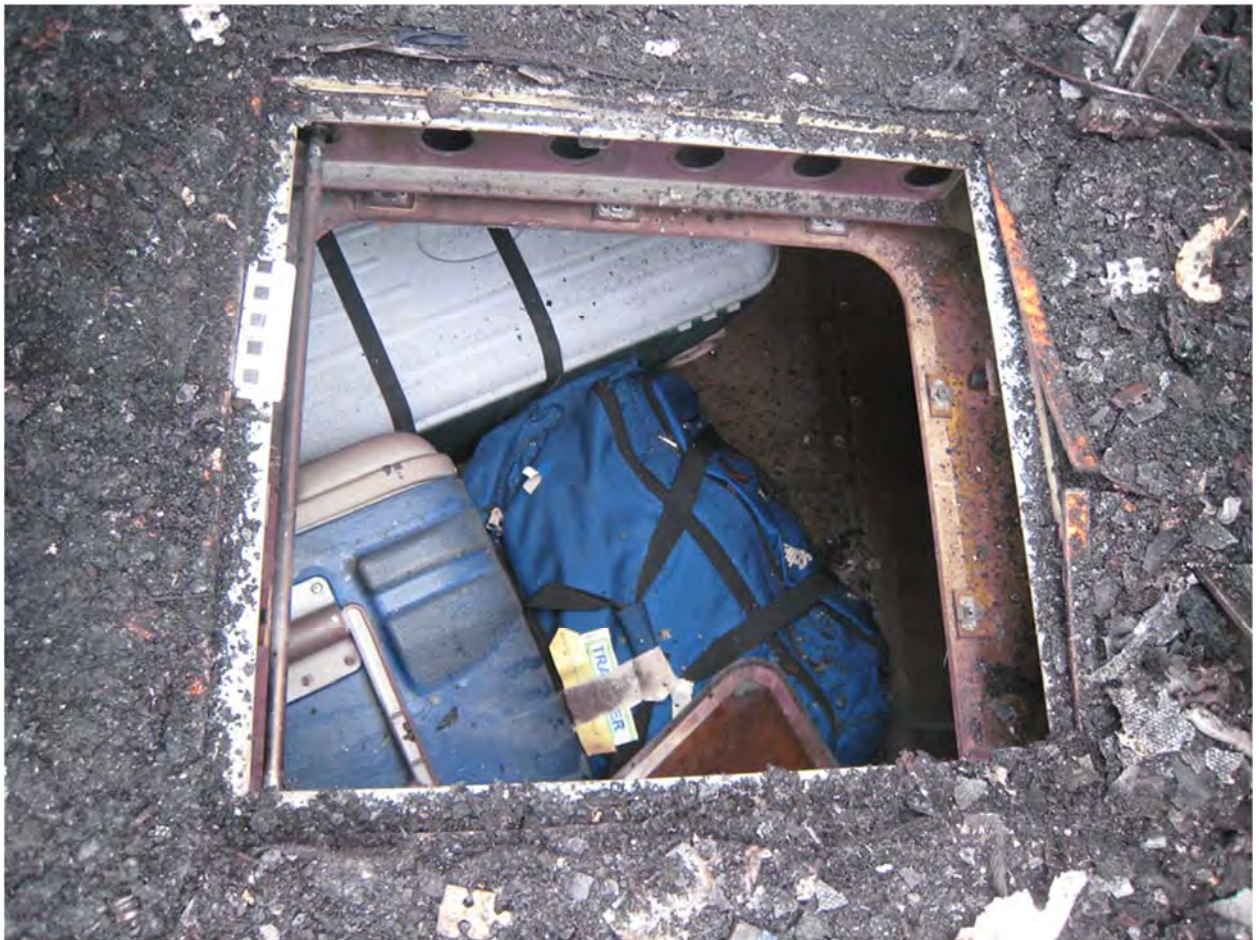
Rear baggage compartment damaged partially, there are no signs of open fire in the compartment. There is soot on the front wall of the compartment and the baggage of the passengers (Fig. 18). The access to the rear baggage compartment after the accident was carried out through the upper hatch with no mechanical damage (Fig. 19).

**Fig. 19. External view of the rear baggage compartment after the accident**

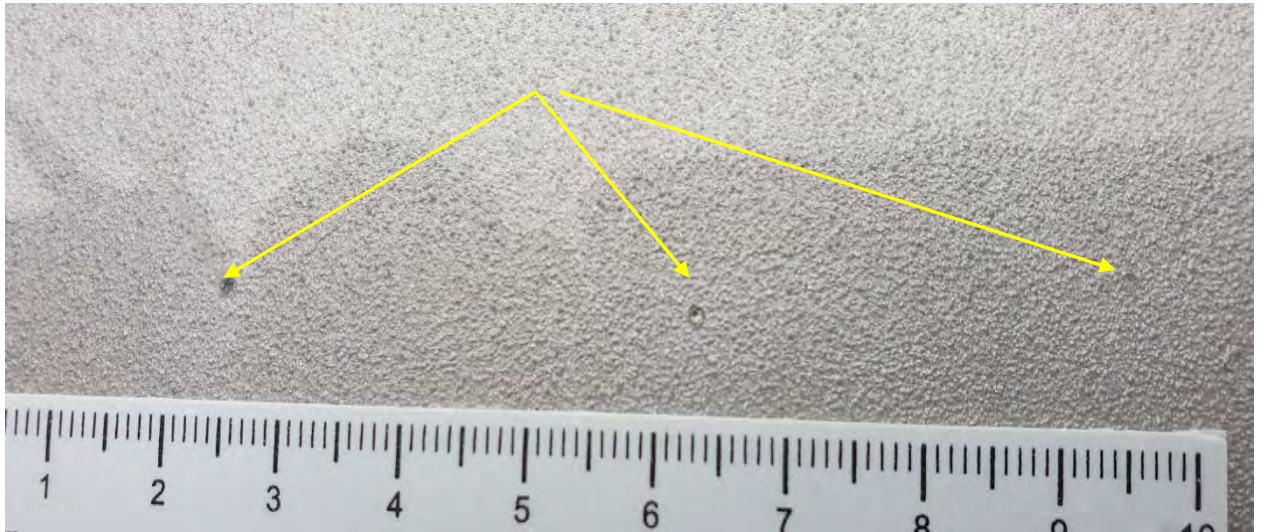
During fuselage examination, including the nose part, after the evaluation of the antennas, transducers (ice detector, temperature probe, angle-of-attack sensor) the exit lights and the cockpit windows there were the traces typical for lightning impact detected (Fig. 23, Fig.24, Fig. 25).

**Fig. 23. The external view of the damage caused by the lightning strike to the upper front part of the fuselage**

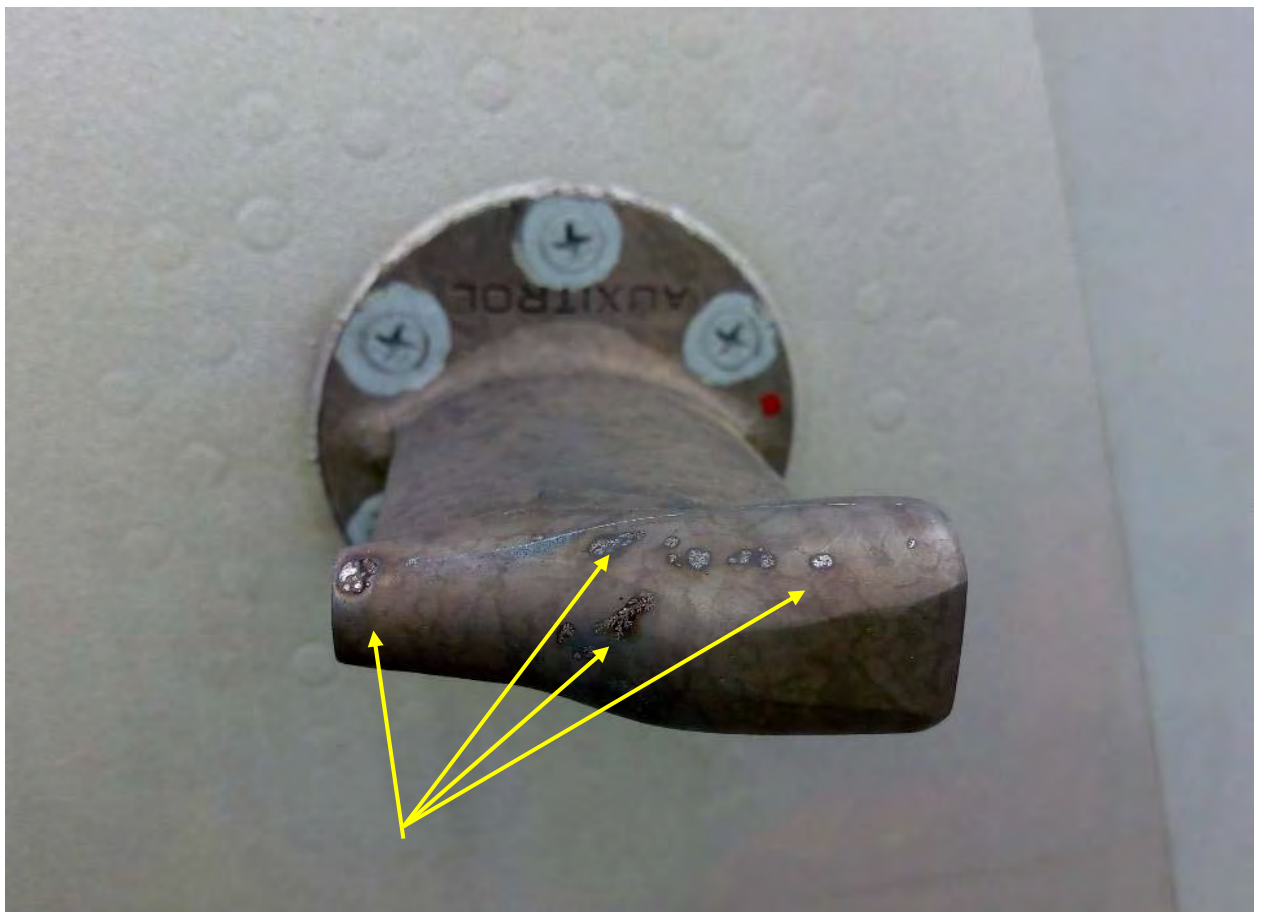
**Fig. 24. Lightning strike traces on the right temperature probe**

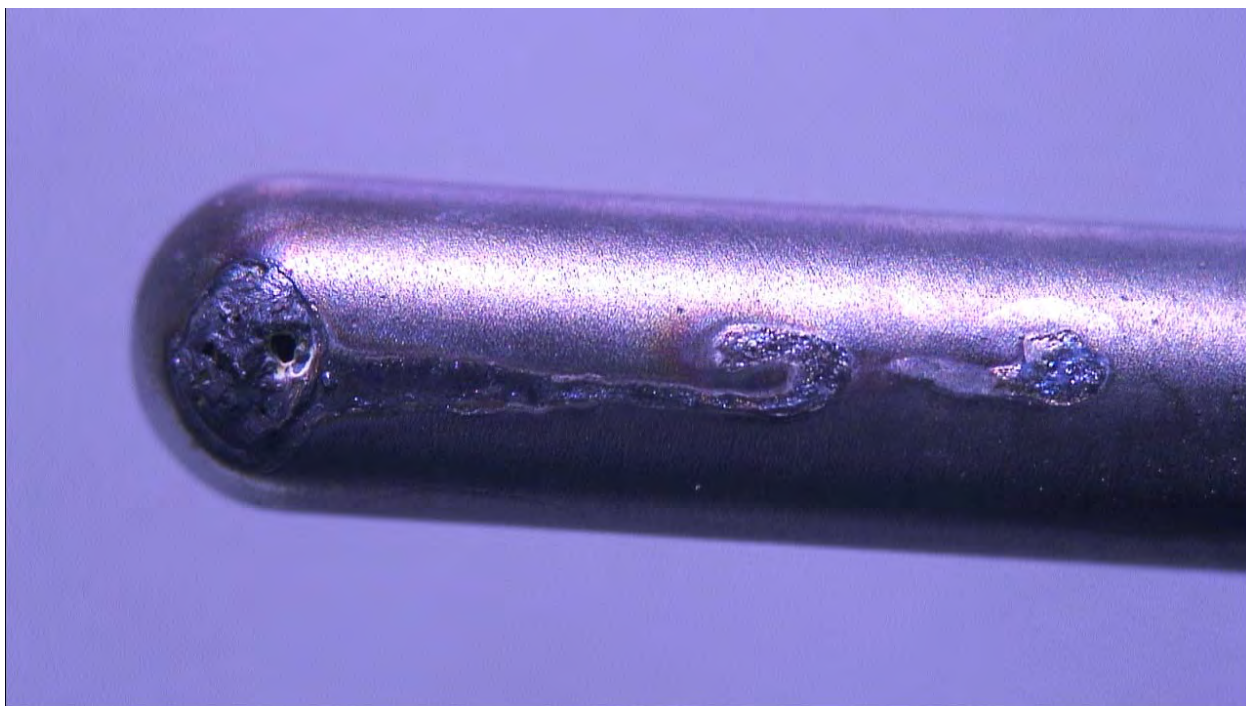
**Fig. 25. Lightning strike traces on the right ice detector**

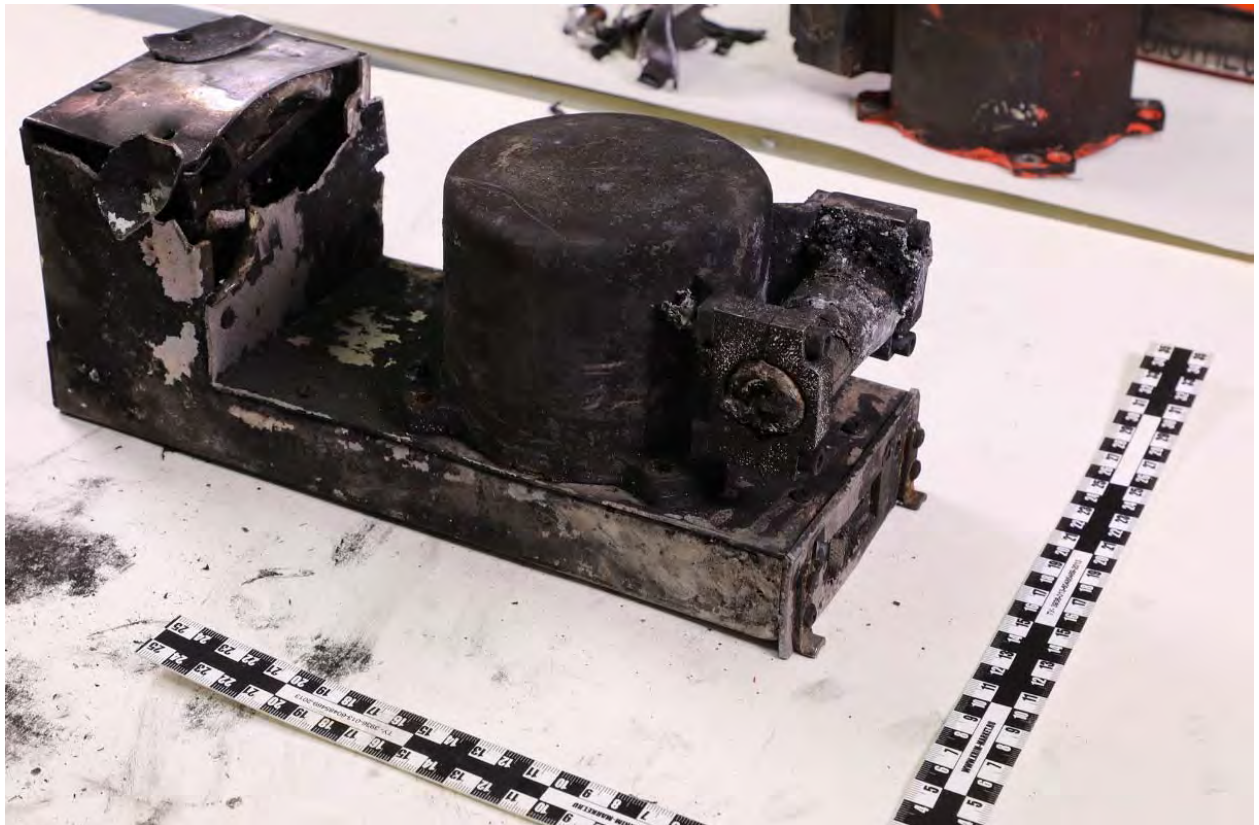
- FDR L3 FA2100 PNR 2100-2043-12 was damaged, as a result of the heat exposure, the body of the recorder unit was partially destroyed (Fig. 30);

**Fig. 30. General view of the FDR L3 FA2100**

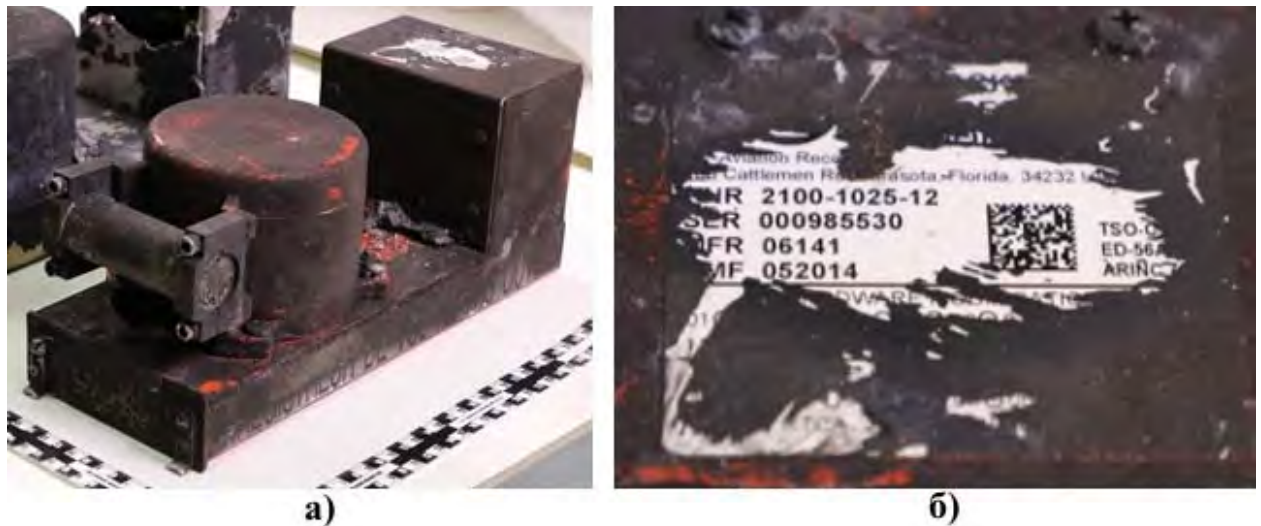
Fig. 31. CVR L3 FA2100: a) general view, б) device label

- CVR L3 FA2100 PNR 2100-1025-12 was damaged, its housings and protected memory module are covered with soot, no deformation (Fig. 31);
- Integrated Data Management Unit (iDMU) PNR 223560006 with a PCMCIA Flash-card s/n 2088-51M. The body of the iDMU is not damaged, was not exposed to fire, is in satisfactory condition (Fig. 32).

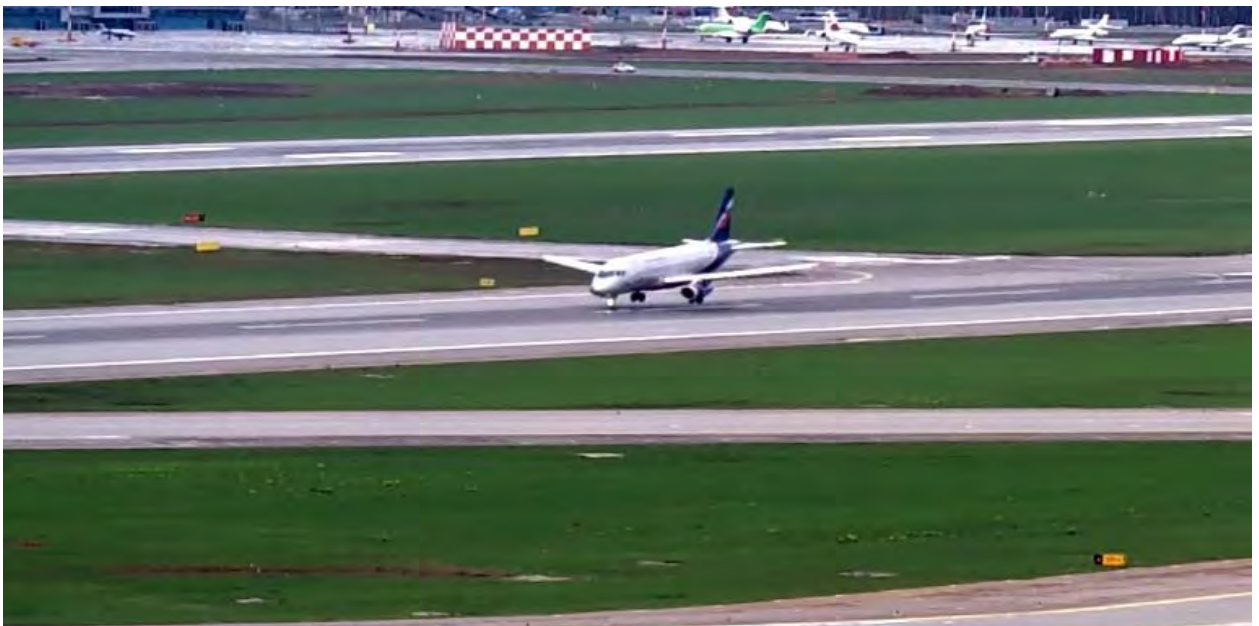
The second touchdown occurred at the distance of  $\approx 1070$  m from the RWY 24L threshold, first by the nose gear leg with the further main gear legs impact with the RWY (Fig. 35), another bounce off the RWY occurred afterwards (Fig. 36). At the area of the second impact there were no fuel traces or aircraft fragments found.

**Fig. 35. The place of the second touchdown**

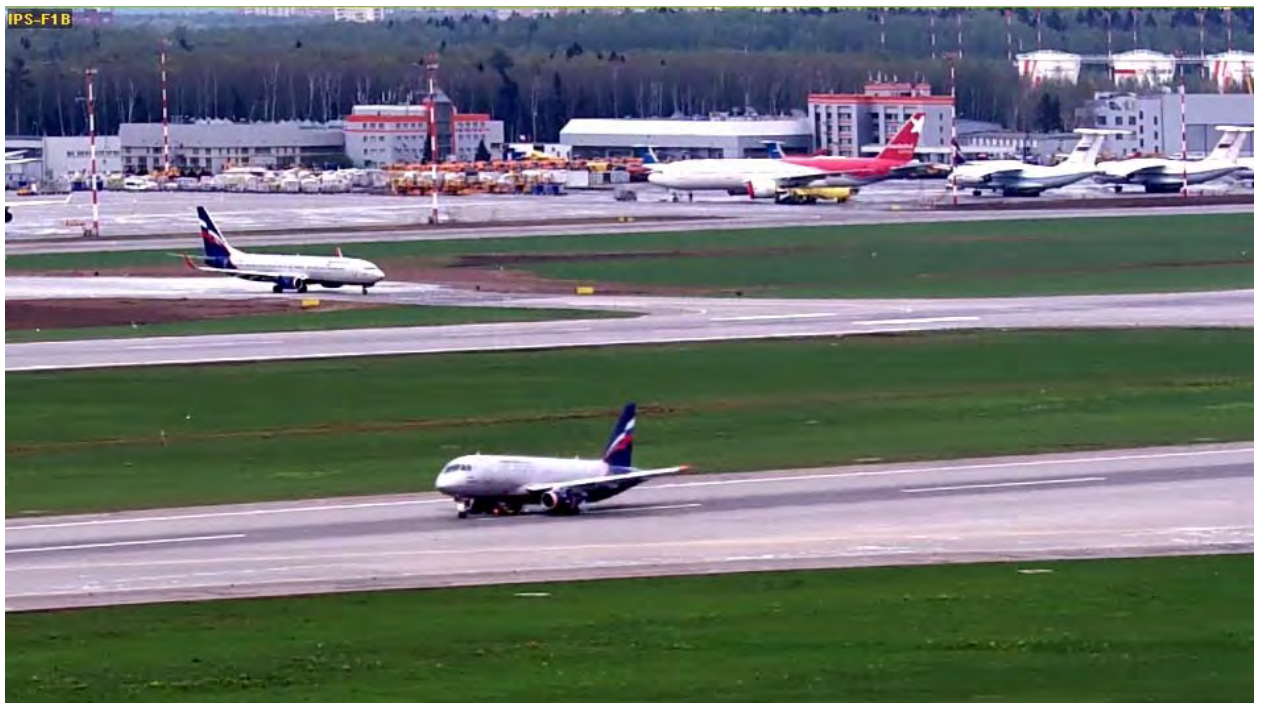
The third touchdown occurred at the area of the A7 TWY, at the distance of about 1360 m from the RWY 24L threshold, first with the right main gear leg, then with the left one (Fig. 37).

**Fig. 37. The place of the third touchdown**

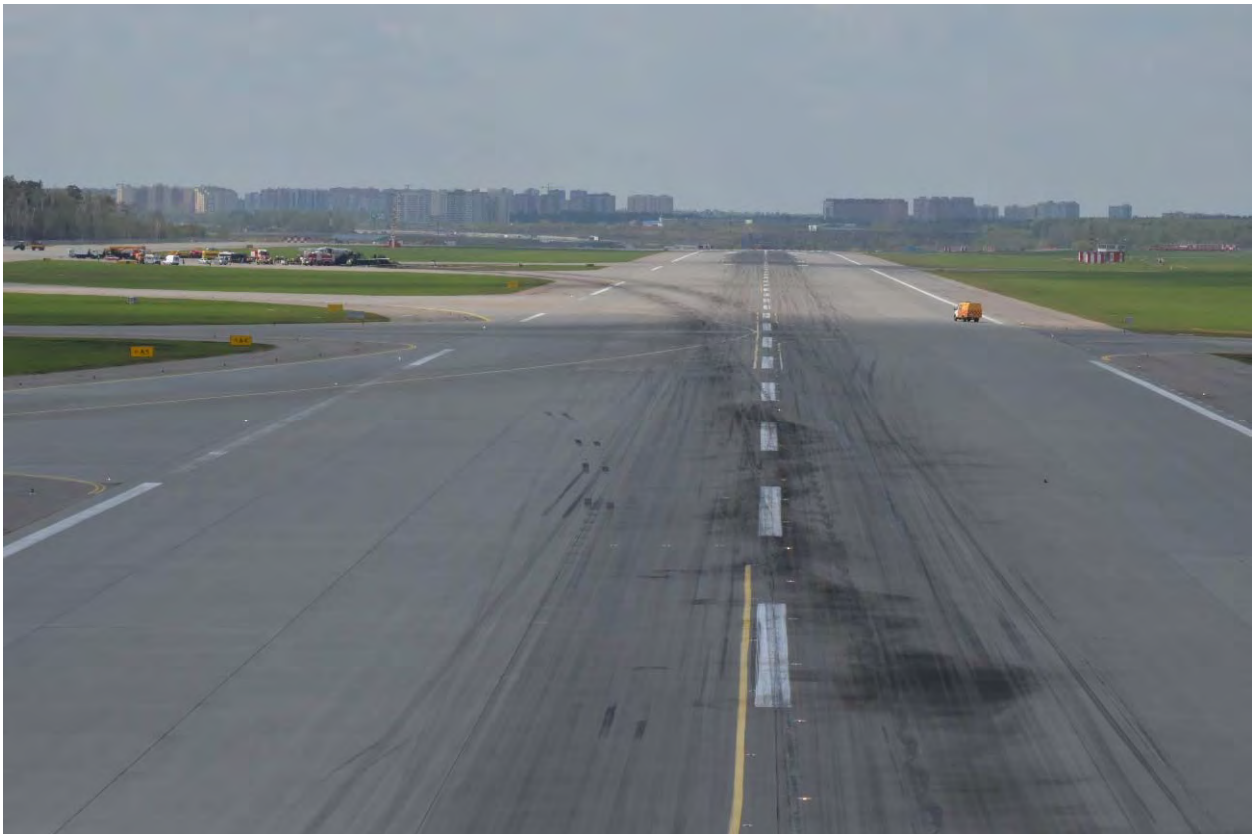
Initially the aircraft moved straightforwardly along the runway centerline on the right side. At the area of TWY A5, the onset of the left shift of the aircraft and its deviation off the RWY centerline was detected (Fig. 38).

**Fig. 38. The onset of the left shift traces off the RWY centerline at the area of the A5 TWY**

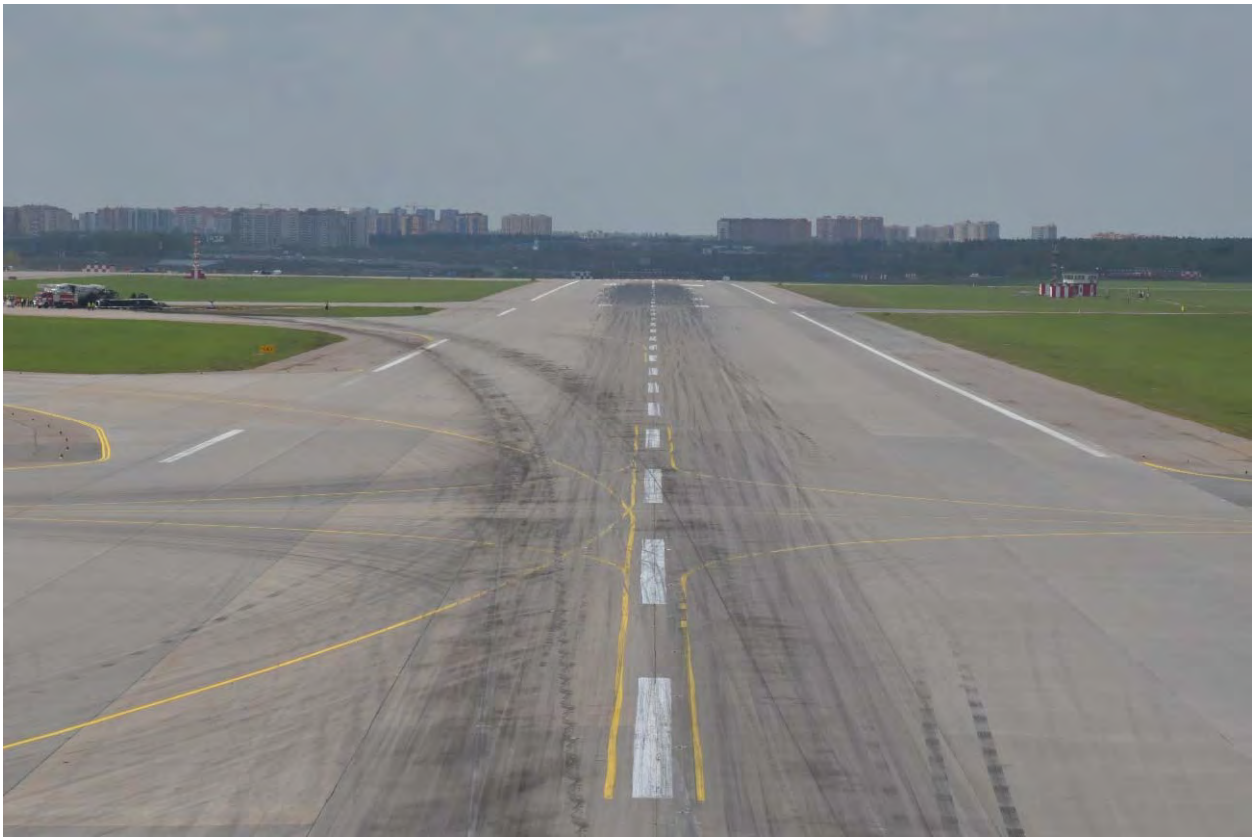
The aircraft excursion of the RWY occurred at the area of the A3 TWY (2460 m off the RWY 24L threshold) (Fig. 39).

**Fig. 39. The aircraft motion traces, the point of the RWY excursion at the area of the A3 TWY**

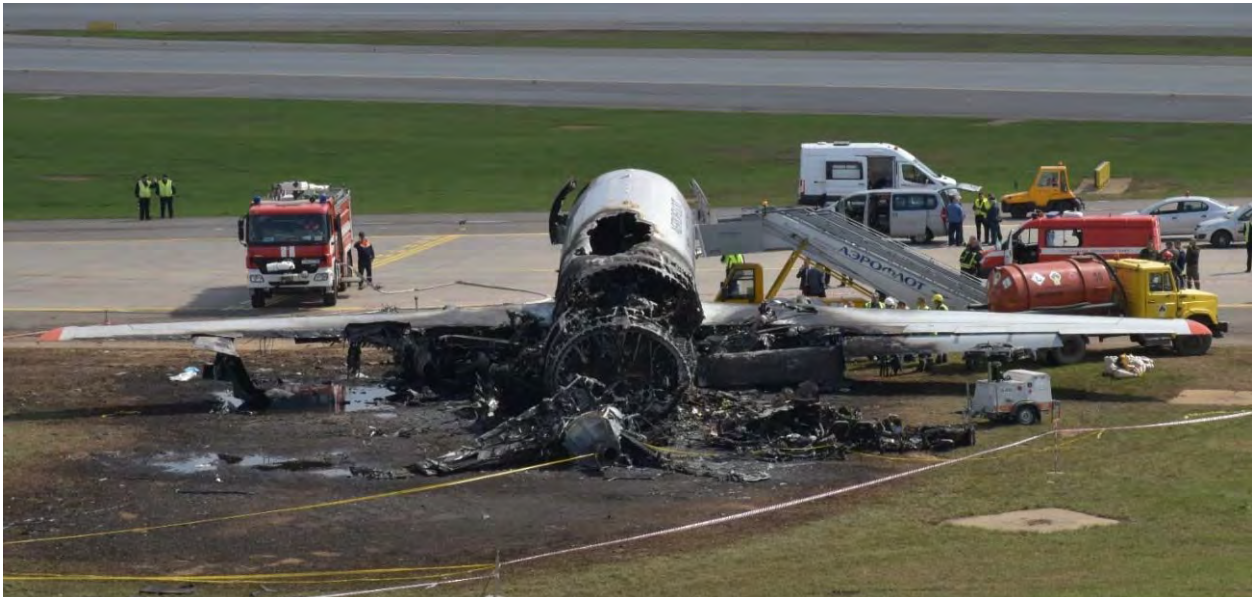
The AC stopped in between the TWYs \2 and 3, at the 55°58'06.20" N., 37°24'07.20" E at the height of 185 m, the true heading of 128° (Fig. 40). The distance from the RWY 24L threshold was  $\approx 2720$  m, the lateral deviation amounted to about 110 m to the left off the runway centerline.

**Fig. 40. The RRJ-95B RA-89098 aircraft at the accident site**
