# Report

Accident on **16 October 2012**  
at **Lorient Lann Bihoué (56) Aerodrome**  
to the **the Bombardier CRJ-700**  
registered **F-GRZE**  
operated by **Brit Air**

**BEA**

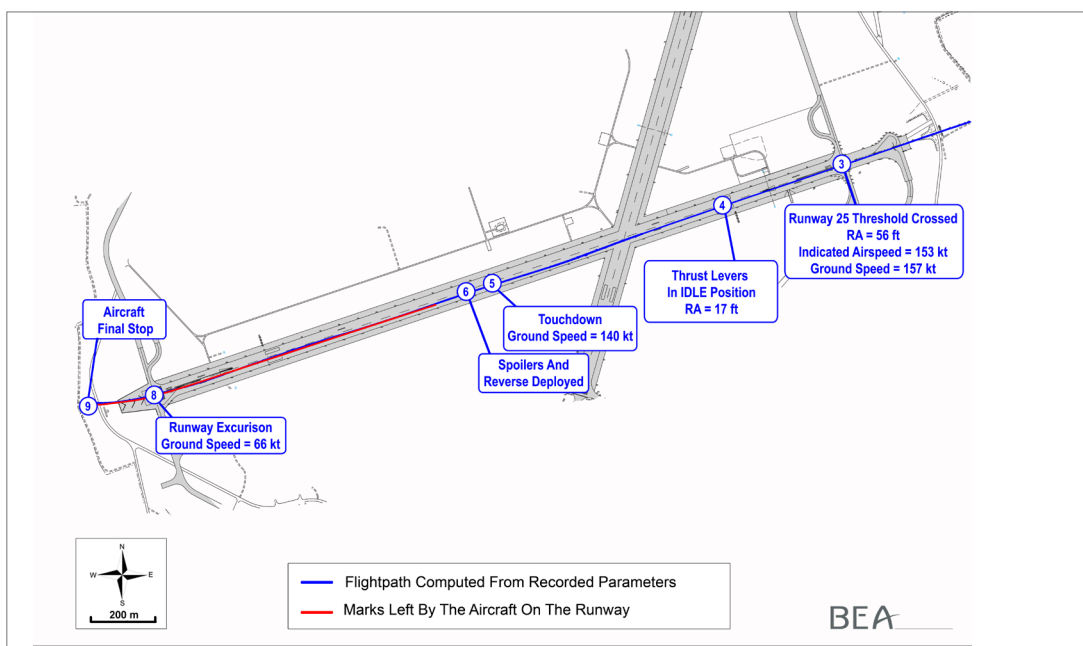
The flight path of the aeroplane was calculated from its ground speed, magnetic heading<sup>(18)</sup> and drift recorded on the FDR. It was consistent with the marks left by the aeroplane on the runway.

The positioning of the thrust levers to IDLE and touchdown of the main landing gear occurred respectively at 330 and 1.130 m from the threshold of runway 25.

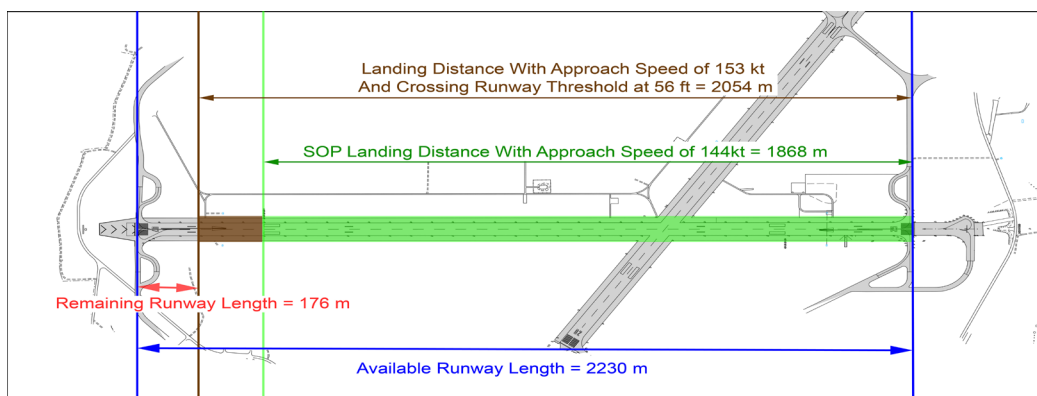
Under the event flight conditions, aeroplane performance would theoretically permit it to land on a contaminated runway, even if the remaining length of runway after the aeroplane came to a complete stop had only been 176 m.

Condition of runway	Gain in runway length with SOP compared with that of the event
Dry	124
Wet	171
Contaminated	186
